**Headquarters, Joint Task Force-Red Hill Public Affairs Office
Ford Island Conference Center
Joint Base Pearl Harbor-Hickam**

PRESS RELEASE

May 5, 2023

**Joint Task Force – Red Hill Announces AFFF Investigation Findings and Publishes
Video Footage**

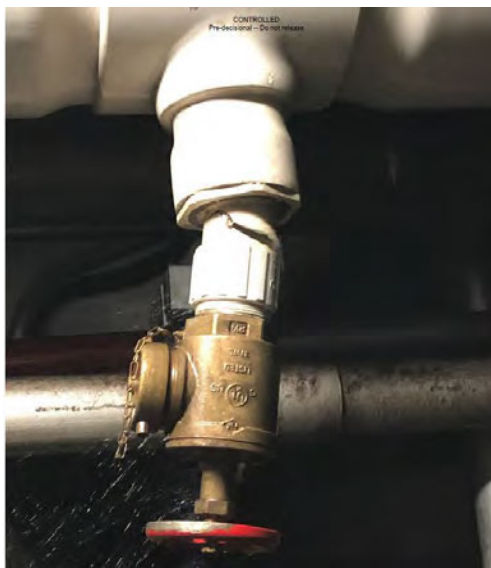
Cracked Low Point Drain

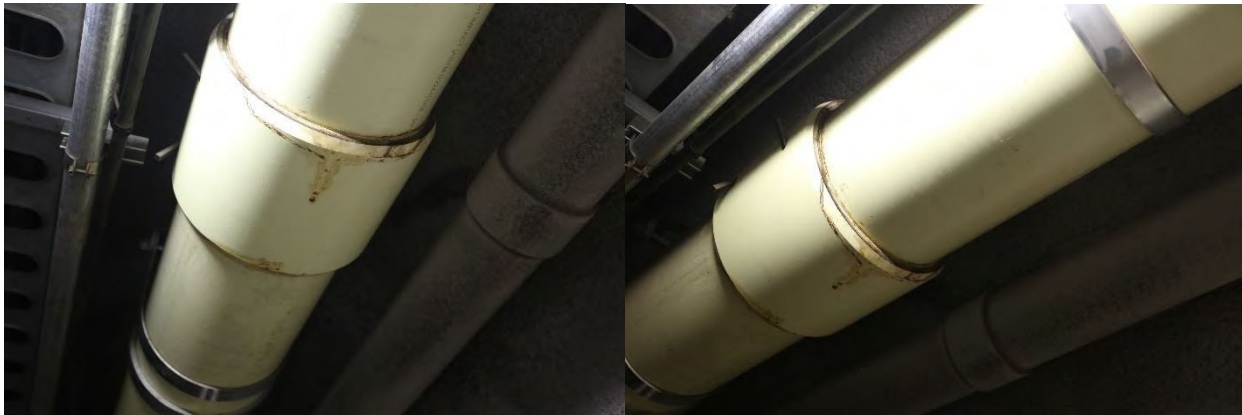
414. On 17 Mar 22, during a walkthrough of Red Hill, the supplement investigation team noted visual evidence of a foreign substance on the outside of the PVC AFFF retention line piping joints that appears to have seeped out.

Installed PVC AFFF Retention Line with Joint Seepage

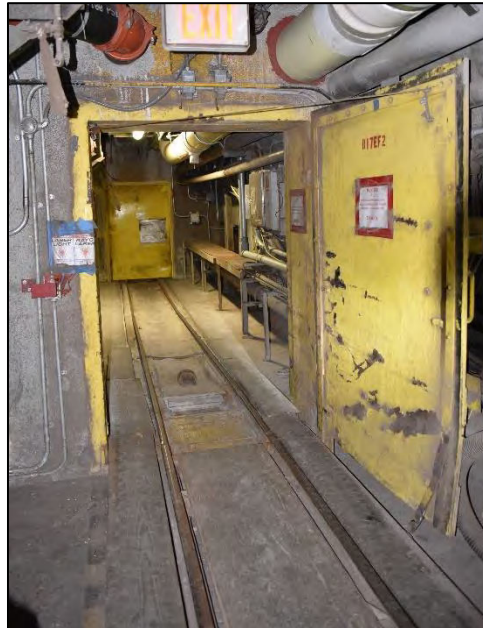
Figure 1: Image of open oil-tight door (foreground) and closed ventilation door on either side of the damaged fire suppression system low point drain valve. [Encl (169)]

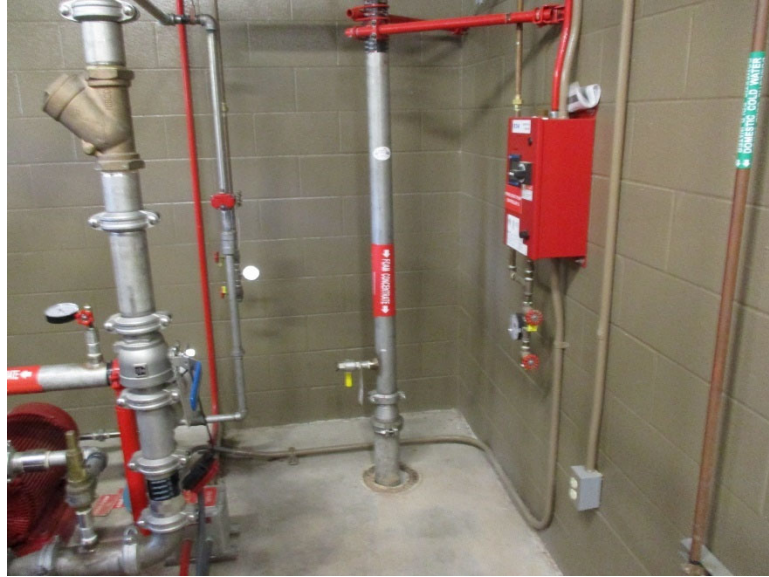
IMG_3054.JPG, taken by author on 6 Dec 2022 – AFFF Concentrate piping existing Building (b) (6)

- The surveillance videos were captured from a camera located outside of the exterior entrance to Adit 6. The videos show personnel entering and exiting the Adit 6 tunnel through the security door on the day of the incident, as well as response activities outside of the tunnel following the release. However, due to the location of the camera, normally closed security door, and location of the air vacuum valve approximately 75 feet down the tunnel, the videos do not provide any additional information about the cause of the discharge.
- The Chief Engineer NAVFAC Hawaii, stated in an interview on 6 December 2022 that AFFF concentrate was discovered within the interstitial space between the stainless steel AFFF concentrate piping and the PVC containment piping at the point where the piping penetrates the floor in the eastern corner of the building.

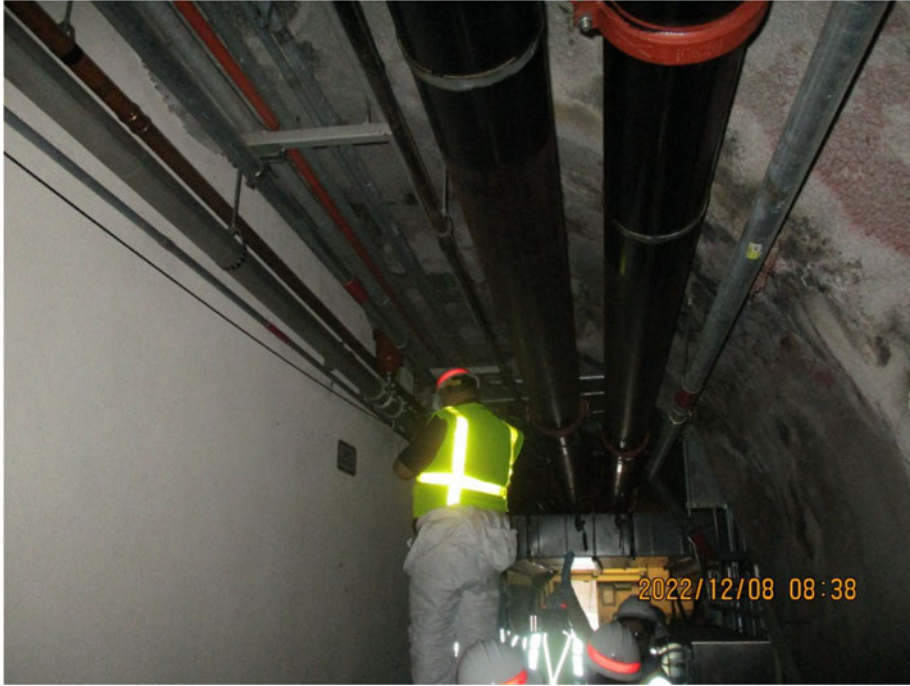
IMG_3172.JPG, taken by author on 8 Dec 2022 – Air Vacuum Valve Location

- During a site visit to Red Hill on 8 December 2022, I viewed the piping and equipment installed under Task Order No. N6247822F4053. The air vacuum valve is located approximately 10 feet above the funnel floor, above adjacent piping and conduit runs. I

utilized a ladder to view the valve closely, with a flashlight being needed to clearly see the upper side of the valve.

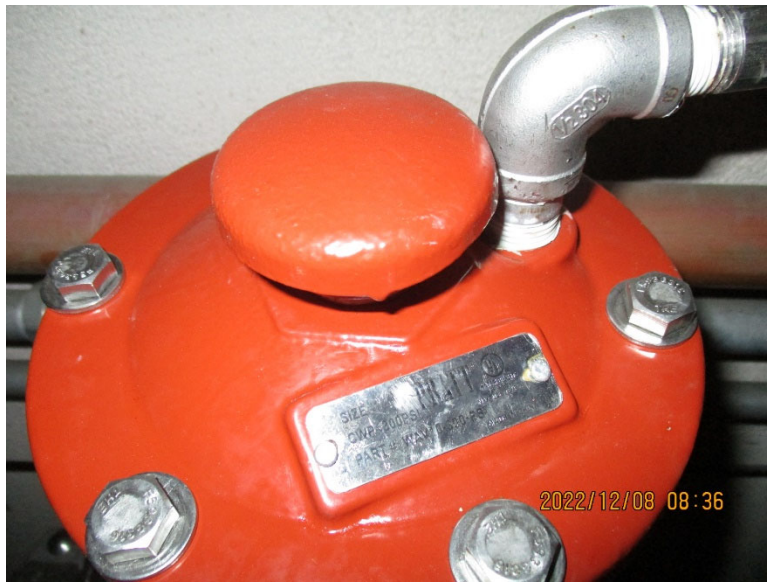
IMG_3158.JPG, taken by author on 8 Dec 2022 – Top of Air Vacuum Valve

- The installed air vacuum valve, Pratt model WAV10-300-FS, was installed with a center hood in place and the drain piping was connected to an orifice located off-center of the top of the valve. The drain piping was routed to discharge through an opening in the top of the drain containment vessel, which is not sealed to allow the discharge at atmospheric pressure.

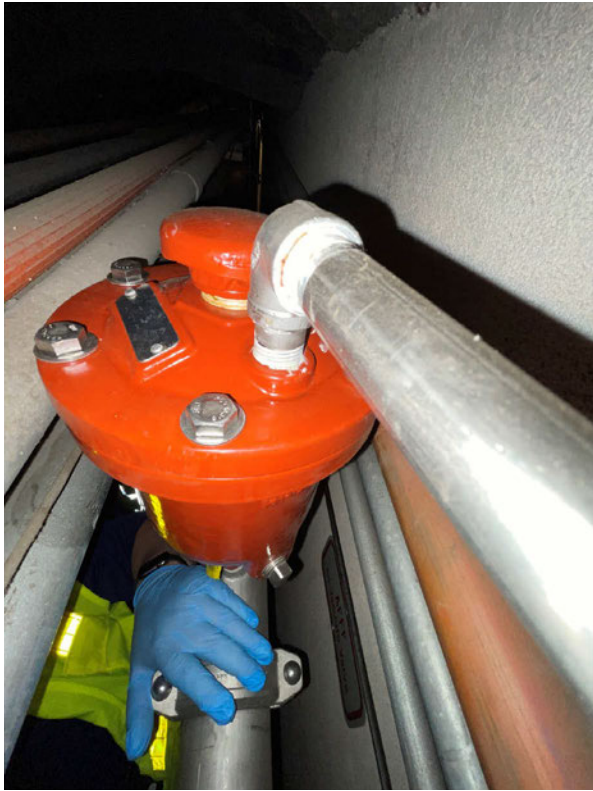
Adit 6 - Air vacuum valve with vent piping connected to flush inlet connection instead of air vent connection (occupied by mushroom)

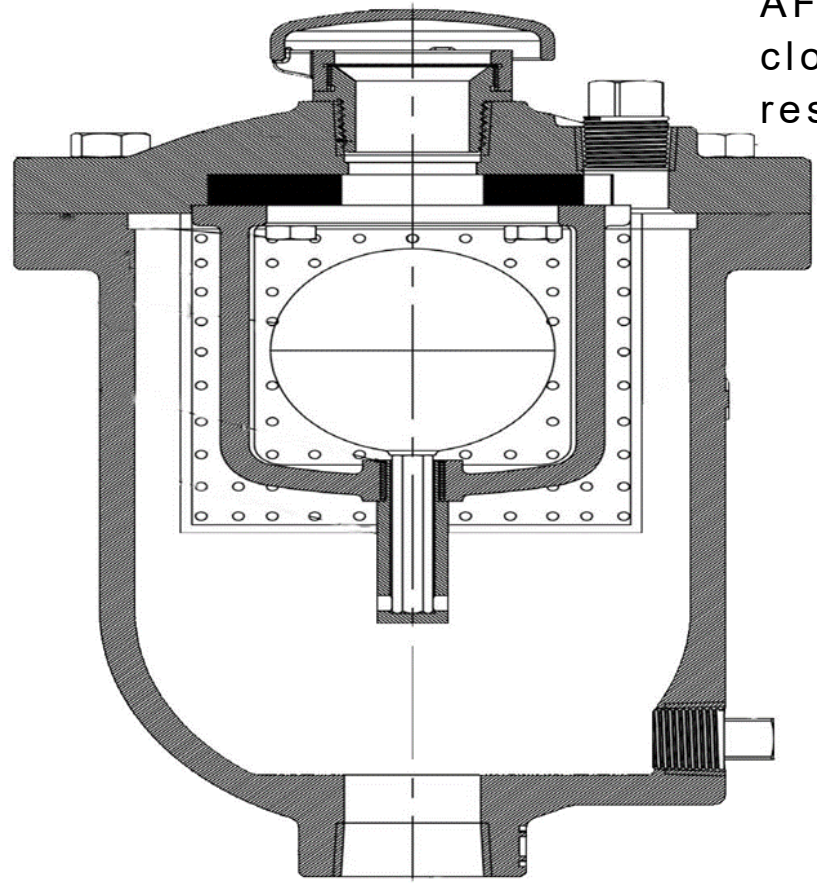
Incorrect Air Vacuum Valve Installation

- Modification included check valve, air vacuum valve and containment vessel
- Air vacuum valve installed improperly

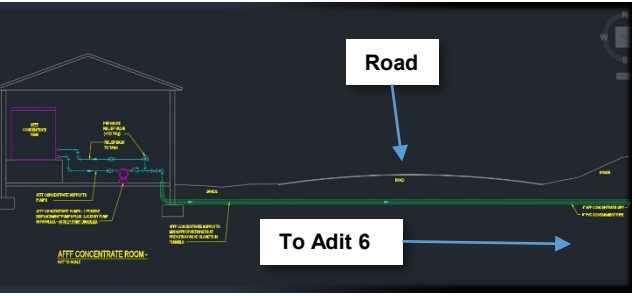
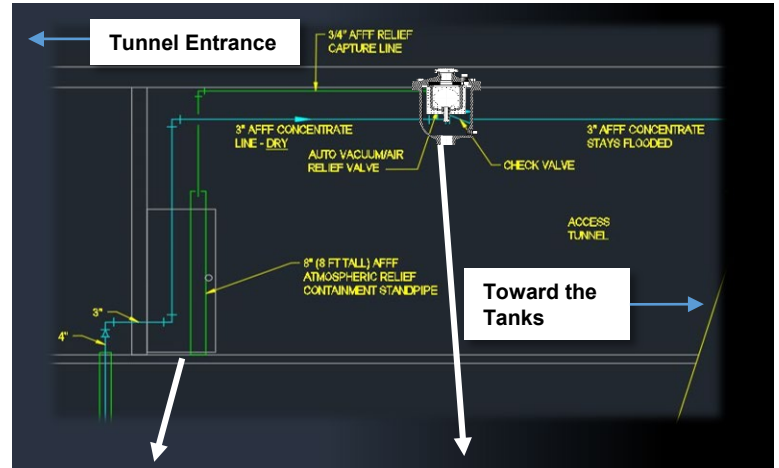
Improperly installed air vacuum valve created a bypass filling, then overflowing the containment standpipe with AFFF concentrate

Contractor did not disable AFFF concentrate pumps... they energize and turn on sending AFFF concentrate into Adit 6
