October 24, 2023

Re: Notification of Incident and Claim for Damages under the Federal Tort Claims Act – Honolulu Board of Water Supply

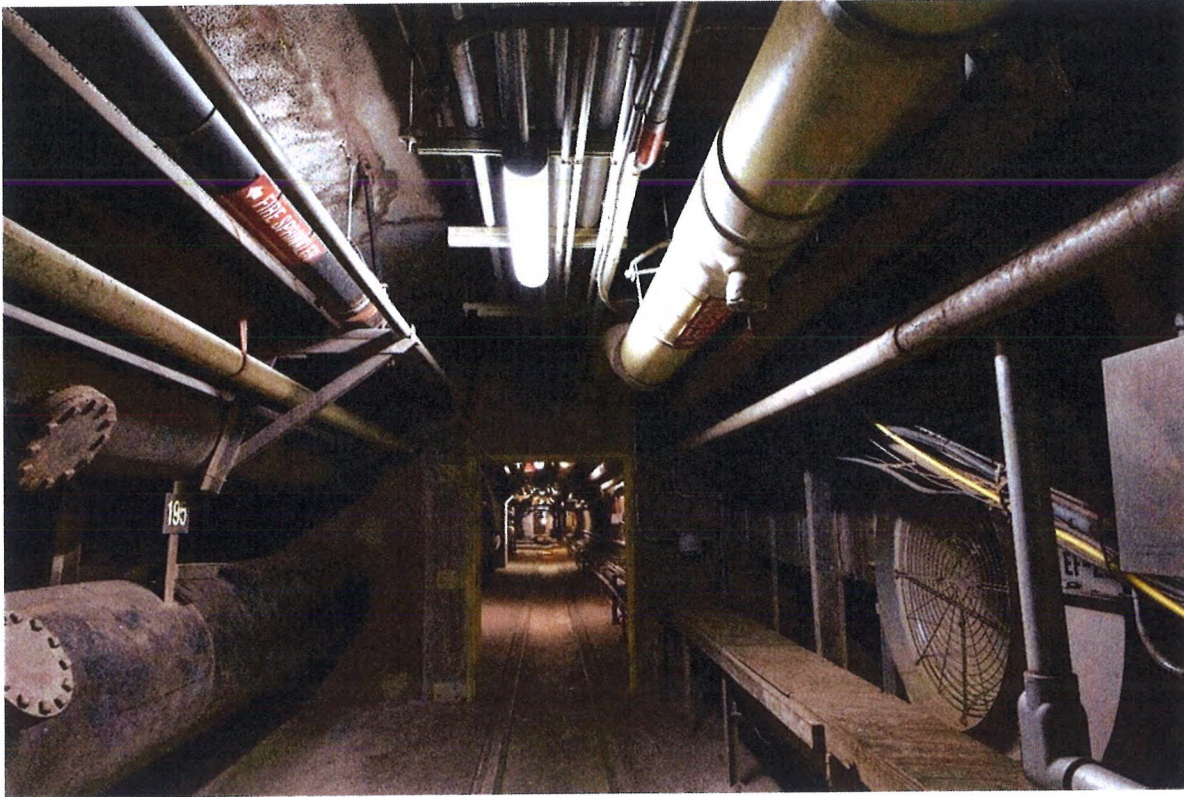
Lower Access Tunnel with AFFF retention line in top right (PVC pipe)

5. The entrance to the pump station is located (b)(3)(A) and 380 feet from the site of the ruptured Aqueous Film Forming Foam (AFFF) retention line low point drain inside the Red Hill lower access tunnel. The top of the well shaft is approximately (b)(3)(A) from the entrance of the pump station. [Encls (7), (9)]
6. Water is pumped from a 110-foot deep vertical well shaft with a bottom elevation of (b)(3)(A) sea level. [Encl (12)]
7. The well includes a horizontal water tunnel, known alternatively as a development tunnel or infiltration gallery, which is connected approximately 100 feet down the vertical well shaft. This horizontal developmental tunnel extends across the water table (b)(3)(A). [Encls (4), (12)]
8. The bottom of the development tunnel is 3 feet below sea level and is 18 feet high by 6 feet wide. (b)(3)(A) [Encl (12)]

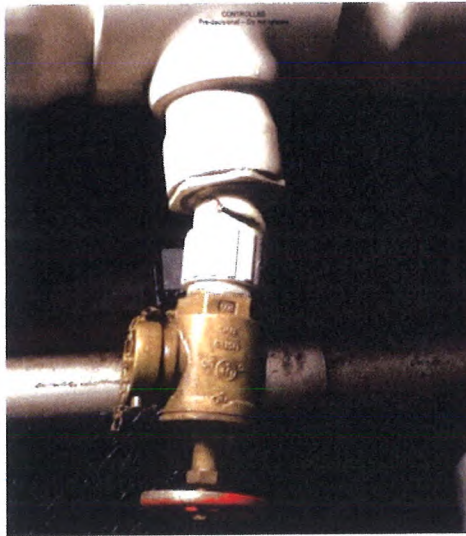
Cracked Low Point Drain

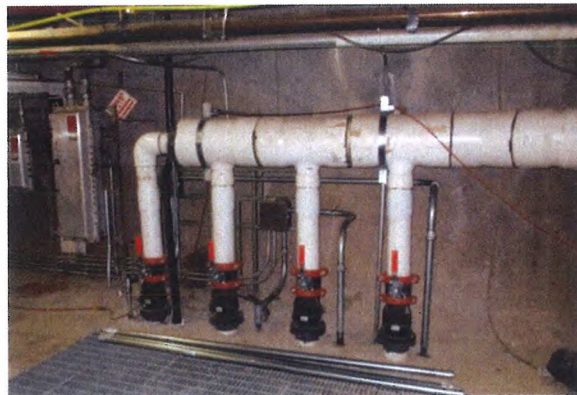
383. On 13 Mar 17, the construction contractor formally notified NAVFAC PAC, in writing, that they constructed the entire AFFF retention line with PVC vice Steel pipe. [Encl (353)]

Original AFFF Retention Line Piping in Immediate Area of an AFFF Sump

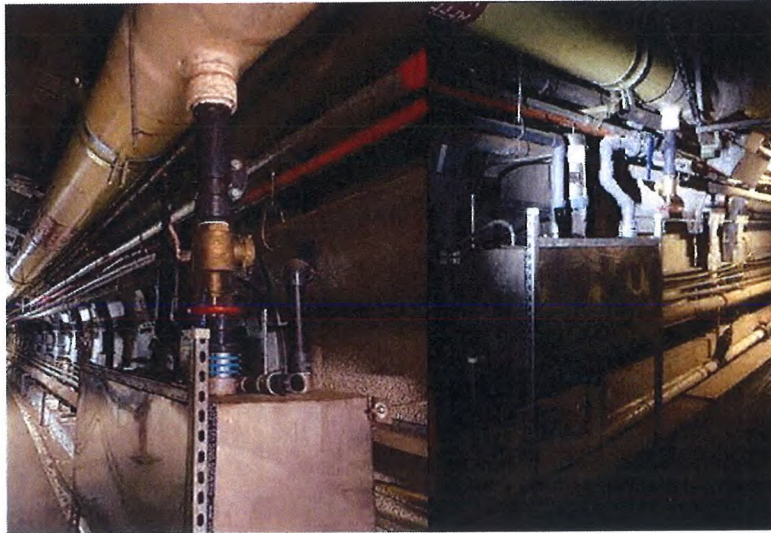
drainage out to a new manual hose connection at the Adit 3 entrance via new 3" PVC piping. This system does not utilize the groundwater sump system. This is the installed configuration today and is in close proximity to the Adit 3 groundwater sump, but does not connect with that sump. This system was not used to drain the AFFF retention line following the November spill. [Encl (354)]

Final Installed Low Point Drain System with PVC Retention Line

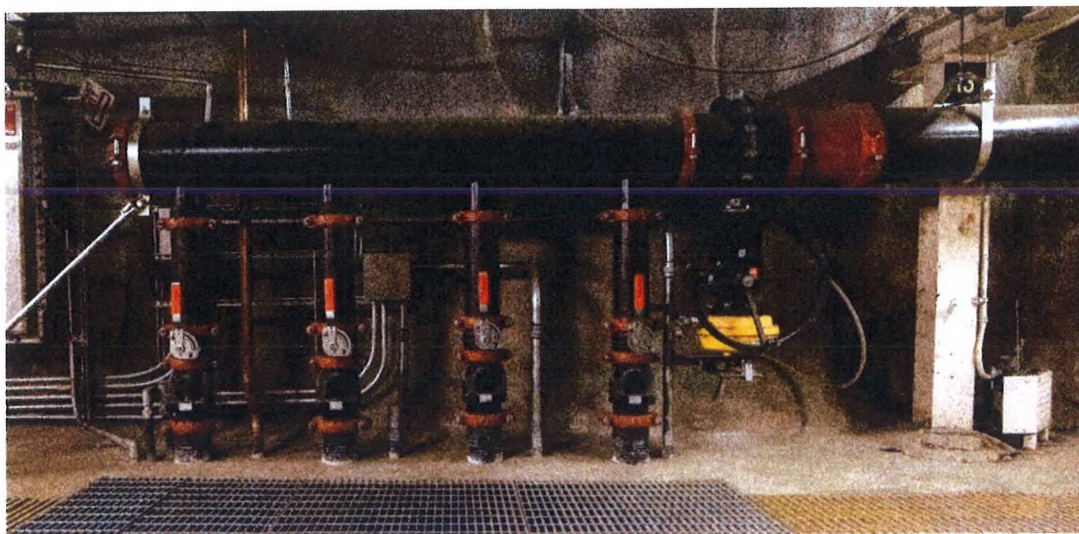
405. On 19 Jun 19, Change R was completed by the construction contractor. This is the configuration today. Commissioning testing was not performed again on the AFFF waste system. However, servicing was performed on the sump pumps (grease, rotation, cleaning) during connection of the new steel piping in the immediate area of the pumps. It was noted at the time that some of the pumps were seized due to lack of preventative maintenance, but were operational at the completion of servicing. [Encls (332), (362), (364)]

Final Change R Piping in Immediate Area of an AFFF Sump

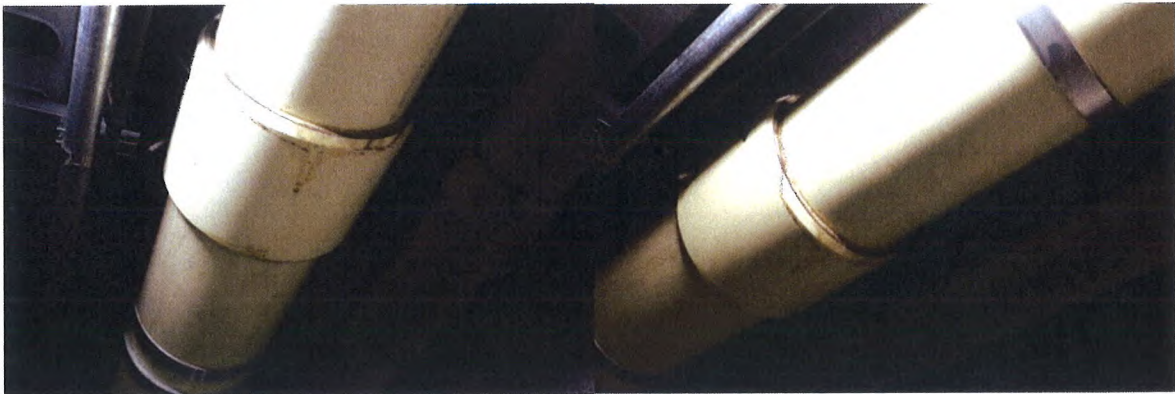
414. On 17 Mar 22, during a walkthrough of Red Hill, the supplement investigation team noted visual evidence of a foreign substance on the outside of the PVC AFFF retention line piping joints that appears to have seeped out.

Installed PVC AFFF Retention Line with Joint Seepage

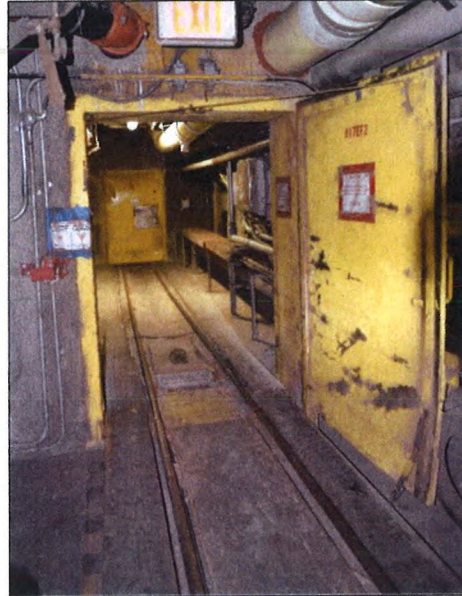
Figure 1: Image of open oil-tight door (foreground) and closed ventilation door on either side of the damaged fire suppression system low point drain valve. [Encl (169)]

178. After driving through the doorway, he again stopped the train and disembarked to close the ventilation control door. As he turned to close the door, he discovered liquid spraying from the low point drain of the fire suppression system retention line. He reported the leak immediately to the CRO. He recognized the source was a non-fuel system, first reporting it was from a sewage line, then fire suppression agent, then water. Finally, he reported the leak as water with a fuel smell. This line should have been empty. [Encls (83), (173)-(186)]

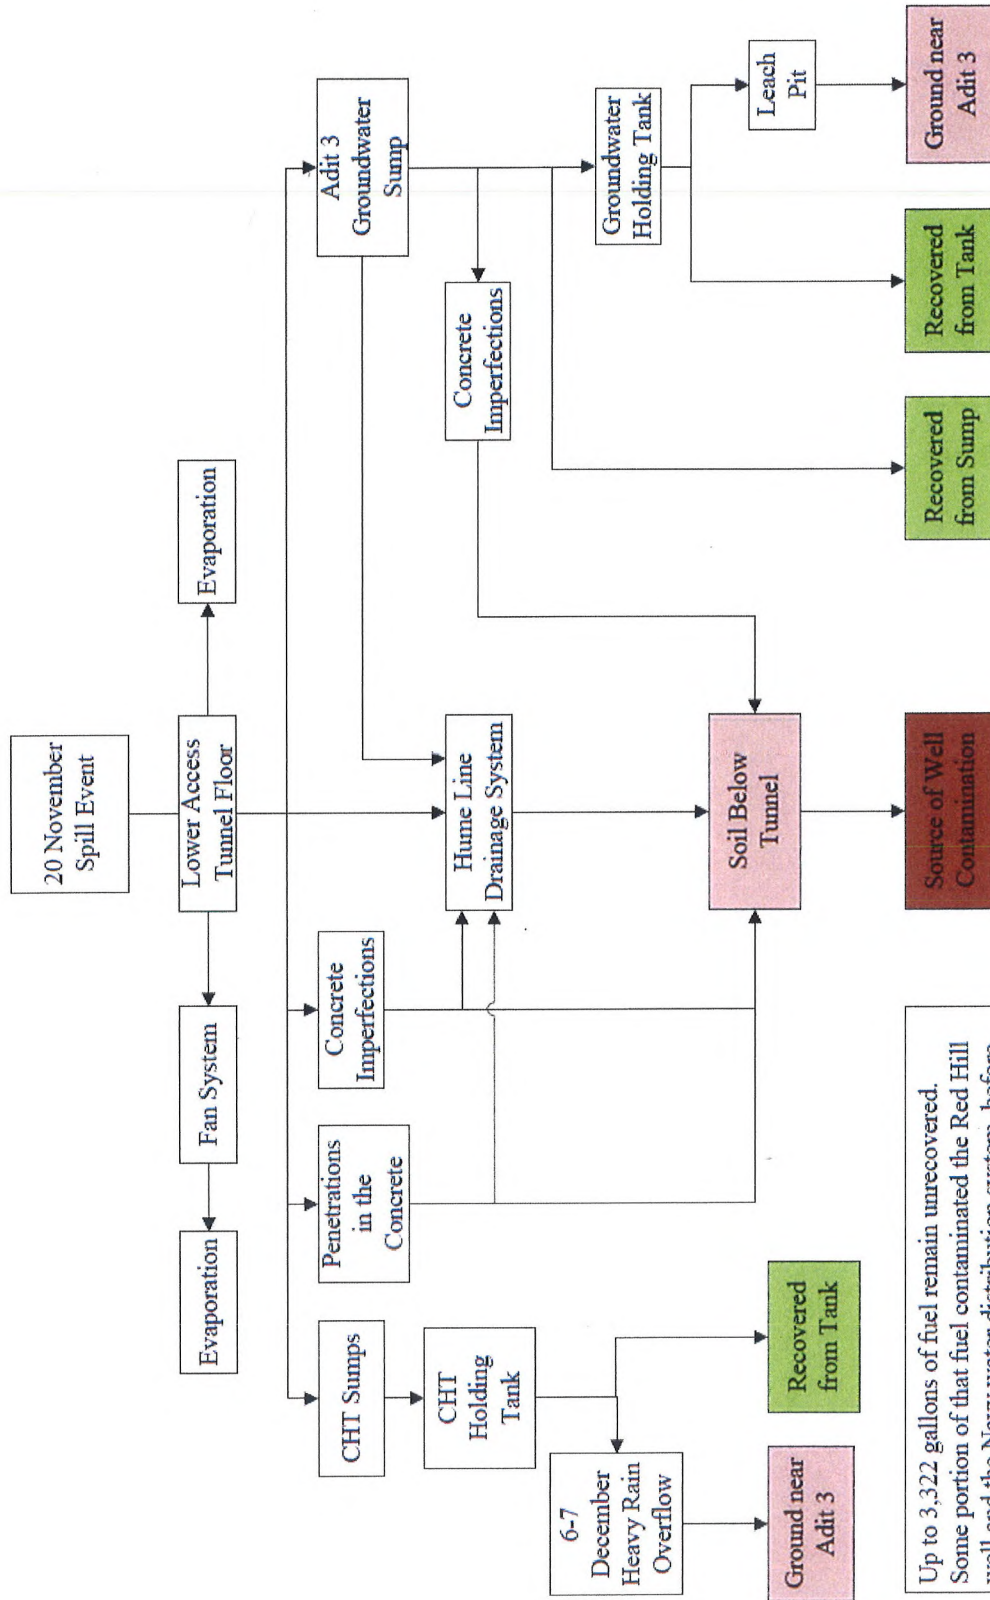
APPENDIX D Potential Release Paths to the Environment

Up to 3,322 gallons of fuel remain unrecovered. Some portion of that fuel contaminated the Red Hill well and the Navy water distribution system, before the well was secured on 28 November 2021.
