BOARD OF WATER SUPPLY

March 29, 2019

Subject: Navy testimony regarding Senate Concurrent Resolution 35, March 20, 2019, by Captain M.K. Delao and the Navy's Destructive Testing Report

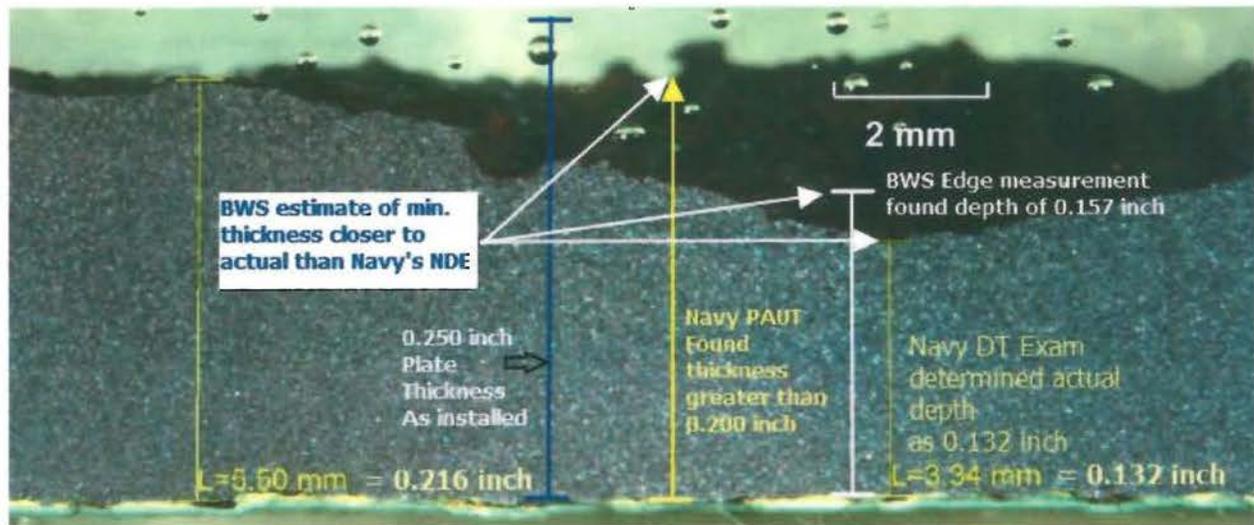
The Navy then states that "...the non-Navy photo (with the ruler, Figure 1) which was used to allege that corrosion of this coupon was worse than the Navy anticipated. Also included are two laboratory photos (Figures 2 and 3) of the same coupon which show, after proper preparation and precise measurements, significant metal thickness remains in this area." The figures refer to Coupon #7. First, BWS was not allowed to handle or otherwise participate in the NDE or destructive testing or to otherwise properly prepare or make more precise measurements, and secondly, this is just one of the 10 coupons examined. For instance, if the Navy had selected Coupon #3 to discuss; the results would be dramatically different. The Navy's NDE indicated that the expected minimum thickness on this coupon would be greater than 0.200 inches as PAUT found no indication (Appendix B). BWS's edge measurements estimated that the edge thickness was 0.157 inch. The destructive testing report showed that the actual minimum thickness on the specimen was 0.132-inch. The figure below shows the cross-section through Coupon #3 at the thinnest location. For reference, 5.5 mm is 0.217 inches, 3.34 mm is 0.1315 inch and a 1/4-inch is 6.35 mm. As can clearly be seen the smallest defect is significantly smaller than the Navy expectation from PAUT of the thickness being greater than 0.200 inch.

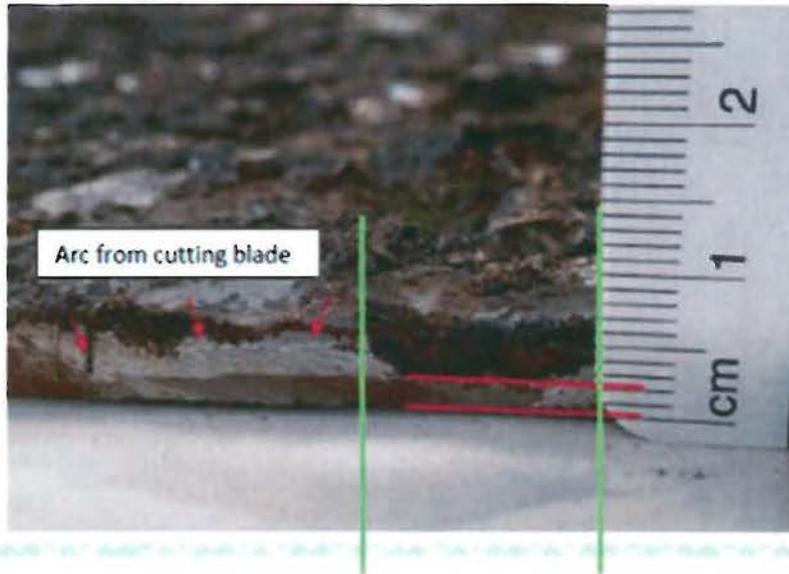
Figure 1: Edge of Coupon #7. Image from non-Navy source alleging the thickness of the remaining steel at the location shown between the two red lines was no more than 2 millimeters, less than the Navy's predictions. The label "Arc from cutting blade" was added by the laboratory to help demonstrate that all 3 photos shown are of the same location of coupon #7.

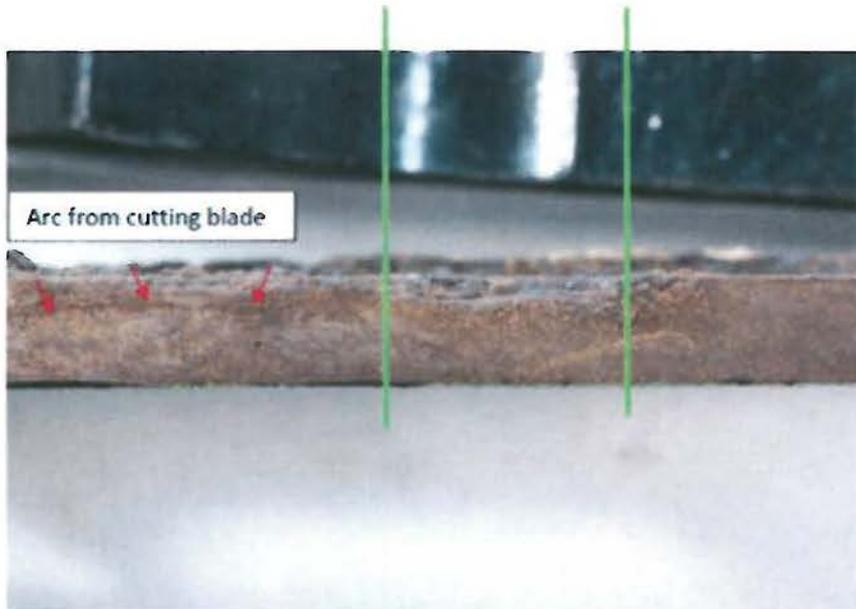
Figure 2: Edge of Coupon #7. Laboratory photo of same location on coupon #7 as depicted in Figure 1 taken after cleaning but before grit blasting. Cleaning apparently removed debris resulting from cutting the coupon out of the tank

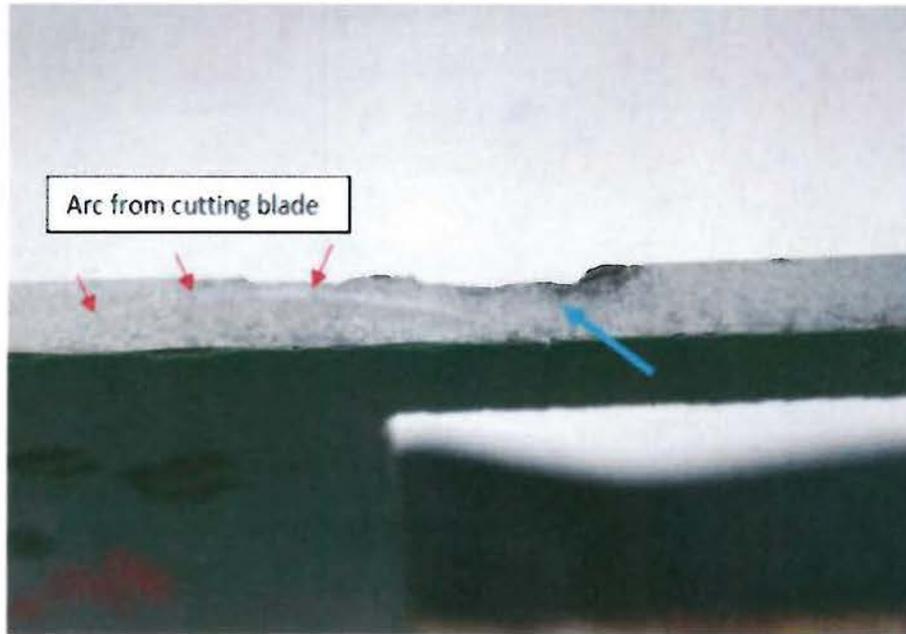
In this specific instance, the BWS edge estimate, based only on the crude measurements allowed by the Navy, were significantly closer to the actual plate minimum thickness. For Coupon #7 it is true that “the corrosion was far worse than the Navy expected.”

Figure 3: Edge of Coupon #7. Laboratory photo of same location on coupon #7 as depicted in Figure 1 taken after grit blasting. Note there is still significant wall thickness remaining in the area in question (blue arrow).
