Section 9

RECOMMENDED REPAIRS

Dames & Moore
Emergency Repairs For Red Hill Tanks at the Fleet Industrial & Supply Center
Contract No. N62742-96-C-1356

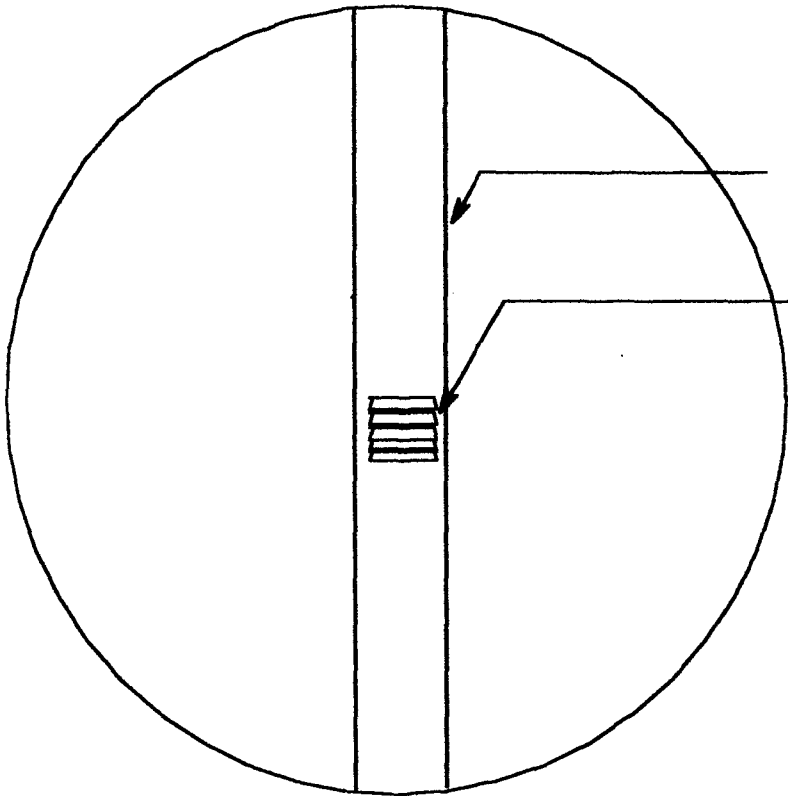
LTR	DESCRIPTION	BY	DATE
REVISIONS			
MID ATLANTIC ENVIRONMENTAL			
EMERGENCY REPAIRS FOR RED HILL TANKS			
Tank #10			
Repair No. 002	File 10r002		
Upper dome	Quadrant D		
Course B	Plate 19		
Drawn by: Tom Kitchen	Date: 2/20/98

2" x 1/4" EXISTING FLAT BAR

Weld Repair 3

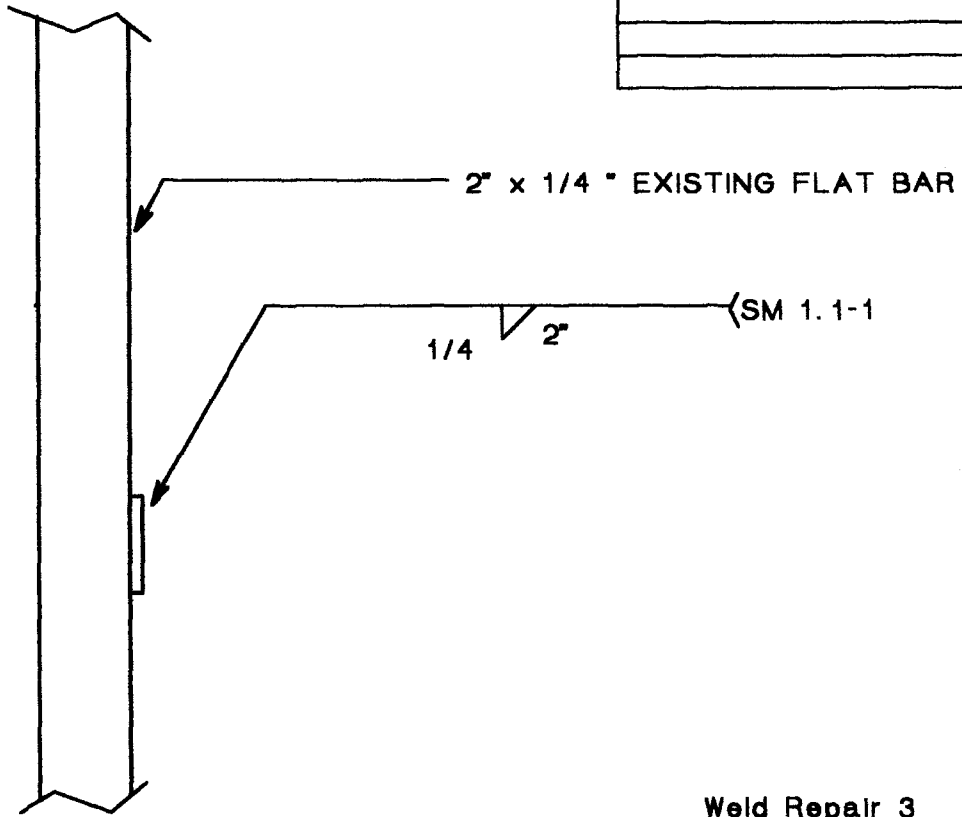
LTR	DESCRIPTION	BY	DATE
REVISIONS			
MID ATLANTIC ENVIRONMENTAL			
EMERGENCY REPAIRS FOR RED HILL TANKS			
Tank #10 AS BUILT DRAWING			
Repair No.: 004	File: 10r004		
Upper dome	Quadrant: D		
Course: B	Plate: 24		
Drawn by: Tom Kitchen	Date: 4/28/98

Weld Repair 3

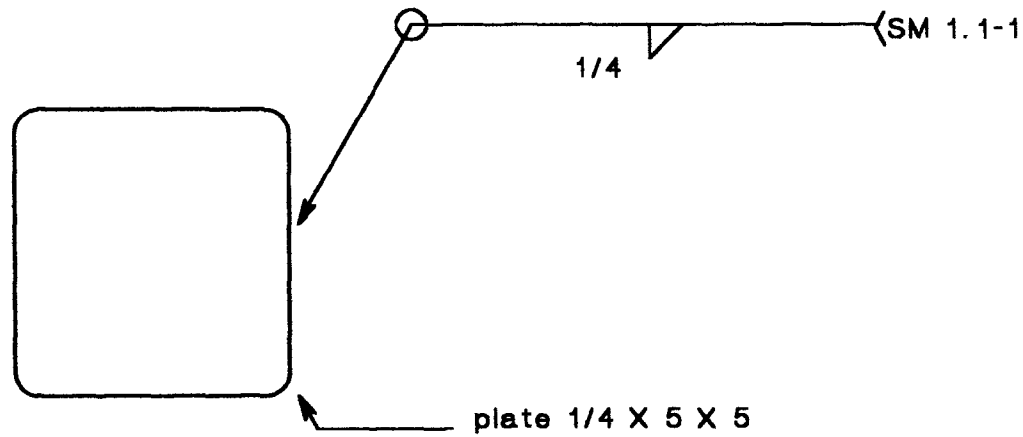
LTR	DESCRIPTION	BY	DATE
REVISIONS			
MID ATLANTIC ENVIRONMENTAL			
EMERGENCY REPAIRS FOR RED HILL TANKS			
Tank #10 AS BUILT DRAWING			
Repair No.:	007	File:	10r007
Upper dome		Quadrant:	C
Course:	EXTENSION	Plate:	18
Drawn by:	Tom Kitchen	Date:	4/28/98

Repair type 5

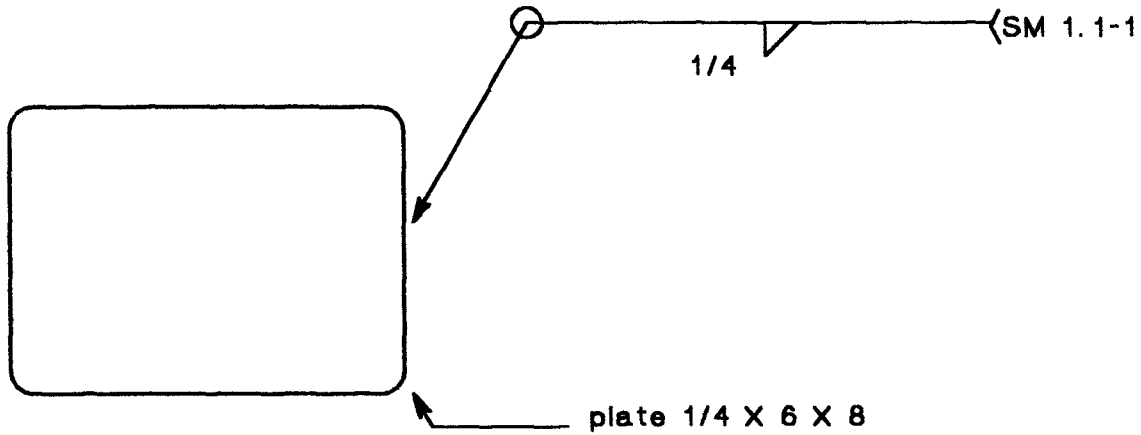
LTR	DESCRIPTION	BY	DATE
REVISIONS			
MID ATLANTIC ENVIRONMENTAL			
EMERGENCY REPAIRS FOR RED HILL TANKS			
Tank #10			
Repair No. 008	File 10r008		
Upper dome	Quadrant C		
Course EXTENSION	Plate 18		
Drawn by Tom Kitchen	Date 4/28/98

Repair type 5

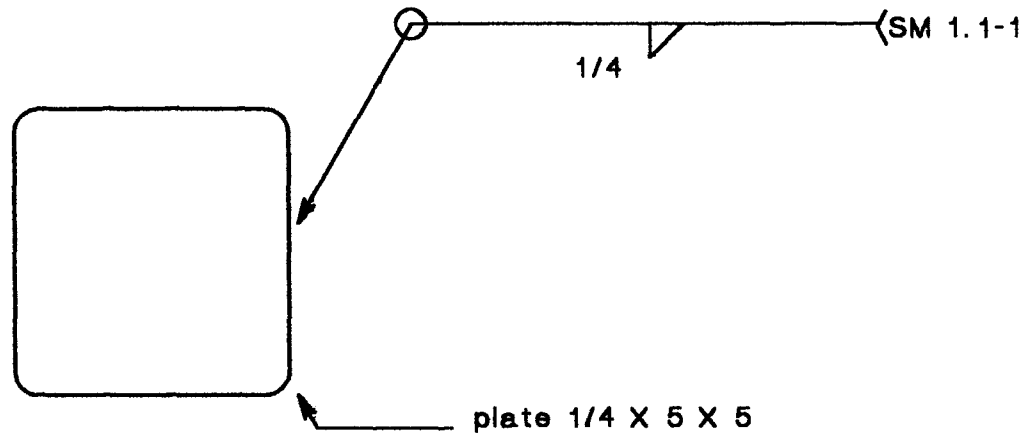
LTR	DESCRIPTION	BY	DATE
REVISIONS			
MID ATLANTIC ENVIRONMENTAL			
EMERGENCY REPAIRS FOR RED HILL TANKS			
Tank #10			
Repair No. 009	File 10r009		
Upper dome	Quadrant C		
Course EXTENSION	Plate 17		
Drawn by Tom Kitchen	Date 4/28/98

Repair type 5

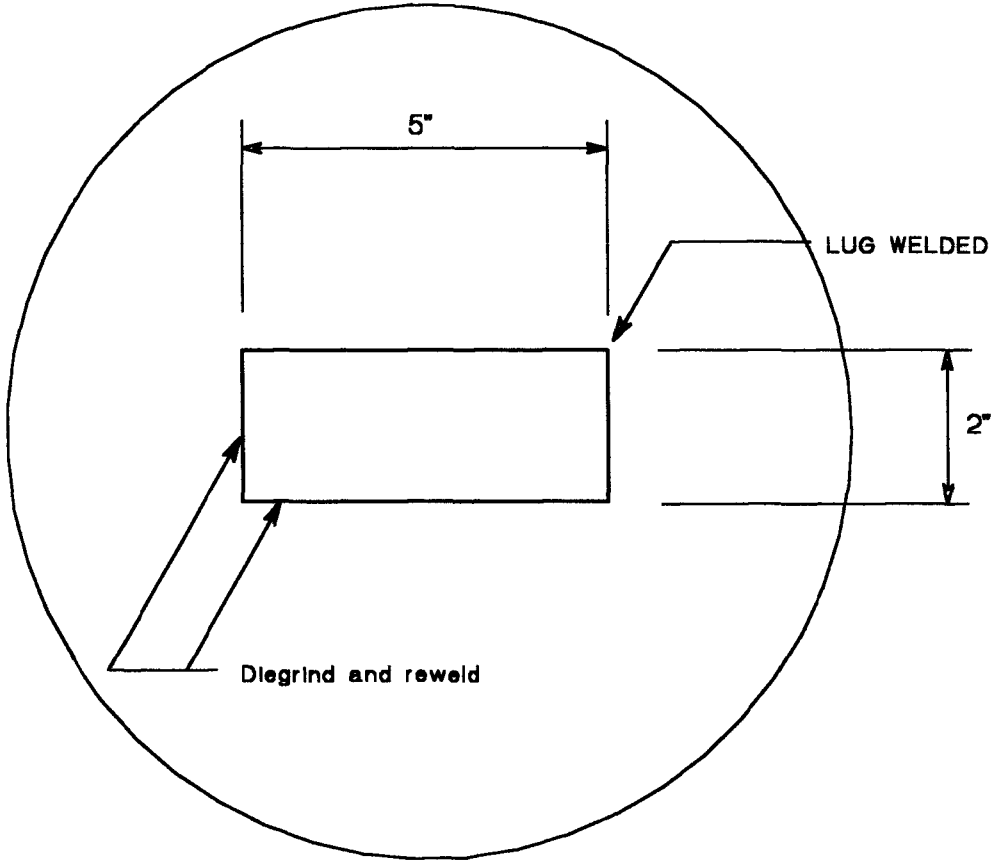
01	ORIGINAL ISSUE	MM	2/20/98
LTR	DESCRIPTION	BY	DATE
REVISIONS			
MID ATLANTIC ENVIRONMENTAL			
EMERGENCY REPAIRS FOR RED HILL TANKS			
Tank #10			
Repair No.:	010	File:	10r010
Upper dome		Quadrant:	A
Course:	C	Plate:	1
Drawn by:	M. Moulton	Date:	2/20/98

TYPE 10 REPAIR

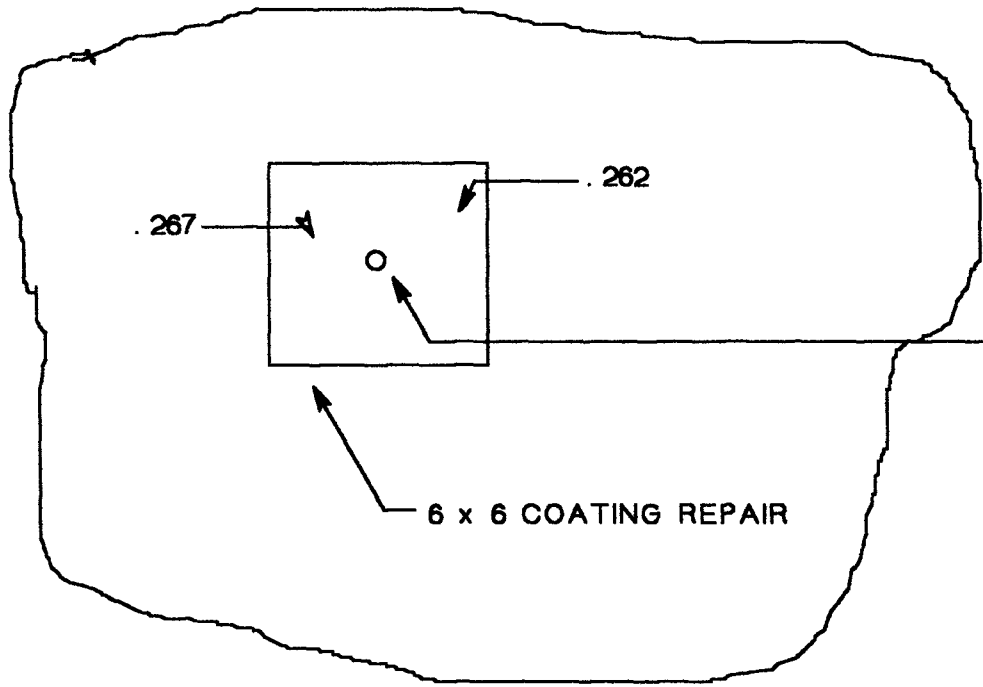
O I	ORIGINAL ISSUE	T K	2/20/98
LTR	DESCRIPTION	BY	DATE
REVISIONS			
MID ATLANTIC ENVIRONMENTAL			
EMERGENCY REPAIRS FOR RED HILL TANKS			
Tank #10			
Repair No.:	011	File:	10r011
CYLINDER		Quadrant:	D
Course:	3 & 4	Plate:	19
Drawn By:	M. Moulton	Date:	2/20/98

NO LEAK DETECTED CHANGE TO COATING REPAIR

TYPE 1 REPAIR

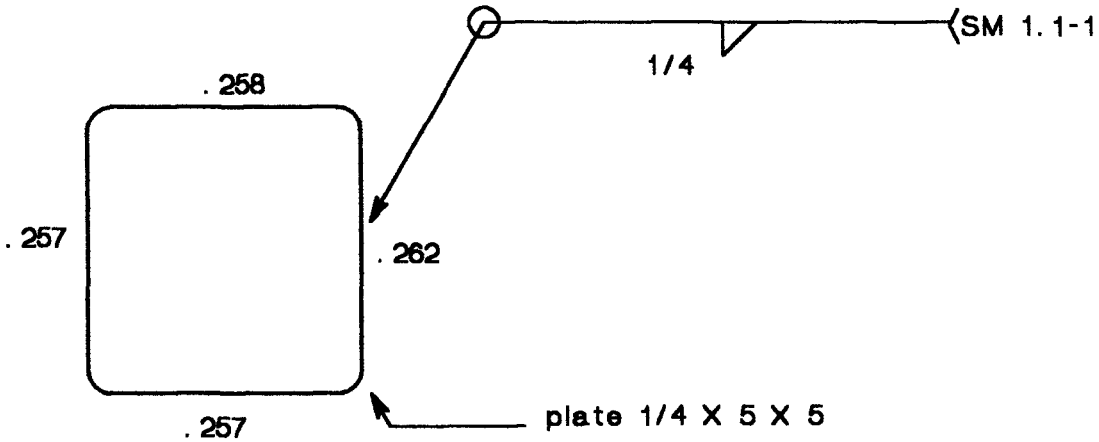
LTR	DESCRIPTION	BY	DATE
REVISIONS			
MID ATLANTIC ENVIRONMENTAL			
EMERGENCY REPAIRS FOR RED HILL TANKS			
Tank #10			
Repair No. : 020	File: 10r020		
Upper dome	Quadrant: A		
Course: C	Plate: 5		
Drawn by: Tom Kitchen	Date: 4/28/98

Repair type 5

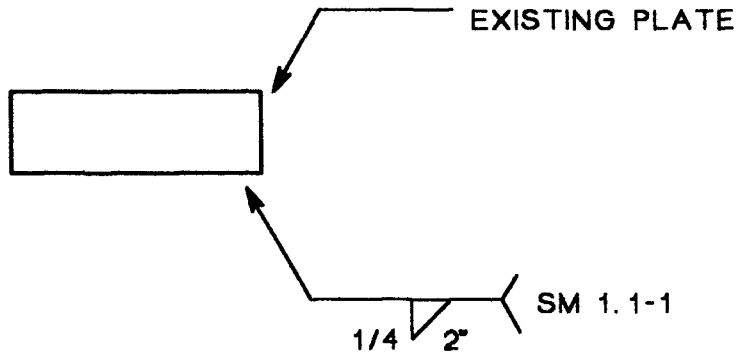
LTR	DESCRIPTION	BY	DATE
REVISIONS			
MID ATLANTIC ENVIRONMENTAL			
EMERGENCY REPAIRS FOR RED HILL TANKS			
Tank #10			
Repair No. 030		File 10r030	
Upper dome		Quadrant B	
Course C		Plate 10	
Drawn by: Tom Kitchen		Date: 4/29/98

TYPE 5 REPAIR

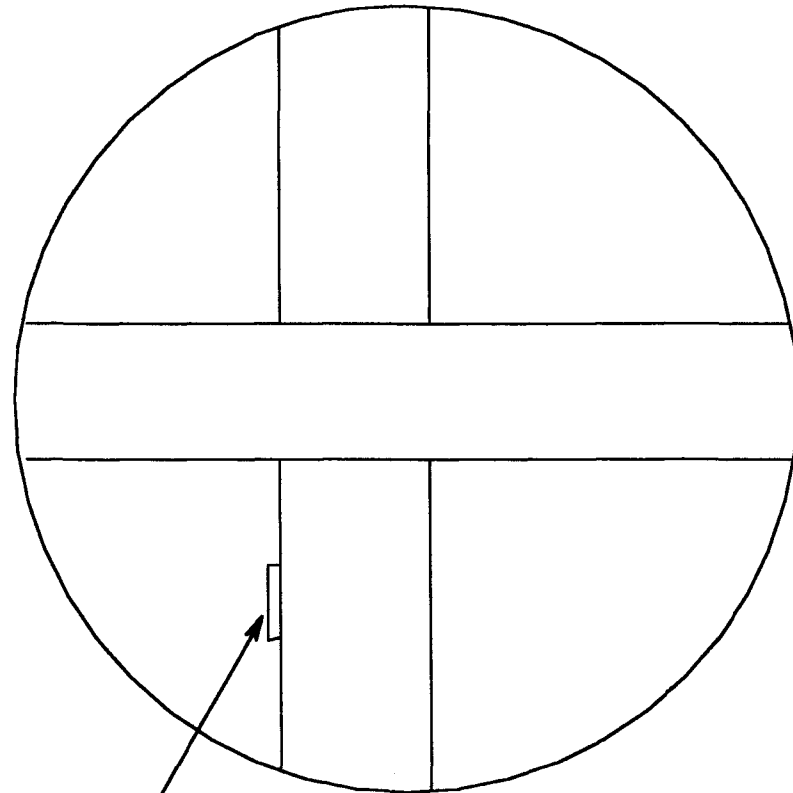
O I	ORIGINAL ISSUE	M M	2/20/98
LTR	DESCRIPTION	BY	DATE
REVISIONS			
MID ATLANTIC ENVIRONMENTAL			
EMERGENCY REPAIRS FOR RED HILL TANKS			
Tank #10			
Repair No.:	060	File:	10r060
Upper dome		Quadrant:	A
Course:	B	Plate:	3
Drawn By:	M. Moulton	Date:	2/20/98

SM 1.1-1
1/4 4"

Repair Type 10

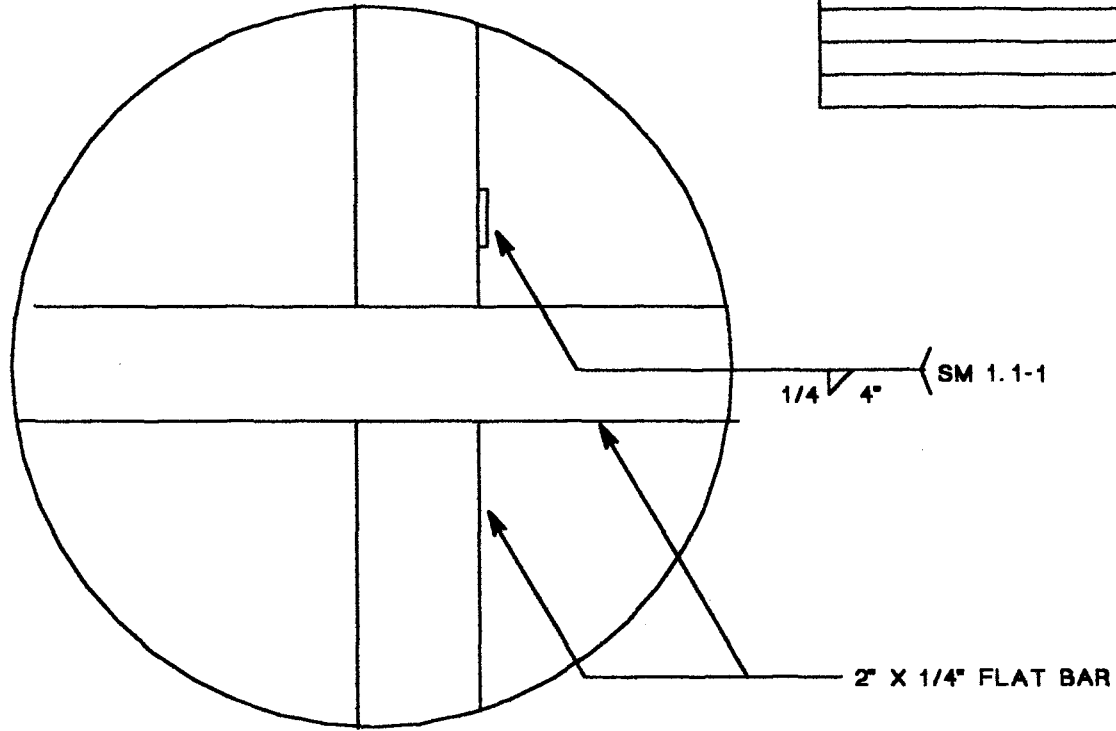
O I	ORIGINAL ISSUE	M M	2/20/98
LTR	DESCRIPTION	BY	DATE
REVISIONS			
MID ATLANTIC ENVIRONMENTAL			
EMERGENCY REPAIRS FOR RED HILL TANKS			
Tank #10			
Repair No.: 070		File: 10r070	
Upper dome		Quadrant: A	
Course: C		Plate: 3	
Drawn By: M. Moulton		Date: 2/20/98

Repair Type 3
