LTR	DESCRIPTION	BY	DATE
<b>REVISIONS</b>			
<b>MID ATLANTIC ENVIRONMENTAL</b>			
<b>EMERGENCY REPAIRS FOR RED HILL TANKS</b>			
Tank #10			
Repair No.: 270		File: 10r270	
Upper dome		Quadrant: B	
Course: EXTENSION		Plate: 10	
Drawn by: Tom Kitchen		Date: 5/13/98

**Dames & Moore**  
Emergency Repairs For Red Hill Tanks at the Fleet Industrial & Supply Center  
Contract No. N62742-96-C-1356

Repair Record

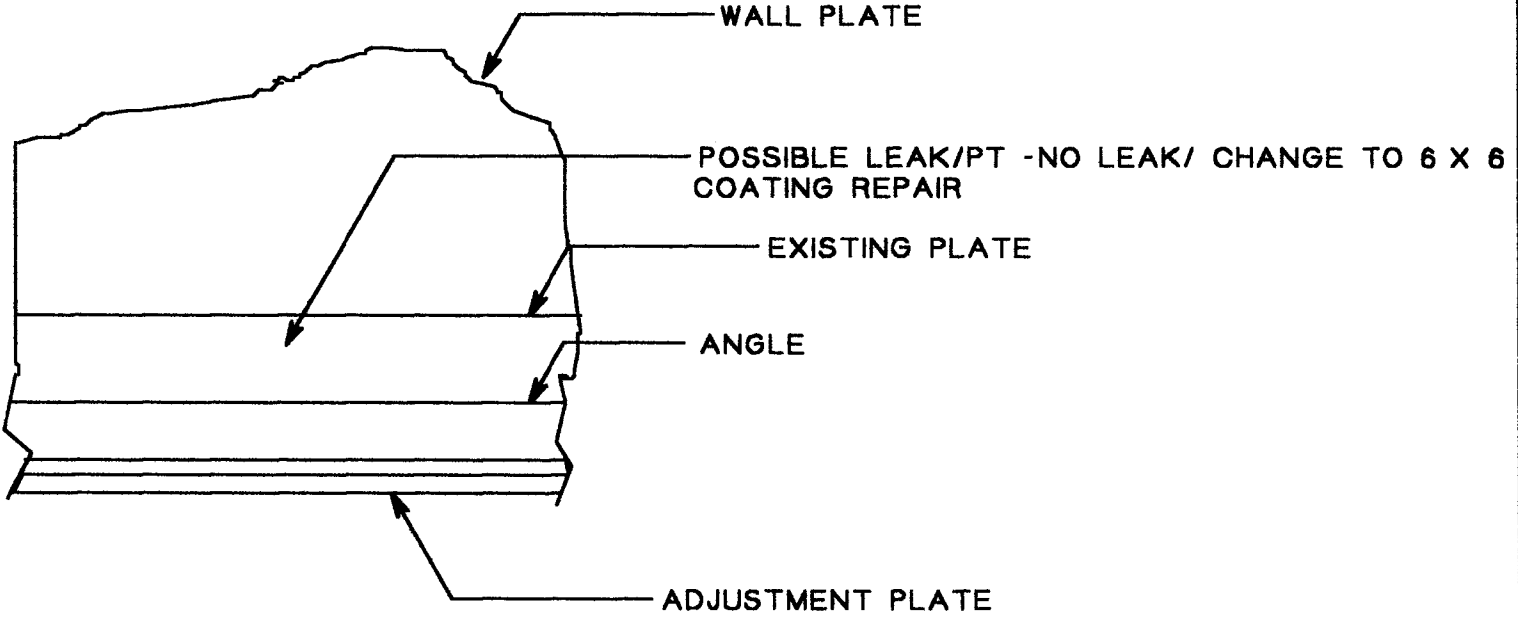
**TYPE 8 REPAIR**

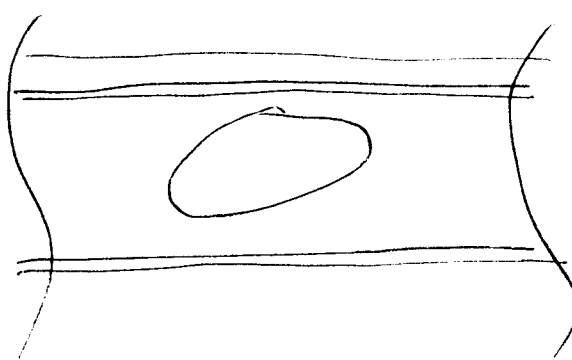
Sketch of Repair Area

<p>CLEAN TO BARE METAL + PERFORM <del>BE</del> V.T.</p> <p>Per. T. Kitchen</p>

<p>NO DEFECTS FOUND Type 8 JJK 3/22/98</p>
--

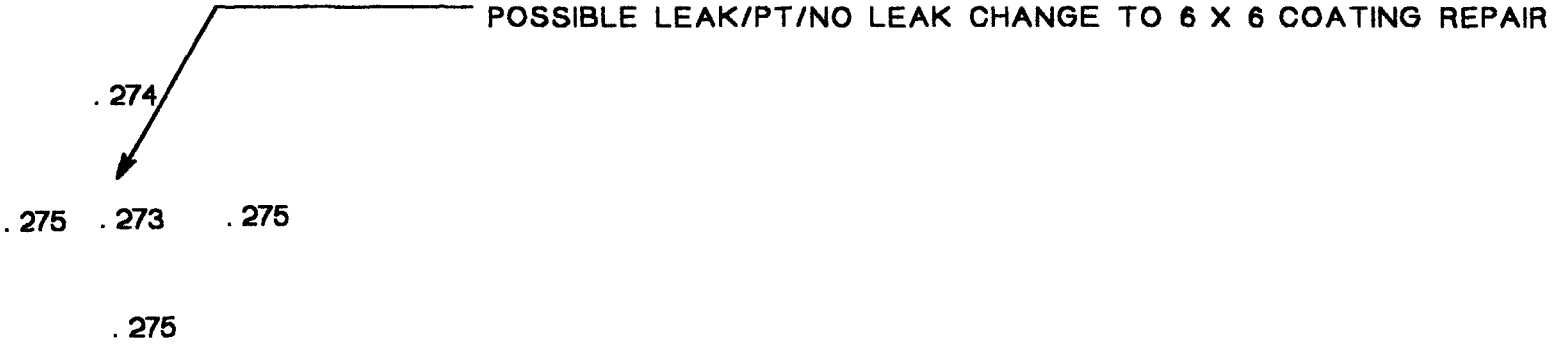
CLEAN TO BARE METAL & PERFORM P.T.  
Per T. Kitchen

NO DEFECTS FOUND *JK* Type 8  
3/22/98

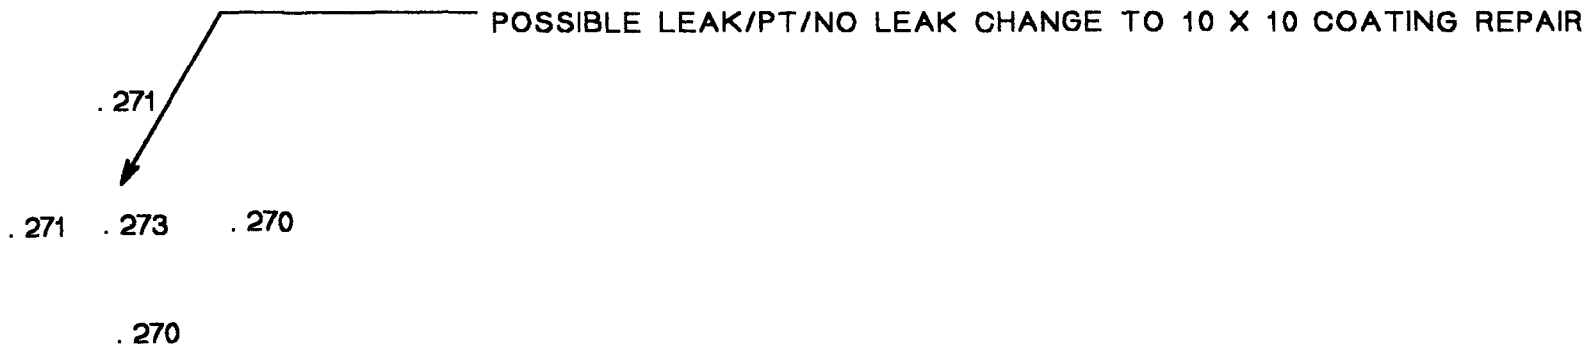
CLEAN TO BARE METAL + PERFORM P.T.  
PER T. Kitchen

NO DEFECTS FOUND Type 8 JWX  
3/22/98

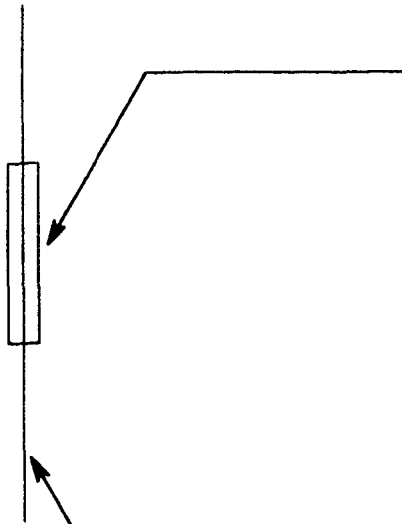
POSSIBLE LEAK/PT/NO LEAK CHANGE TO 4 X 10 COATING REPAIR

VERTICAL SEAM

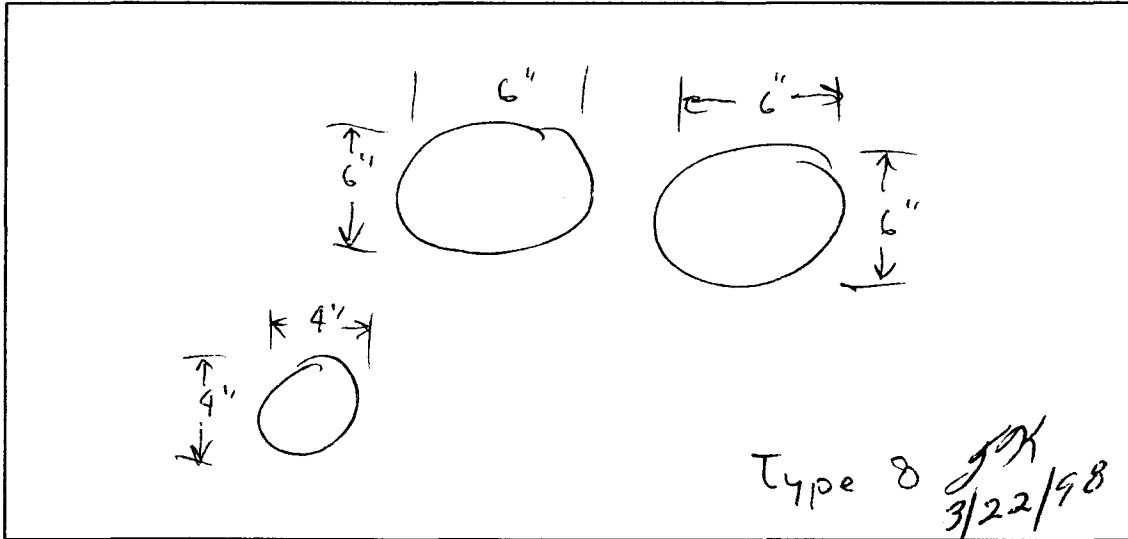
Sketch of Repair Area

4 X 4 COATING REPAIR

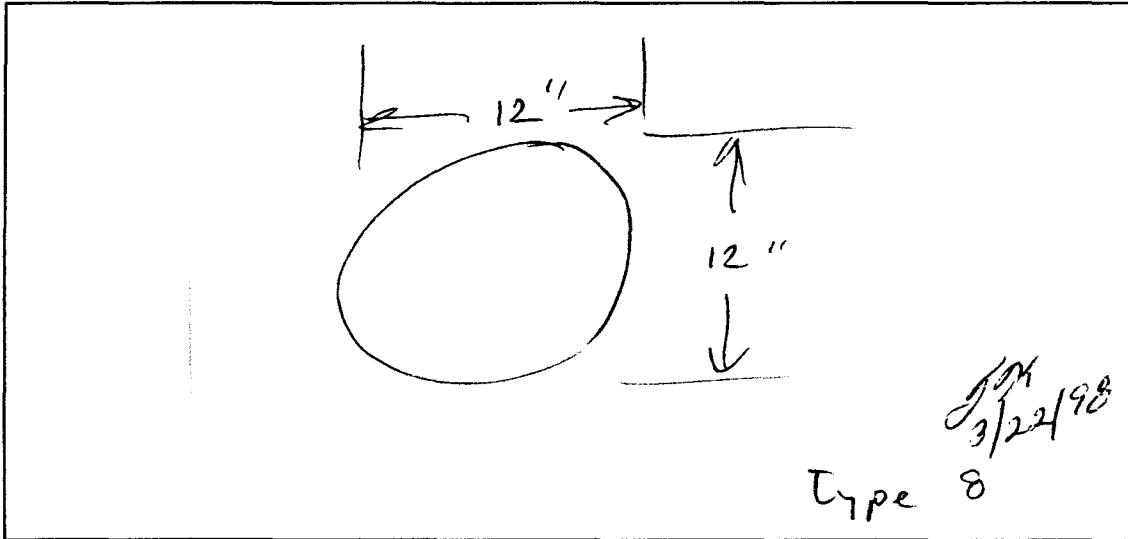
Sketch of Repair Area

12 X 12 COATING REPAIR

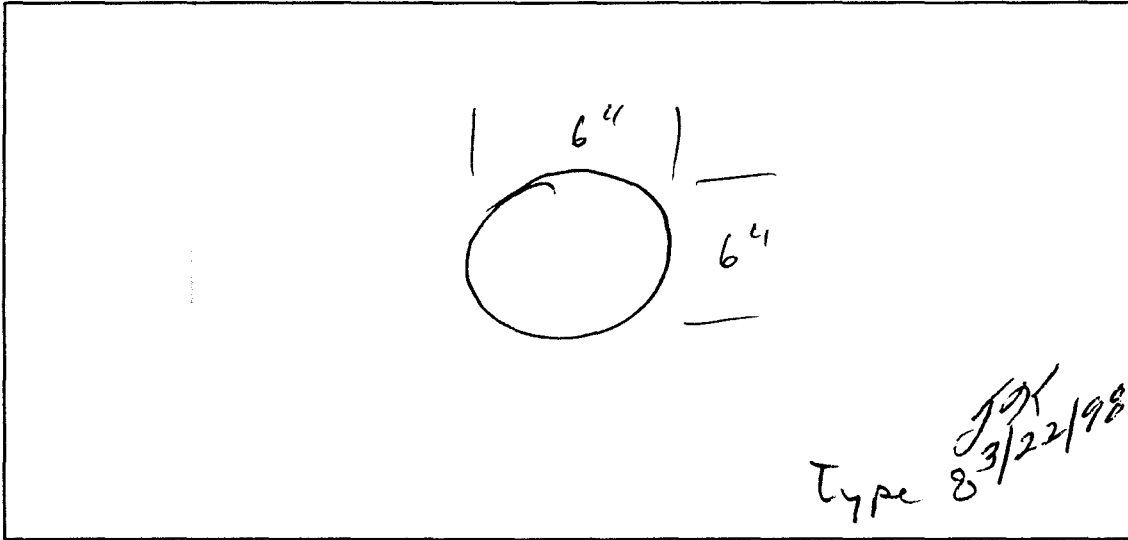
Sketch of Repair Area

6 X 6 COATING REPAIR

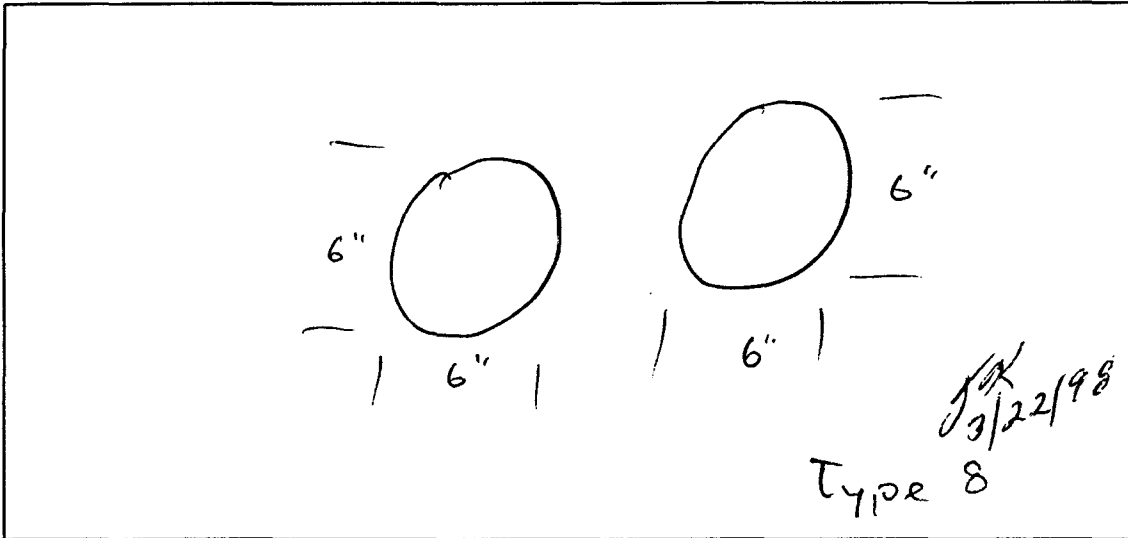
Sketch of Repair Area

6 X 6 COATING REPAIR

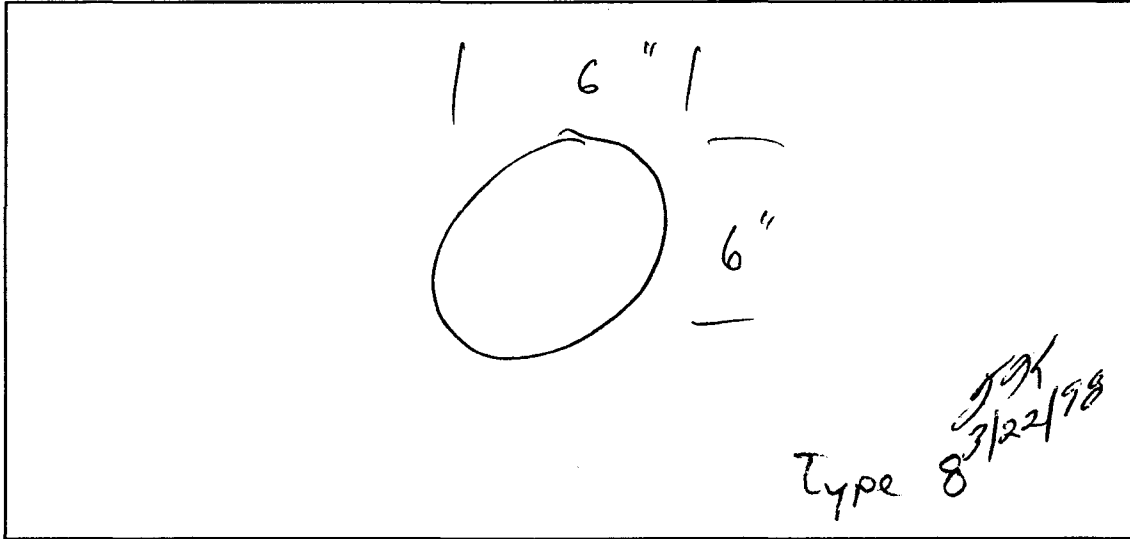
Sketch of Repair Area

6 X 6 COATING REPAIR
