MID ATLANTIC ENVIRONMENTAL	
EMERGENCY REPAIRS FOR RED HILL TANKS	
Tank #7 RECOMMENDED REPAIR DRAWING	
Repair No. 031	File 7R031
cylinder	Quadrant C
Course 24	Plate 15
Drawn by Tom Klitcher	Date 5/4/98

Dames & Moore
Emergency Repairs For Red Hill Tanks at the Fleet Industrial & Supply Center
Contract No. N62742-96-C-1356

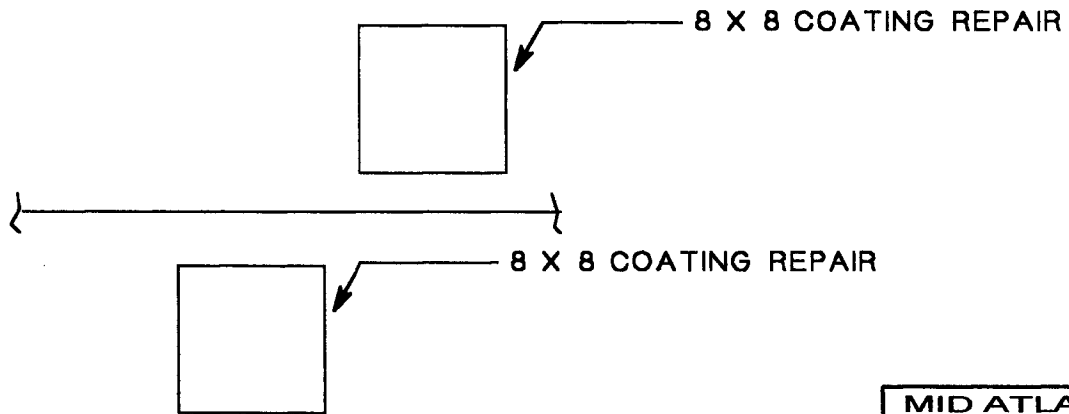
TYPE 8 REPAIR

Coating Type: Epoxy

NDT Performed: Visual: DFT: Average DFT: 8-15 mils

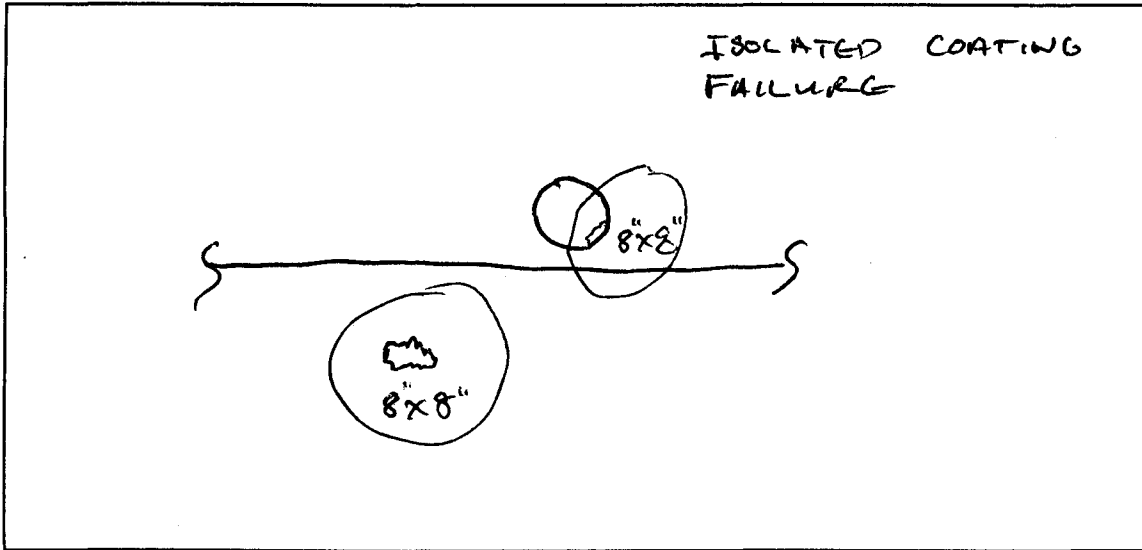
Sketch of Repair Area

Tank No.: 7 Repair No.: 031 Type: 8 Location: C15-24

Repair Acceptable: John Zschell Date Accepted: 4-3-98

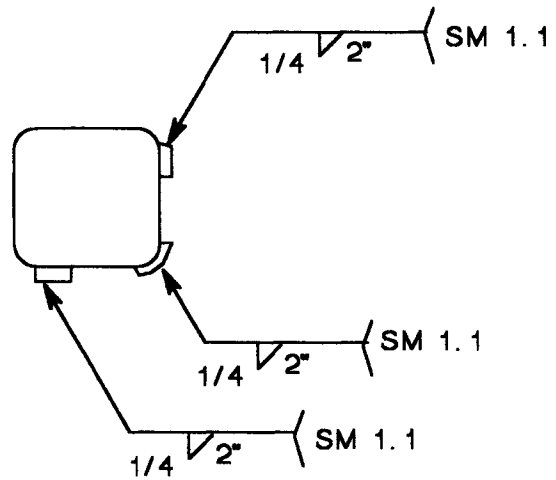
TYPE 10 REPAIR

WPS No.: SM1.1-1

NDT Performed: Visual Vacuum Box Dye Penetrant

Coating Type: Epoxy

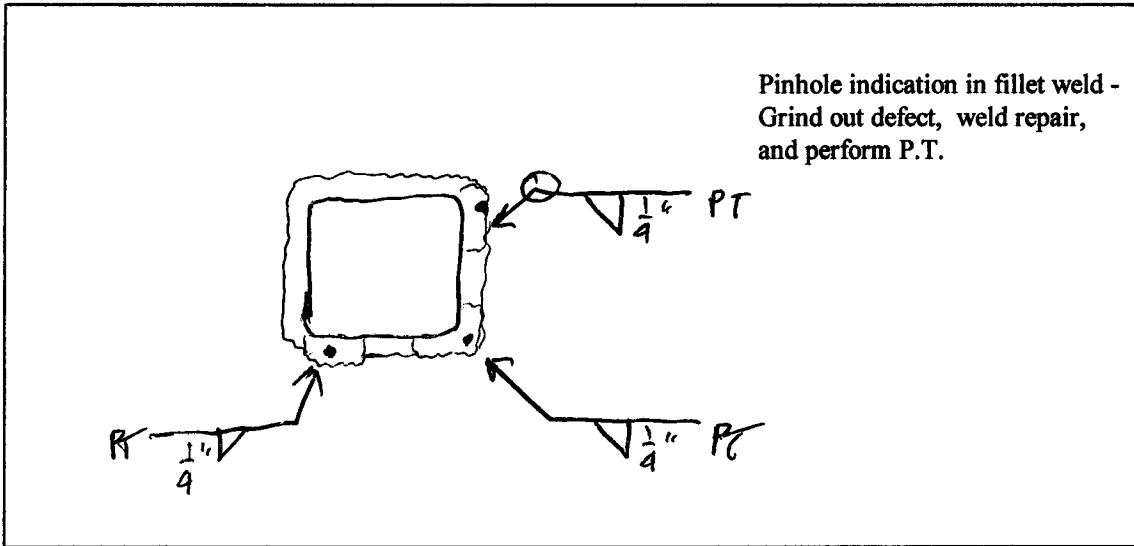
Sketch of Repair Area

Tank No.: 7 Repair No.: 032 Type: 10 Location: C18-28

Repair Acceptable: John Zschell Date Accepted: 4-2-98

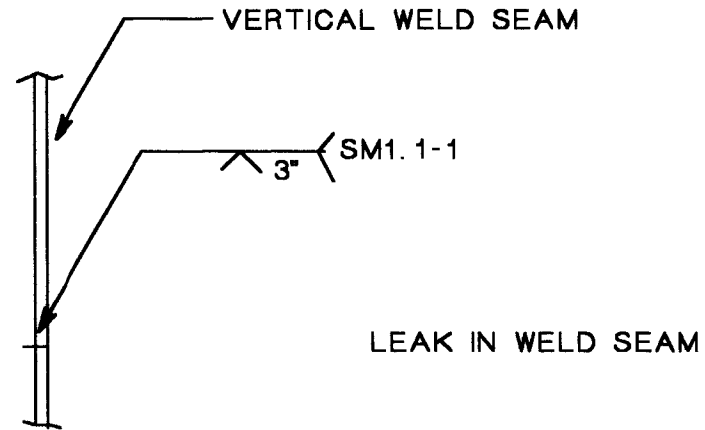
TYPE 10 REPAIR

WPS No.: SM1.1-1

NDT Performed: Visual Vacuum Box Dye Penetrant

Coating Type: Epoxy

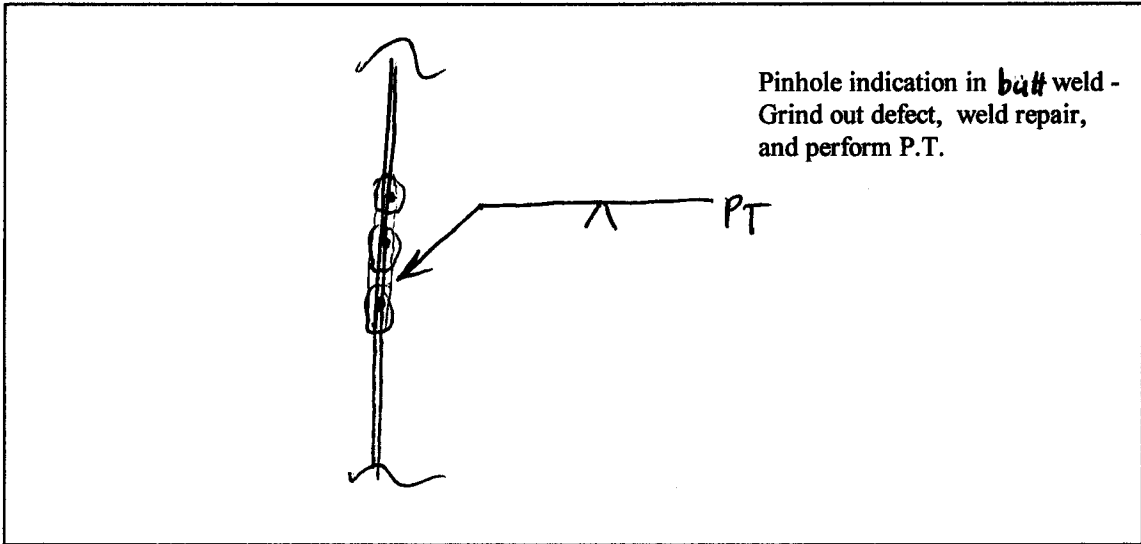
Sketch of Repair Area

Tank No.: 7 Repair No.: 033 Type: 9 Location: D21-3

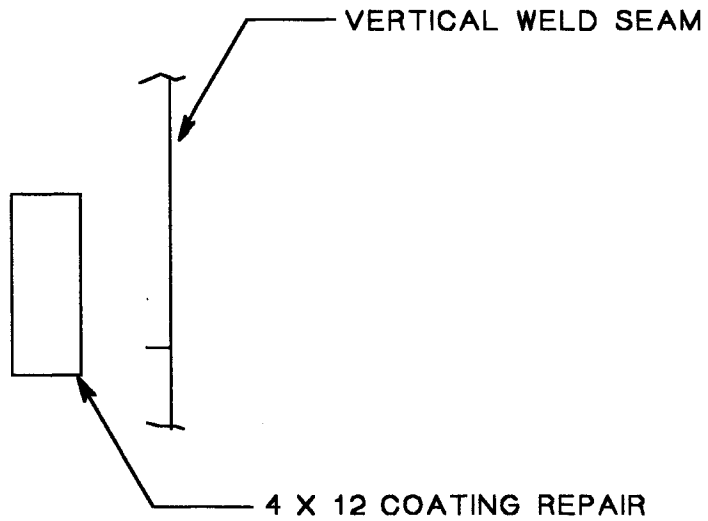
TYPE 8 REPAIR

Coating Type: EPoxy

NDT Performed: Visual: DFT: Average DFT: 8-15 mils

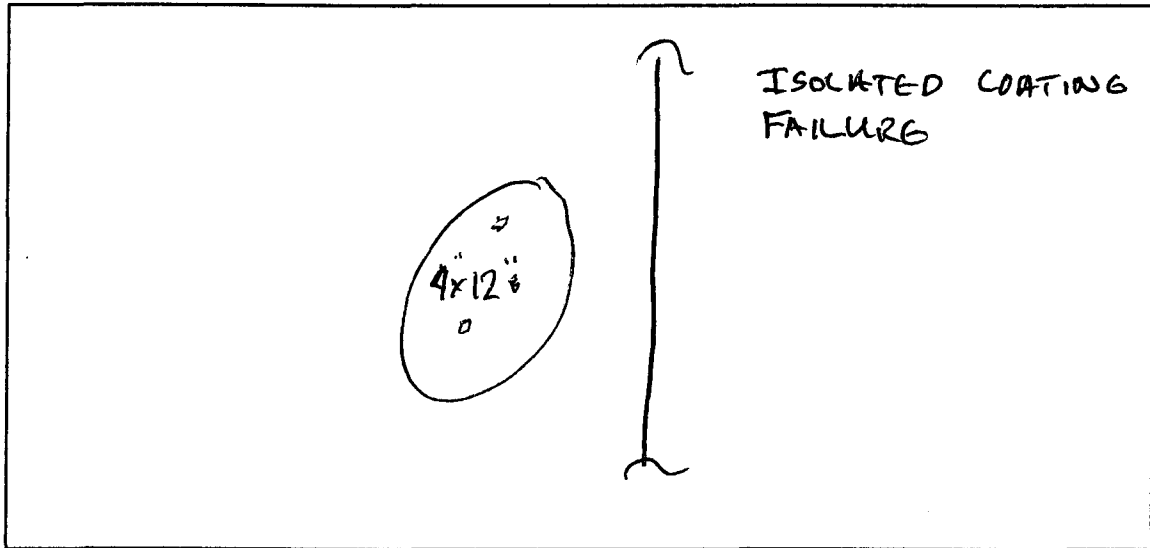
Sketch of Repair Area

Tank No.: 7 Repair No.: 034 Type: 8 Location: C17-3

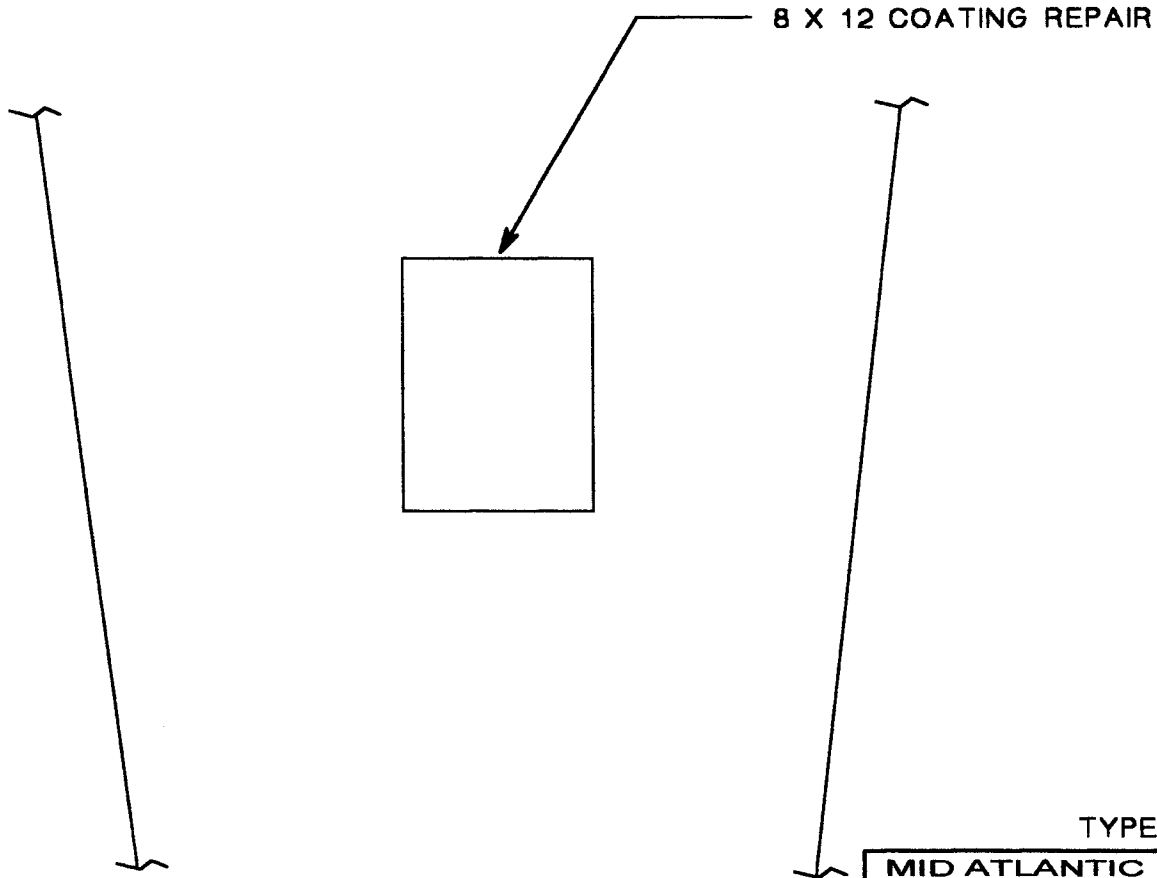
TYPE 8 REPAIR

Coating Type: EPOXY

NDT Performed: Visual: DFT: Average DFT: 8-15 mils

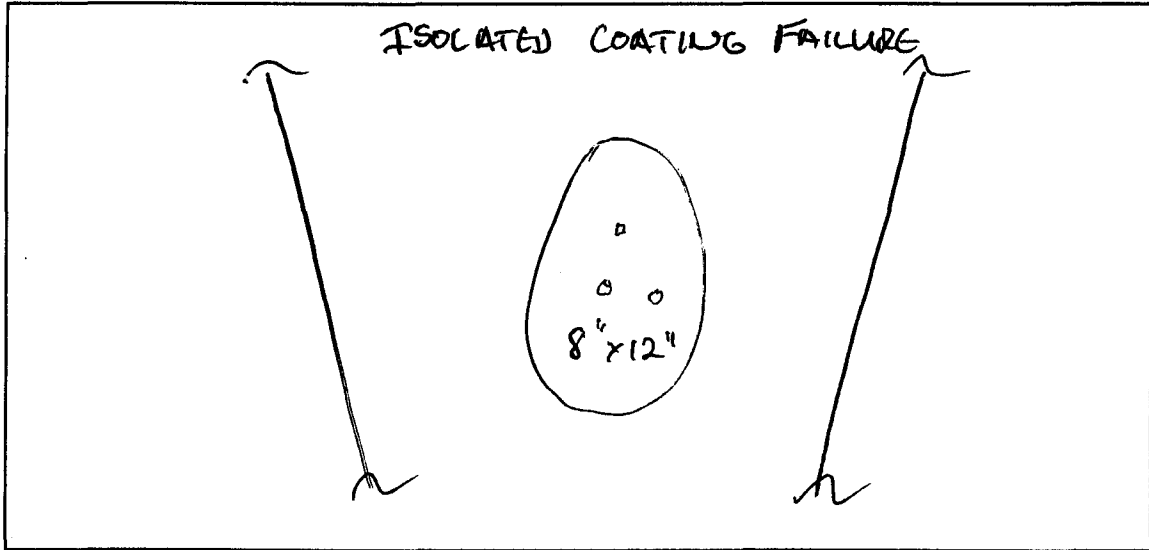
Sketch of Repair Area

Tank No.: 7 Repair No.: 035 Type: 8 Location: C16-3

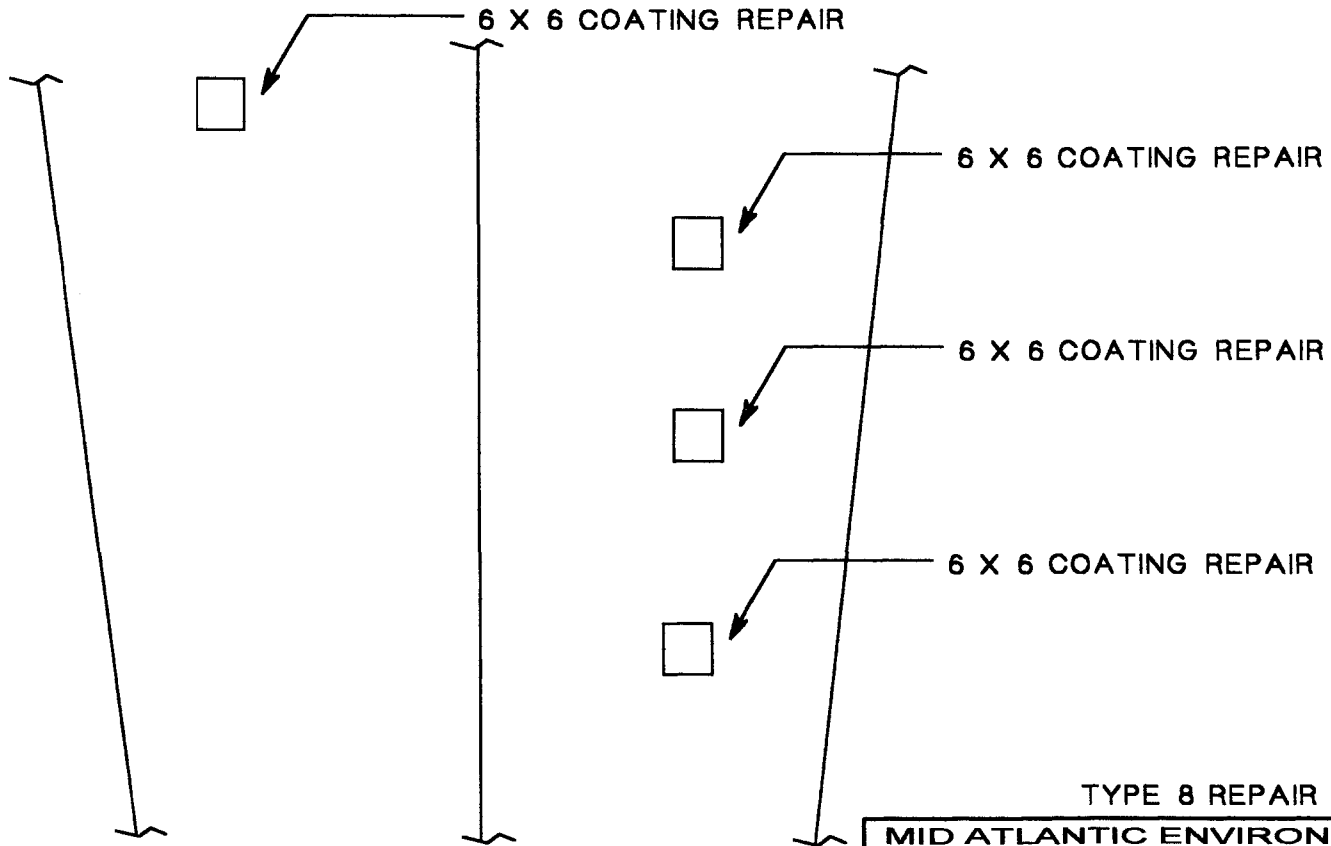
TYPE 8 REPAIR

Coating Type: EPOXY

NDT Performed: Visual: DFT: Average DFT: 15-22 mils

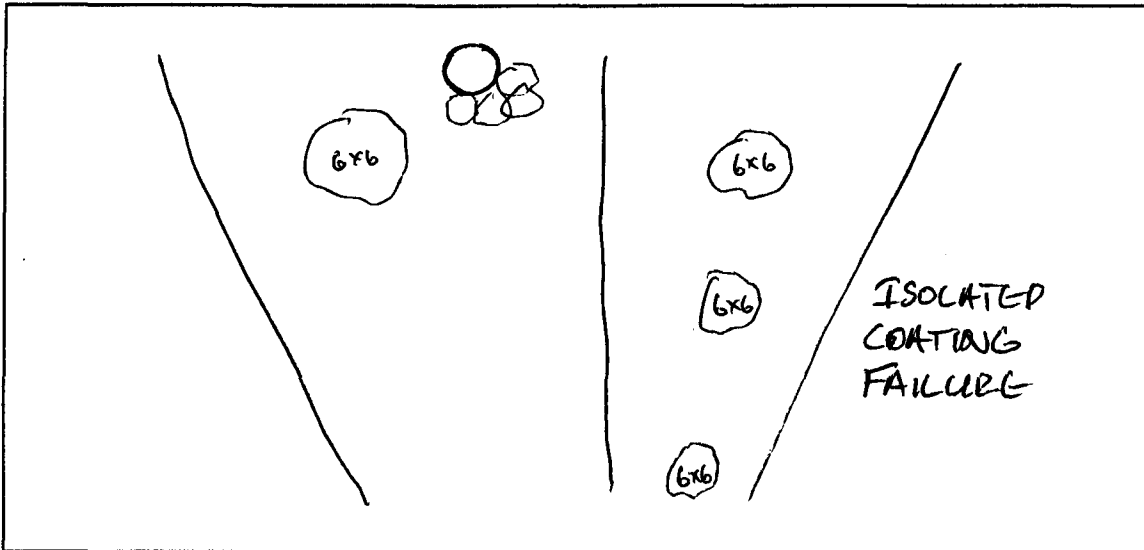
Sketch of Repair Area

Tank No.: 7 Repair No.: 036 Type: 8 Location: C18-2

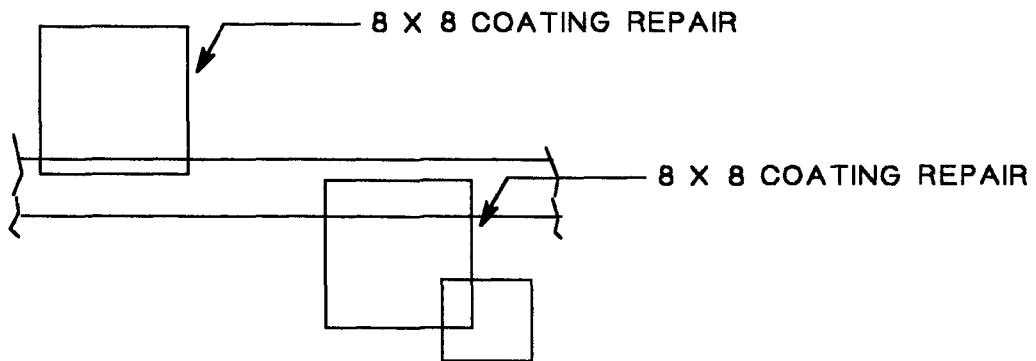
TYPE 8 REPAIR

Coating Type: EPOXY

NDT Performed: Visual: DFT: Average DFT: 15-22 mils

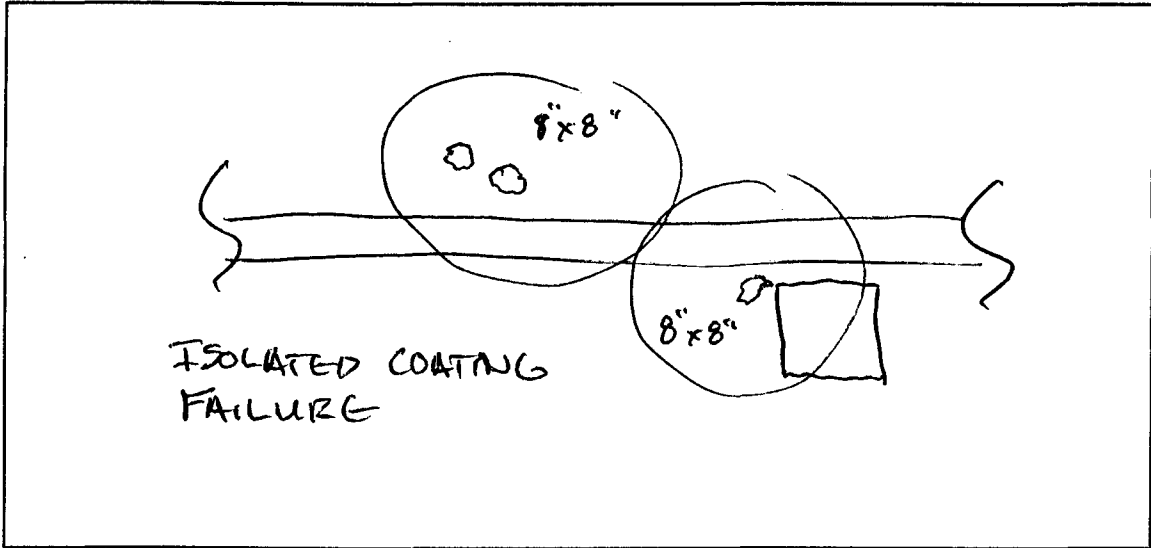
Sketch of Repair Area

Tank No.: 7 Repair No.: 037 Type: 8 Location: C15-2

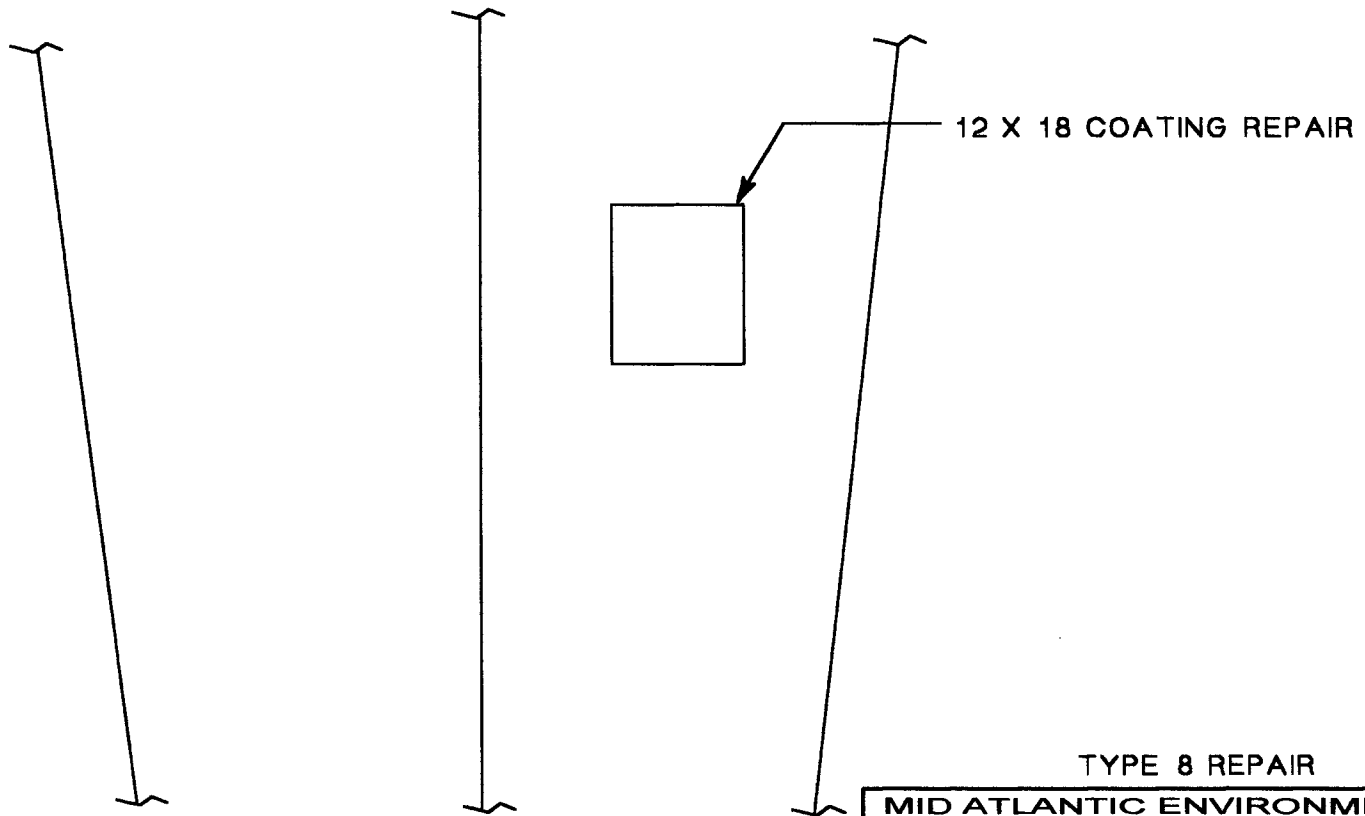
TYPE 8 REPAIR

Coating Type: EPOXY

NDT Performed: Visual: DFT: Average DFT: 15-22 mils

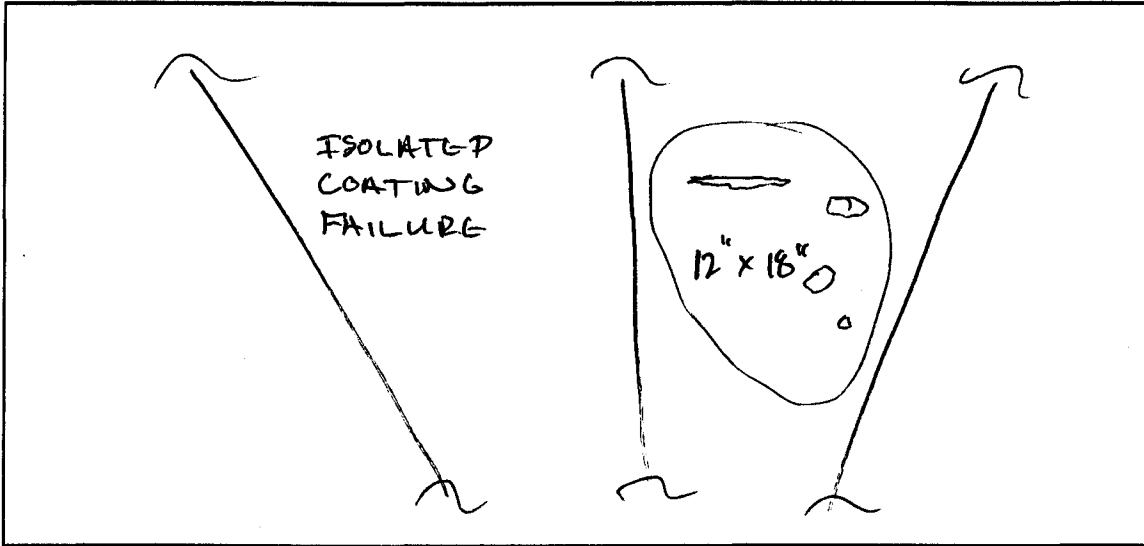
Sketch of Repair Area

Tank No.: 7 Repair No.: 038 Type: 8 Location: D21-2

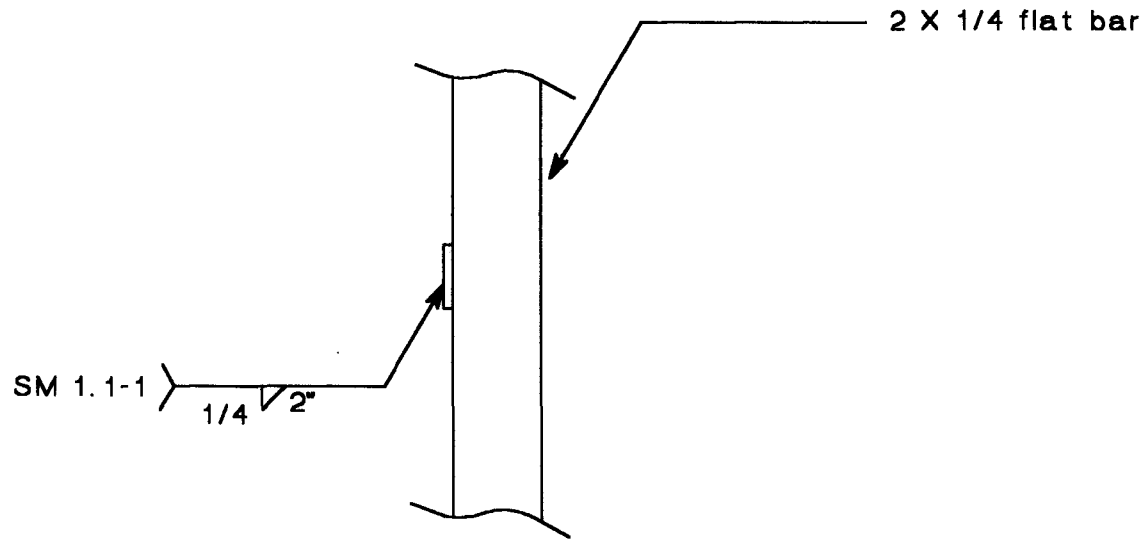
TYPE 10 REPAIR

WPS No.: SM 1.1-1

NDT Performed: Visual Vacuum Box Dye Penetrant

Coating Type: Epoxy

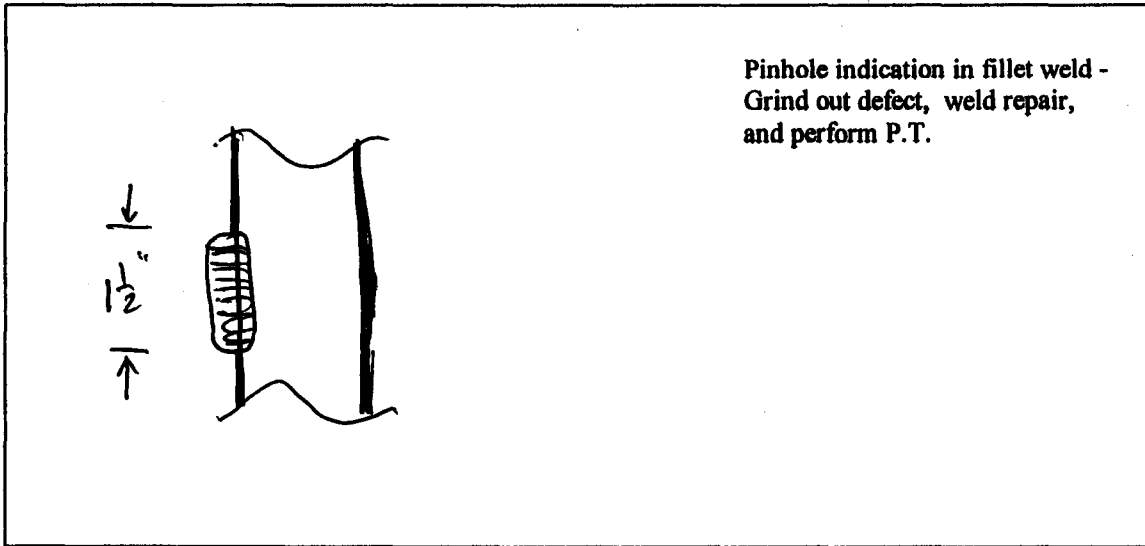
Sketch of Repair Area

Tank No.: 7 Repair No.: 039 Type: 10 Location: A3-B

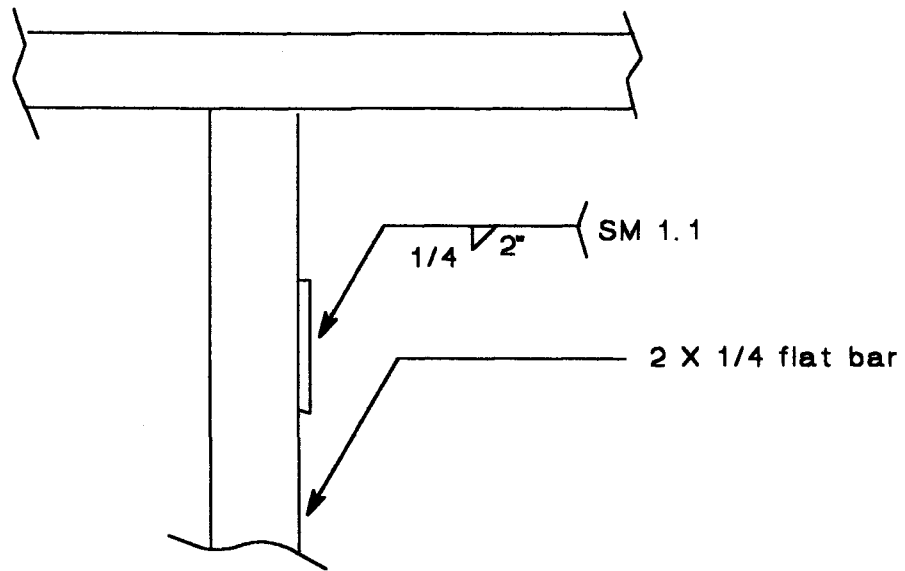
TYPE 10 REPAIR

WPS No.: SM1.1-1

NDT Performed: Visual Vacuum Box Dye Penetrant

Coating Type: Epoxy

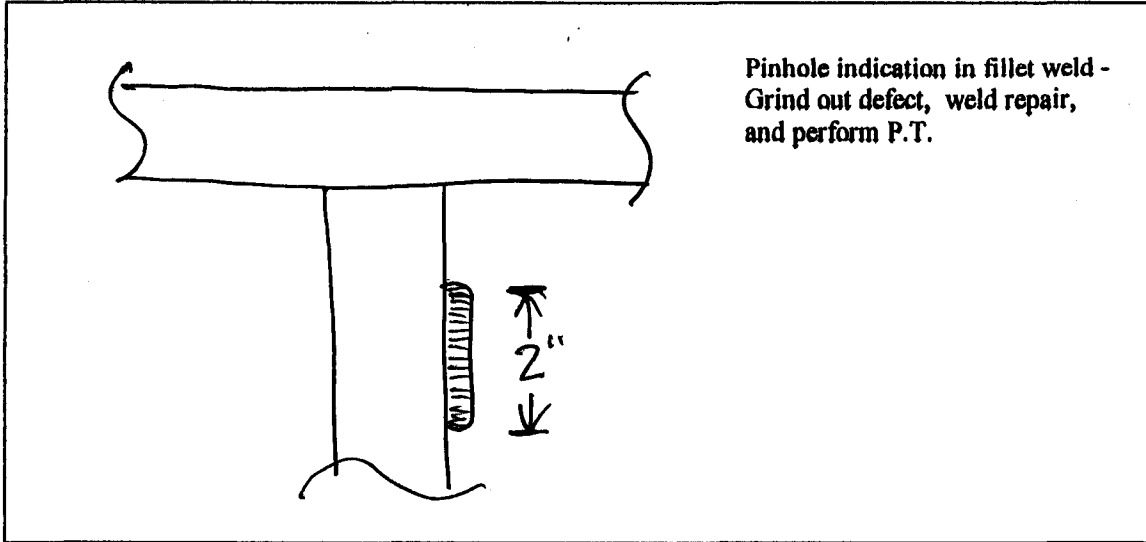
Sketch of Repair Area

Tank No.: 7 Repair No.: 040 Type: 10 Location: B9-A

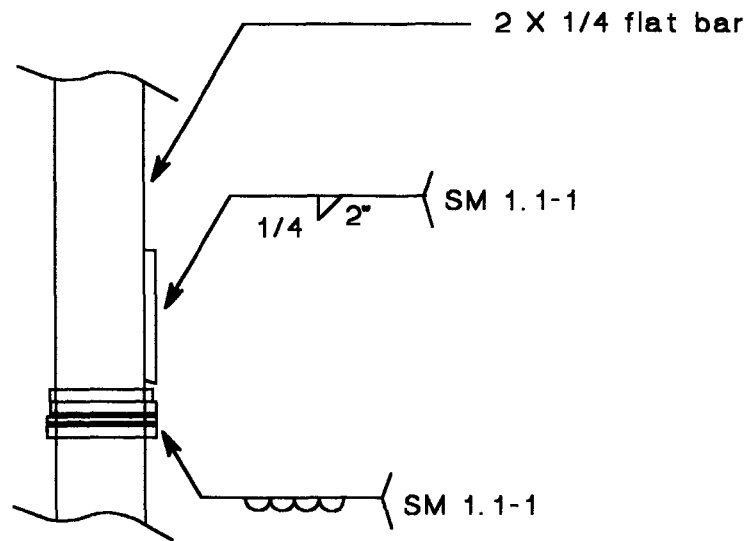
TYPE 10 REPAIR

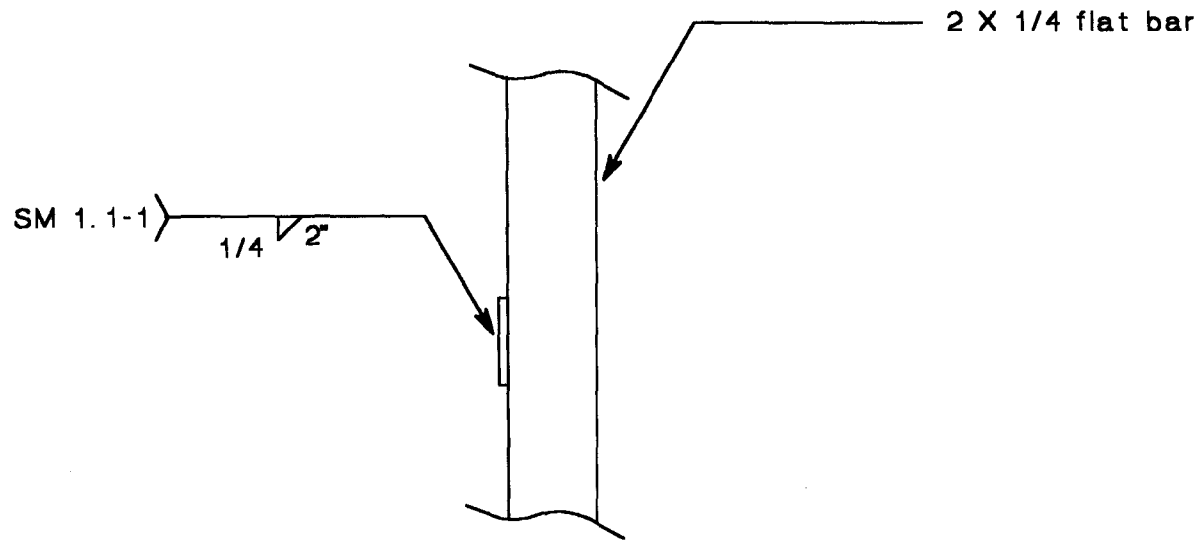
TYPE 10 REPAIR

WPS No.: SM 1.1-1

NDT Performed: Visual Vacuum Box Dye Penetrant

Coating Type: EPOXY

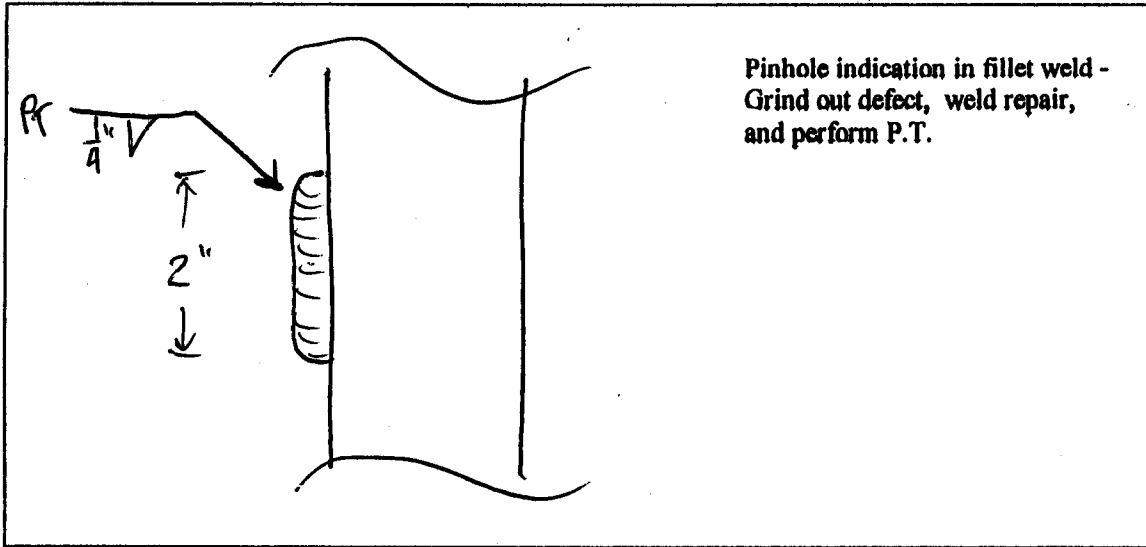
Sketch of Repair Area

Tank No.: 7 Repair No.: 042 Type: 10 Location: A3-A

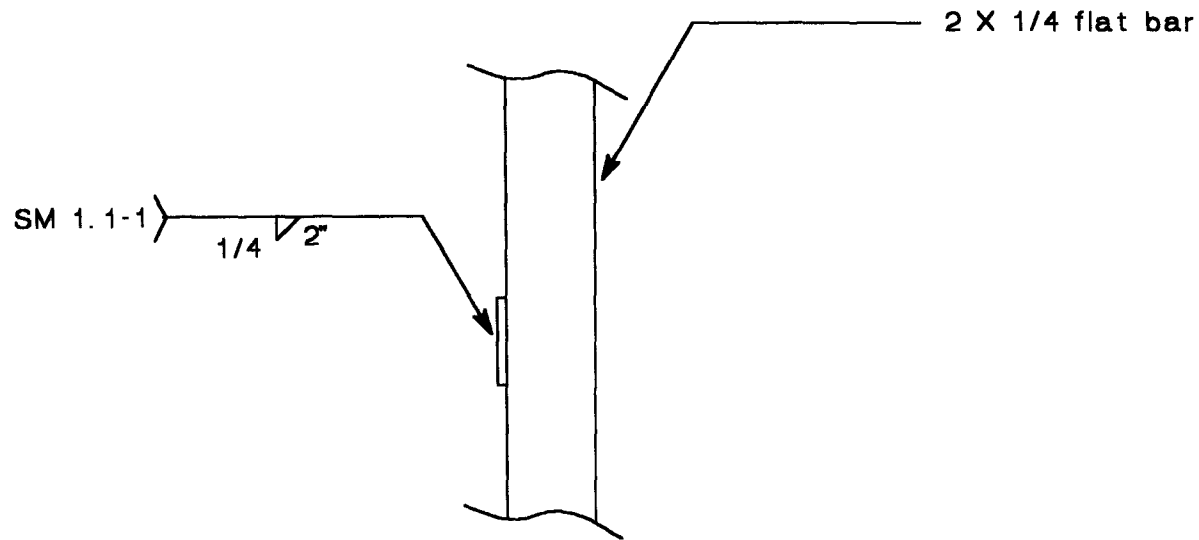
TYPE 10 REPAIR

WPS No.: SM1.1-1

NDT Performed: Visual Vacuum Box Dye Penetrant

Coating Type: EPOXY

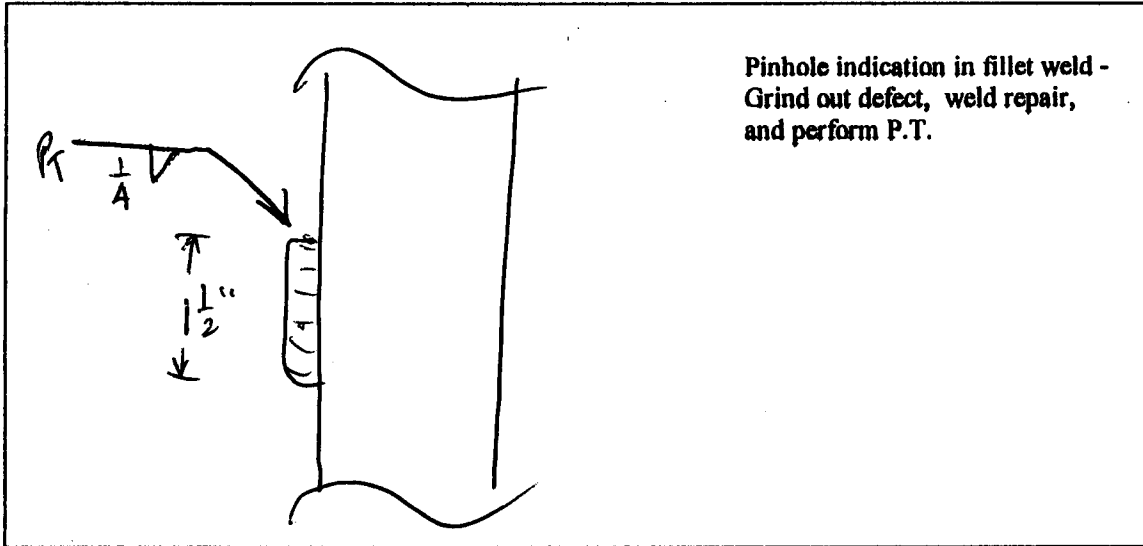
Sketch of Repair Area

Tank No.: 7 Repair No.: 043 Type: 10 Location: A3-A

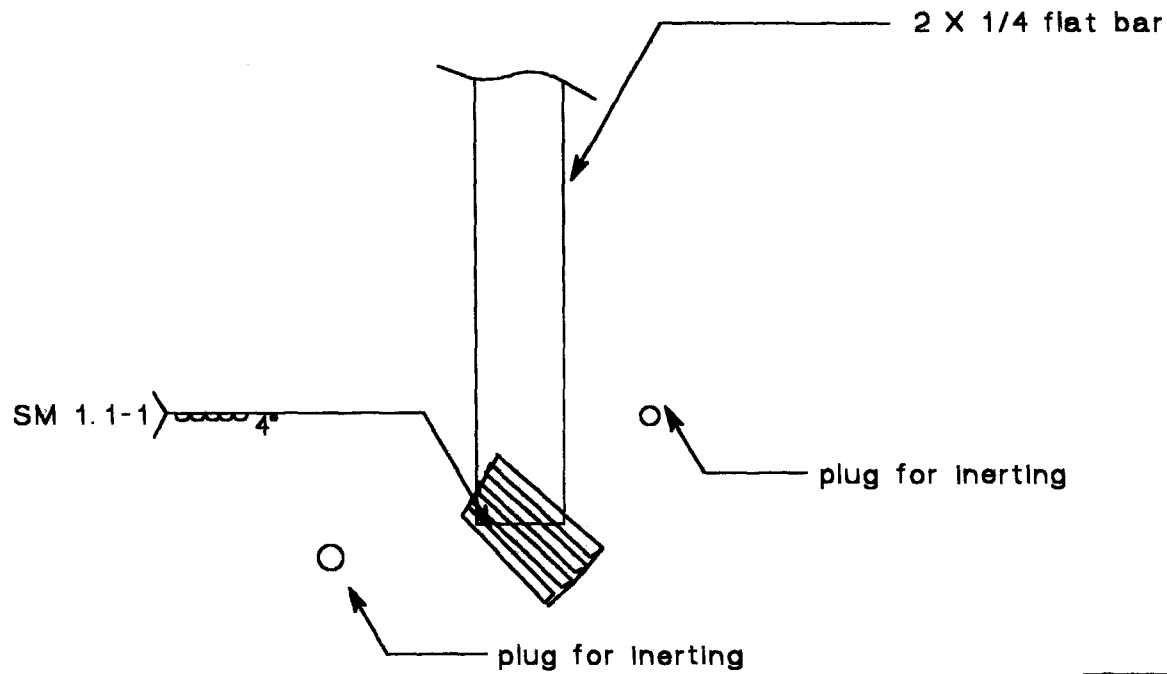
TYPE 10 REPAIR

WPS No.: SM 1.1-1

Coating Type: EPOXY

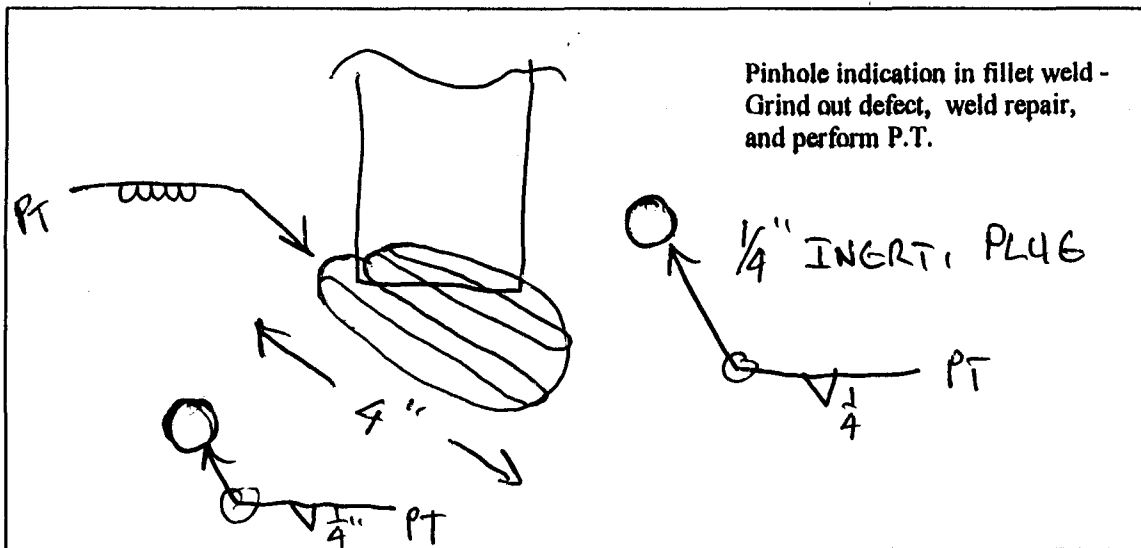
Sketch of Repair Area

Tank No.: 7 Repair No.: 044 Type: 10 Location: A3-A

NDT Performed:

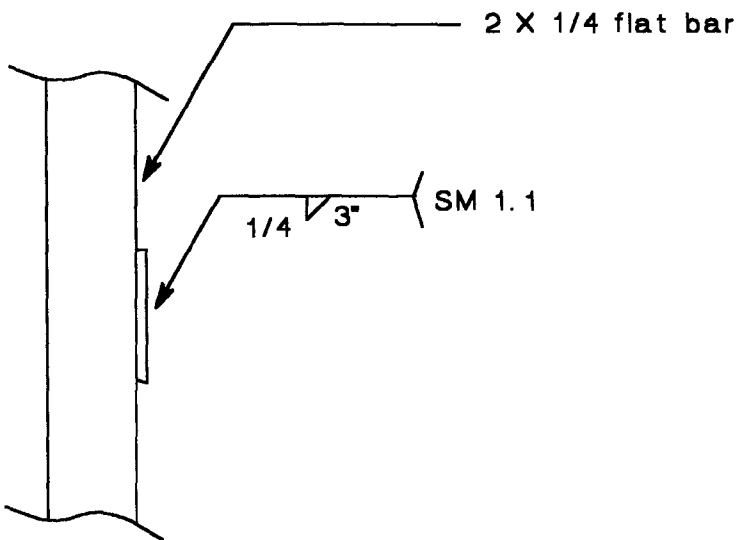
TYPE 10 REPAIR

WPS No.: SM 1.1-1

NDT Performed: Visual Vacuum Box Dye Penetrant

Coating Type: EPOXY

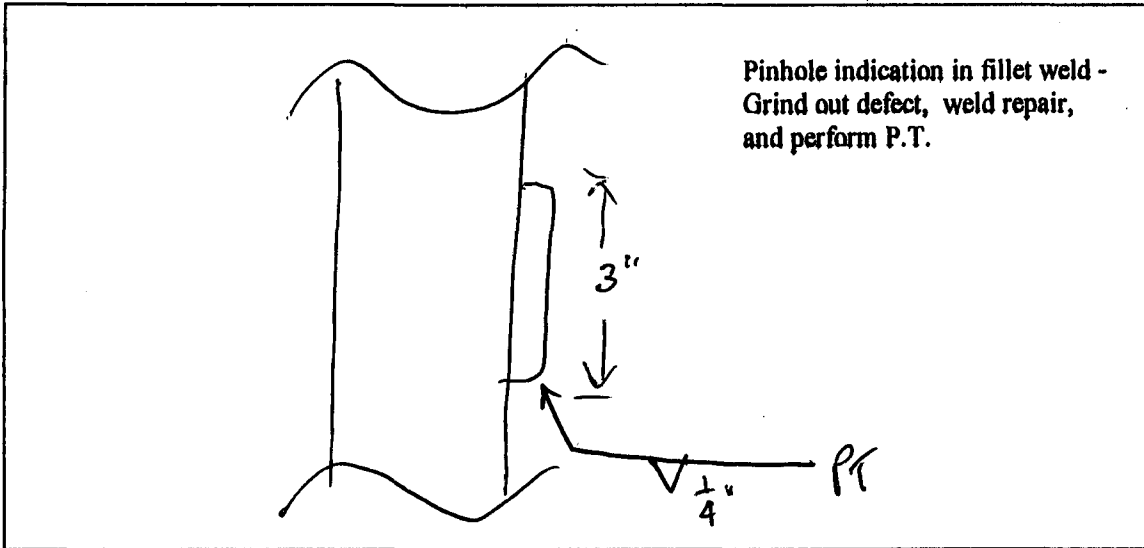
Sketch of Repair Area

Tank No.: 7 Repair No.: 045 Type: 10 Location: A4-A
