Section 9

RECOMMENDED REPAIRS

Dames & Moore
Emergency Repairs For Red Hill Tanks at the Fleet Industrial & Supply Center
Contract No. N62742-96-C-1356

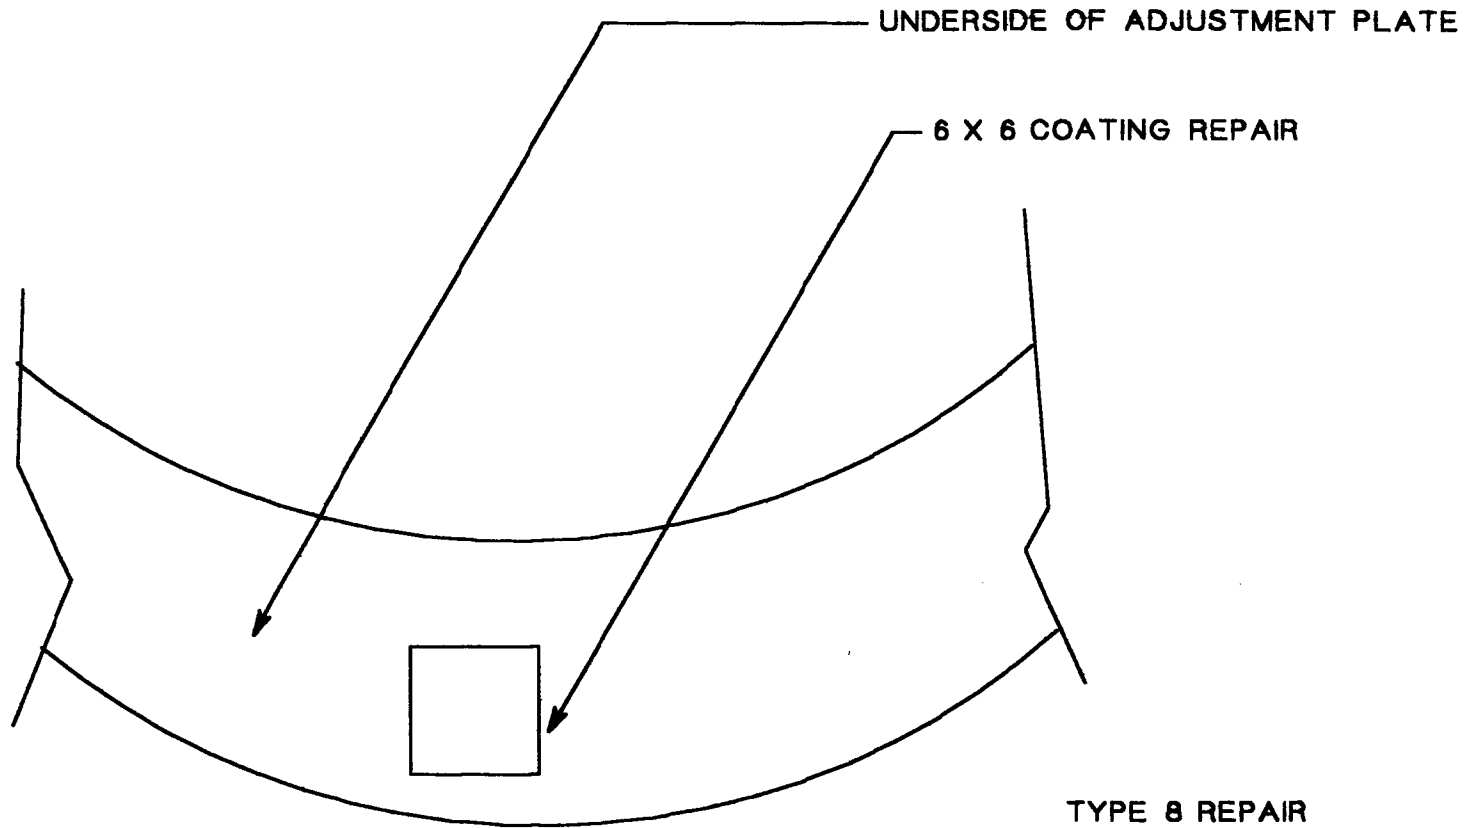
MID ATLANTIC ENVIRONMENTAL	
EMERGENCY REPAIRS FOR RED HILL TANKS	
Tank #8 AS BUILT DRAWINGS	
Repair No.: 002	File: 8R001
UPPER DOME	Quadrant: C
Course: EXTENSION	PLATE: 14
Drawn by: Tom Kitchen	Date: 5/4/98

NOTE: AREA EAS FOUND TO BE GROUND TO BARE METAL

TYPE 8 REPAIR
