Section 9

RECOMMENDED REPAIRS

Dames & Moore
Emergency Repairs For Red Hill Tanks at the Fleet Industrial & Supply Center
Contract No. N62742-96-C-1356

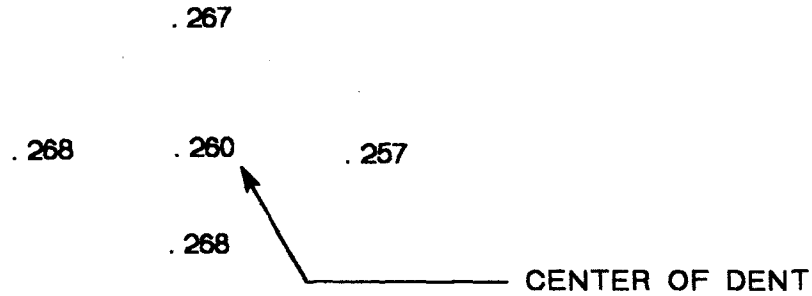
O I	ORIGINAL ISSUE	M M	2/20/98
LTR	DESCRIPTION	BY	DATE
REVISIONS			
MID ATLANTIC ENVIRONMENTAL			
EMERGENCY REPAIRS FOR RED HILL TANKS			
Tank #10 AS BUILT DRAWING			
Repair No.:	001	File:	10r001
Upper dome		Quadrant:	C
Course:	B	Plate:	17
Drawn By:	M. Moulton	Date:	2/20/98

NOTE: DENT OCCURED BEFORE PAINTING. PAINT REPAIR NOT NECESSARY

TYPE 7 REPAIR

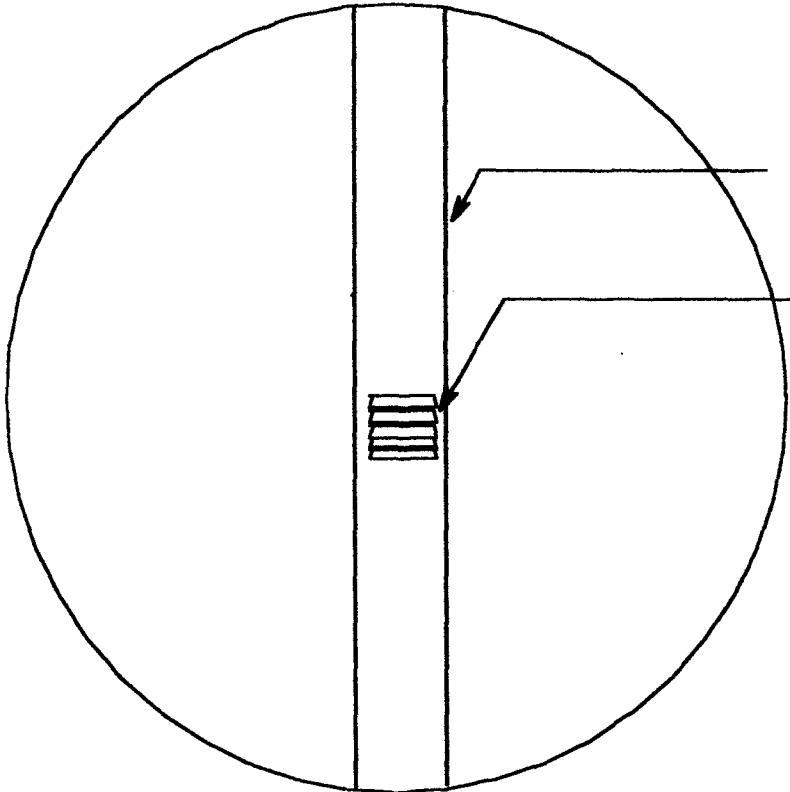
LTR	DESCRIPTION	BY	DATE
REVISIONS			
MID ATLANTIC ENVIRONMENTAL			
EMERGENCY REPAIRS FOR RED HILL TANKS			
Tank #10			
Repair No. 002	File: 10r002		
Upper dome	Quadrant: D		
Course: B	Plate: 19		
Drawn by: Tom Kitchen	Date: 2/20/98

2" x 1/4" EXISTING FLAT BAR

SM 1.1-1

Weld Repair 3

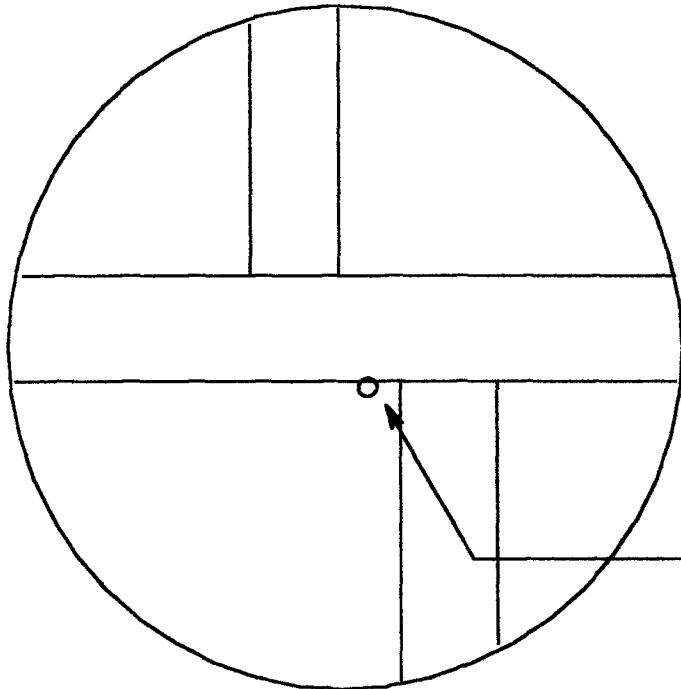
LTR	DESCRIPTION	BY	DATE
REVISIONS			
MID ATLANTIC ENVIRONMENTAL			
EMERGENCY REPAIRS FOR RED HILL TANKS			
Tank #10			
Repair No.:	003	File:	10r003
Upper dome		Quadrant:	C
Course:	B	Plate:	13
Drawn By:	M. Moulton	Date:	2/19/98

No Leak Detected

no repair required

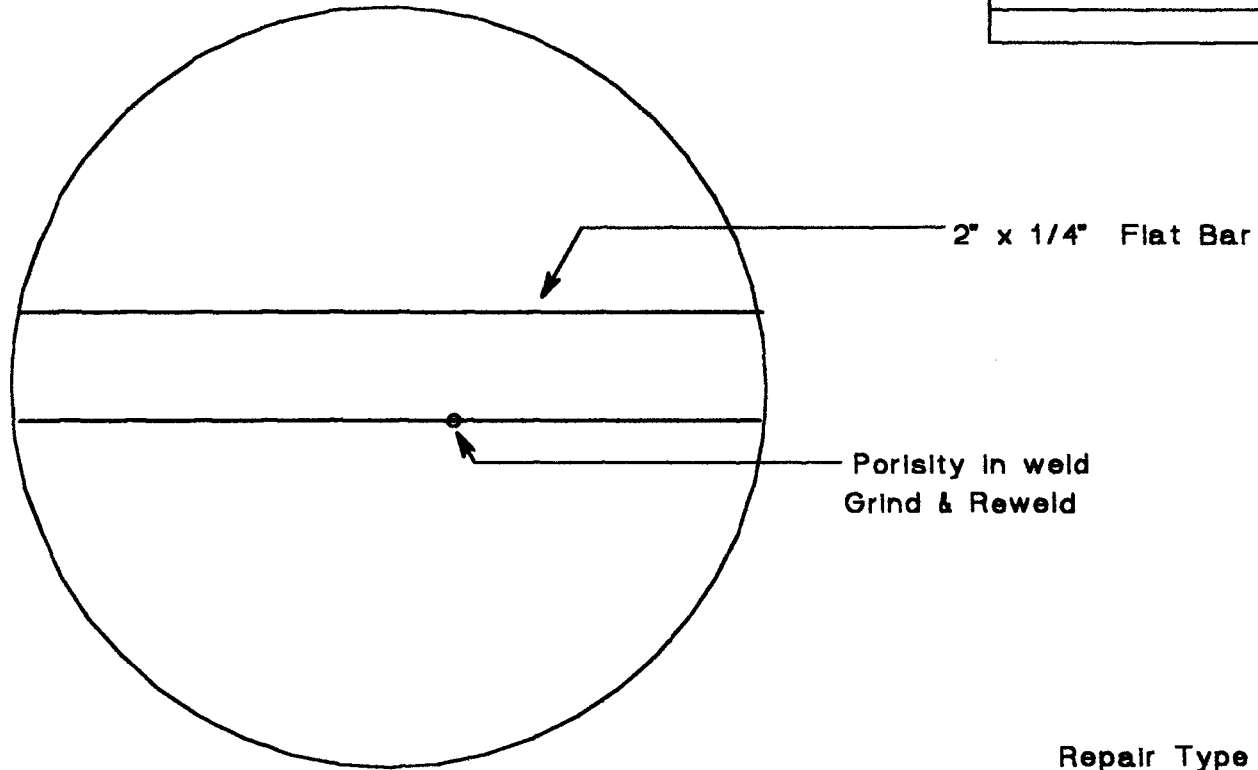
LTR	DESCRIPTION	BY	DATE
REVISIONS			
MID ATLANTIC ENVIRONMENTAL			
EMERGENCY REPAIRS FOR RED HILL TANKS			
Tank #10			
Repair No. : 006	File:10r006		
Upper dome	Quadrant: C		
Course: EXTENSION	Plate: 15 & 16		
Drawn by: M. Moulton	Date: 12/19/97

Porisity in weld
Grind & Reweld

Repair Type 10

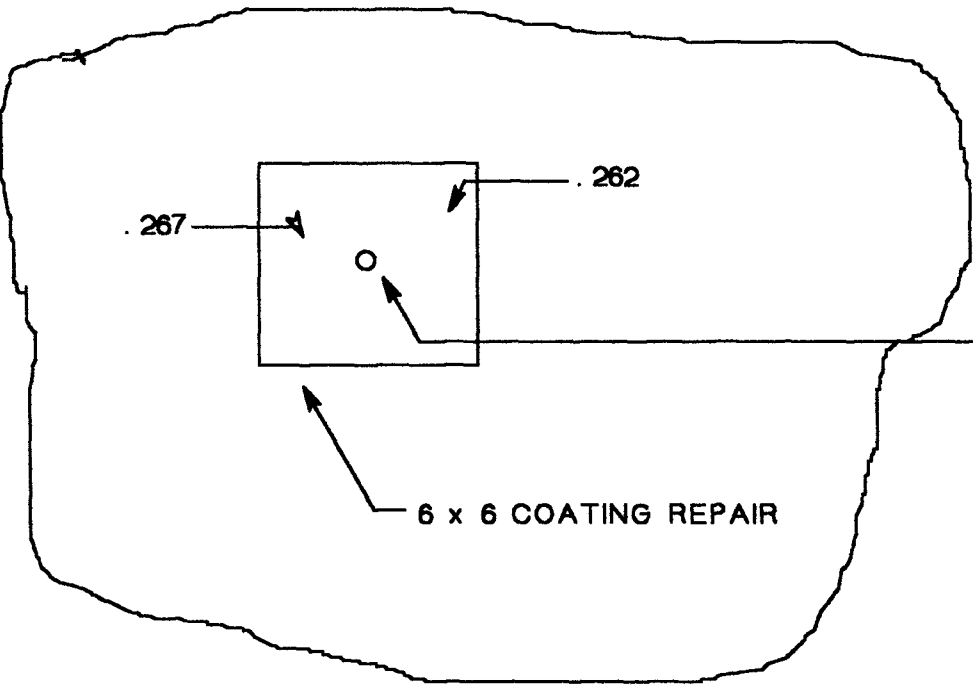
O I	ORIGINAL ISSUE	T K	2/20/98
LTR	DESCRIPTION	BY	DATE
REVISIONS			
MID ATLANTIC ENVIRONMENTAL			
EMERGENCY REPAIRS FOR RED HILL TANKS			
Tank #10			
Repair No.:	011	File:	10r011
CYLINDER		Quadrant:	D
Course:	3 & 4	Plate:	19
Drawn By:	M. Moulton	Date:	2/20/98

NO LEAK DETECTED CHANGE TO COATING REPAIR

6 x 6 COATING REPAIR

TYPE 1 REPAIR

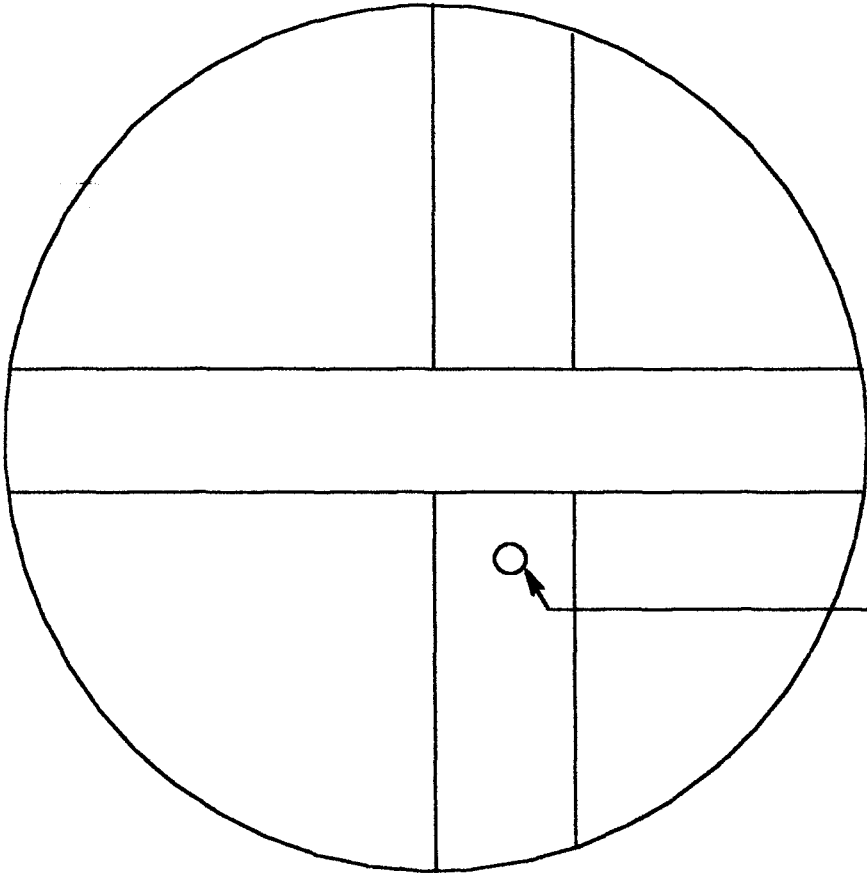
MID ATLANTIC ENVIRONMENTAL	
EMERGENCY REPAIRS FOR RED HILL TANKS	
Tank #10	
Repair No. 080	File:10r080
Upper dome	Quadrant: A
Course: B	Plate: 3
Drawn By: M. Moulton	Date: 2/20/98

No Leak Detected

NO REPAIR REQUIRED
