**Dames & Moore**  
Emergency Repairs For Red Hill Tanks at the Fleet Industrial & Supply Center  
Contract No. N62742-96-C-1356

**Repair Record**

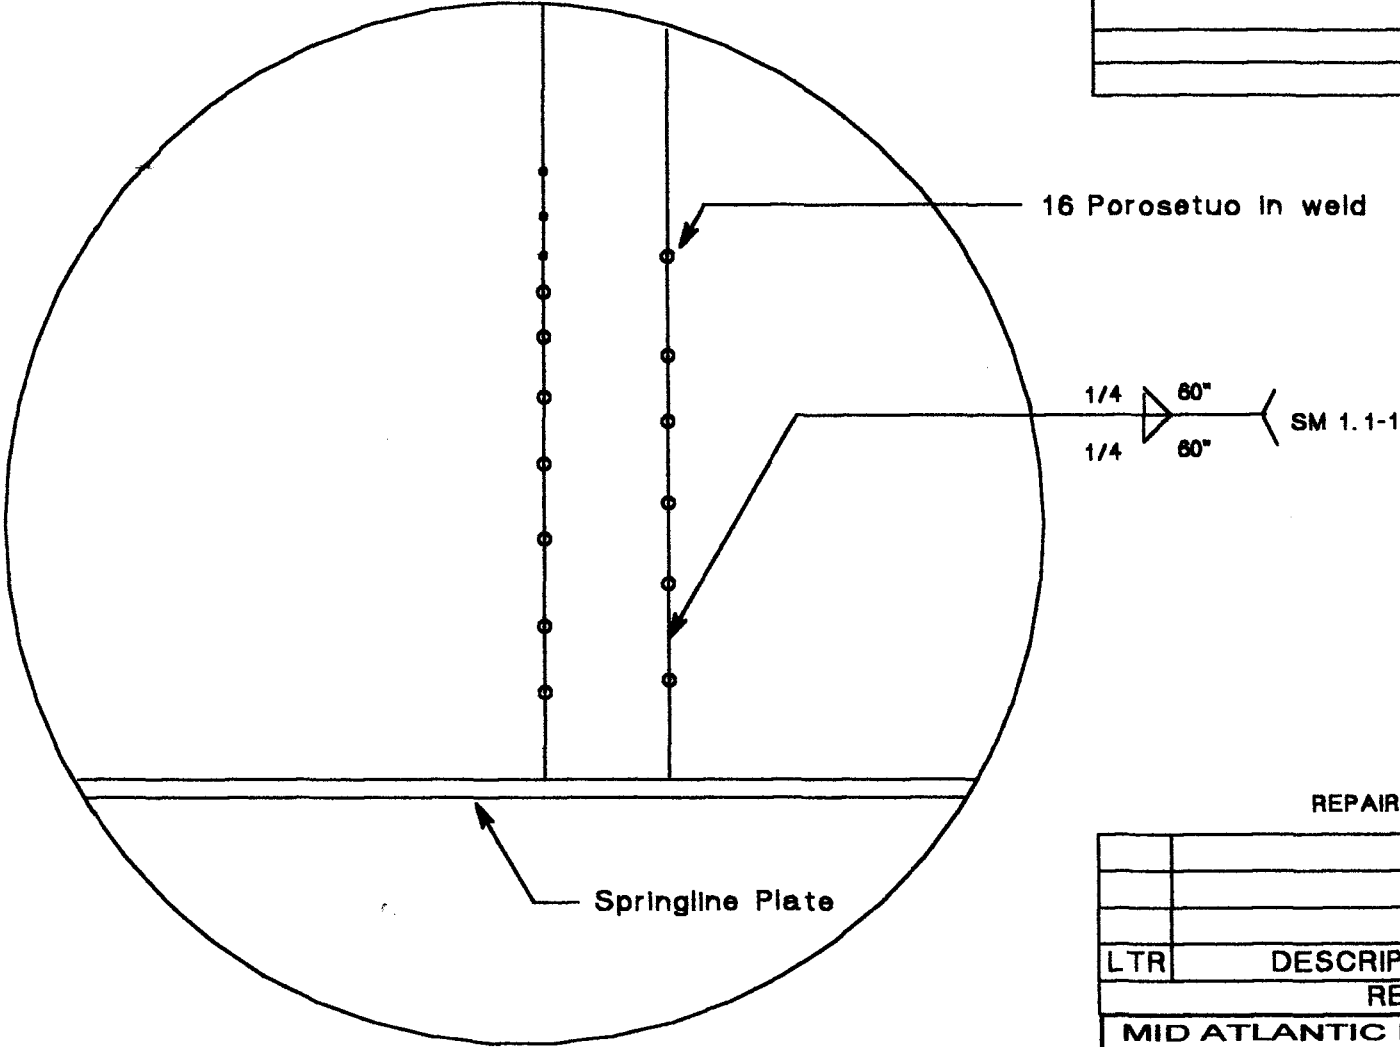
LTR	DESCRIPTION	BY	DATE
REVISIONS			
MID ATLANTIC ENVIRONMENTAL EMERGENCY REPAIRS FOR RED HILL TANKS			
Tank #10			
Repair No.:	100	File:	10r100
Upper dome		Quadrant:	A
Course:	A	Plate:	1 & 2
Drawn by:	M. Moulton	Date:	12/20/97

REPAIR TYPE 11

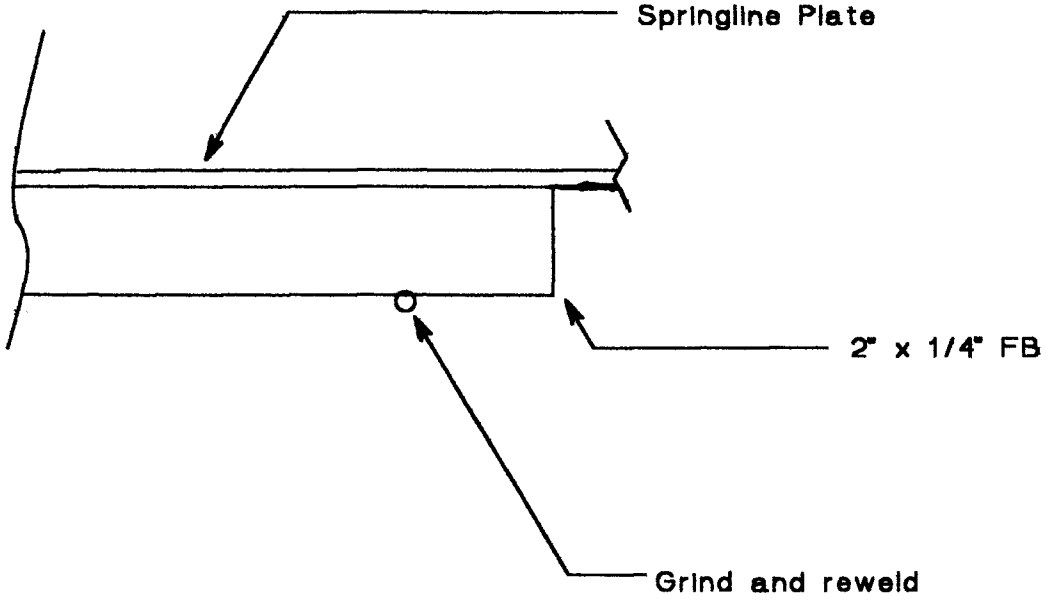
O I	ORIGINAL ISSUE	M M	2/20/98
LTR	DESCRIPTION	BY	DATE
REVISIONS			
MID ATLANTIC ENVIRONMENTAL EMERGENCY REPAIRS FOR RED HILL TANKS			
Tank #10			
Repair No.: 120		File: 10r120	
Upper dome		Quadrant: A	
Course: A		Plate: 3	
Drawn By: M. Moulton		Date: 2/20/98

Repair Type 10

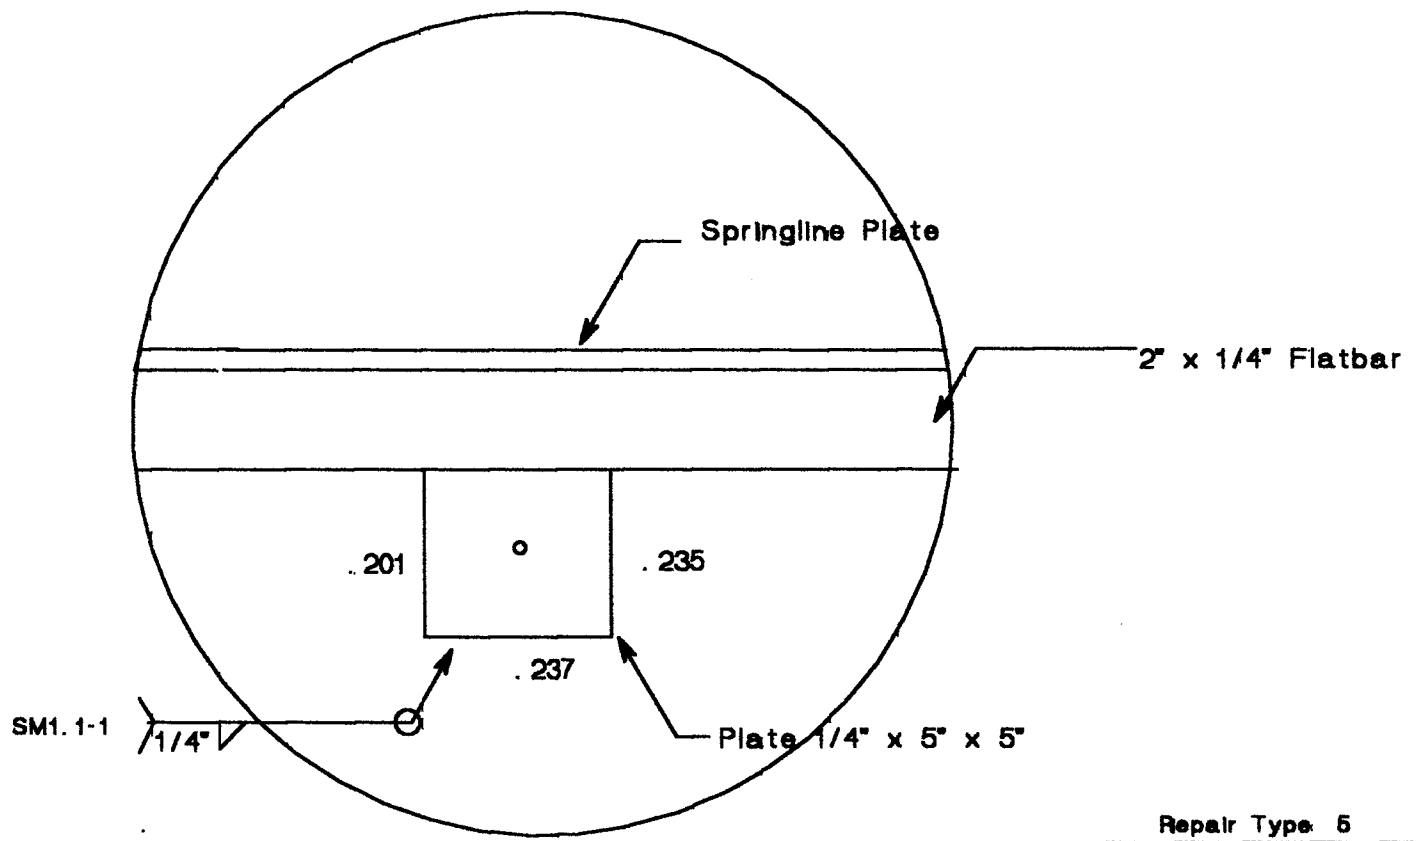
O I	ORIGINAL ISSUE	M M	2/20/98
LTR	DESCRIPTION	BY	DATE
REVISIONS			
<b>MID ATLANTIC ENVIRONMENTAL</b>			
<b>EMERGENCY REPAIRS FOR RED HILL TANKS</b>			
Tank #10			
Repair No. 130		File: 10r130	
Upper dome		Quadrant: A	
Course: A		Plate: 3	
Drawn By: M. Moulton		Date: 2/20/98

Repair Type 5

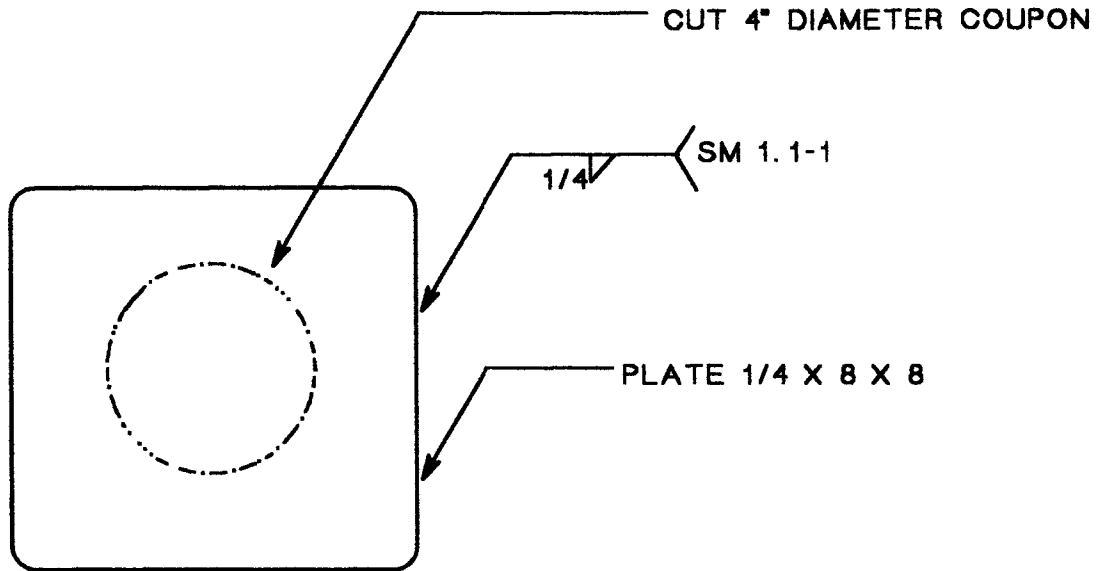
LTR	DESCRIPTION	BY	DATE
<b>REVISIONS</b>			
<b>MID ATLANTIC ENVIRONMENTAL</b>			
<b>EMERGENCY REPAIRS FOR RED HILL TANKS</b>			
Tank #10			
Repair No. 131	File: 10r131		
Upper dome	Quadrant: A		
Course: C	Plate: 5		
Drawn by: Tom Kitchen	Date: 2/20/98

**TYPE 6 REPAIR**

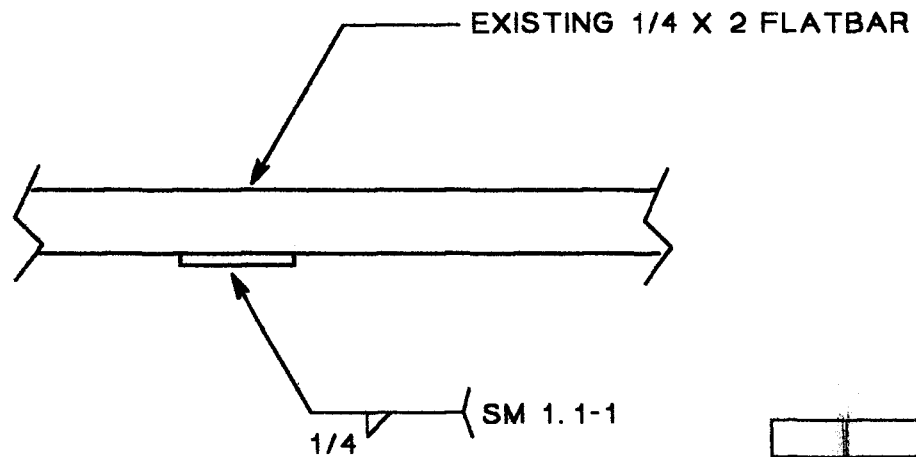
LTR	DESCRIPTION	BY	DATE
REVISIONS			
MID ATLANTIC ENVIRONMENTAL			
EMERGENCY REPAIRS FOR RED HILL TANKS			
Tank #10			
Repair No.: 150		File: 10r150	
Upper dome		Quadrant: A	
Course: A & B		Plate: 4	
Drawn by: Tom Kitchen		Date: 2/20/98

TYPE 10 REPAIR

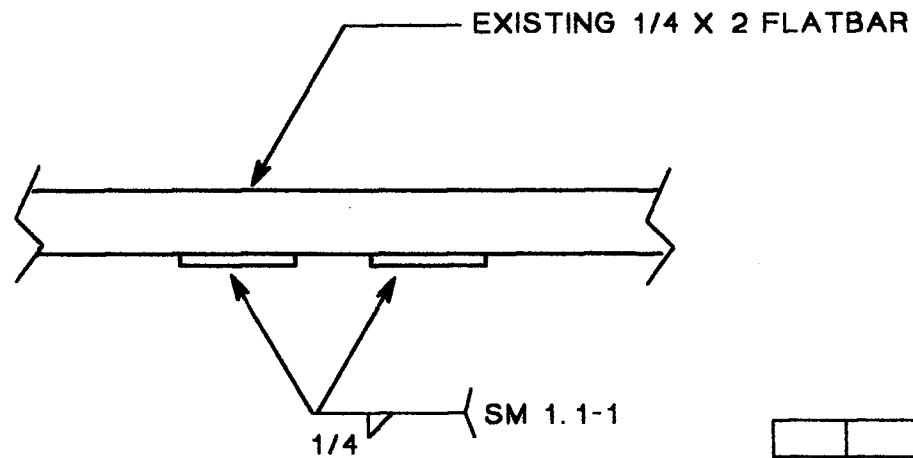
LTR	DESCRIPTION	BY	DATE
REVISIONS			
MID ATLANTIC ENVIRONMENTAL			
EMERGENCY REPAIRS FOR RED HILL TANKS			
Tank #10			
Repair No.: 160		File: 10r160	
Upper dome		Quadrant: A	
Course: A		Plate: 5	
Drawn by: Tom Kitchen		Date: 2/20/98

TYPE 10 REPAIR

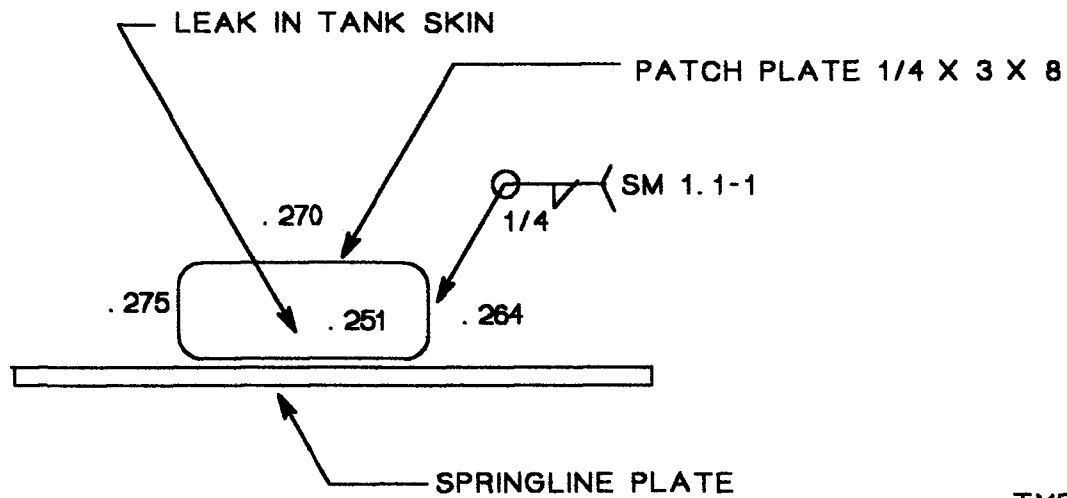
LTR	DESCRIPTION	BY	DATE
REVISIONS			
MID ATLANTIC ENVIRONMENTAL			
EMERGENCY REPAIRS FOR RED HILL TANKS			
Tank #10			
Repair No. 170	File: 10udr170		
Upper dome	Quadrant: A		
Course: A	Plate: 5		
Drawn by: Tom Kitchen	Date: 2/20/98

TYPE 5 REPAIR

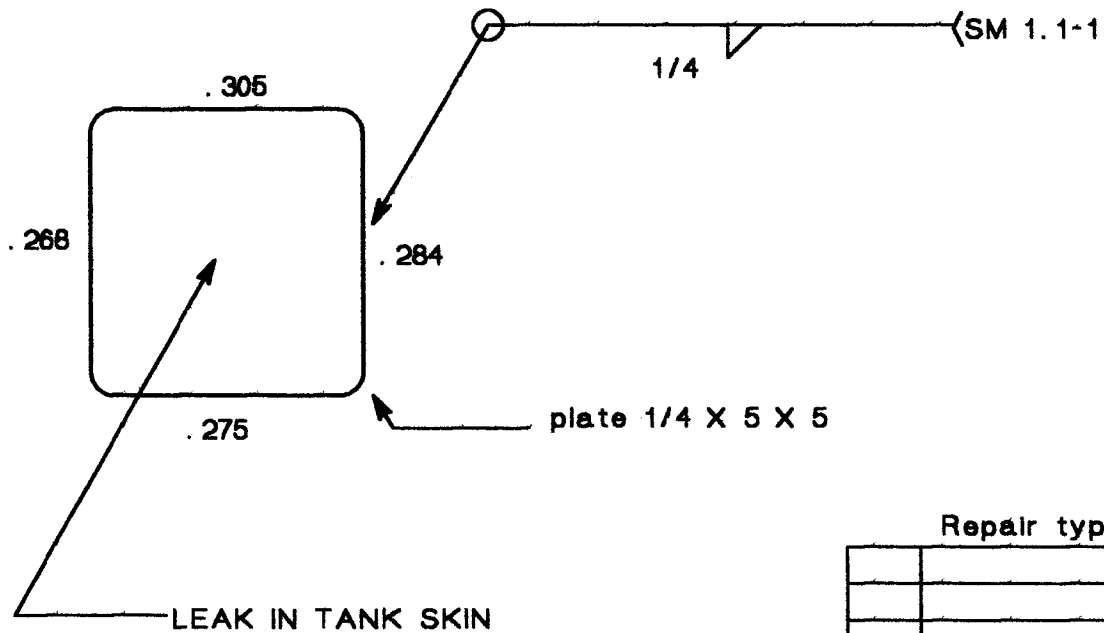
LTR	DESCRIPTION	BY	DATE
REVISIONS			
MID ATLANTIC ENVIRONMENTAL			
EMERGENCY REPAIRS FOR RED HILL TANKS			
Tank #10			
Repair No.:	180	File:	10-180
Upper dome		Quadrant:	B
Course:	EXTENSION	Plate:	9
Drawn by:	Tom Kitchen	Date:	4/28/98

Repair type 5

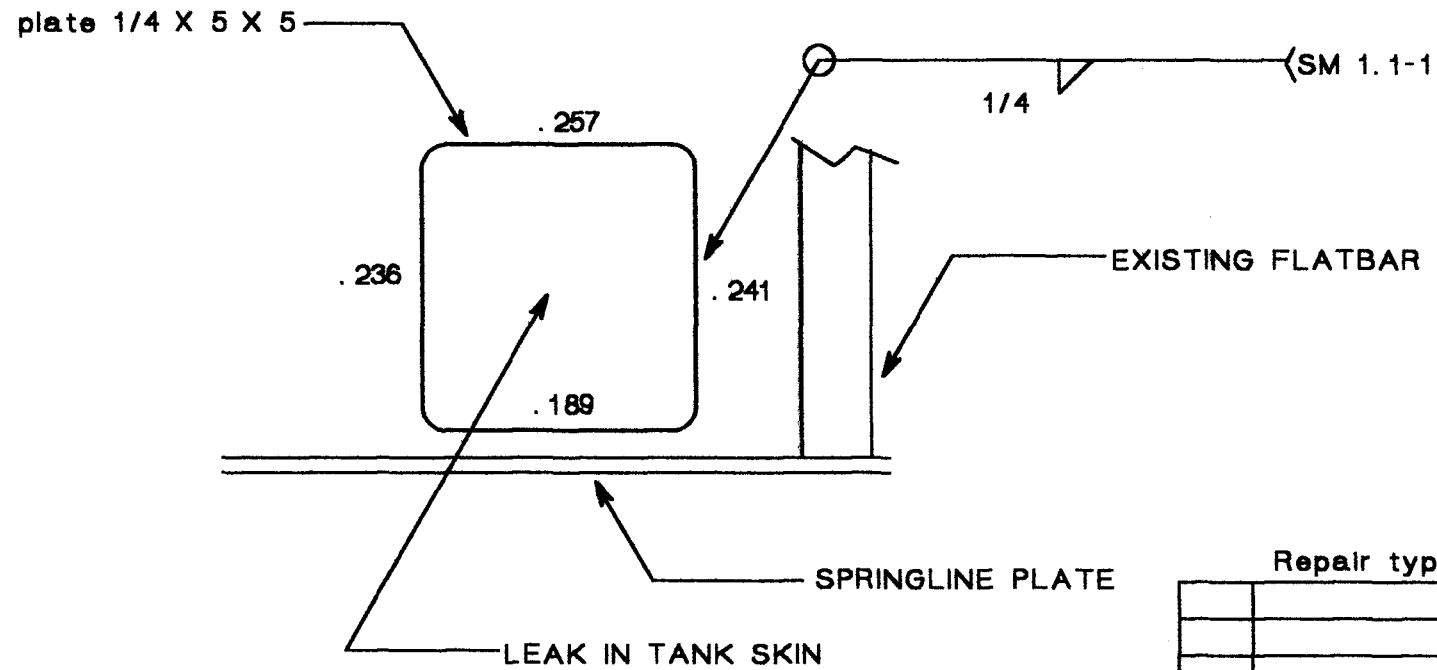
LTR	DESCRIPTION	BY	DATE
REVISIONS			
MID ATLANTIC ENVIRONMENTAL			
EMERGENCY REPAIRS FOR RED HILL TANKS			
Tank #10			
Repair No.:	190	File:	10r190
Upper dome		Quadrant:	B
Course:	EXTENSION	Plate:	9
Drawn by:	Tom Kitchen	Date:	4/28/98

Repair type 5

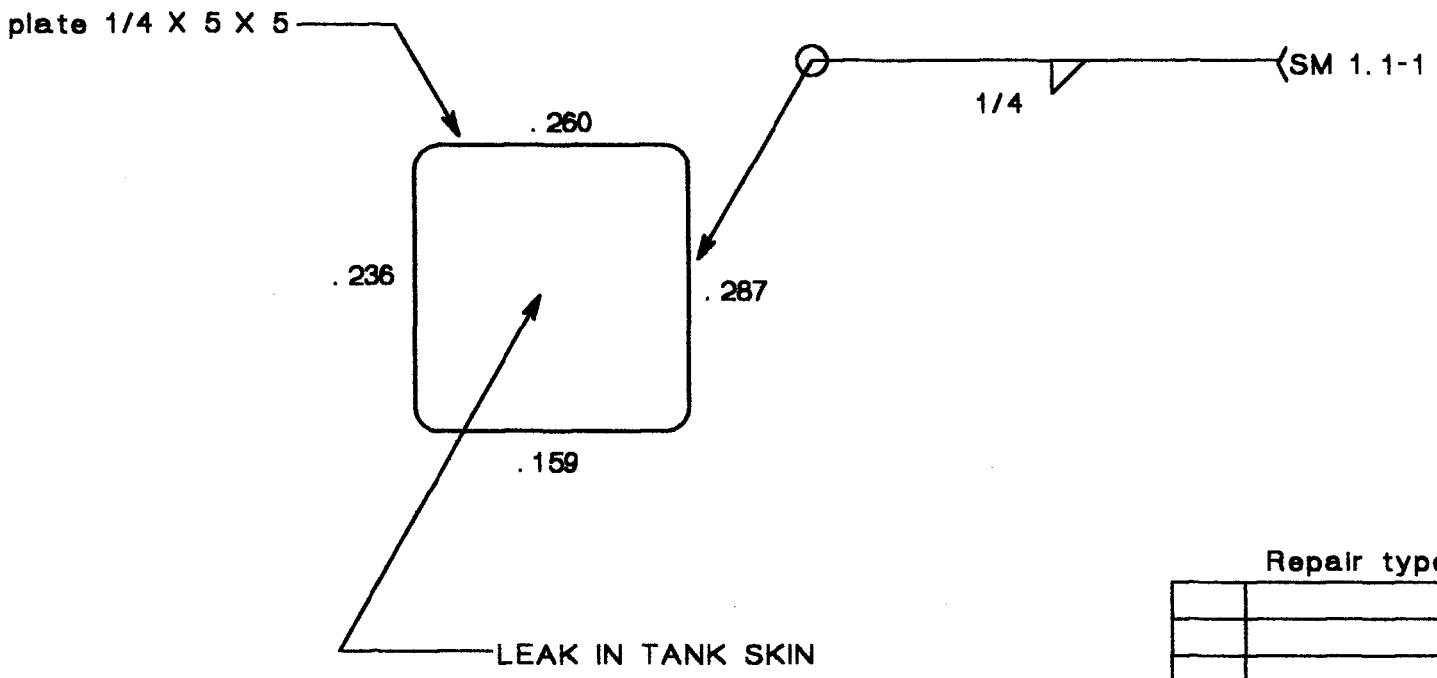
LTR	DESCRIPTION	BY	DATE
REVISIONS			
MID ATLANTIC ENVIRONMENTAL			
EMERGENCY REPAIRS FOR RED HILL TANKS			
Tank #10			
Repair No. 200	File 10r200		
Upper dome	Quadrant B		
Course EXTENSION	Plate 10		
Drawn by Tom Kitchen	Date 4/28/98

Repair type 5

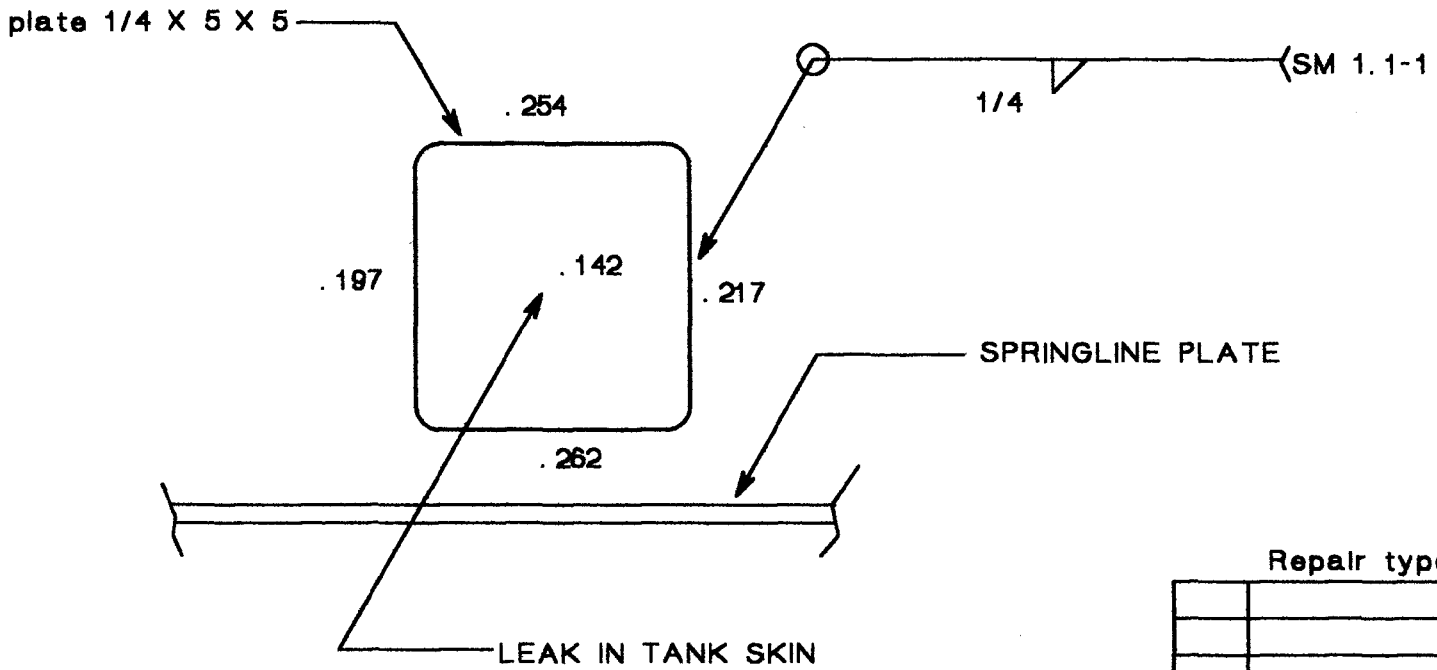
LTR	DESCRIPTION	BY	DATE
REVISIONS			
MID ATLANTIC ENVIRONMENTAL			
EMERGENCY REPAIRS FOR RED HILL TANKS			
Tank #10			
Repair No.:	210	File:	10r210
Upper dome		Quadrant:	B
Course:	EXTENSION	Plate:	10
Drawn by:	Tom Kitchen	Date:	4/28/98

Repair type 5

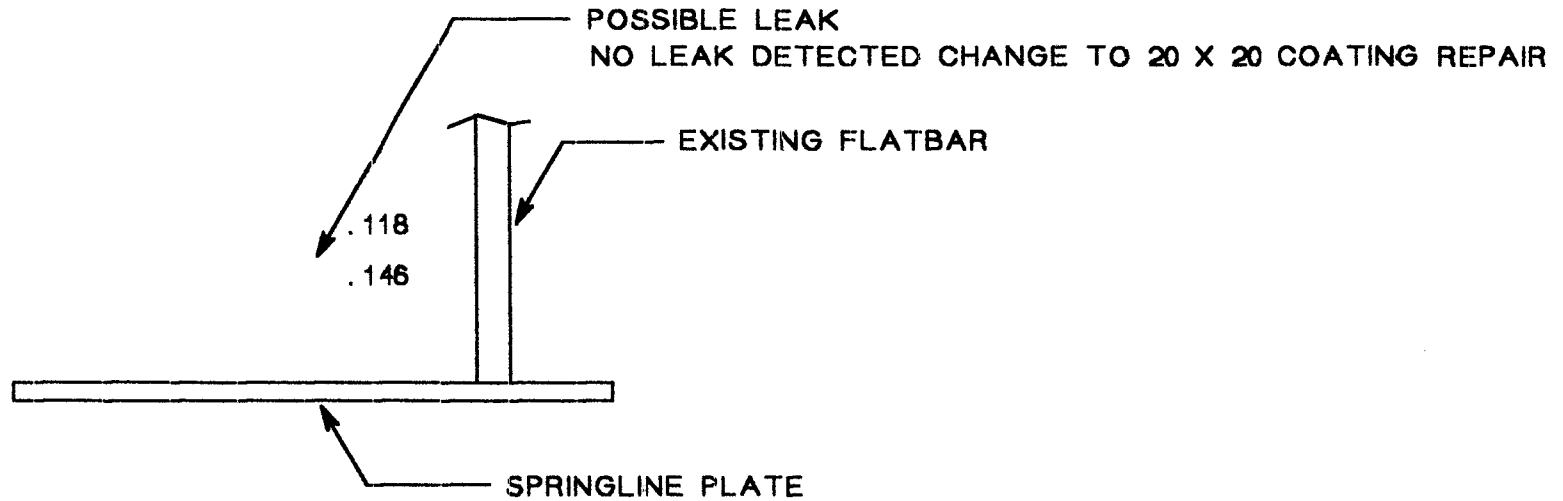
LTR	DESCRIPTION	BY	DATE
REVISIONS			
MID ATLANTIC ENVIRONMENTAL			
EMERGENCY REPAIRS FOR RED HILL TANKS			
Tank #10			
Repair No. 220		File 10udr220	
Upper dome		Quadrant B	
Course EXTENSION		Plate 11	
Drawn by Tom Kitchen		Date 5/13/98

TYPE 8 REPAIR

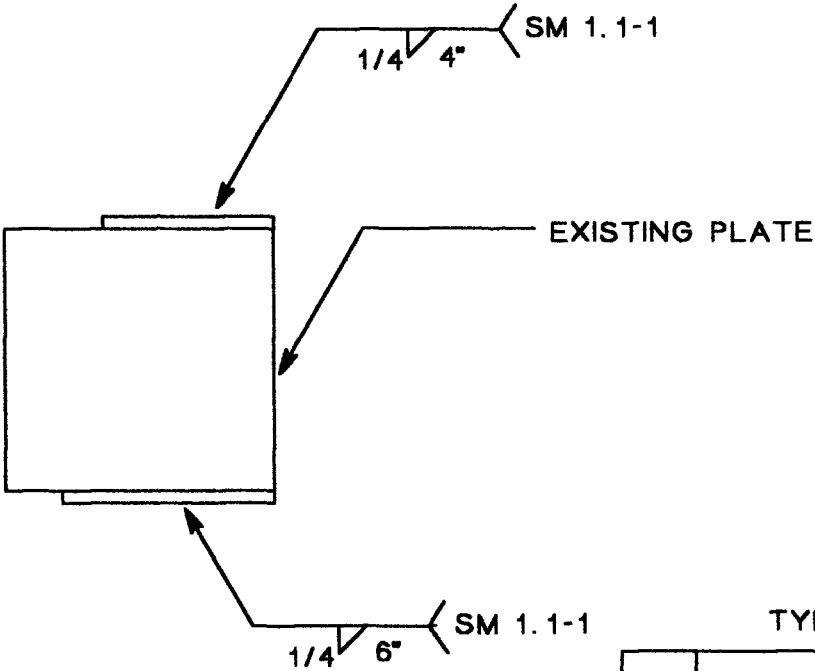
LTR	DESCRIPTION	BY	DATE
<b>REVISIONS</b>			
<b>MID ATLANTIC ENVIRONMENTAL</b>			
<b>EMERGENCY REPAIRS FOR RED HILL TANKS</b>			
Tank #10			
Repair No. 230		File 10r230	
Cylinder		Quadrant B	
Course 1		Plate 11	
Drawn by: Tom Kitchen		Date: 5/13/98

**TYPE 10 REPAIR**

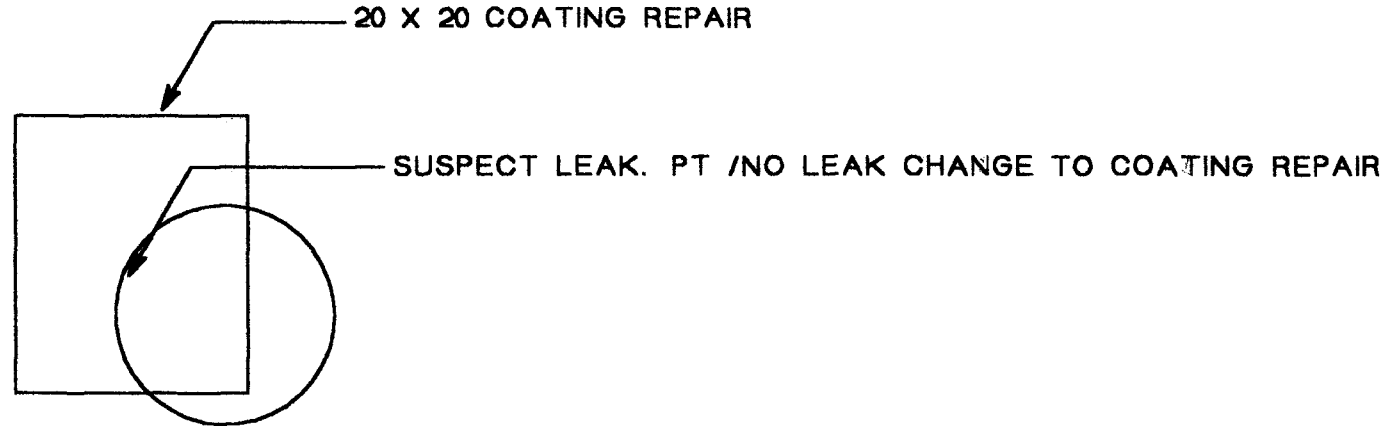
LTR	DESCRIPTION	BY	DATE
<b>REVISIONS</b>			
<b>MID ATLANTIC ENVIRONMENTAL</b>			
<b>EMERGENCY REPAIRS FOR RED HILL TANKS</b>			
Tank #10			
Repair No. : 250	File: 10r250		
Upper dome	Quadrant: B		
Course: EXTENSION	Plate: 9		
Drawn by: Tom Kitchen	Date: 5/13/98

**TYPE B REPAIR**

NO DEFECTS FOUND

CLEAN TO BARE METAL + PERFORM P.T.

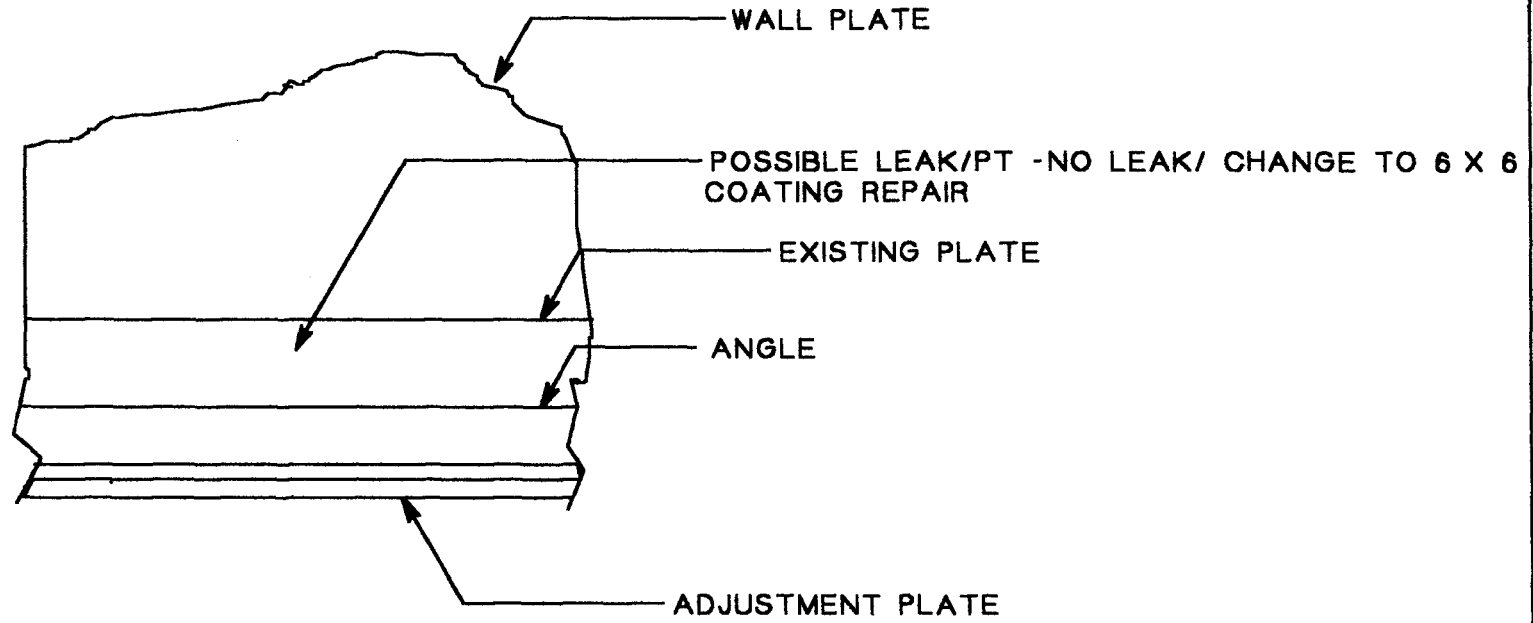
LTR	DESCRIPTION	BY	DATE
<b>REVISIONS</b>			
<b>MID ATLANTIC ENVIRONMENTAL</b>			
<b>EMERGENCY REPAIRS FOR RED HILL TANKS</b>			
Tank #10			
Repair No. 260		File 10r260	
Upper dome		Quadrant B	
Course EXTENSION		Plate 9	
Drawn by Tom Kitchen		Date 5/13/98

**TYPE 8 REPAIR**
