LTR	DESCRIPTION	BY	DATE
REVISIONS			
MID ATLANTIC ENVIRONMENTAL			
EMERGENCY REPAIRS FOR RED HILL TANKS			
Tank #10			
Repair No. : 270	File: 10r270		
Upper dome	Quadrant: B		
Course: EXTENSION	Plate: 10		
Drawn by: Tom Kitchen	Date: 5/13/98

Dames & Moore
Emergency Repairs For Red Hill Tanks at the Fleet Industrial & Supply Center
Contract No. N62742-96-C-1356

Repair Record

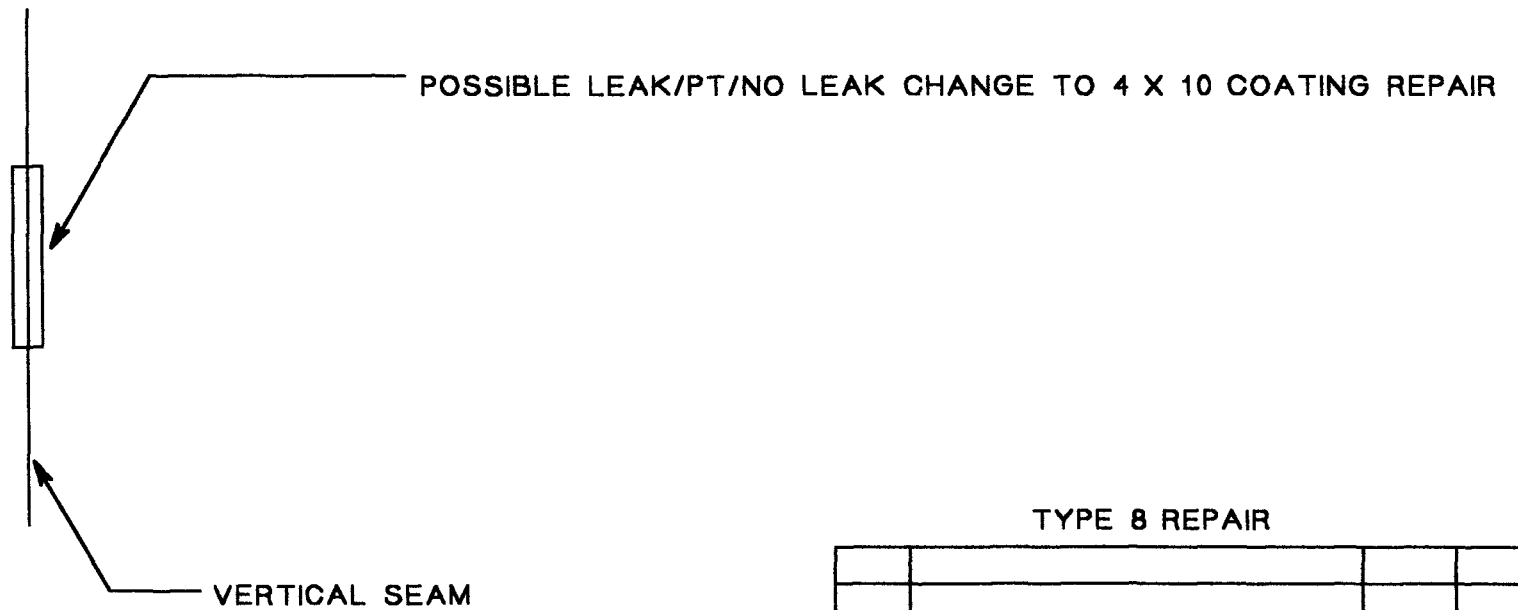
CALENDER OF EVENTS		
EVENT	BY	DATE
Defect Inspected	JF & TK	2/20/98

TYPE 8 REPAIR

NO DEFECTS FOUND Type 8 JH
3/22/98

CLEAN TO BARE METAL & PERFORM P.T. PER
T. Kitchen
