2.1 Mid Atlantic Environmental, Inc. conducted an inspection on Tank #8 at the Red Hill Underground Storage Facility, Pearl Harbor, Hawaii. This inspection was conducted in accordance with the scope of work identified by Contract Number N00604-97-R-0013, PRL 96-21, titled "Emergency Repair for Red Hill Tanks."

RED HILL TANK NO. 7  
PRODUCT: DFM

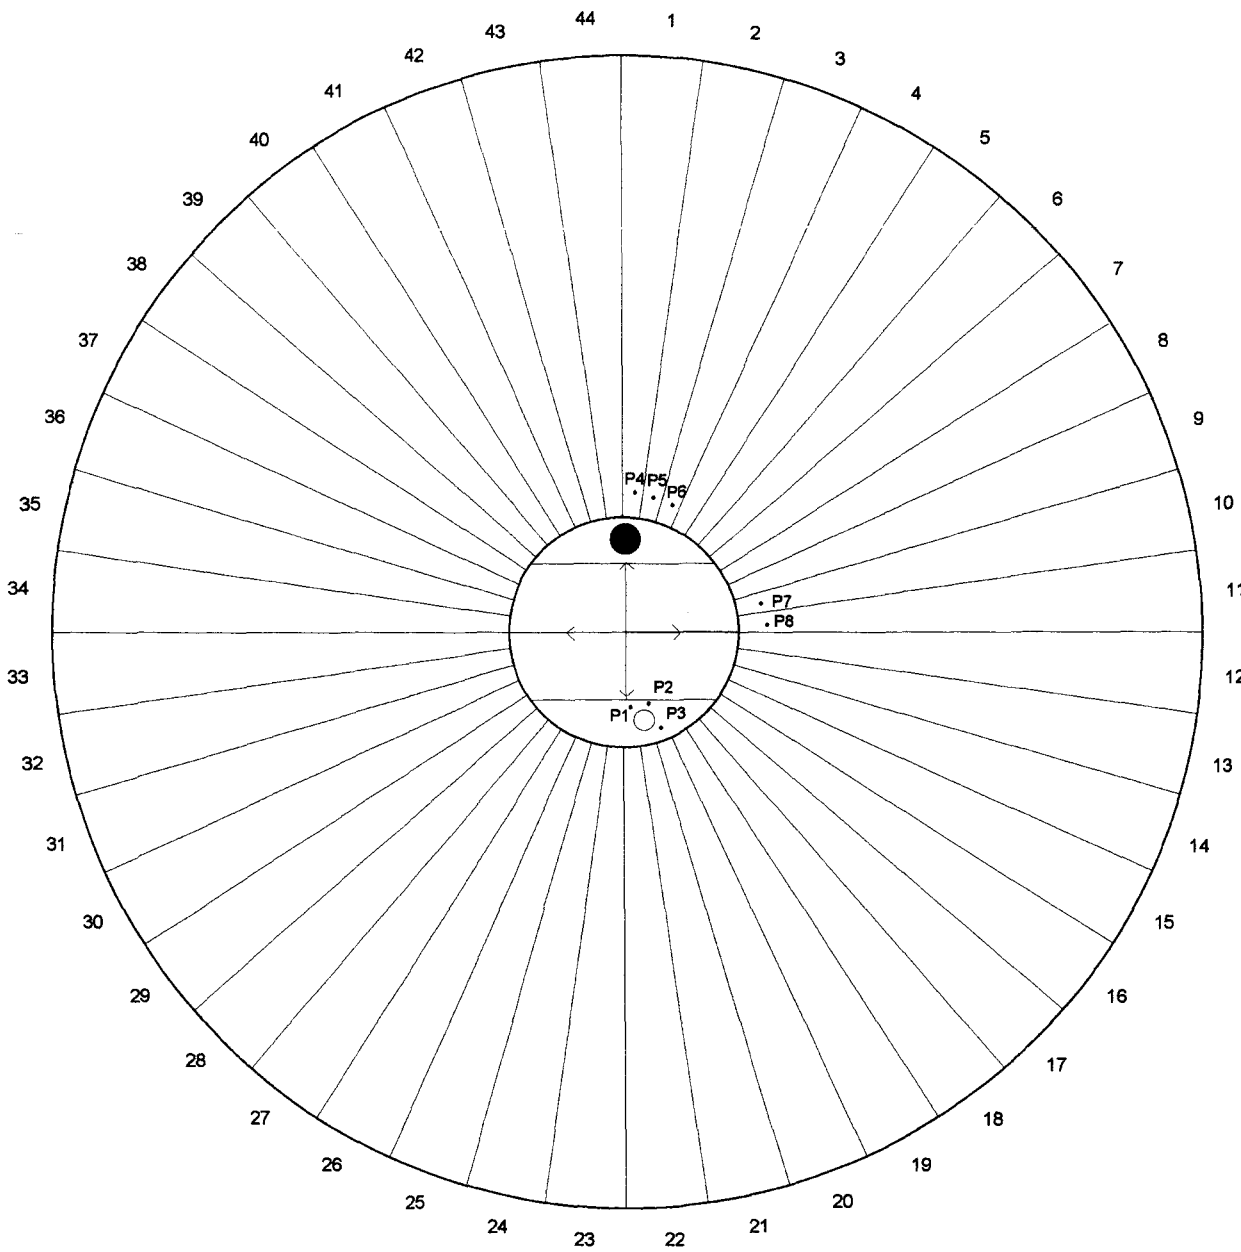
Drawing Title:  
**Bottom Layout with Pit Indications**

7.2.1 The original bottom thickness was determined to be 0.500 inches and the first ascending plate to be 0.250 inches. The ultrasonic thickness measurements taken determined that backside corrosion in this area is not a problem. Pitting is not a problem since the remaining metal thickness is well within the 0.10 inches of metal required by API Standard 653 by the next inspection. Also the coating to be applied to the tank bottom should prevent any increase in pit depth. Although pitting is not a problem with regard to structural integrity, it did present a problem regarding the coating to be applied. Pictures of this pitting are included with this report. The surface contamination test results yielded 0% ferrous salts, 32 ppm NaCl and a pH level of 7. These results are within the limits set forth in the KTA SCAN Kit technical data and the NACE technical committee report on Surface Preparation of Contaminated Steel Surfaces. The Caustic Soda test of the tank bottom indicated that all Flame Sprayed Aluminum had been removed. By visual inspection, scattered pitting was observed on the tank bottom and first ascending plates. The deeper pits were measured and recorded on the Bottom Layout With Pit Indications drawing.

- P1 = 0.120
- P2 = 0.160
- P3 = 0.120
- P4 = 0.119
- P5 = 0.075
- P6 = 0.071
- P7 = 0.090
- P8 = 0.125
