MID ATLANTIC ENVIRONMENTAL	
EMERGENCY REPAIRS FOR RED HILL TANKS	
Tank #7 RECOMMENDED REPAIR DRAWING	
Repair No. 031	File 7R031
cylinder	Quadrant C
Course 24	Plate 15
Drawn by Tom Klitcher	Date 5/4/98

Dames & Moore
Emergency Repairs For Red Hill Tanks at the Fleet Industrial & Supply Center
Contract No. N62742-96-C-1356

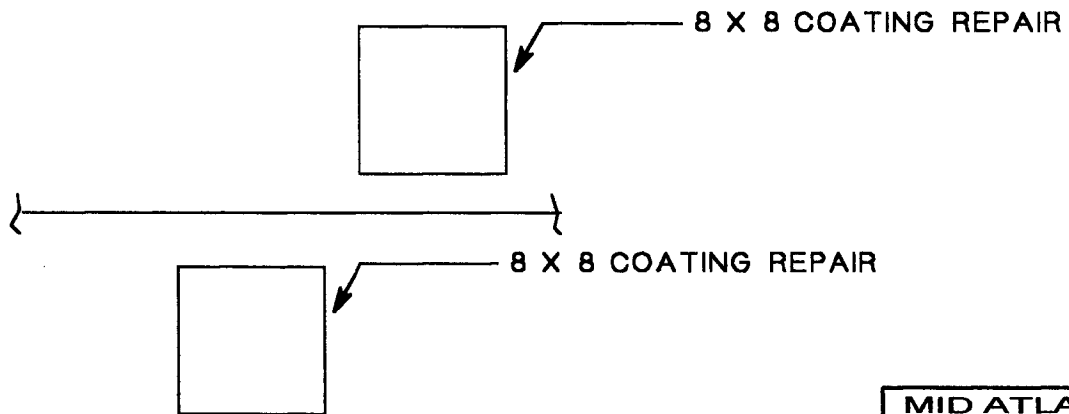
TYPE 8 REPAIR

Coating Type: Epoxy

NDT Performed: Visual: DFT: Average DFT: 8-15 mils

Repair Acceptable: John Zehnd Date Accepted: 4-3-98

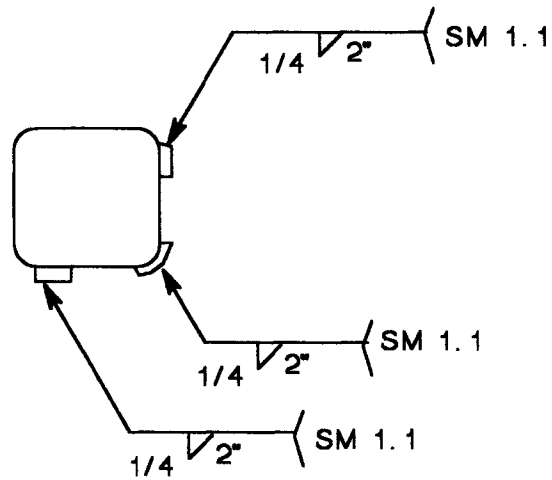
MID ATLANTIC ENVIRONMENTAL	
EMERGENCY REPAIRS FOR RED HILL TANKS	
Tank #7 RECOMMENDED REPAIR DRAWINGS	
Repair No.: 032	File: 7r032
CYLINDER	Quadrant: C
Course: 28	Plate: 18
Drawn by: Tom Klitcher	Date: 5/4/98

TYPE 10 REPAIR

WPS No.: SM1.1-1

NDT Performed: Visual Vacuum Box Dye Penetrant

Repair Acceptable: John Zschell Date Accepted: 4-2-98

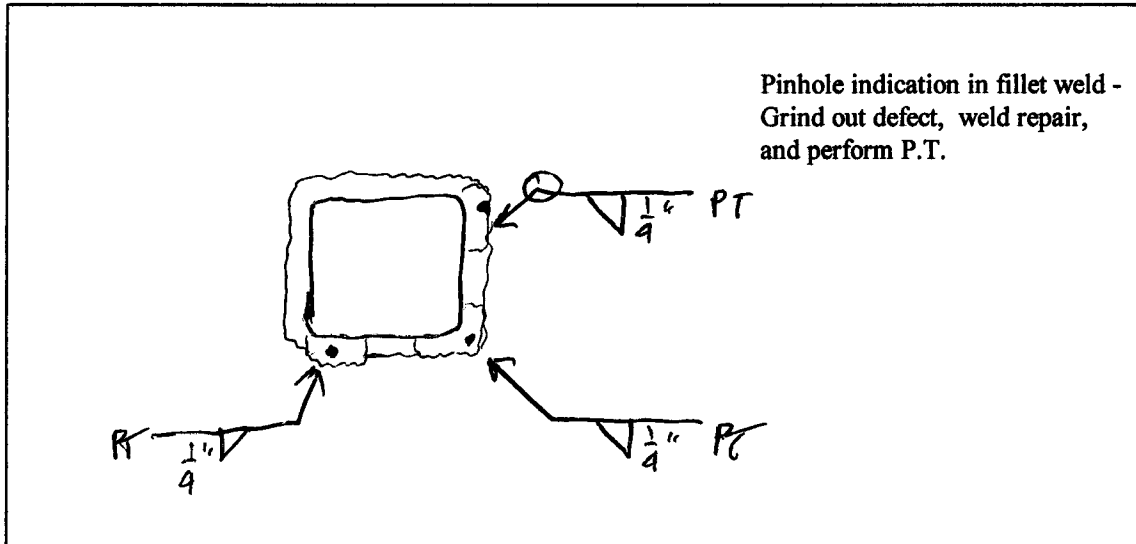
Sketch of Repair Area

Tank No.: 7 Repair No.: 032 Type: 10 Location: C18-28

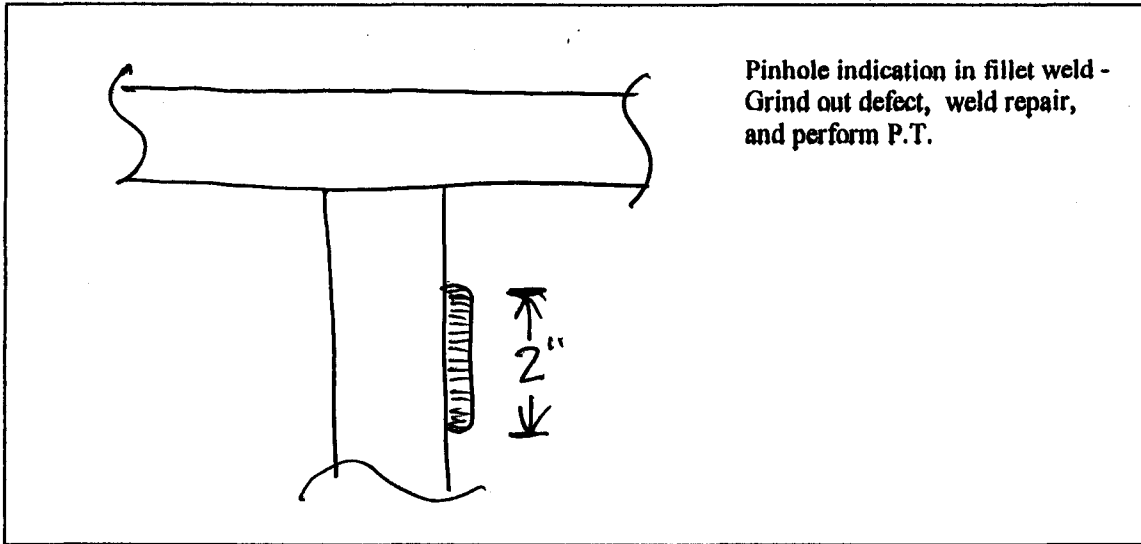
Sketch of Repair Area

Tank No.: 7 Repair No.: 040 Type: 10 Location: B9-A

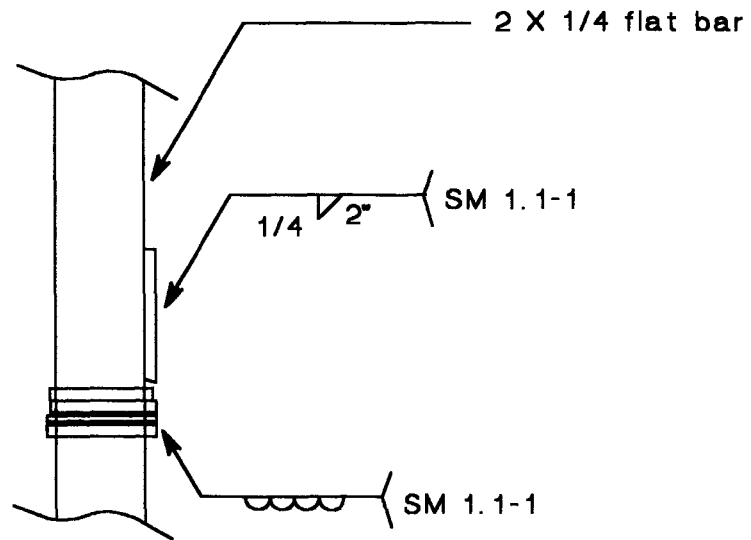
MID ATLANTIC ENVIRONMENTAL	
EMERGENCY REPAIRS FOR RED HILL TANKS	
Tank #7 RECOMMENDED REPAIR DRAWINGS	
Repair No. : 041	File: 7r041
Upper Dome	Quadrant: a
Course: 7	Plate: 2
Drawn by: Tom Kitchen	Date: 5/4/98

TYPE 10 REPAIR

WPS No.: SM 1.1-1

NDT Performed: Visual Vacuum Box Dye Penetrant

Repair Acceptable: John Zurell Date Accepted: 4-15-98

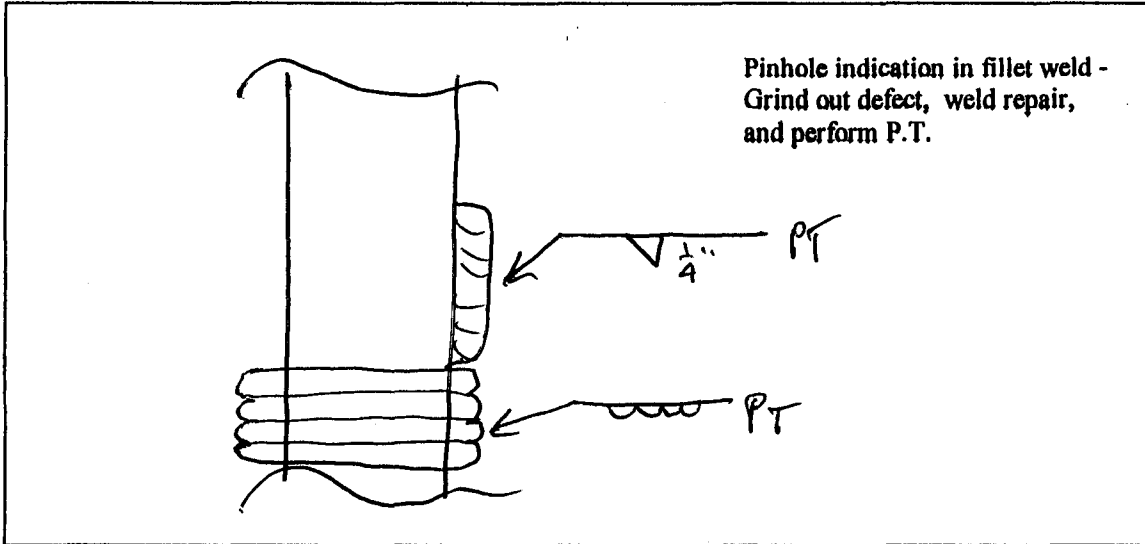
Sketch of Repair Area

Tank No.: 7 Repair No.: 041 Type: 10 Location: A2 - A

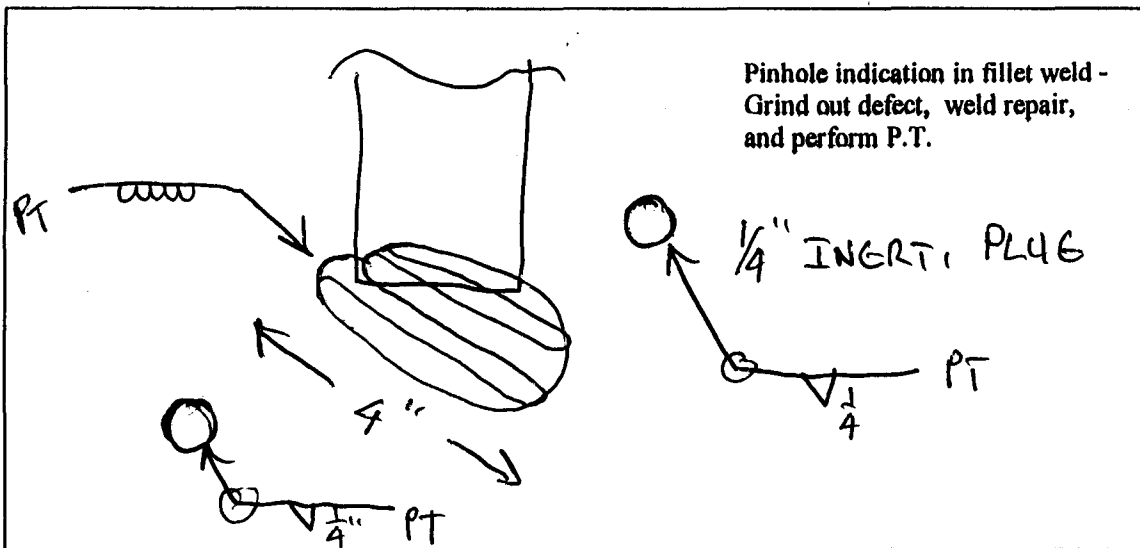
Sketch of Repair Area

Tank No.: 7 Repair No.: 044 Type: 10 Location: A3-A

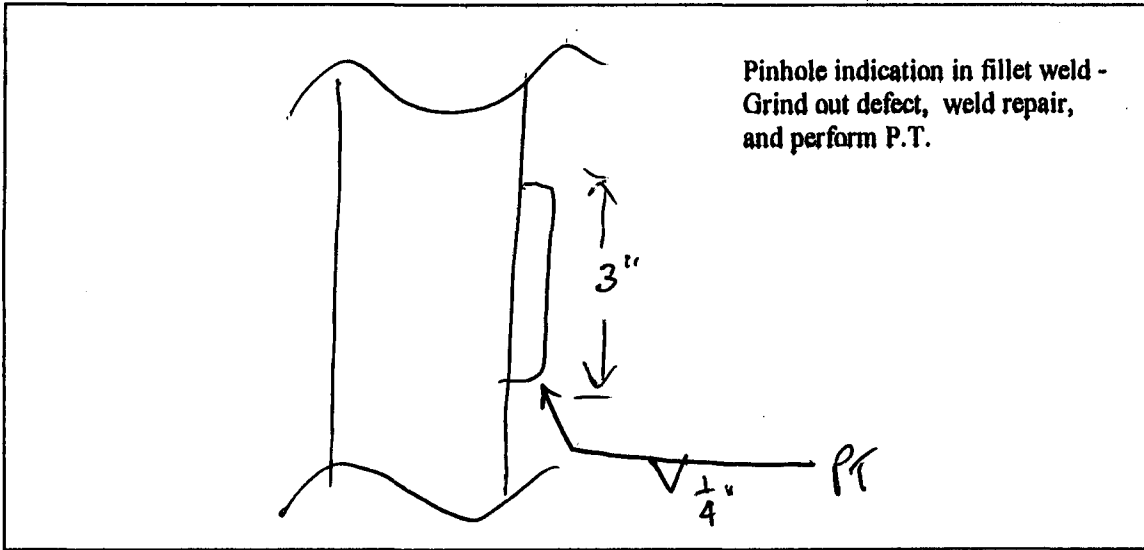
Sketch of Repair Area

Tank No.: 7 Repair No.: 045 Type: 10 Location: A4-A
