MID ATLANTIC ENVIRONMENTAL	
EMERGENCY REPAIRS FOR RED HILL TANKS	
Tank #7 RECOMMENDED REPAIR DRAWINGS	
Repair No. 046	File: 7r046
Upper Dome	Quadrant: B
Course: A	Plate: 10
Drawn by: Tom Kitchen	Date: 5/4/98

**Dames & Moore**  
Emergency Repairs For Red Hill Tanks at the Fleet Industrial & Supply Center  
Contract No. N62742-96-C-1356

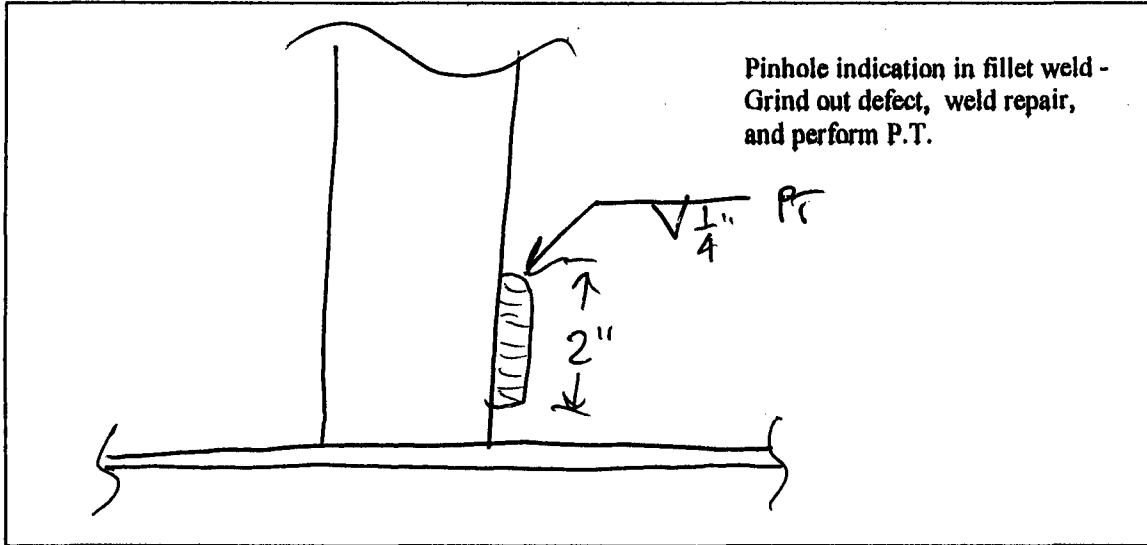
Sketch of Repair Area

Tank No.: 7 Repair No.: 046 Type: 10 Location: B10-A

Weld Repair

WPS No.: SM1.1-1

NDT Performed: Visual  Vacuum Box  Dye Penetrant

Repair Acceptable: John Zschell Date Accepted: 4-15-98

Coating Type: EPOXY

NDT Performed: Visual:  DFT:  Average DFT: 8-15 mils

Repair Acceptable: John Zschell Date Accepted: 4-17-98

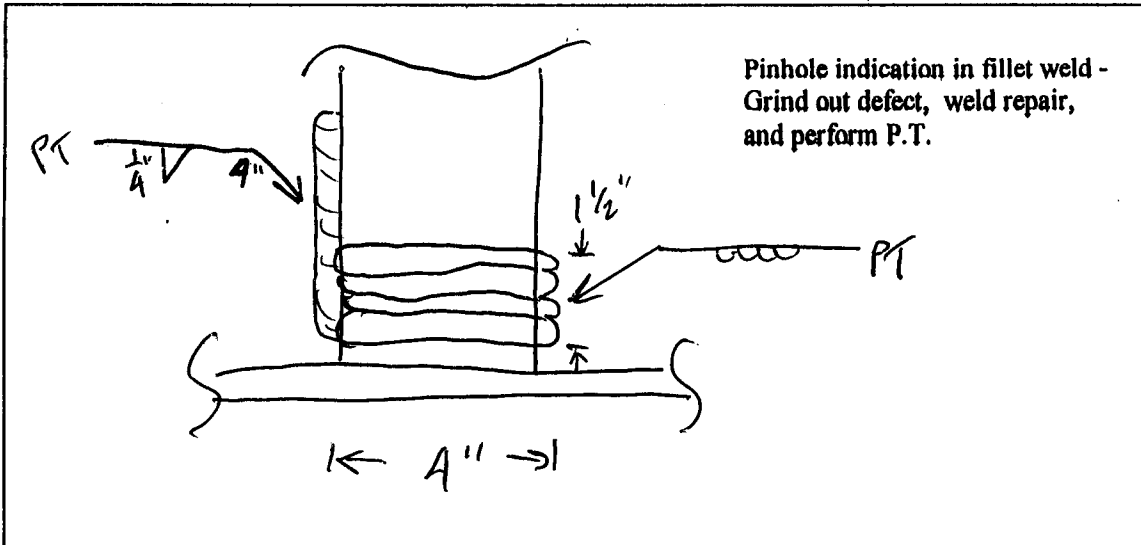
Sketch of Repair Area

Tank No.: 7 Repair No.: 047 Type: 10 Location: B11-A

Weld Repair

WPS No.: SM 1.1-1

NDT Performed: Visual  Vacuum Box  Dye Penetrant

Repair Acceptable: John Zurell Date Accepted: 4-15-98

Coating Type: EPOXY

NDT Performed: Visual:  DFT:  Average DFT: 8-15 mls

Repair Acceptable: John Zurell Date Accepted: 4-17-98

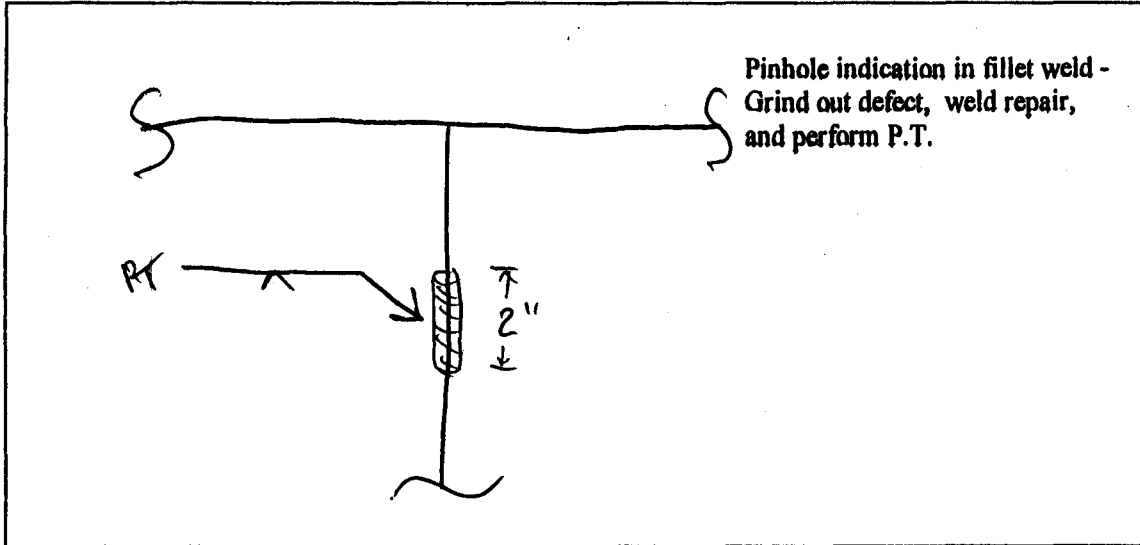
Sketch of Repair Area

Tank No.: 7 Repair No.: 048 Type: 9 Location: B11-8

Weld Repair

WPS No.: SM1.1-1

NDT Performed: Visual  Vacuum Box  Dye Penetrant

Repair Acceptable: John Zehell Date Accepted: 4-15-98

Coating Type: EPOXY

NDT Performed: Visual:  DFT:  Average DFT: 8-15 mils

Repair Acceptable: John Zehell Date Accepted: 4-17-98

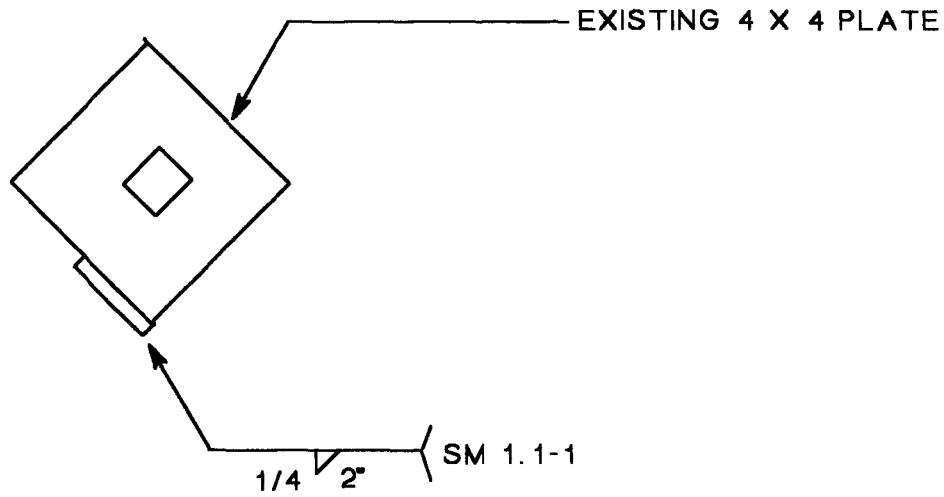
MID ATLANTIC ENVIRONMENTAL	
EMERGENCY REPAIRS FOR RED HILL TANKS	
Tank #7 REPAIR DRAWING	
Repair No. : 049	File: 7R049
CYLINDER	Quadrant: B
Course: 15	Plate: 9
Drawn by: Tom Kitchen	Date: 5/4/98

TYPE 10 REPAIR

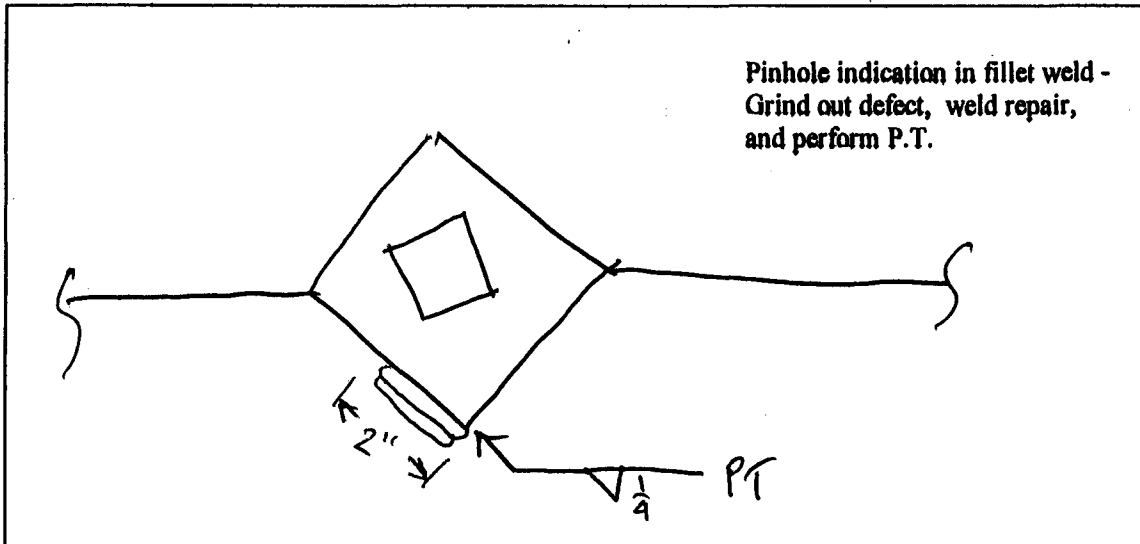
Sketch of Repair Area

Tank No.: 7    Repair No.: 049    Type: 10    Location: B9-15

Weld Repair

WPS No.: SM1.1-1

NDT Performed:                      Visual     Vacuum Box     Dye Penetrant

Repair Acceptable: John Zschell                      Date Accepted: 4-15-98

Coating Type: EPOXY

NDT Performed:                      Visual:     DFT:     Average DFT: 8-15 mils

Repair Acceptable: John Zschell                      Date Accepted: 4-17-98

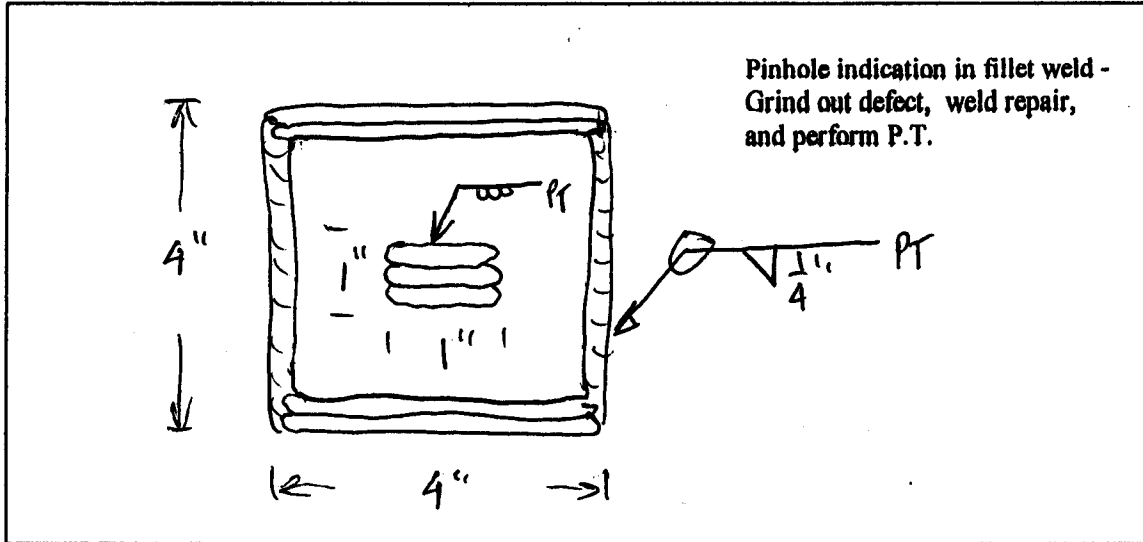
Sketch of Repair Area

Tank No.: 7    Repair No.: 050    Type: 10    Location: B11-28

Weld Repair

WPS No.: SM 1.1-1

NDT Performed:                      Visual     Vacuum Box     Dye Penetrant

Repair Acceptable: John Zurell                      Date Accepted: 4-15-98

Coating Type: EPOXY

NDT Performed:                      Visual:     DFT:     Average DFT: 8-15 mls

Repair Acceptable: John Zurell                      Date Accepted: 4-17-98

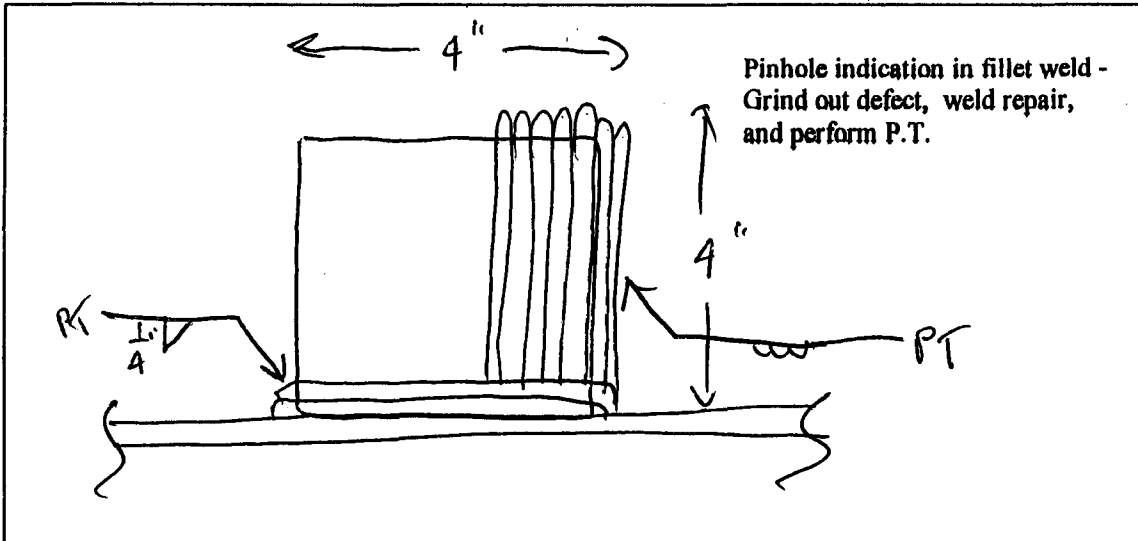
Sketch of Repair Area

Tank No.: 7 Repair No.: 051 Type: 10 Location: B8-28

Weld Repair

WPS No.: SM 1.1-1

NDT Performed: Visual  Vacuum Box  Dye Penetrant

Repair Acceptable: John Zschell Date Accepted: 4-15-98

Coating Type: EPOXY

NDT Performed: Visual:  DFT:  Average DFT: 8-15 mils

Repair Acceptable: John Zschell Date Accepted: 4-17-98

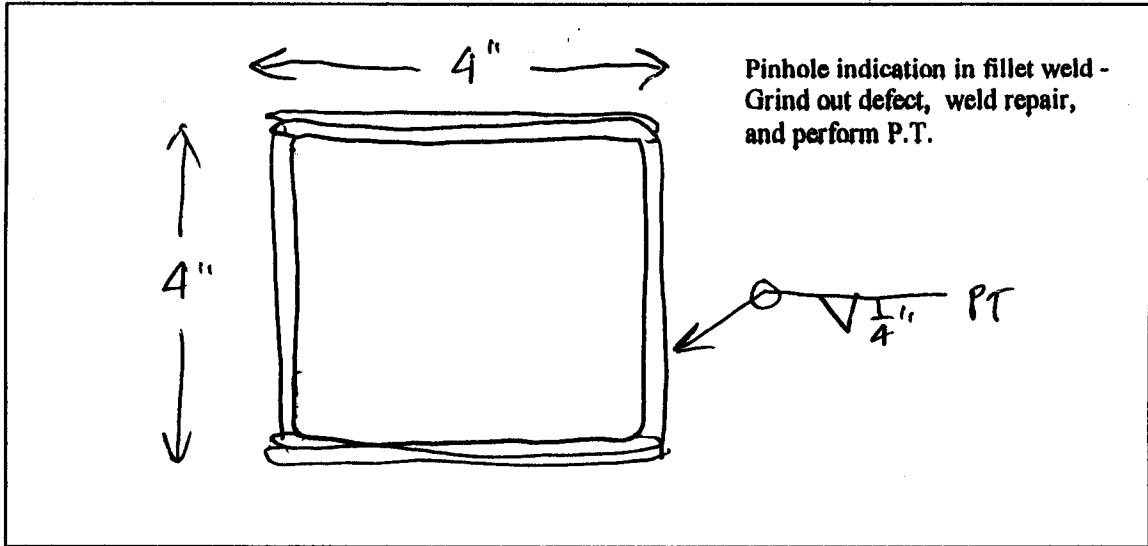
Sketch of Repair Area

Tank No.: 7 Repair No.: 052 Type: 10 Location: B7-28

Weld Repair

WPS No.: SM 1.1-1

NDT Performed: Visual  Vacuum Box  Dye Penetrant

Repair Acceptable: John Zschell

Coating Type: EPOXY

NDT Performed: Visual:  DFT:  Average DFT: 8-15 mils

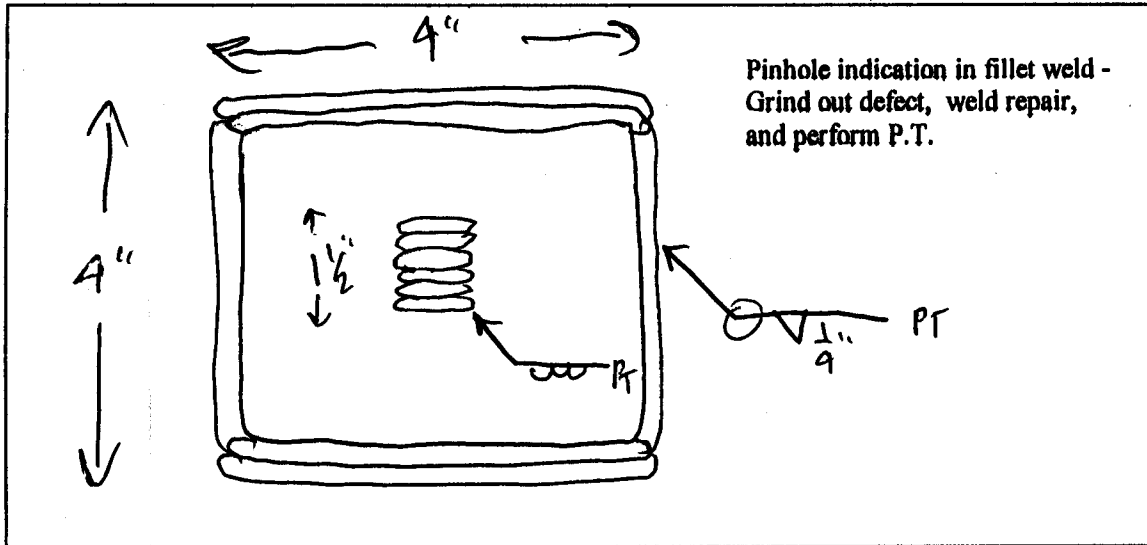
Sketch of Repair Area

Tank No.: 7 Repair No.: 053 Type: 10 Location: B6-28

Weld Repair

WPS No.: SMI.1-1

NDT Performed: Visual  Vacuum Box  Dye Penetrant

Repair Acceptable: John Zschell Date Accepted: 4.15.98

Coating Type: EPOXY

NDT Performed: Visual:  DFT:  Average DFT: 8-15 mils

Repair Acceptable: John Zschell Date Accepted: 4.17.98

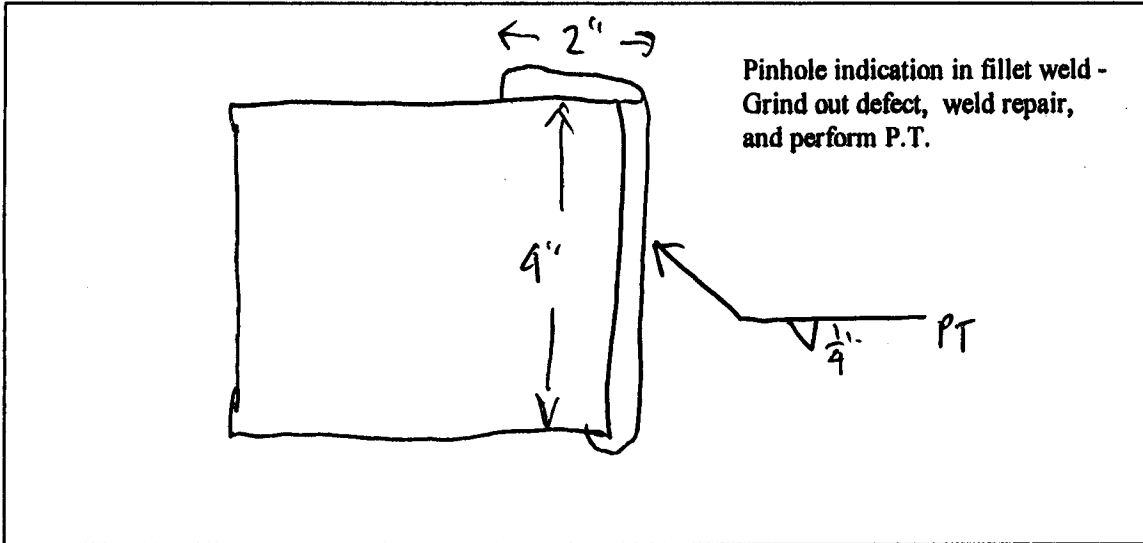
Sketch of Repair Area

Tank No.: 7 Repair No.: 054 Type: 10 Location: B5-28

Weld Repair

WPS No.: SM 1.1-1

NDT Performed: Visual  Vacuum Box  Dye Penetrant

Repair Acceptable: John Zibrell

Coating Type: EPOXY

NDT Performed: Visual:  DFT:  Average DFT: 8-15 mils

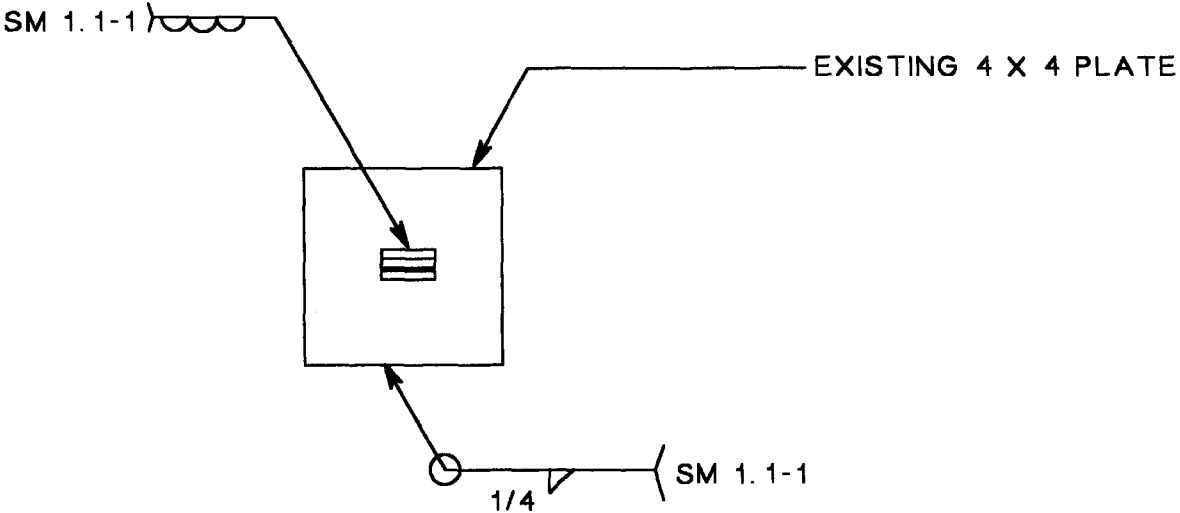
MID ATLANTIC ENVIRONMENTAL	
EMERGENCY REPAIRS FOR RED HILL TANKS	
Tank #7 RECOMMENDED REPAIR DRAWING	
Repair No.: 055	File: 7R055
CYLINDER	Quadrant: A
Course: 28	Plate: 4
Drawn by: Tom Kitchen	Date: 5/4/98

TYPE 10 REPAIR

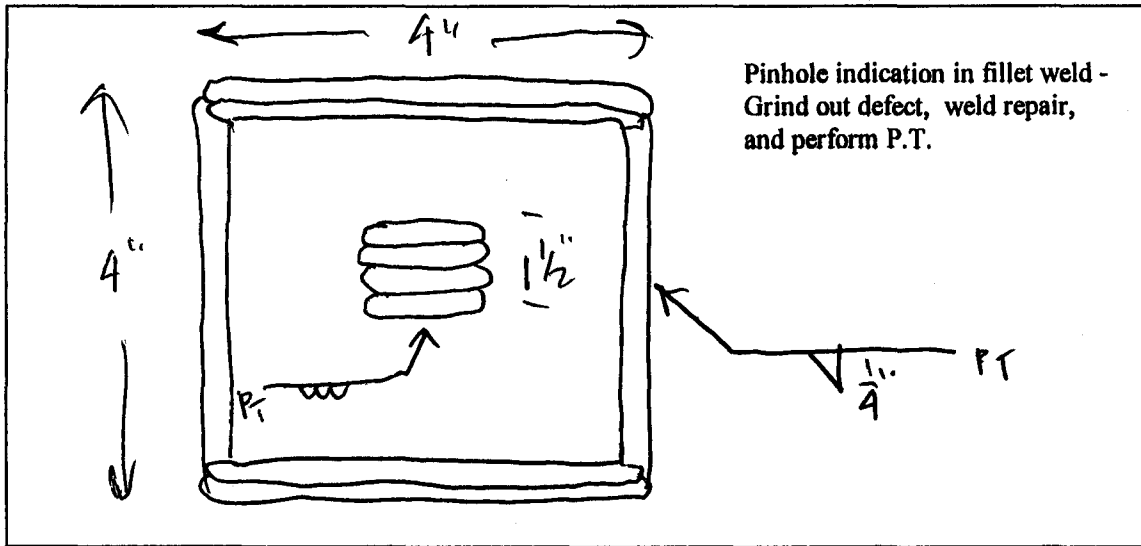
Sketch of Repair Area

Tank No.: 7 Repair No.: 055 Type: 10 Location: B4-28

Weld Repair

WPS No.: SM 1.1-1

NDT Performed: Visual  Vacuum Box  Dye Penetrant

Repair Acceptable: John Zschell

Coating Type: EPOXY

NDT Performed: Visual:  DFT:  Average DFT: 8-15

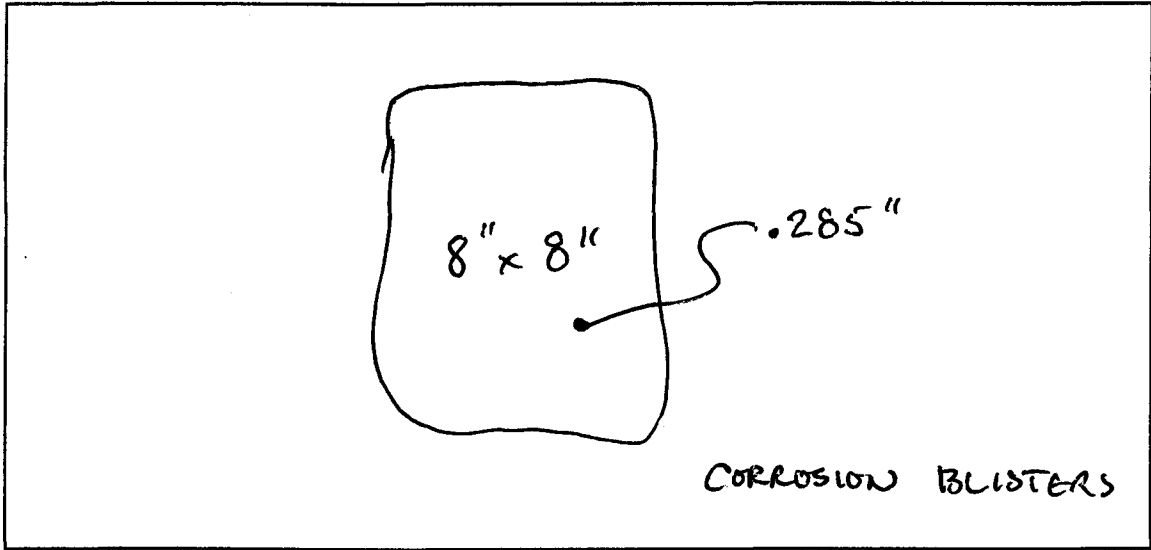
Sketch of Repair Area

Tank No.: 7    Repair No.: 057    Type: 0    Location: B11-3

Coating Type: EPOXY

NDT Performed:                      Visual:     DFT:     Average DFT: 8-15 mils

Repair Acceptable: John Zachell                      Date Accepted: 4-17-98

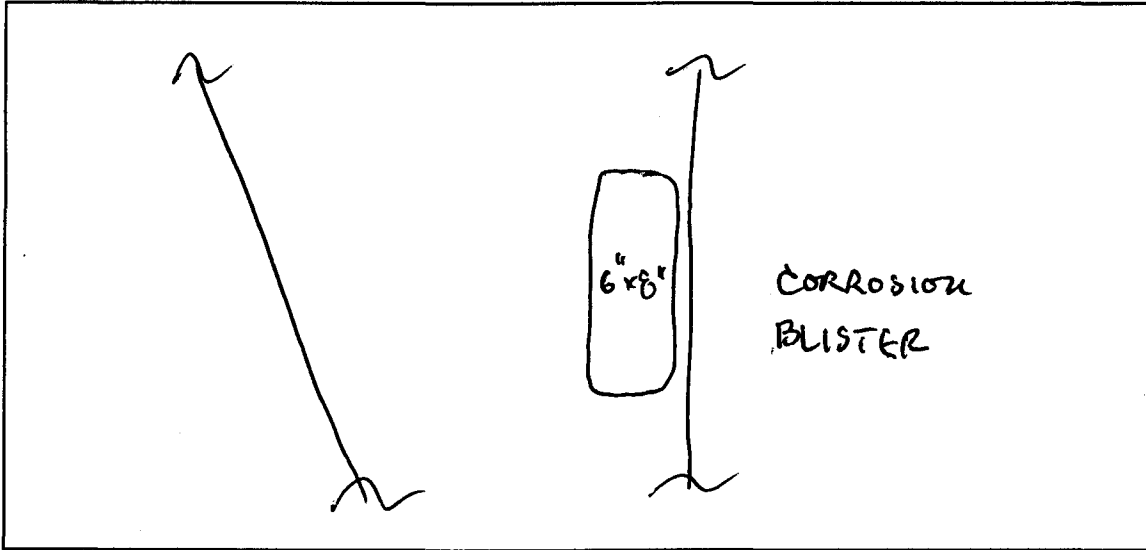
Sketch of Repair Area

Tank No.: 7    Repair No.: 058    Type: 8    Location: B11-3

Coating Type: EPOXY

NDT Performed:                      Visual:     DFT:     Average DFT: 8-15 m.l.s

Repair Acceptable: John Zachell                      Date Accepted: 4-17-98

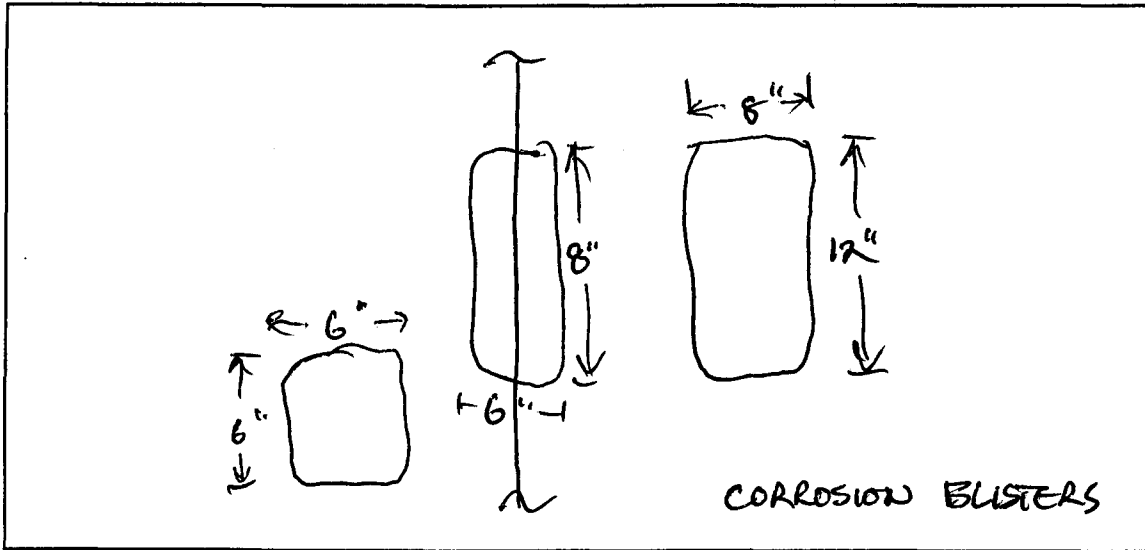
Sketch of Repair Area

Tank No.: 7    Repair No.: 059    Type: 8    Location: A3-3

Coating Type: EPOXY

NDT Performed:                      Visual:                       DFT:                       Average DFT: 8-15 mils

Repair Acceptable: John Zschell                      Date Accepted: 4.17.98

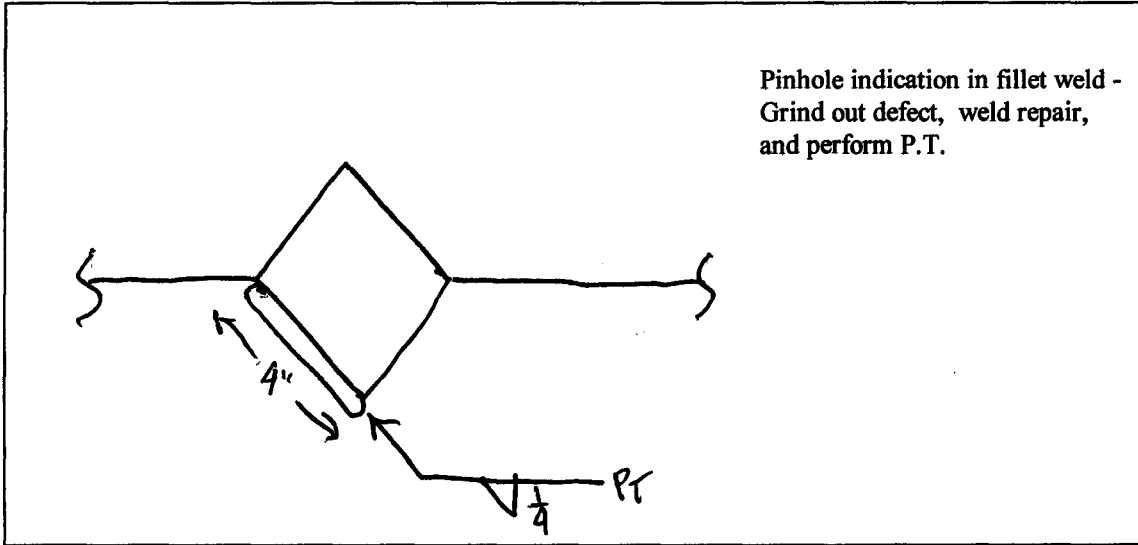
Sketch of Repair Area

Tank No.: 7    Repair No.: 060    Type: 10    Location: A1-17

Weld Repair

WPS No.: SM1.1-1

NDT Performed:                      Visual     Vacuum Box     Dye Penetrant

Repair Acceptable: John Zudrell                      Date Accepted: 4-15-98

Coating Type: Epoxy

NDT Performed:                      Visual:     DFT:     Average DFT: 8-15 mils

Repair Acceptable: John Zudrell                      Date Accepted: 4-17-98
