MID ATLANTIC ENVIRONMENTAL	
EMERGENCY REPAIRS FOR RED HILL TANKS	
Tank #7 RECOMMENDED REPAIR DRAWING	
Repair No. 062	File 7R062
Lower Dome	Quadrant A
Course 3	Plate 1
Drawn by Tom Kitchen	Date 5/4/98

Dames & Moore
Emergency Repairs For Red Hill Tanks at the Fleet Industrial & Supply Center
Contract No. N62742-96-C-1356

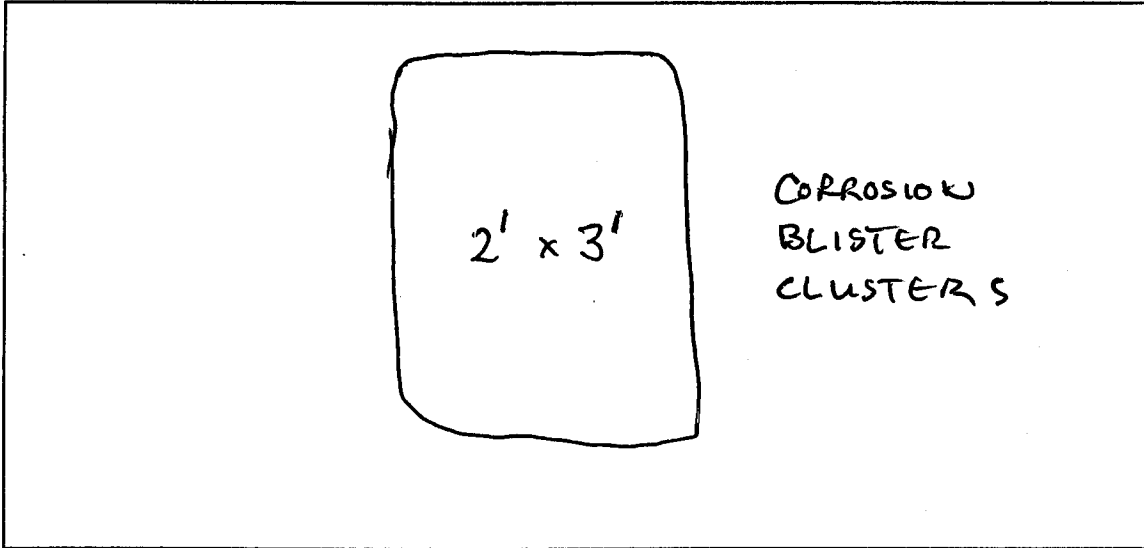
Tank No.: 7 Repair No.: 062 Type: 8 Location: A1-3

24 X 36 COATING REPAIR

TYPE 8 REPAIR

Coating Type: EPOXY

NDT Performed: Visual: DFT: Average DFT: 8-15 mils

Repair Acceptable: John Zschell Date Accepted: 4-17-98

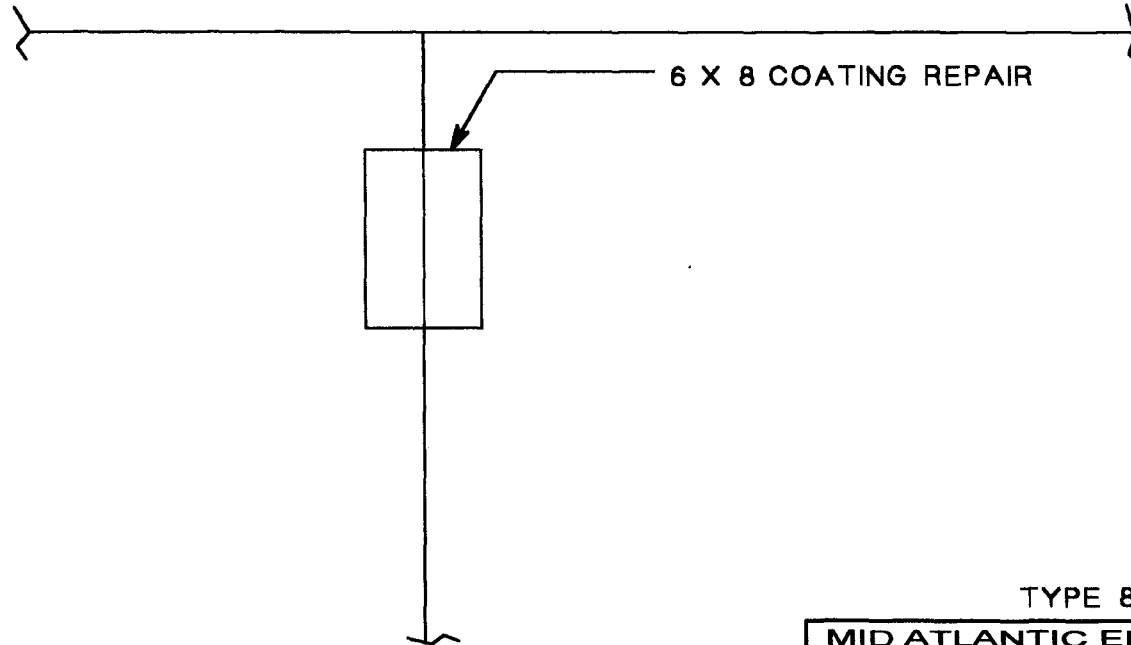
MID ATLANTIC ENVIRONMENTAL	
EMERGENCY REPAIRS FOR RED HILL TANKS	
Tank #7 RECOMMENDED REPAIR DRAWING	
Repair No.: 063	File: 7R063
Lower Dome	Quadrant: A
Course: 2	Plate: 7
Drawn by: Tom Kitchen	Date: 5/4/98

TYPE 8 REPAIR

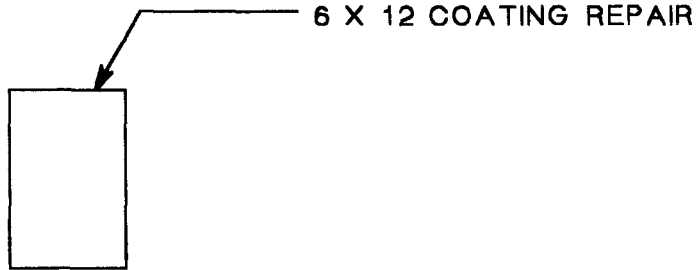
MID ATLANTIC ENVIRONMENTAL	
EMERGENCY REPAIRS FOR RED HILL TANKS	
Tank #7 RECOMMENDED REPAIR DRAWING	
Repair No.: 064	File: 7R064
Lower Dome	Quadrant: A
Course: 2	Plate: 1
Drawn by: Tom Kitchen	Date: 5/4/98

TYPE 8 REPAIR

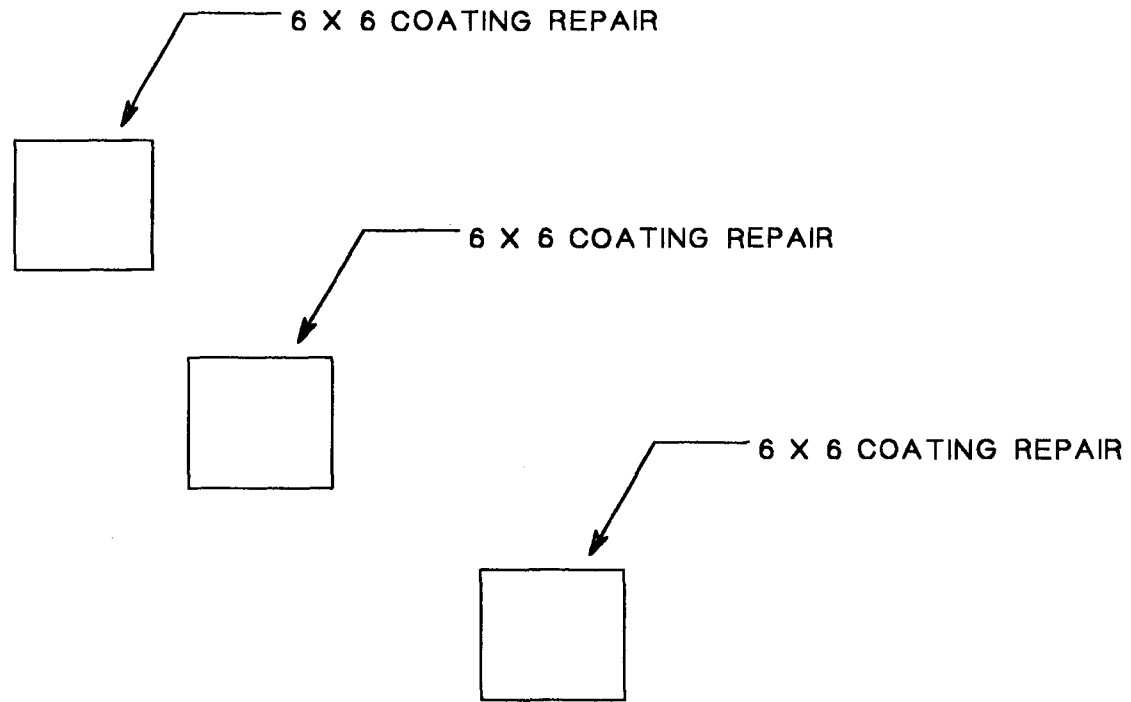
MID ATLANTIC ENVIRONMENTAL	
EMERGENCY REPAIRS FOR RED HILL TANKS	
Tank #7 RECOMMENDED REPAIR DRAWING	
Repair No.: 065	File: 7R065
Lower Dome	Quadrant: A
Course: 1	Plate: 1
Drawn by: Tom Kitchen	Date: 5/4/98

TYPE 8 REPAIR

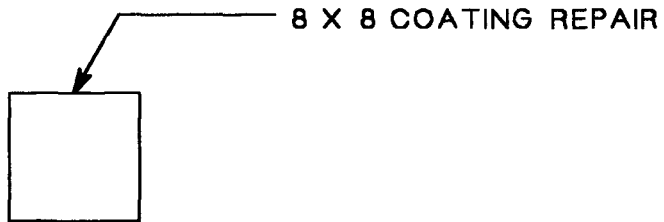
MID ATLANTIC ENVIRONMENTAL	
EMERGENCY REPAIRS FOR RED HILL TANKS	
Tank #7 RECOMMENDED REPAIR DRAWING	
Repair No.: 066	File: 7R066
Lower Dome	Quadrant: B
Course: 1	Plate: 9
Drawn by: Tom Kitchen	Date: 5/4/98

TYPE 8 REPAIR
