2.1 Mid Atlantic Environmental, Inc. conducted an inspection on Tank #8 at the Red Hill Underground Storage Facility, Pearl Harbor, Hawaii. This inspection was conducted in accordance with the scope of work identified by Contract Number N00604-97-R-0013, PRL 96-21, titled "Emergency Repair for Red Hill Tanks."

RED HILL TANK NO. 8
PRODUCT: DFM

OI		TK	
LTR	DESCRIPTION	BY	DATE
REVISIONS			
MID ATLANTIC ENVIRONMENTAL			
EMERGENCY REPAIRS FOR RED HILL TANKS			
Tank #8			
Floor Layout		File: 8filo	
Tank bottom			
Drawn By: T. Kitchen		Date: 7/20/98

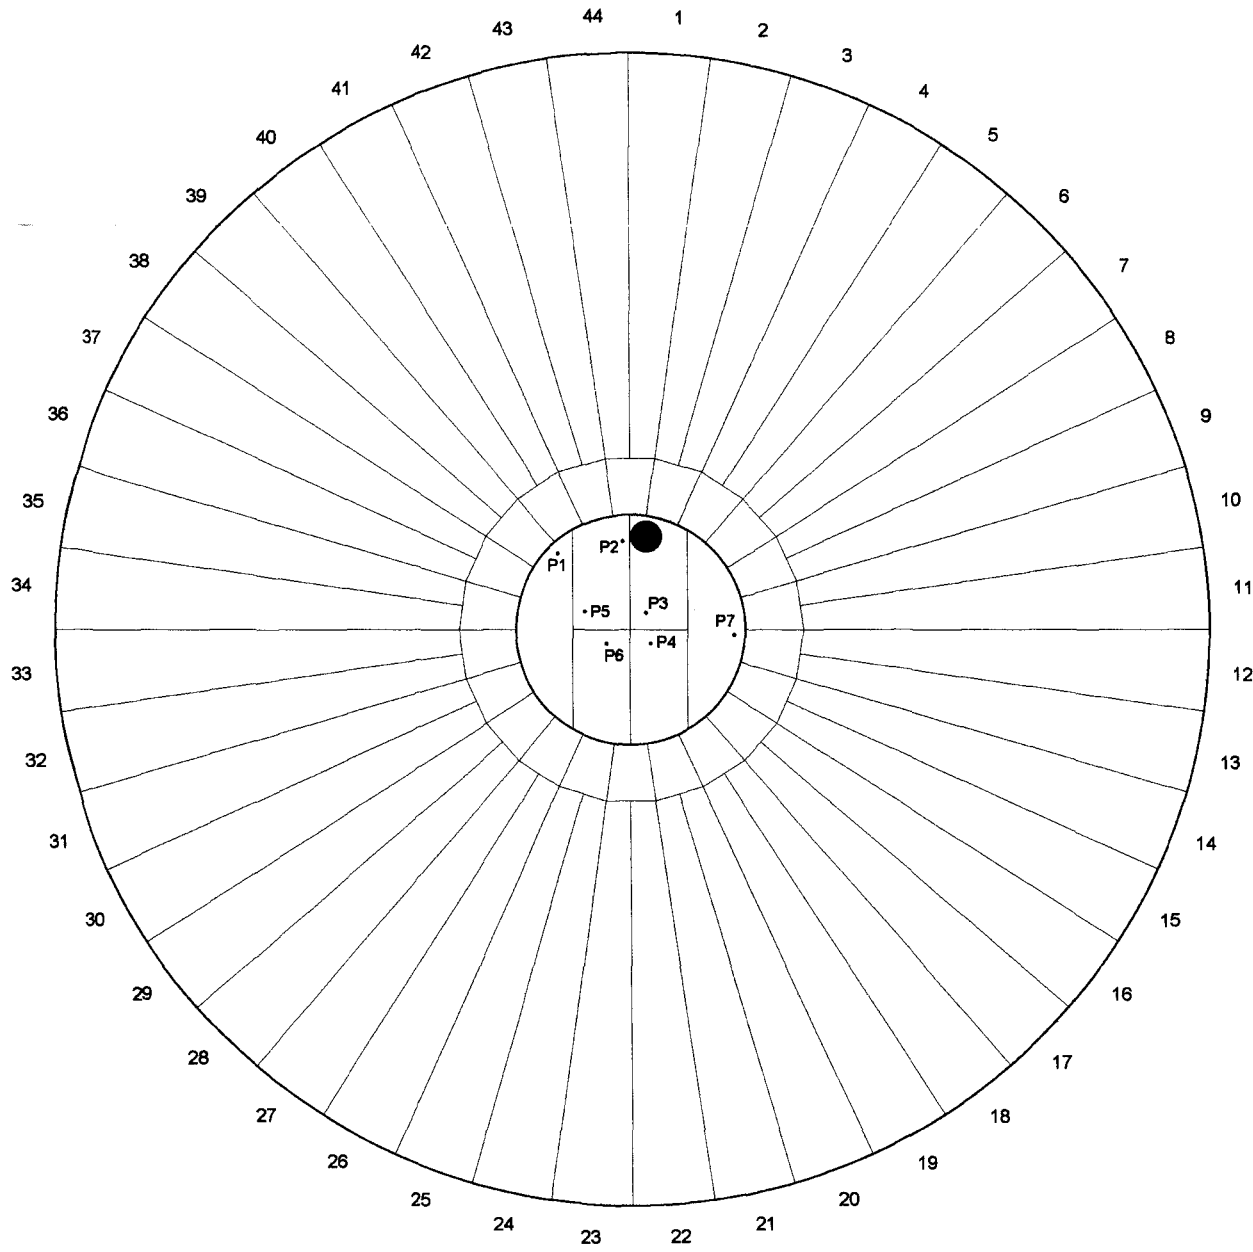
Drawing Title:
Bottom Layout with Pit Indications

7.2.1 The original bottom thickness was determined to be 0.500 inches and the first ascending plate to be 0.250 inches. The ultrasonic thickness measurements taken determined that backside corrosion in this area is not a problem. Pitting on the bottom plates is widespread and the enclosed drawing shows that many patch plates had been added in the past. Although pitting is widespread it is not a problem since the remaining metal thickness is well within the 0.10 inches of metal required by API Standard 653 by the next inspection. Also the coating to be applied to the tank bottom should prevent any increase in pit depth. Although pitting is not a problem with regard to structural integrity, it did present a problem regarding the coating to be applied. Pictures of this pitting are included with this report. The surface contamination test results yielded 0% ferrous salts, 32 ppm NaCl and a pH level of 7. These results are within the limits set forth in the KTA SCAN Kit technical data and the NACE technical committee report on Surface Preparation of Contaminated Steel Surfaces. The Caustic Soda test of the tank bottom indicated that all Flame Sprayed Aluminum had been removed. By visual inspection, scattered pitting was observed on the tank bottom and first ascending plates. The deeper pits were measured and recorded on the Bottom Layout With Pit Indications drawing.

Remarks/Legend: Pitting was general over 30% of bottom

Pit Depth in inches:

- P1 = 0.15
- P2 = 0.11
- P3 = 0.09
- P4 = 0.12
- P5 = 0.09
- P6 = 0.09
- P7 = 0.12
