SUBJECT: DESTRUCTIVE ANALYSIS OF 10 STEEL COUPONS REMOVED FROM RED HILL FUEL STORAGE TANK NO. 14, PURSUANT TO SECTION 5.3 OF THE ADMINISTRATIVE ORDER ON CONSENT STATEMENT OF WORK, RED HILL BULK FUEL STORAGE FACILITY, JOINT BASE PEARL HARBOR-HICKAM, OAHU, HAWAII

Destructive Analysis of 10 Steel Coupons Removed from Red Hill Fuel Storage Tank #14

REPORT No. 201801967

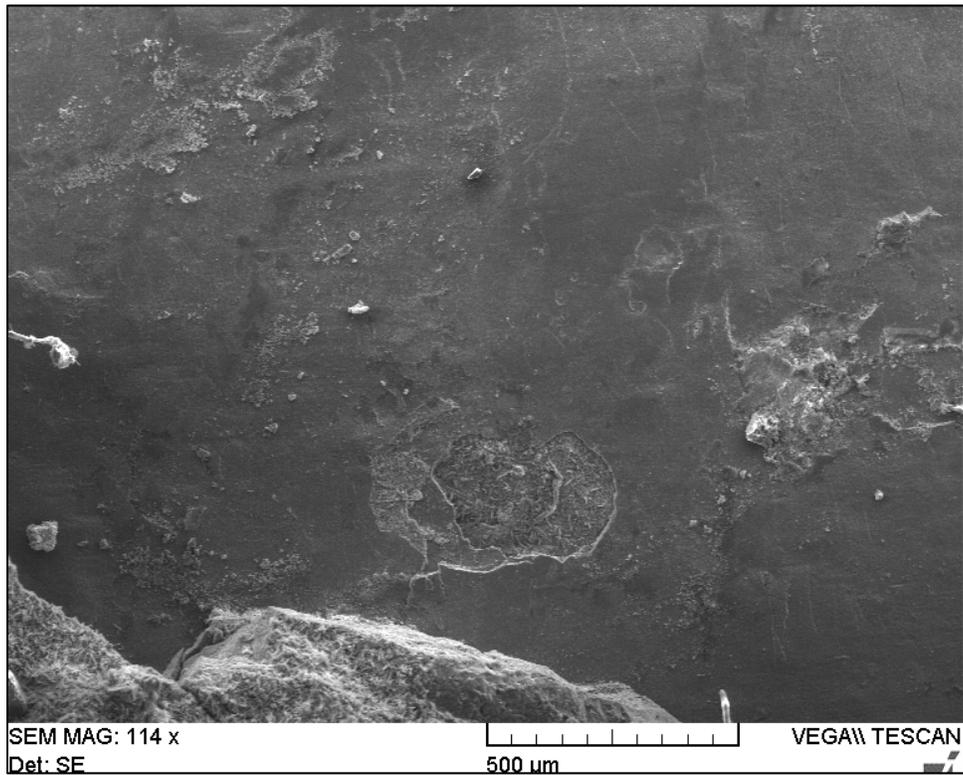
Figure 51. A representative SEM image of a pit on a specimen excised from Coupon 5 labeled as 5-2, prior to cleaning. (SEM, 67X)

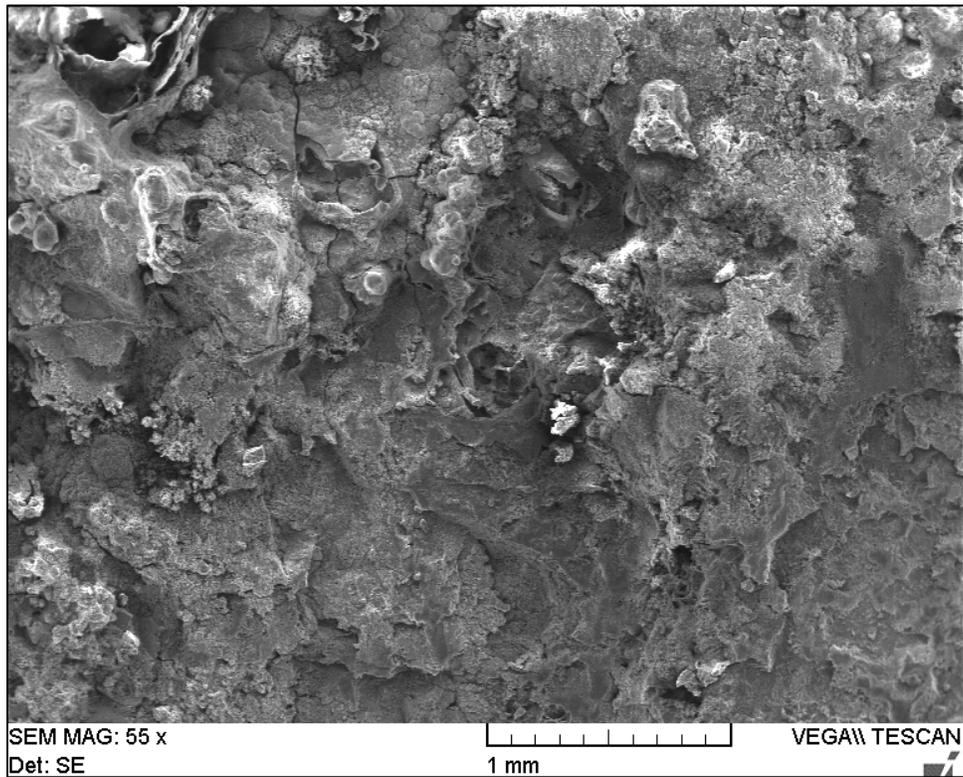
Figure 55. A representative SEM image of a pit on a specimen excised from Coupon 6 labeled as 6-3, prior to cleaning. (SEM, 32X)

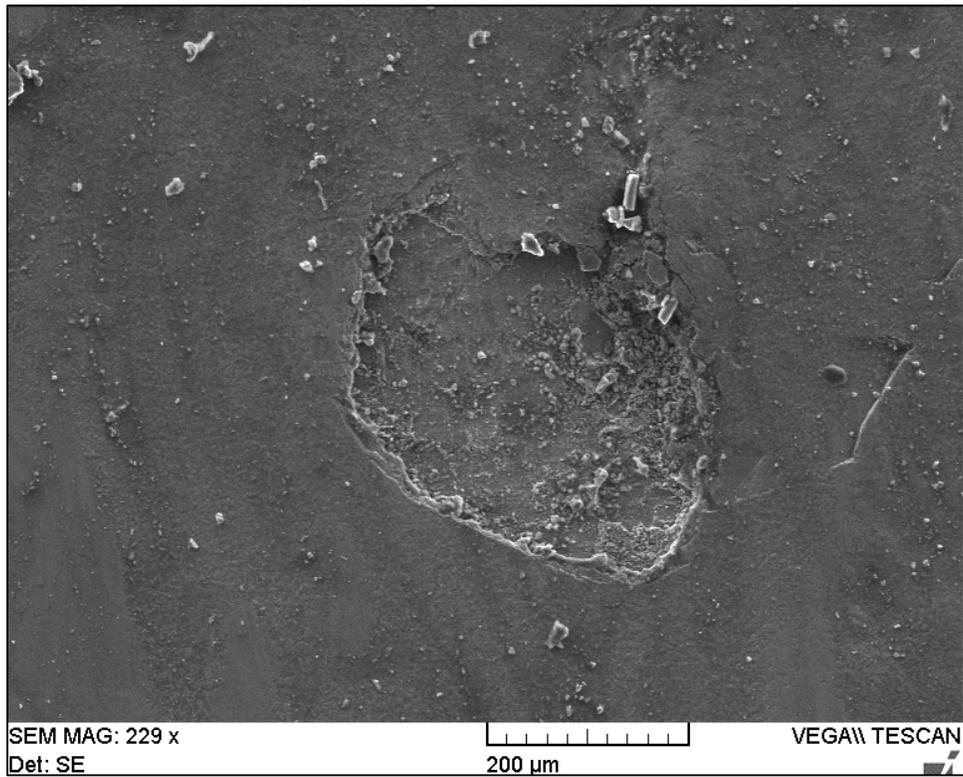
Figure 63. A representative SEM image of a pit on a specimen excised from Coupon 10 labeled as 10-2, prior to cleaning. (SEM, 135X)

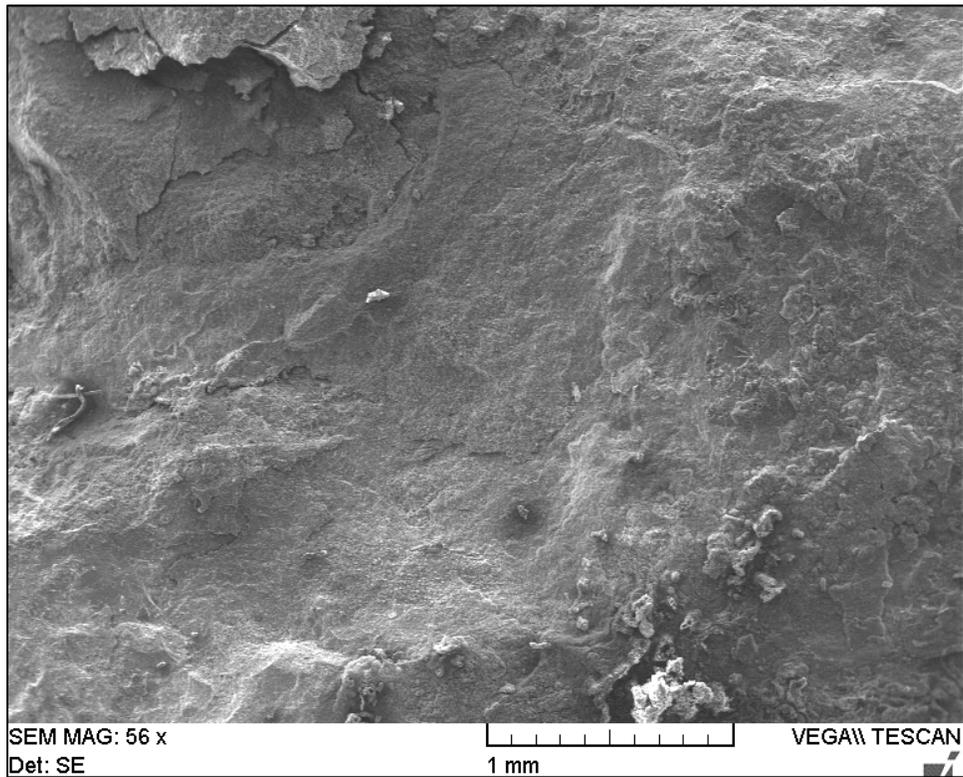
Figure 65. A representative SEM image of a pit on a specimen excised from Coupon A-1 labeled as A1-1, prior to cleaning. (SEM, 33X)

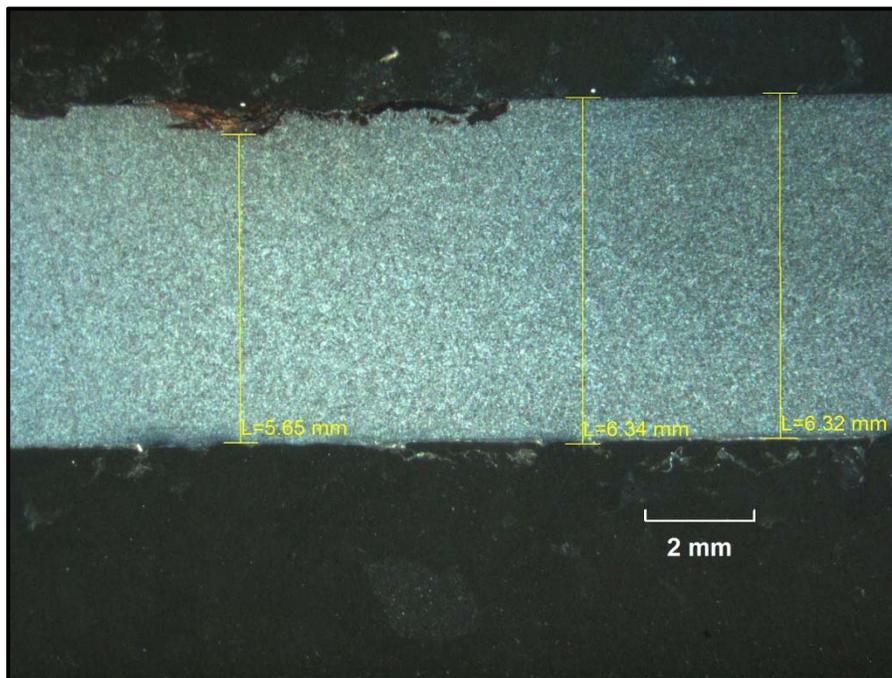
Figure 180. The prepared metallographic cross-section from Sample 1-1 is shown during examination with a stereomicroscope. The thickest location(s) are shown, as well as the thickness remaining underneath the deepest observed pit. (7X)

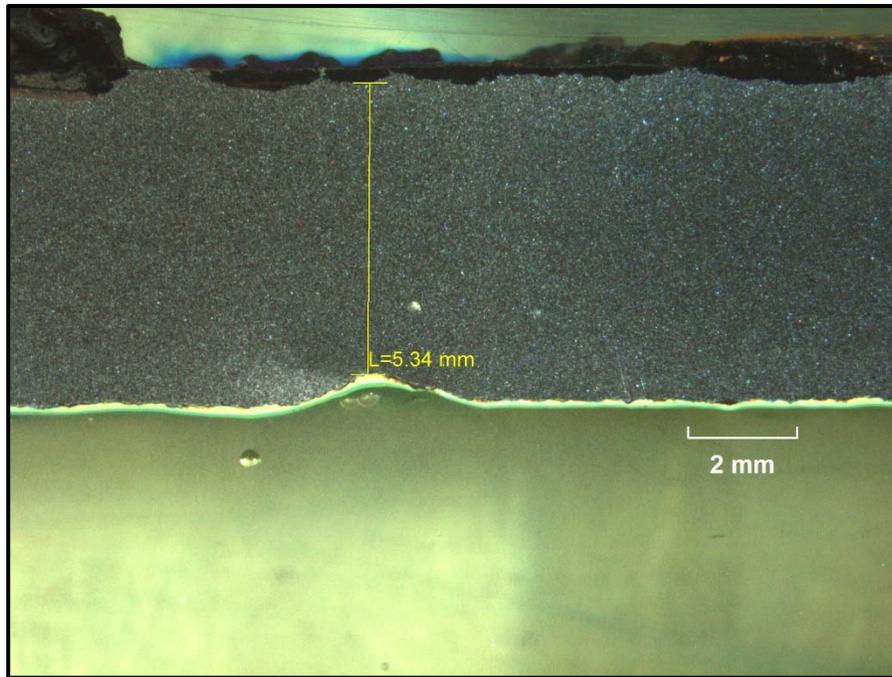
Figure 181. The prepared metallographic cross-section from Sample 1-3 is shown during examination with a stereomicroscope. The thickest remaining wall is shown. Note that the reduction in wall thickness was due to a depression on the painted face of the specimen. (7X)

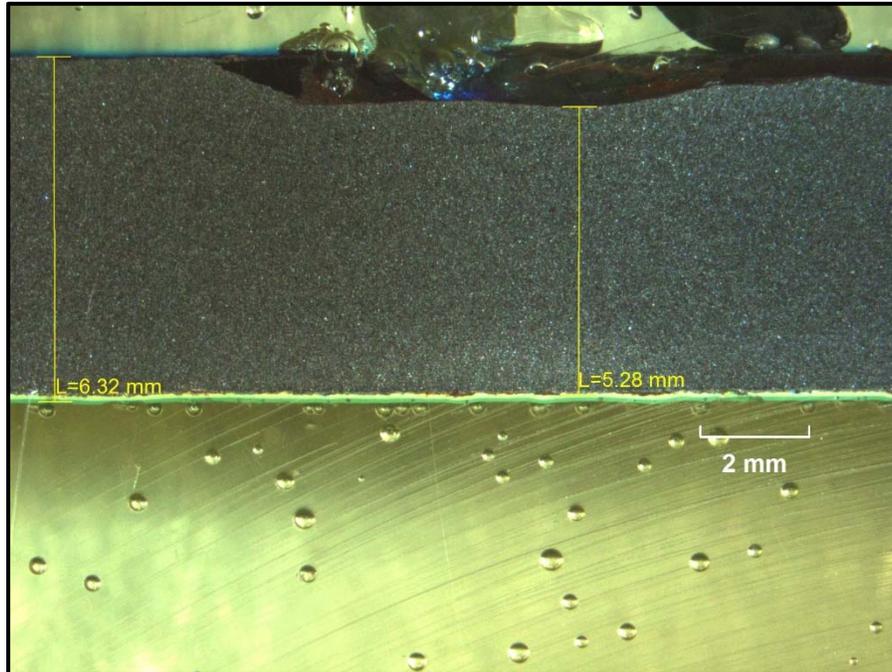
Figure 182. The prepared metallographic cross-section from Sample 1-4 is shown during examination with a stereomicroscope. The thickest location(s) are shown, as well as the thickness remaining underneath the deepest observed pit. (7X)

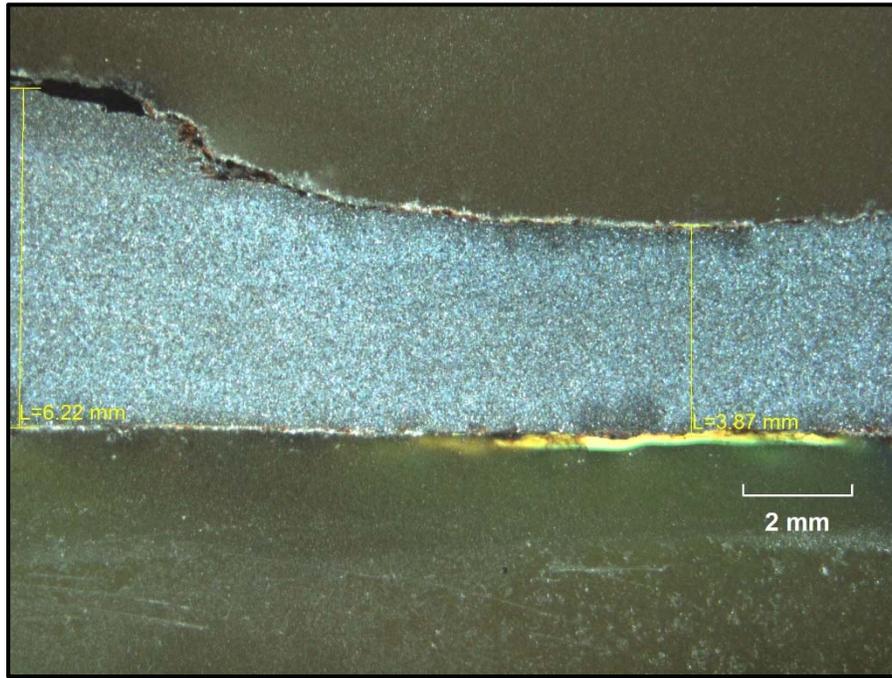
Figure 183. The prepared metallographic cross-section from Sample 2-1 is shown during examination with a stereomicroscope. The thickest location(s) are shown, as well as the thickness remaining underneath the deepest observed pit. (7X)

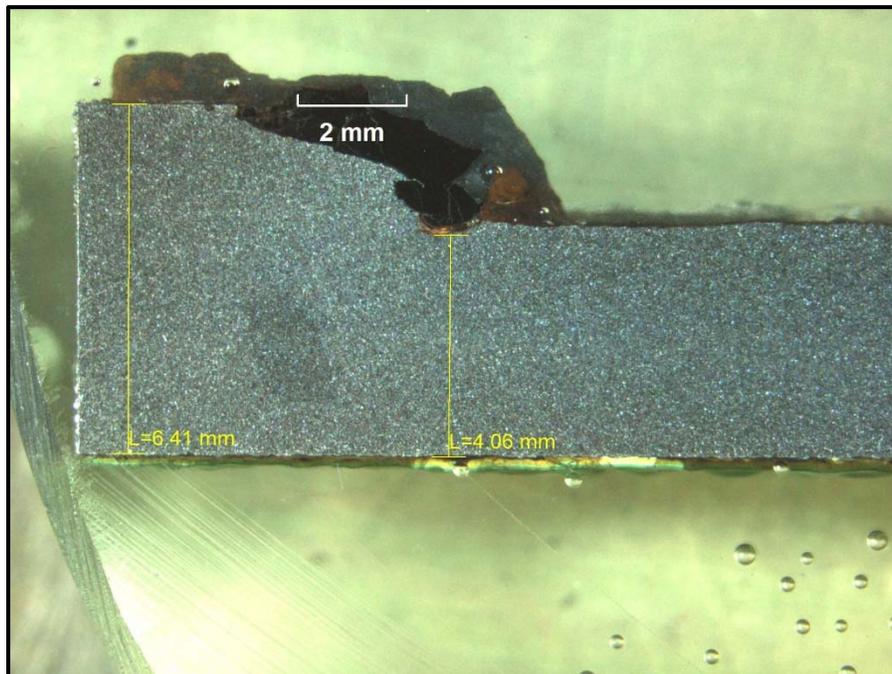
Figure 184. The prepared metallographic cross-section from Sample 2-2 is shown during examination with a stereomicroscope. The thickest location(s) are shown, as well as the thickness remaining underneath the deepest observed pit. (7X)

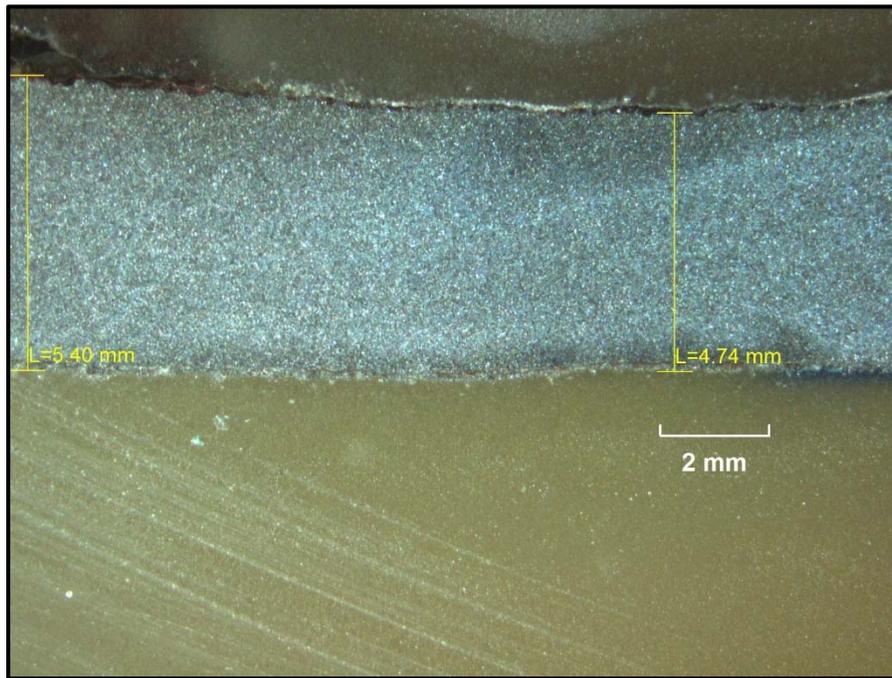
Figure 185. The prepared metallographic cross-section from Sample 2-3 is shown during examination with a stereomicroscope. The thickest location(s) are shown, as well as the thickness remaining underneath the deepest observed pit. (7X)

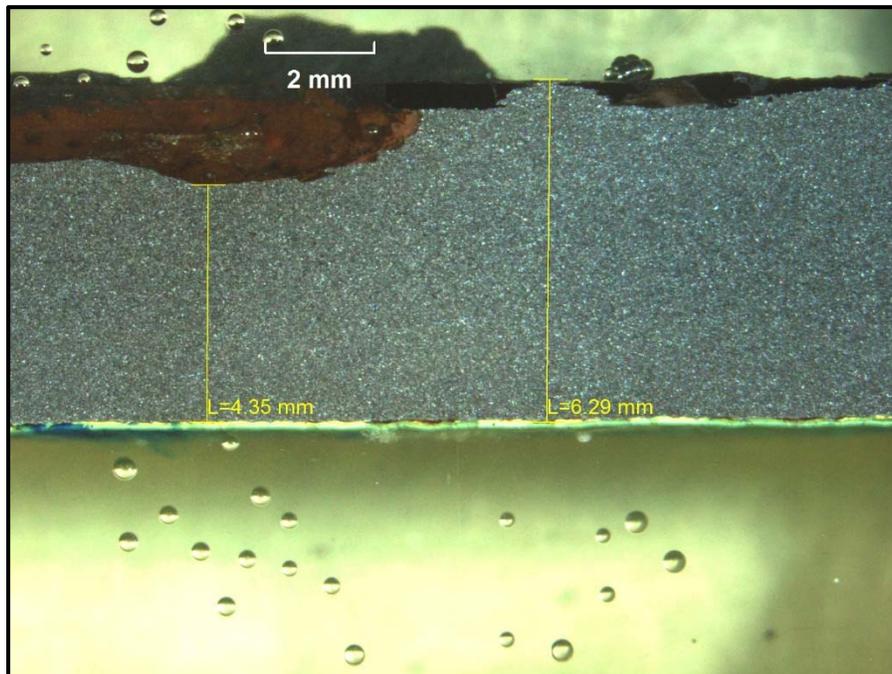
Figure 186. The prepared metallographic cross-section from Sample 3-1 is shown during examination with a stereomicroscope. The thickest location(s) are shown, as well as the thickness remaining underneath the deepest observed pit. (7X)

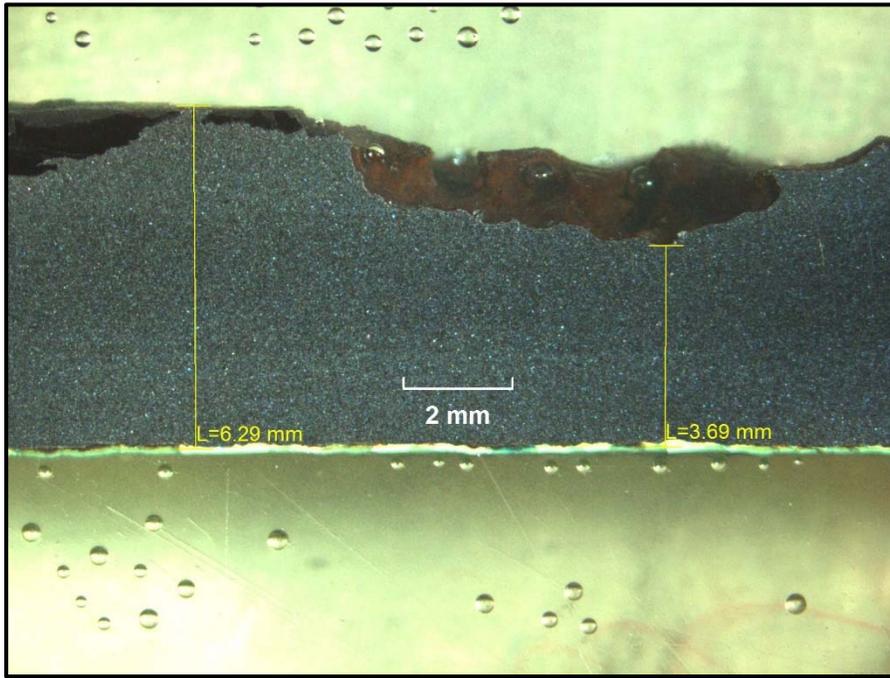
Figure 187. The prepared metallographic cross-section from Sample 3-2 is shown during examination with a stereomicroscope. The thickest location(s) are shown, as well as the thickness remaining underneath the deepest observed pit. (7X)

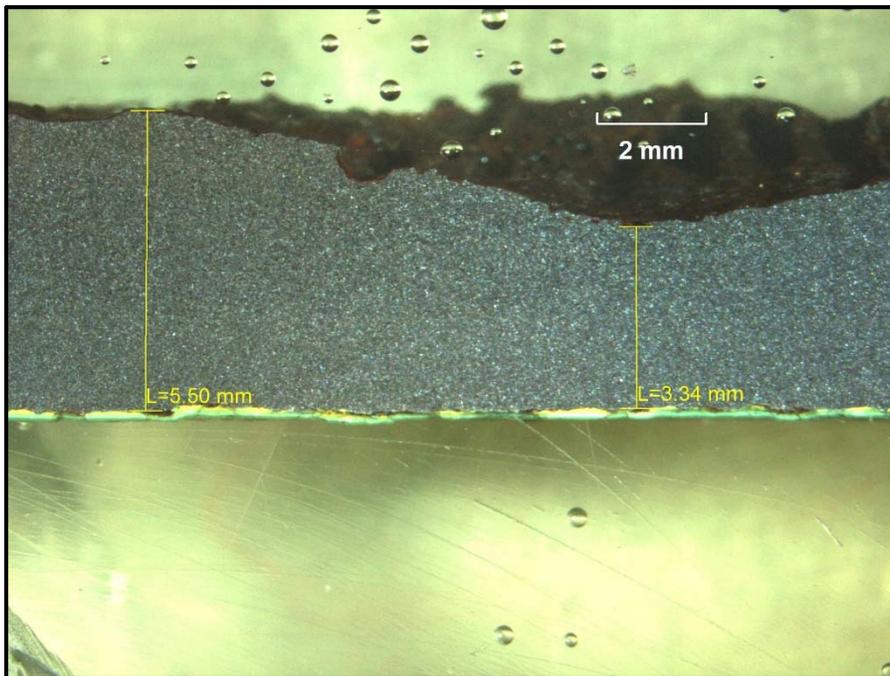
Figure 188. The prepared metallographic cross-section from Sample 3-3 is shown during examination with a stereomicroscope. The thickest location(s) are shown, as well as the thickness remaining underneath the deepest observed pit. (7X)

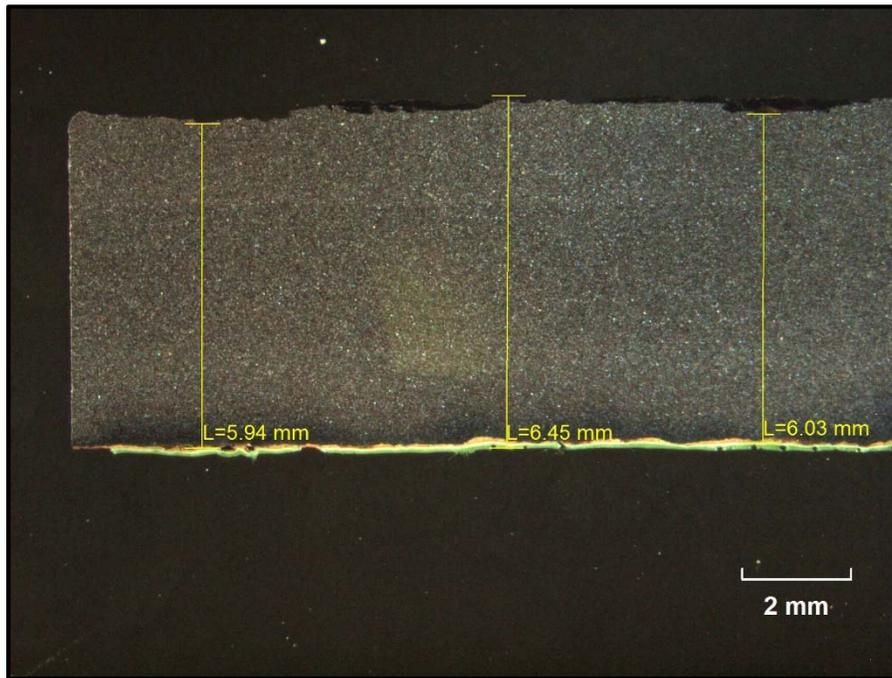
Figure 189. The prepared metallographic cross-section from Sample 3-4 is shown during examination with a stereomicroscope. The thickest location(s) are shown, as well as the thickness remaining underneath the deepest observed pit. (7X)

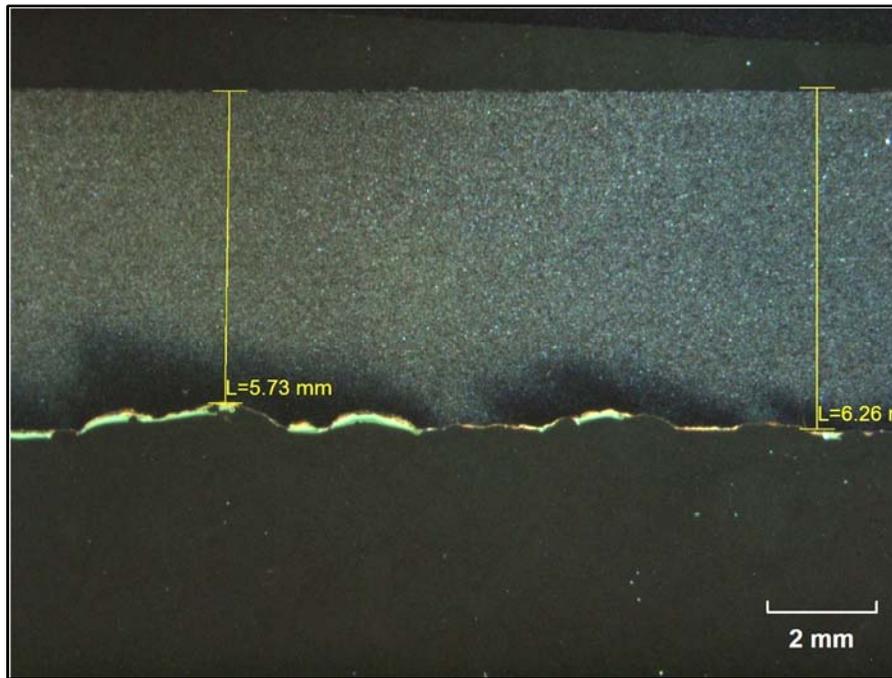
③ Suspected NDT inspection indication was a depression on the painted face of Sample 5-4. No pits observed.

Figure 191. The prepared metallographic cross-section from Sample 5-4 is shown during examination with a stereomicroscope. The thickest remaining wall is shown. Note that the reduction in wall thickness was due to a depression on the painted face of the specimen. (7X)

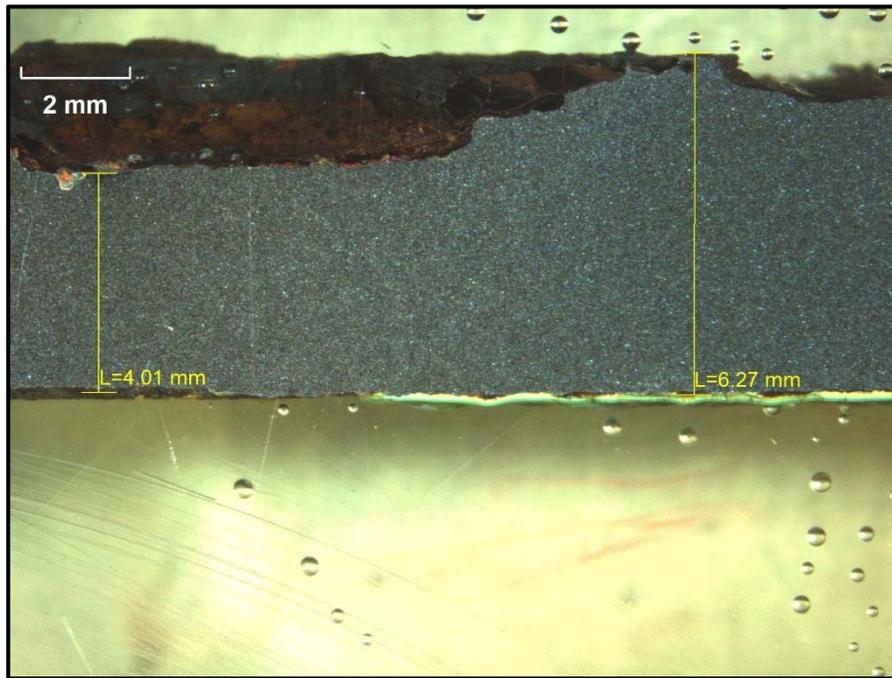
Figure 193. The prepared metallographic cross-section from Sample 6-1 is shown during examination with a stereomicroscope. The thickest location(s) are shown, as well as the thickness remaining underneath the deepest observed pit. (7X)

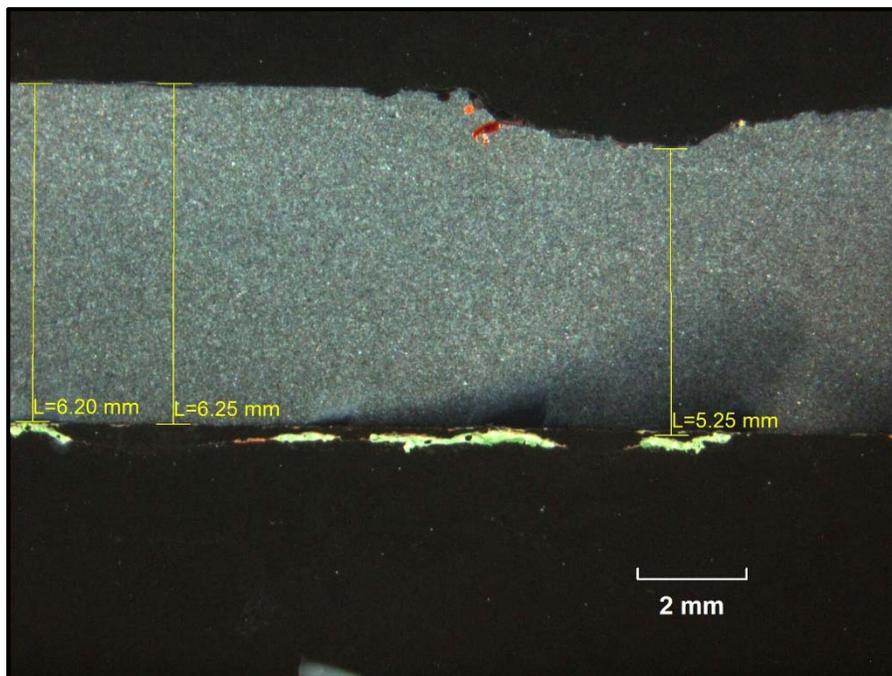
Figure 194. The prepared metallographic cross-section from Sample 6-2 is shown during examination with a stereomicroscope. The thickest location(s) are shown, as well as the thickness remaining underneath the deepest observed pit. (7X)

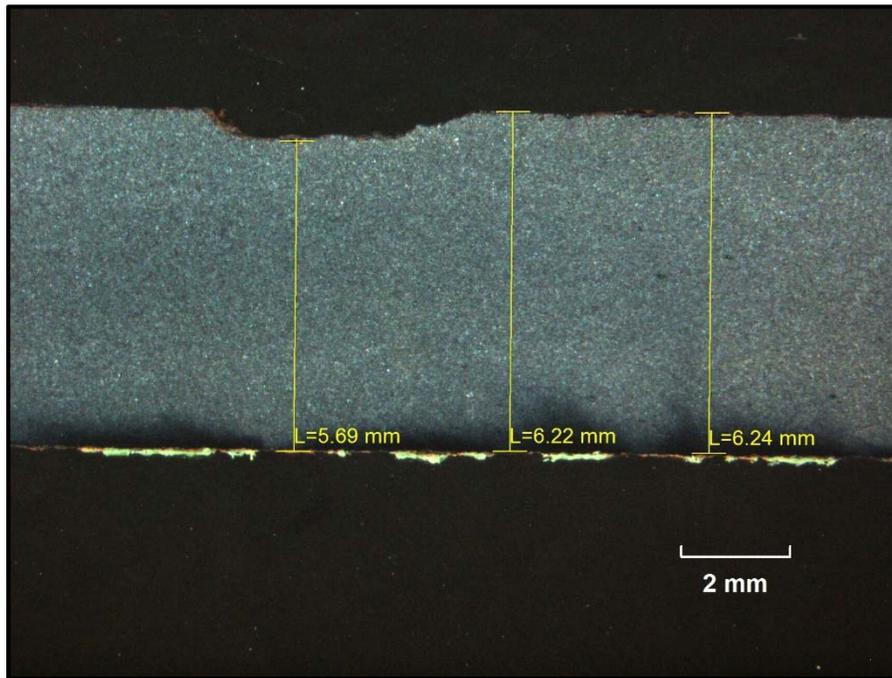
Figure 195. The prepared metallographic cross-section from Sample 6-3 is shown during examination with a stereomicroscope. The thickest location(s) are shown, as well as the thickness remaining underneath the deepest observed pit. (7X)

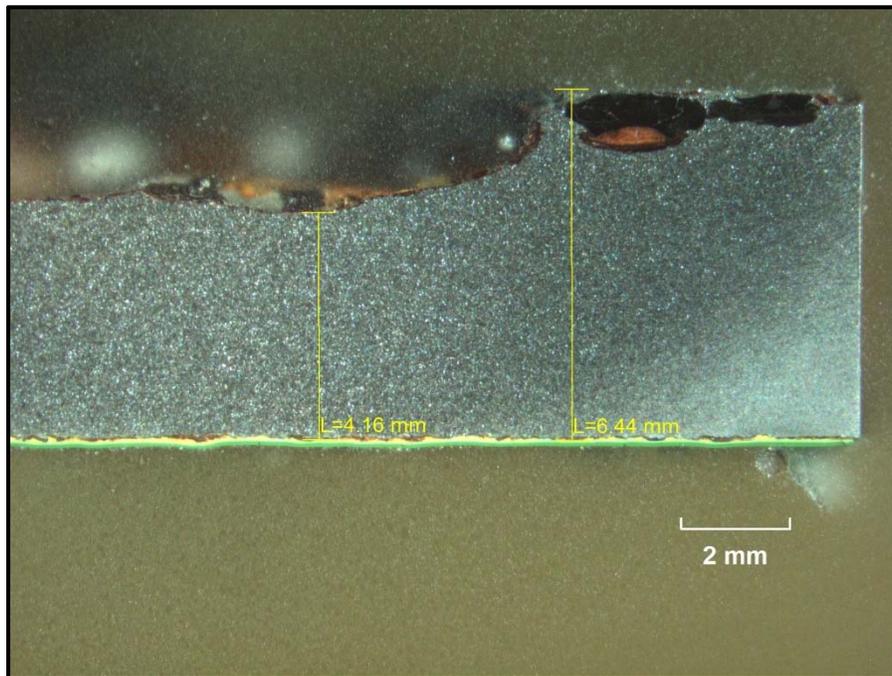
Figure 196. The prepared metallographic cross-section from Sample 7-1 is shown during examination with a stereomicroscope. The thickest location(s) are shown, as well as the thickness remaining underneath the deepest observed pit. (7X)

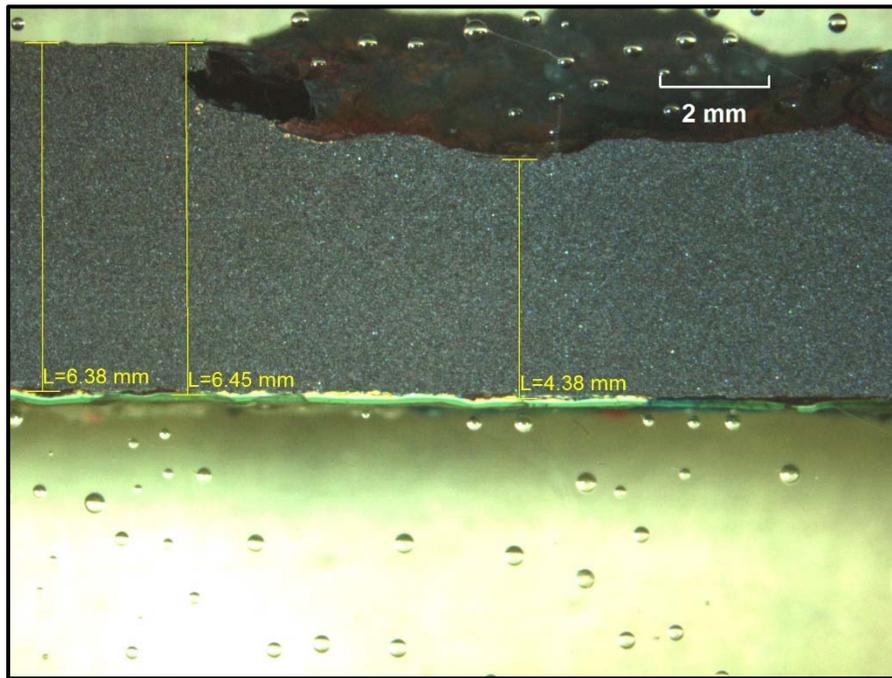
Figure 197. The prepared metallographic cross-section from Sample 7-3 is shown during examination with a stereomicroscope. The thickest location(s) are shown, as well as the thickness remaining underneath the deepest observed pit. (7X)

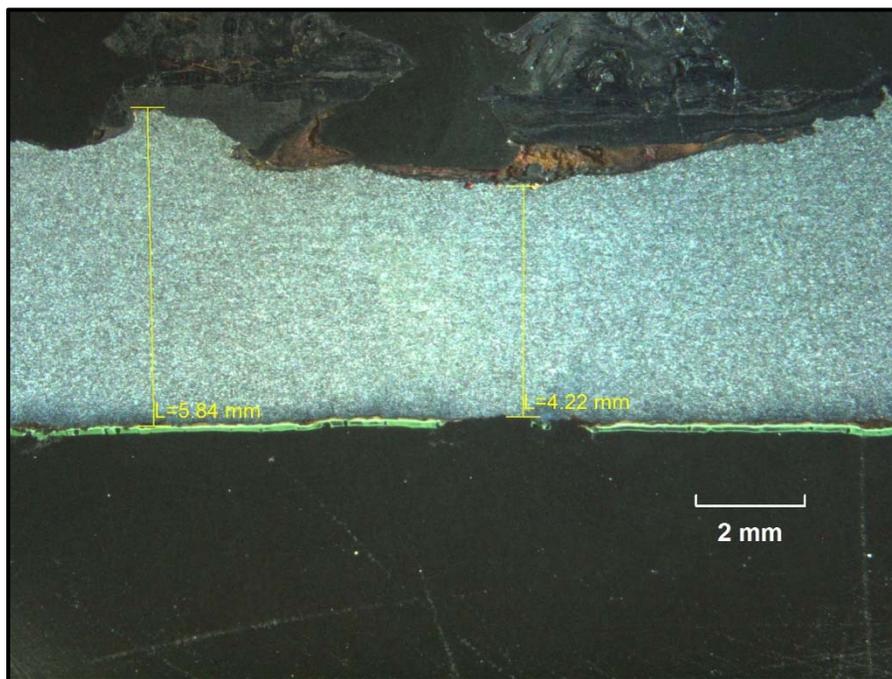
Figure 198. The prepared metallographic cross-section from Sample 7-4 is shown during examination with a stereomicroscope. The thickest location(s) are shown, as well as the thickness remaining underneath the deepest observed pit. (7X)

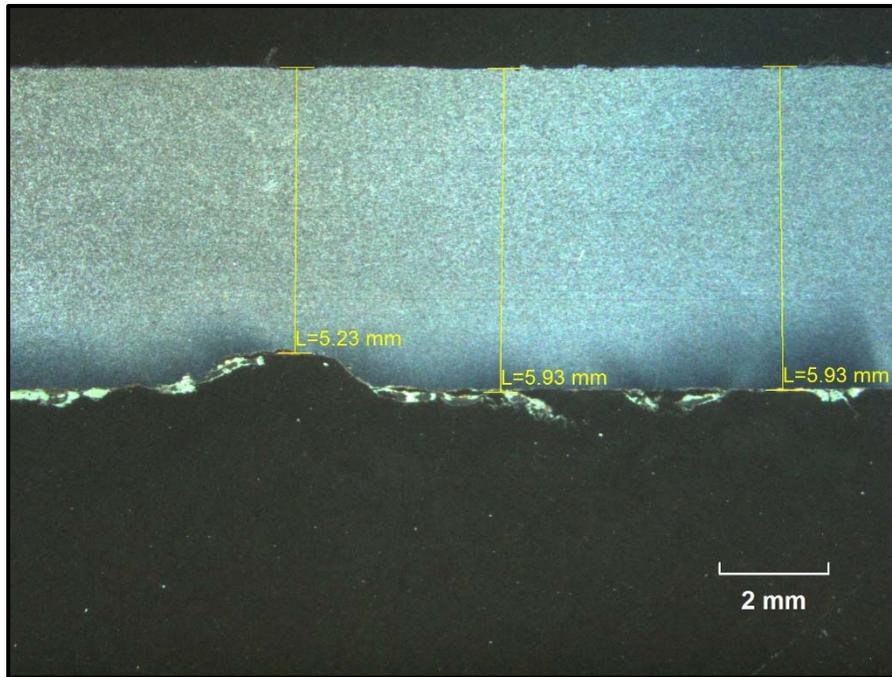
④ This is the weld-repaired plate section. Sample 8-3 exhibited a depression or pit on the painted surface.

Figure 199. The prepared metallographic cross-section from Sample 8-3 is shown during examination with a stereomicroscope. The thickest remaining wall is shown. Note that the reduction in wall thickness was due to a depression on the painted face of the specimen. (7X)

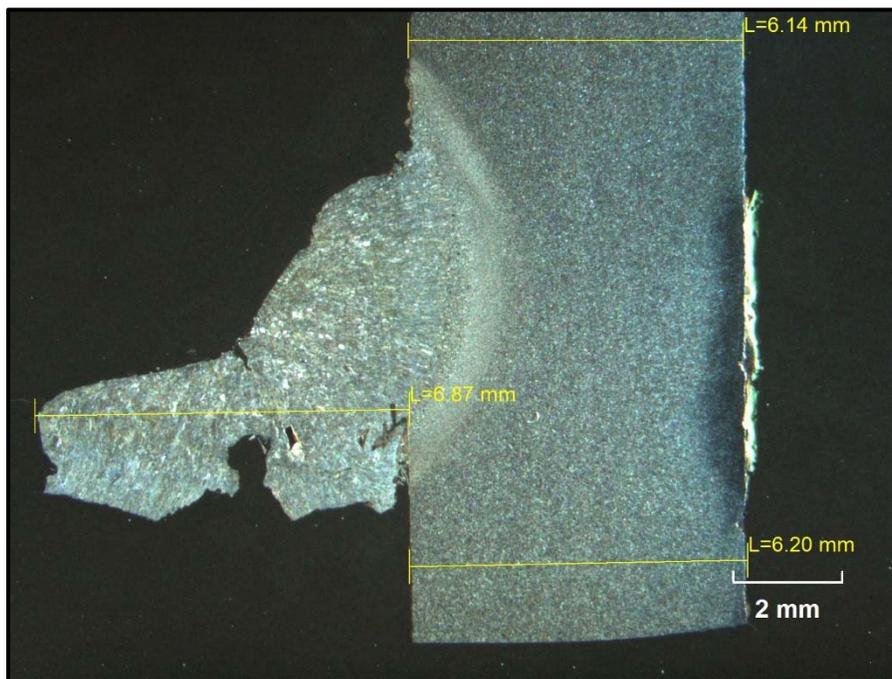
⑤ No pits observed. Suspected NDT inspection indication was a weld nugget on the interior surface of the coupon (thick area) on Sample 10-4.

Figure 202. The prepared metallographic cross-section from Sample 10-4 is shown during examination with a stereomicroscope. Image is rotated 90° from other images. The anomaly detected during NDE was likely the weld nugget on the interior surface of the coupon (left). No pitting or significant wall loss was observed. (7X)

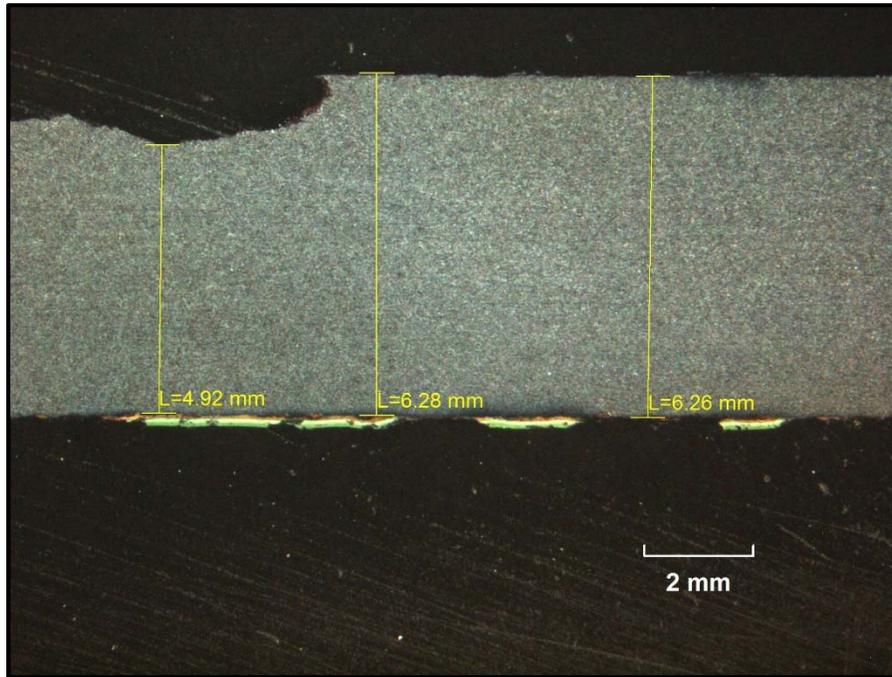
Figure 203. The prepared metallographic cross-section from Sample A1-1 is shown during examination with a stereomicroscope. The thickest location(s) are shown, as well as the thickness remaining underneath the deepest observed pit. (7X)

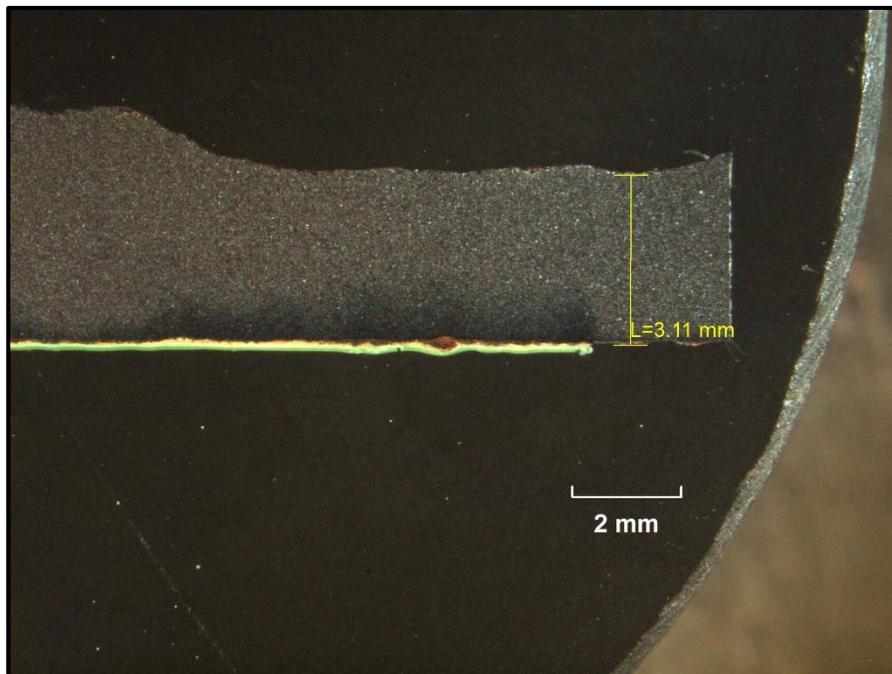
Figure 204. The prepared metallographic cross-section from Sample A1-4 is shown during examination with a stereomicroscope. The thickness remaining underneath the deepest observed pit is shown. (7X)

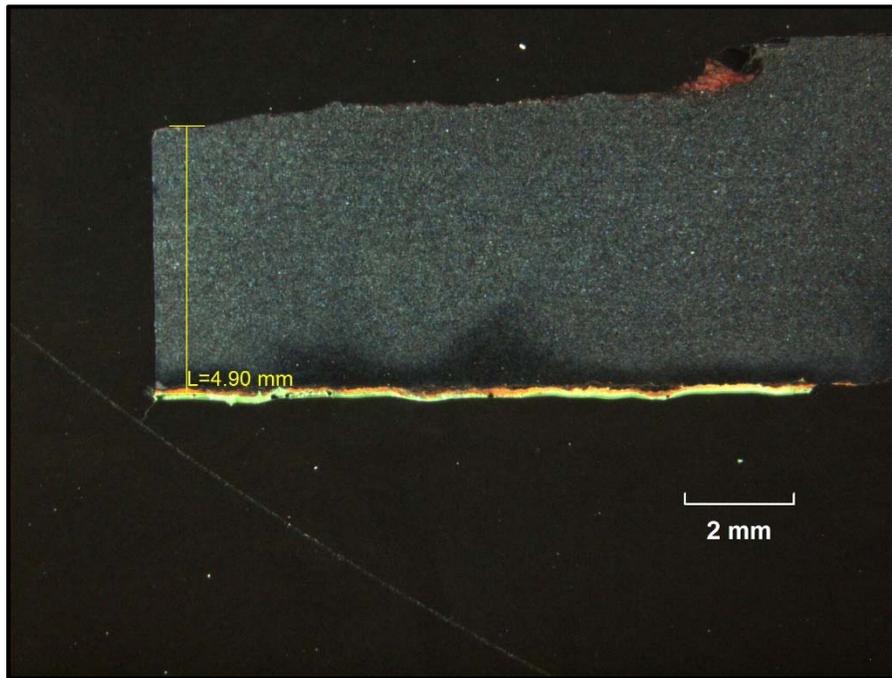
Figure 205. The prepared metallographic cross-section from Sample A1-5 is shown during examination with a stereomicroscope. The thickness remaining underneath the deepest observed pit is shown. (7X)

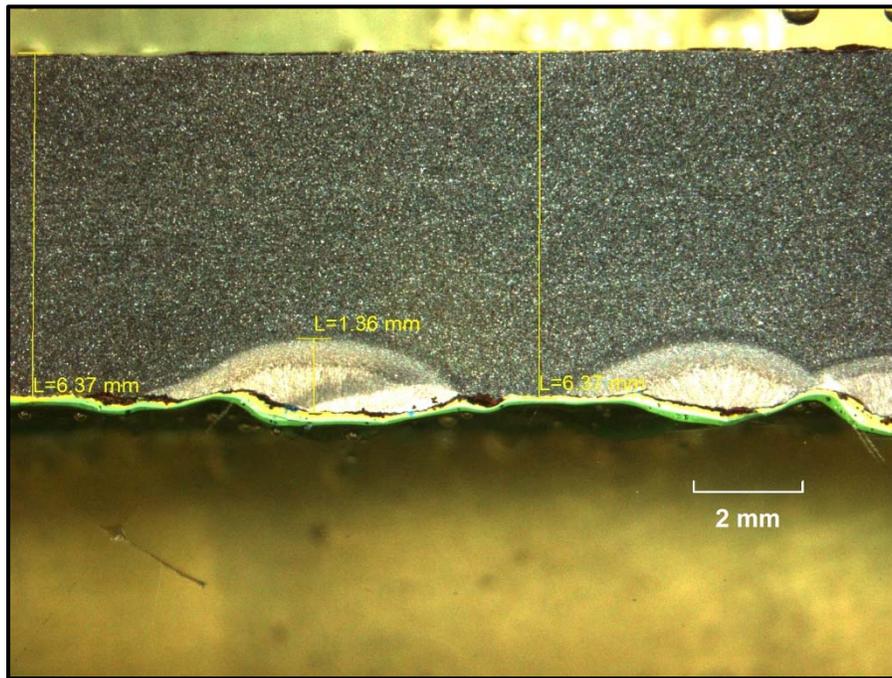
⑥ No pits observed. Suspected NDT inspection indications are areas of melting on the painted face, underneath the paint on Sample A2-4.

Figure 207. The prepared metallographic cross-section from Sample A2-4 is shown during examination with a stereomicroscope. The NDE indication was most likely locations of melting/re-solidification underneath the painted surface. No pitting was observed. (7X)

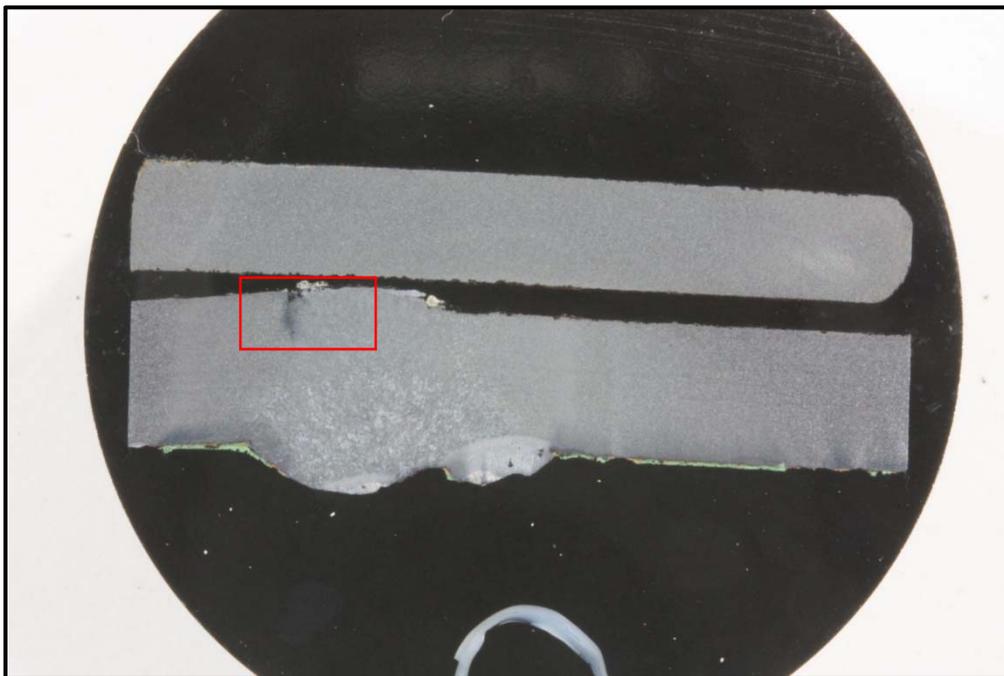
Coupon 8 exhibited what is presumed to be a prior weld repair and/or addition of a backing plate, where a patch was made on the tank wall. Representative images of the welds are presented as Figures 208 through 213. A full weld evaluation is outside the scope of this effort. The results are thus provided for information only.

Figure 208. The prepared metallographic cross-section through welded sample 8-1 is shown in an overall view. The painted exterior surface is along the bottom section. The area identified by the red box is shown in the next figure at higher magnification.
