# Report On Tank 15 Phase 2 As Built Repairs

March, 2006

**CONTRACT NUMBER N62742-03-C-1402  
CLEAN AND REPAIR TANKS 1, 6, 15, AND 16, AT RED HILL  
FLEET AND INDUSTRIAL SUPPLY CENTER, PEARL HARBOR, HAWAII**

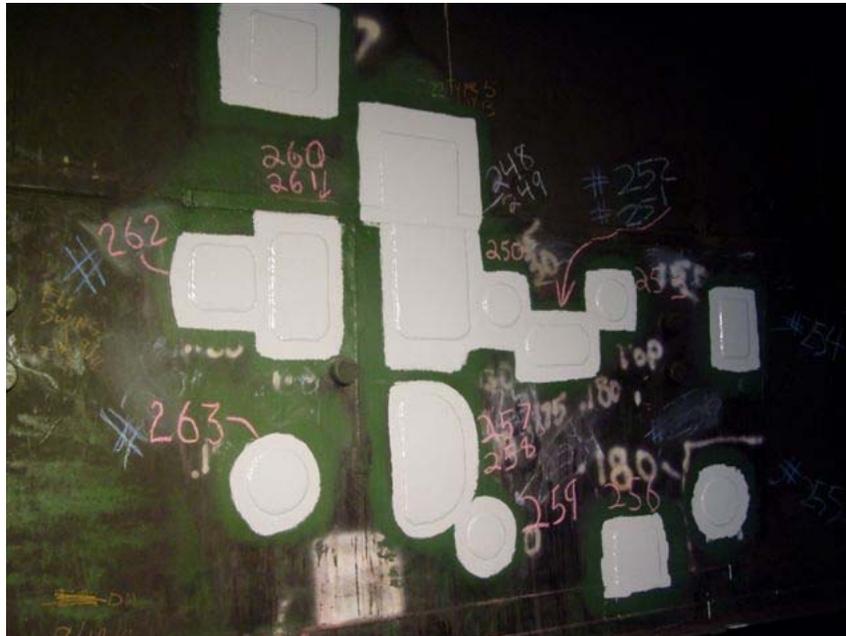
Typical patch plate repairs (note the Dunkin & Bush assigned flaw numbers)

5 repairs were added as the result of further examination of grout nozzles for flaws (15158 – 15162). Five flawed nozzles were removed and patched over with an 8" diameter plate.

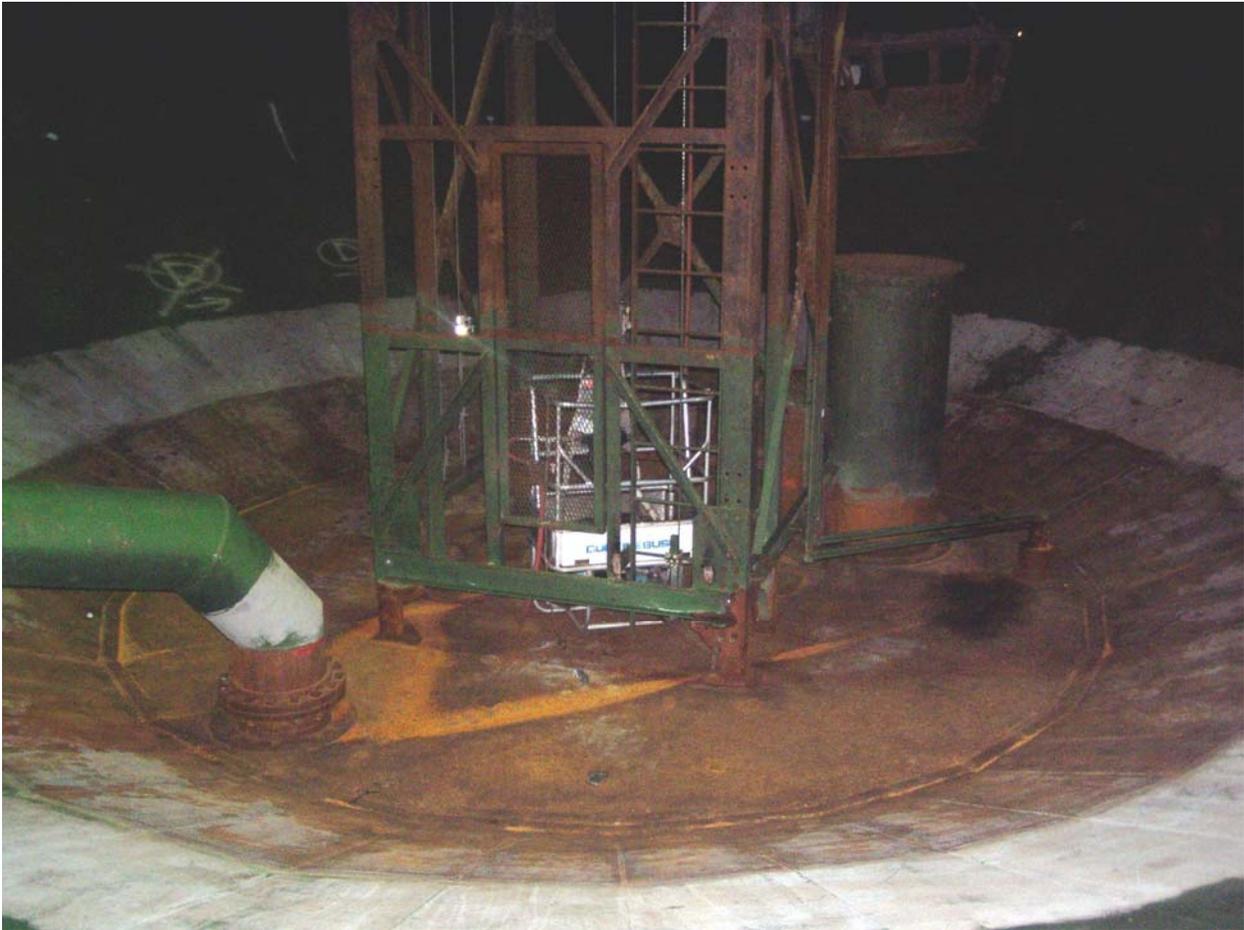
Tank 15 bottom after anchors and clips were removed. Also note where the elevator landing platform and steps were removed from the facing side of the tower structure.

Unused anchors, clips, and angles were removed from the tank bottom as recommended by Weston Solutions. Areas where these attachments were removed were ground smooth and vacuum box tested (if removed from the bottom plates).

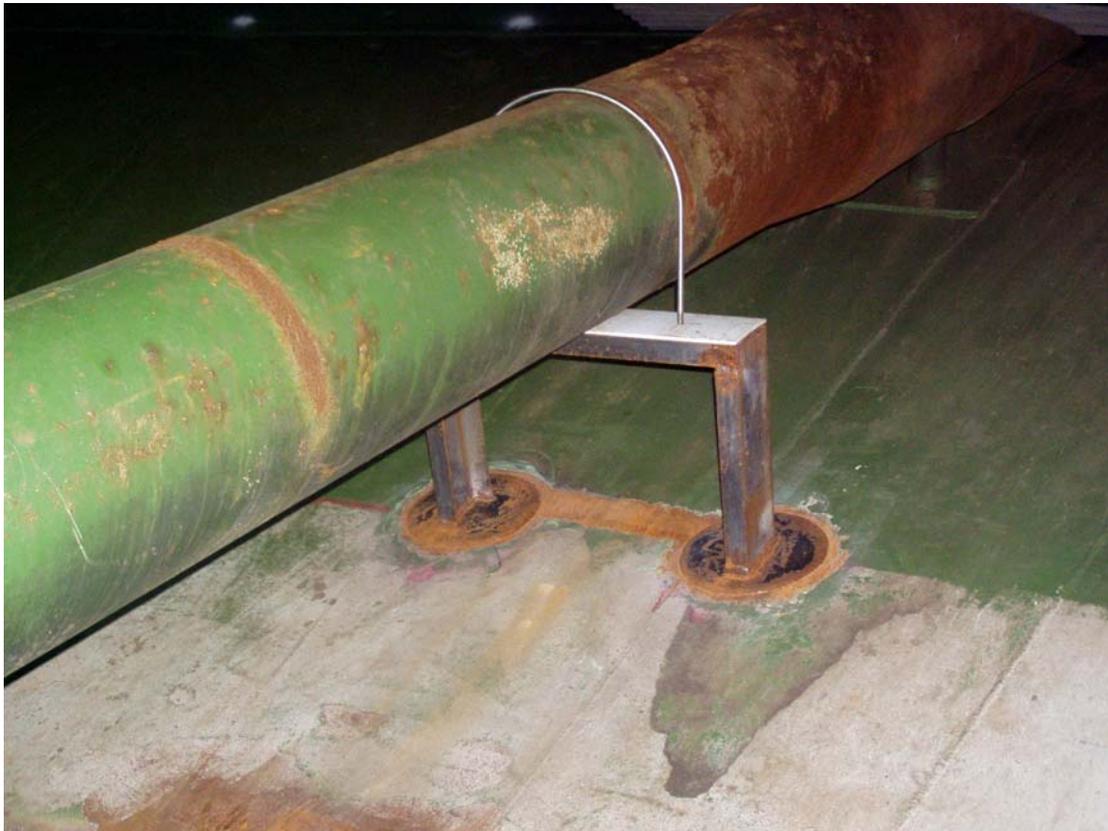
New 18" line support with re-pads

The 18" line supports were removed and replaced as recommended by Weston Solutions. Two existing supports were removed, areas where they were attached to the tank bottom were ground smooth and vacuum box tested.

One new support was installed shown in the photograph below. Reinforcing plates attached to the tank bottom were PT'd and vacuum box tested.

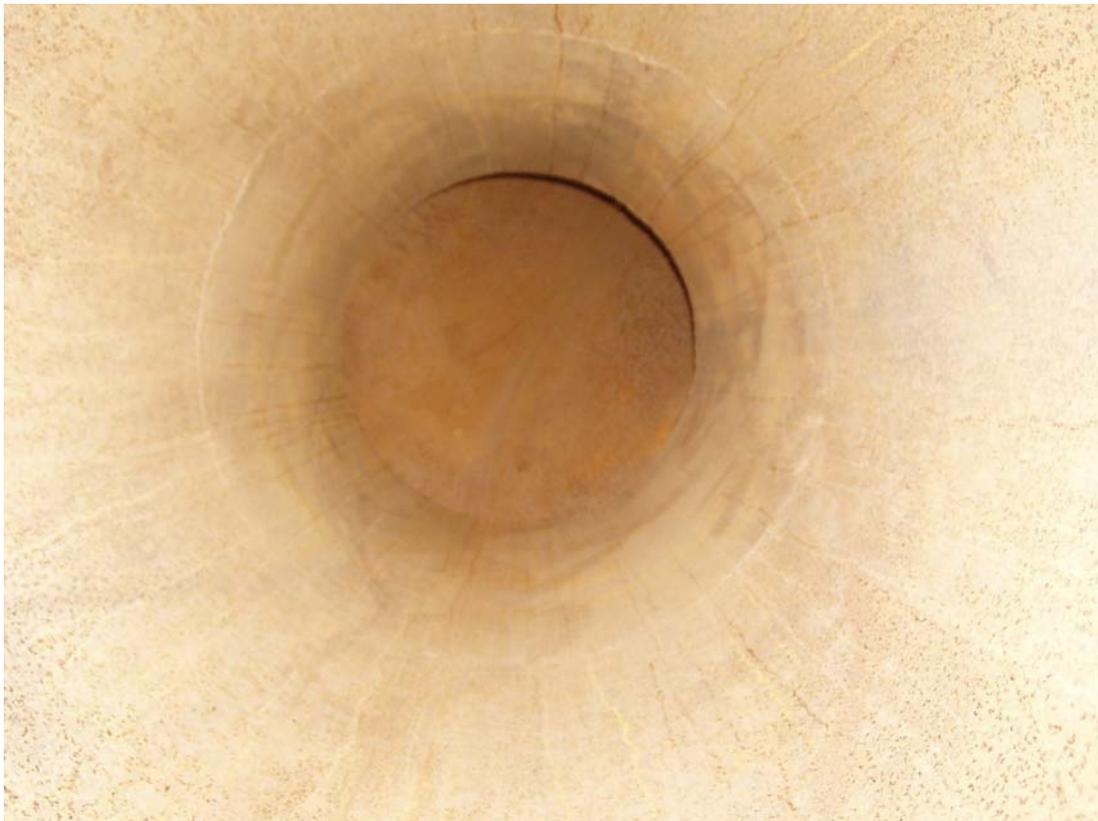
View looking down the 32" line from inside tank 15. Note the circumferential weld before the bend. This is weld repair "A" identified in the Weston Solutions sketch.

Five internal circumferential weld joints of the 32" line beneath the tank bottom were weld repaired and PT'd as recommended by Weston Solutions. Locations are shown on the Weston Solutions sketch dated 12/29/5.

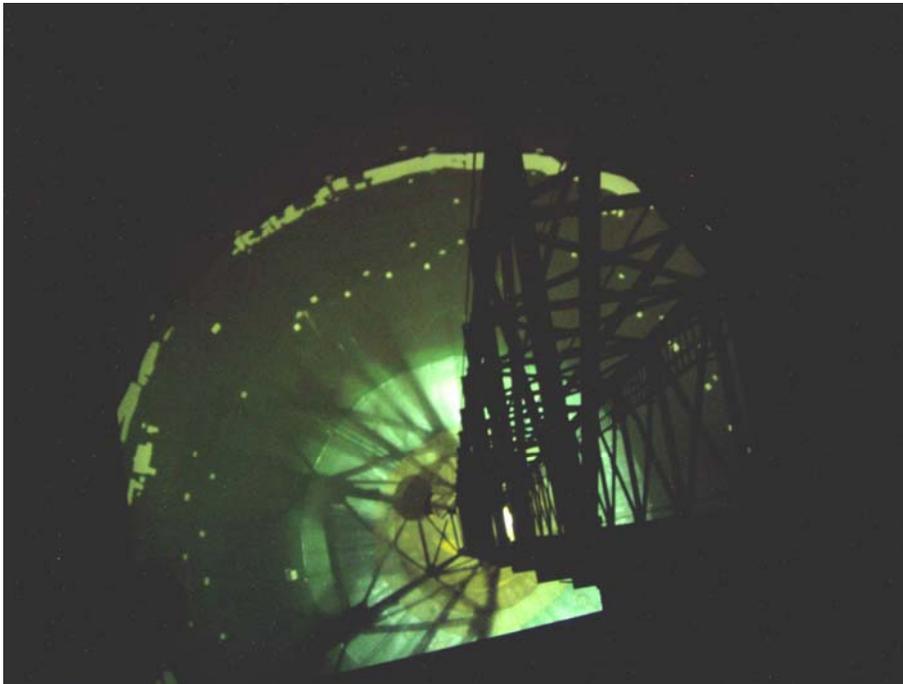
Tank 15 Lower Dome Coating Repairs

Coating repairs were completed using the approved single coat paint system with surface preparation done in accordance with manufacturers recommendations.

1. 89 weld and patch plate repairs.
2. 112 grout nozzles.
3. Scattered areas of the lower dome and barrel totaling approximately 82 square meters. Coating repair areas in the lower dome were described in the Dunkin & Bush Report on Coating Failure Observations dated September 30, 2005.

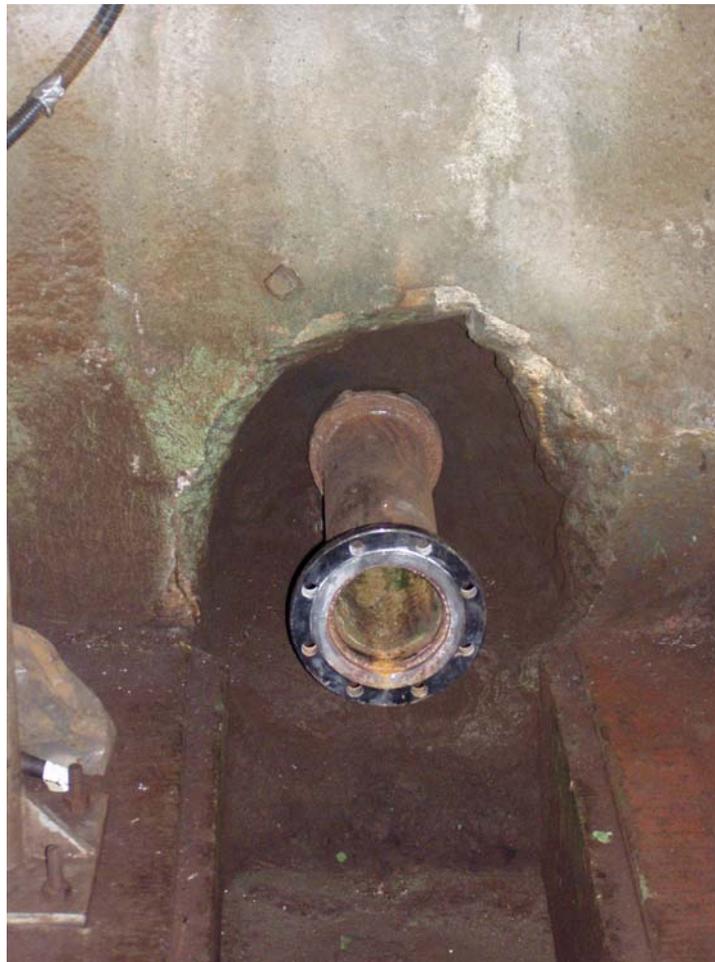
1. **Removal, repair, reinstallation and testing of the 6" slop line.** The existing slop was removed as directed by the government. The flexible stainless steel portion of the line was found to be leaking at weld joints and was replaced with a 24 foot section of new 5" diameter flexible stainless steel tubing. The existing carbon steel slop line pipe was re used, with a new flange installed at the lower tunnel.

View of new slop line from lower tunnel before installation of 6" valve.

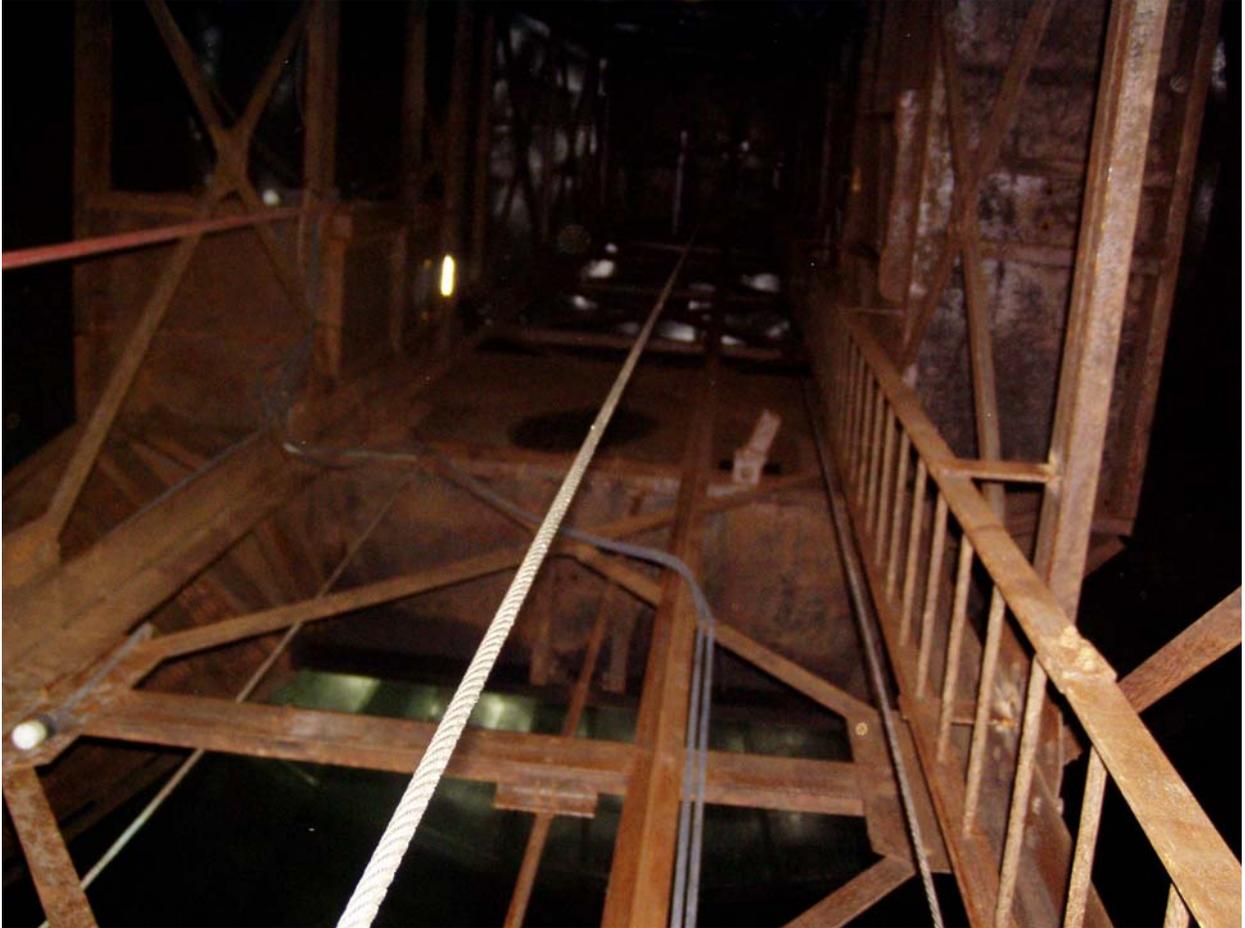
Tank 15 relocated ladder – note the clips attaching the ladder to the tower.

2. **Relocation of the ladder** in the central tower from the quadrant “A” side (facing) to the quadrant “D” side (right side of photograph). This required cutting and re welding clips connecting the ladder over the full height of the tower.

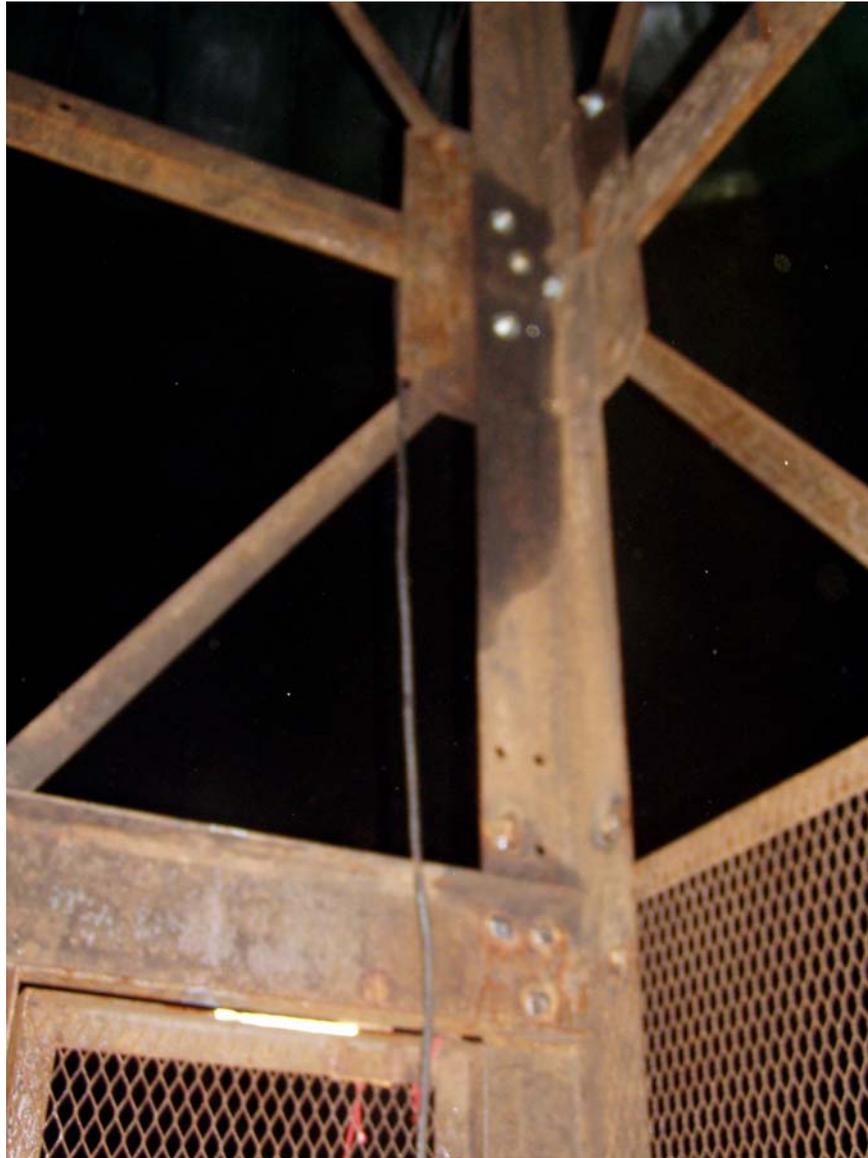
Typical area of replaced fasteners - note plug weld repair of flame cut holes.

3. **Central tower structural repairs** including the installation of 48 missing fasteners, and repairs to cracked weld joints below the catwalk platform on the tower structure.

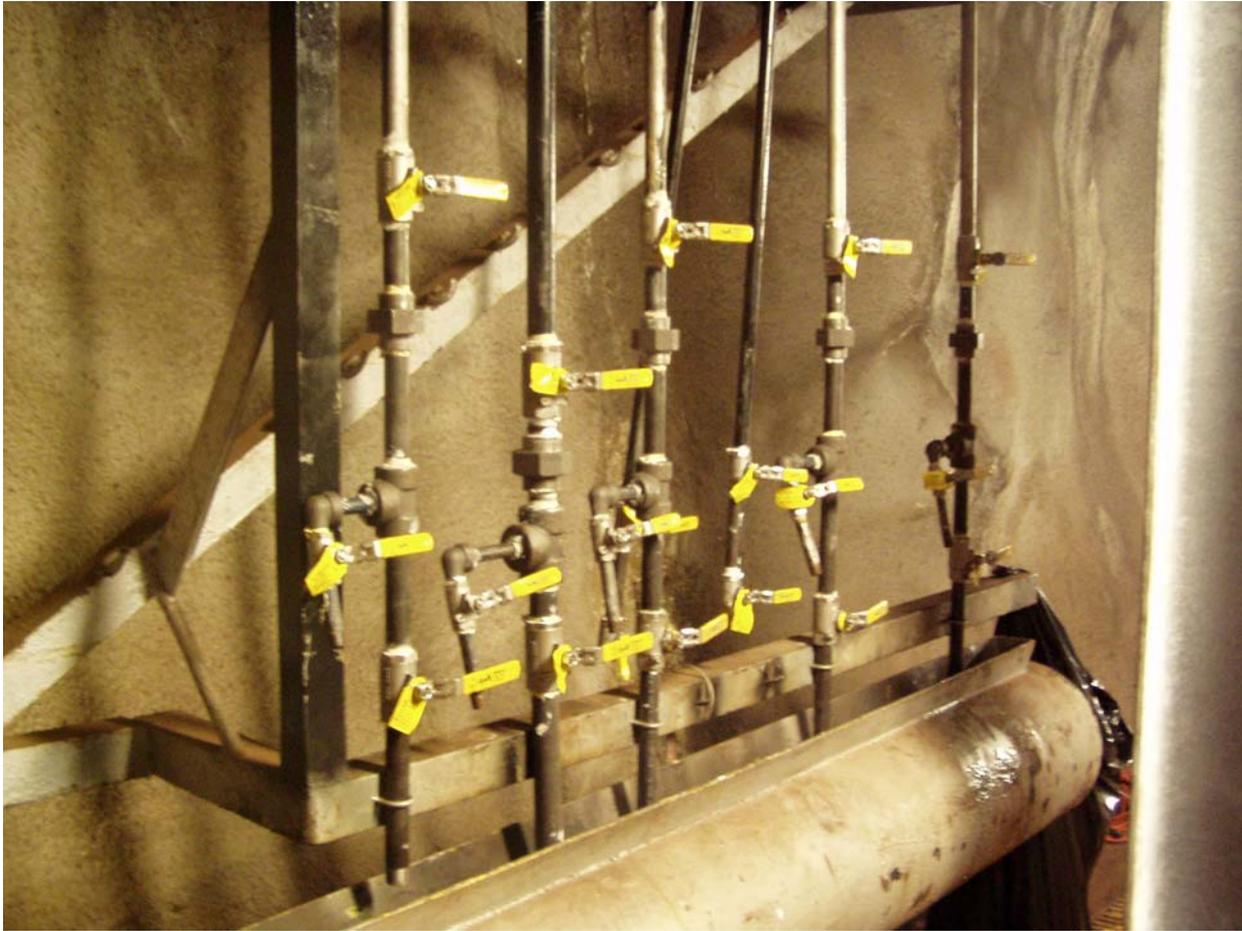
Tank 15 sample line valves at lower tunnel – note added branch and valve for filling sample bottles.

**4. Replacement of sample line valves in the lower tunnel.**

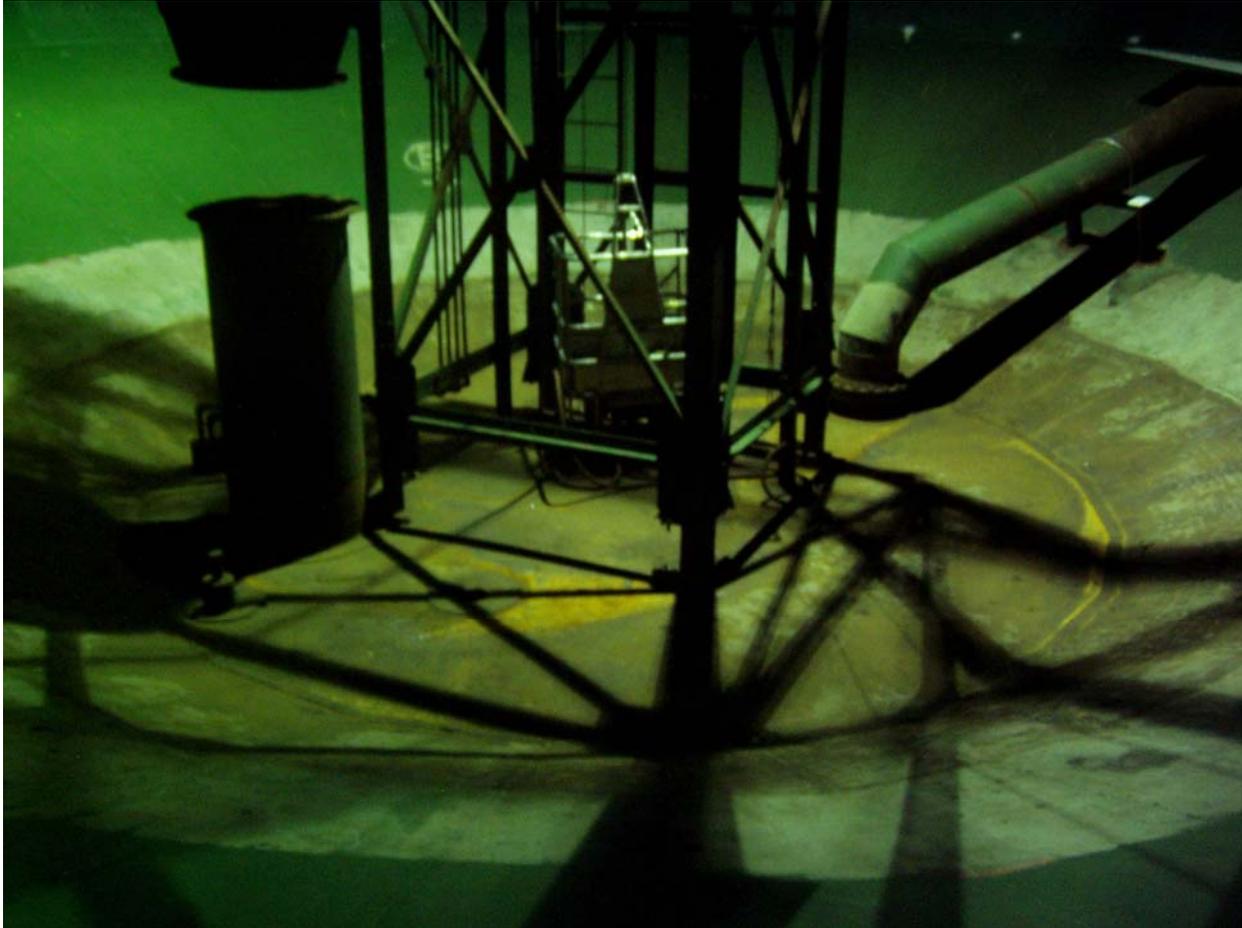
View of tank 15 bottom area where gauging equipment and attachments were removed

- 5. Removal of the existing counterweight tube, gauge float, guy wires and attachments.**

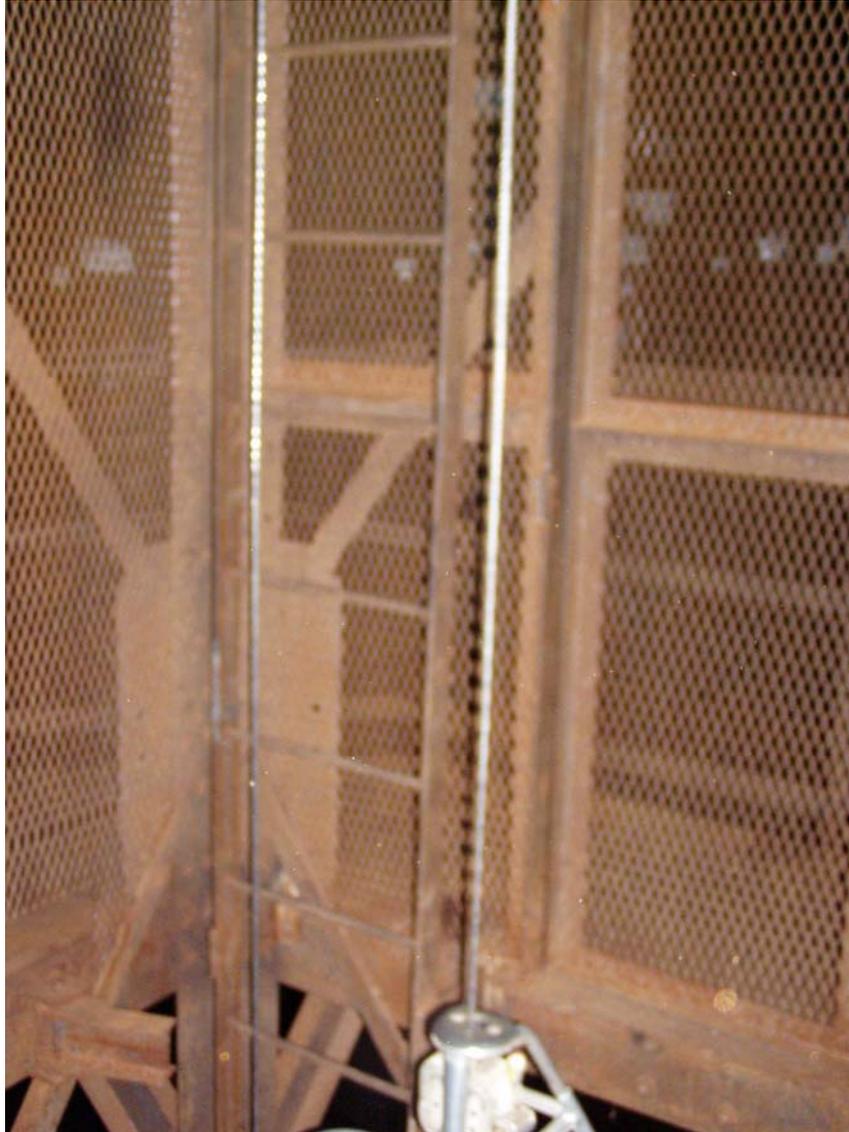
Area where elevator cage was removed at the platform level – note the relocated ladder.

6. **Removal of the elevator cage** and lower landing & steps from the central tower structure.

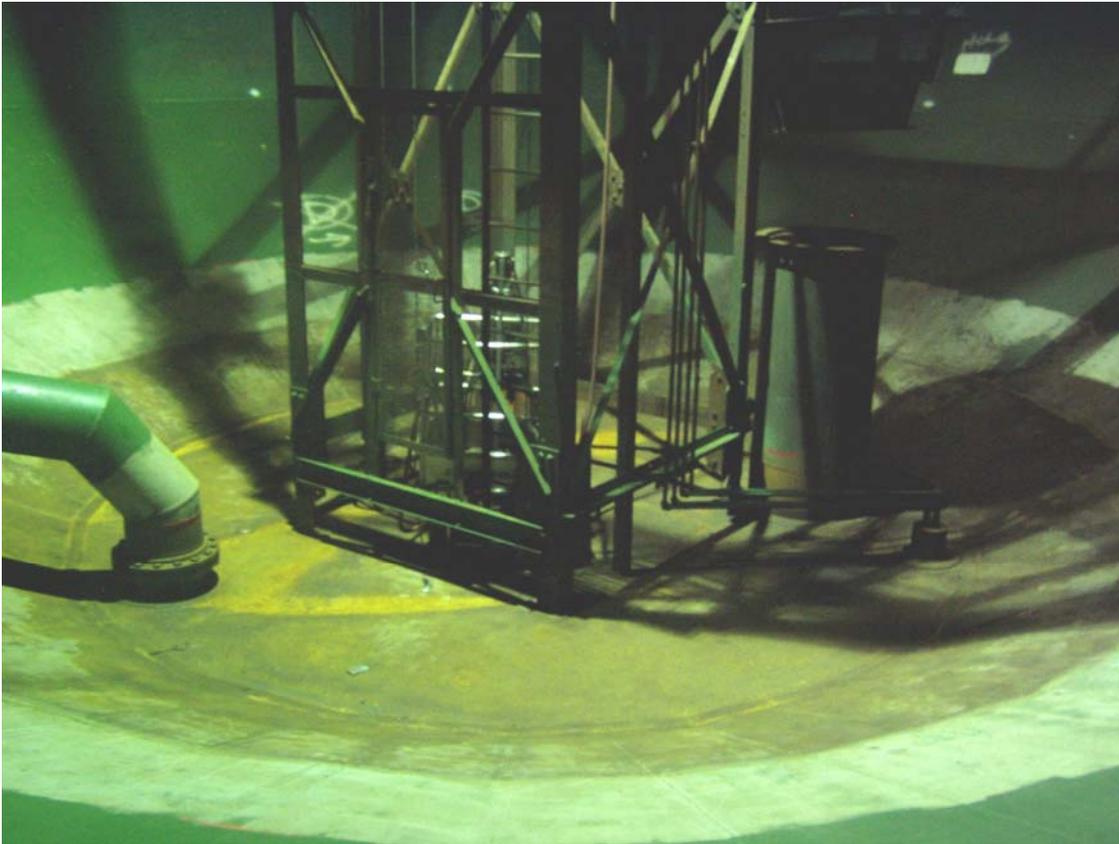
View of tank 15 bottom area where the elevator platform and steps were removed.
