BOARD OF WATER SUPPLY

Subject: Honolulu Board of Water Supply Comments on Navy's "AOC SOW Section 5 Corrosion and Metal Fatigue Practices, Destructive Testing Results Report" dated July 7, 2019 and IMR's Report "Destructive Analysis of 10 Steel Coupons Removed from Red Hill Fuel Storage Tank #14" dated December 17, 2018

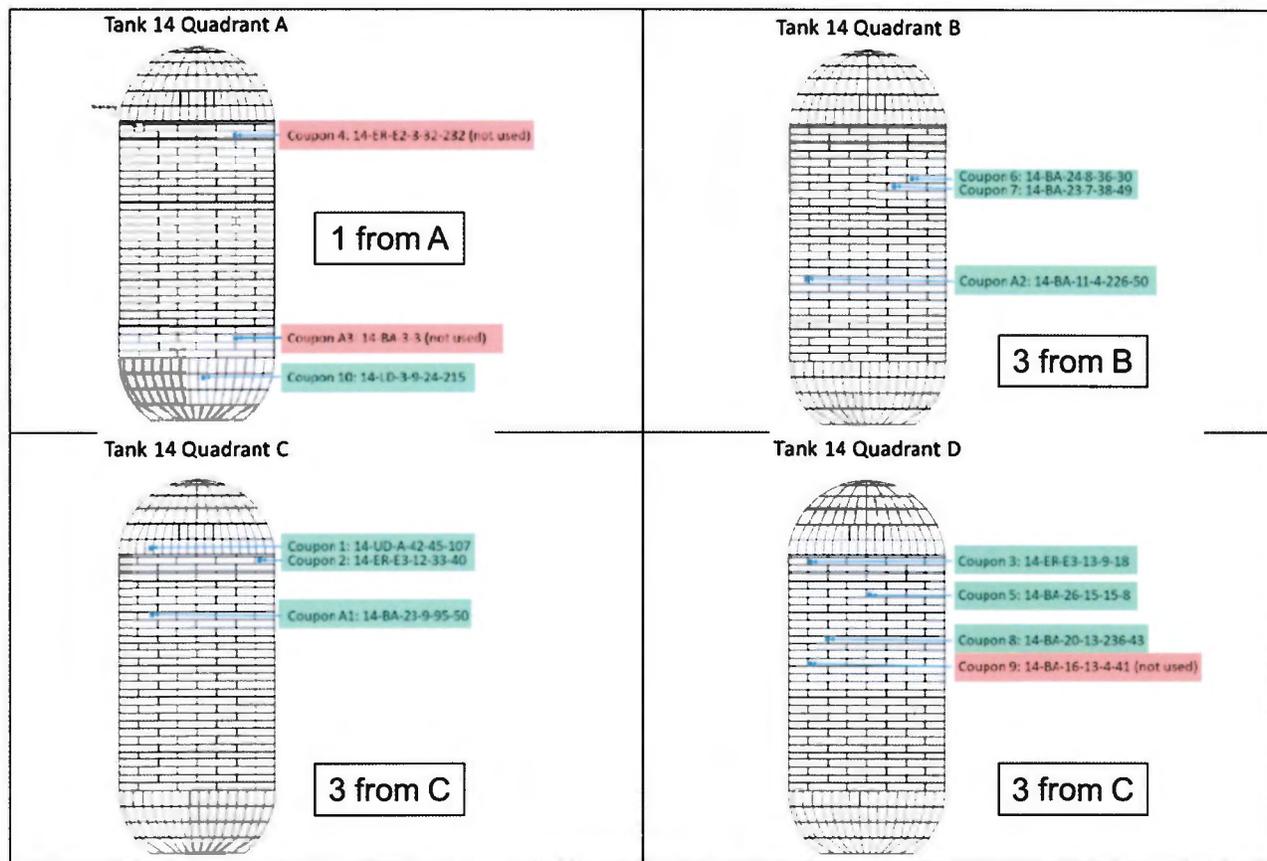
Figure 2-1 Schematic of Tank 14 Coupon Locations

within Tank 14 much less the conditions of all the tanks at the RHBFSF. Ultimately, the Navy extracted eight coupons from the tank barrel (i.e., the vertical walls), one from just inside the upper dome, and one from sloped section of the lower dome; shown below for the locations marked in green. The locations marked in red were identified as possible coupon locations but were not extracted. The BWS is not aware of any random locations selected based on the BFET scans specifically to assess the welds. The Navy's description of the NDE result at these coupon locations do not discuss the BFET result at all. Further, the BWS is not aware of any coupons extracted from the lower dome bottom plate.

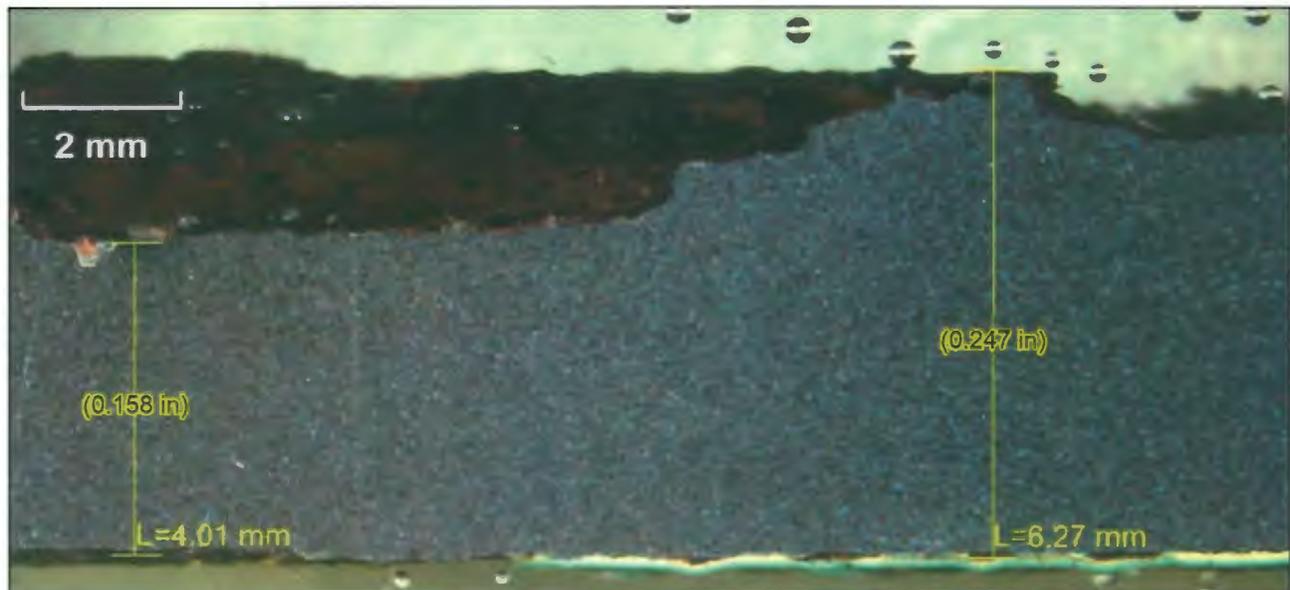
Figure 1 – Destructive Testing Cross-section from Sample 6-1

In addition, Coupon 6 required repair but its thinned condition was missed by both LFET and PAUT. The DT report attempts to downplay this missed corrosion location as follows:

“Coupon 6 showed more metal loss than was predicted by the NDE and was just below the repair threshold. The destructive testing identified this to be a pit of very small volume. The NDE method used (LFET) does not always detect metal losses of very small volume” (p. 61, Navy, 2019a).

However, the BWS disagrees with both the DT report’s characterization of the corrosion pit identified at Coupon 6 and the significance of the inability of the LFET method to identify such a pit. First, both LFET methods as described in the Tank Inspection and Repair, and Maintenance (TIRM) Report (Navy, 2016b) should have detected the pitting found in Coupon 6. From the October 2016 TIRM Report, there were two LFET methods being considered:

1. The larger, TesTex Falcon Mark II 2000 device should have been able to detect the pit in Coupon 6. According to the Navy this device has a probability of detection (POD) of 100% at 25% wall loss on pits with an aspect ratio of 3:1. The deepest pit in Coupon 6 amounted to ~37% wall loss and aspect ratio of greater than 3:1 (width to depth ratio). Figure 1 shows the cross-section through the deepest pit in Coupon 6 where the size and depth of the pit is obvious.
2. The smaller, TesTex TS-2000 device should have been able to detect the pit in Coupon 6 as the Navy stated this device can detect pits with a diameter of 1.57 mm. The width of the corrosion pit in Coupon 6 was much, much wider than 1.57 mm as is shown in Figure 1.

Second, the BWS believes Figure 1 clearly demonstrates this pit cannot be described as a “*pit of very small volume.*” This figure clearly shows a broad pit of considerable volume.

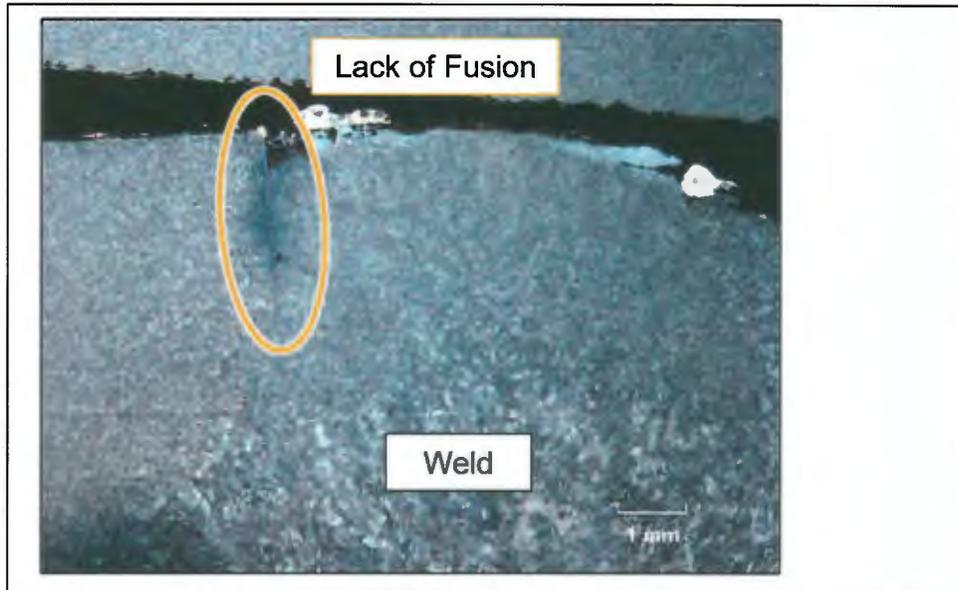
Figure 2 -- (Image from: IMR Test Labs. 2018)

4. The DT inspection did find weld defects. The one coupon that actually had a weld contained a linear defect that was found by destructive testing. This lack of fusion linear weld defect is shown below.

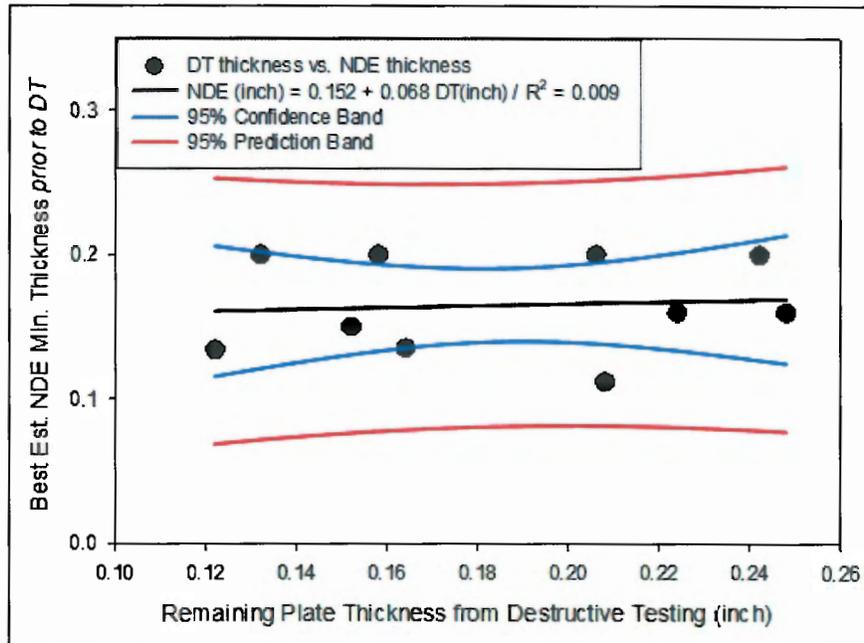
Figure 4 – Relationship between NDE thickness estimate prior to DT and the actual remaining thickness determined from DT.

Figure 4 clearly indicates the NDE techniques are neither accurate nor reliable. First, the slope (0.068) of the line drawn through the DT vs NDE data is very flat (close to zero), indicating the NDE results are essentially insensitive to actual corrosion depth. For comparison, if NDE was perfectly accurate, then the DT thickness would be equal to the NDE thickness and the slope of the line drawn through the data would be 1.0. Instead, the calculated slope is consistent with what one would expect if the NDE results were simply chosen at random without regard to the actual coupon thickness. Another indication is the coefficient of determination (R^2), which measures NDE accuracy by comparing the variation in NDE results to the residual variation after accounting for the actual coupon thickness (using the regression line). As noted in Figure 4, the R^2 value is effectively zero (0.009), indicating none of the observed variation in NDE-measured thickness is attributable to corresponding variation in the actual thickness of the test coupons.

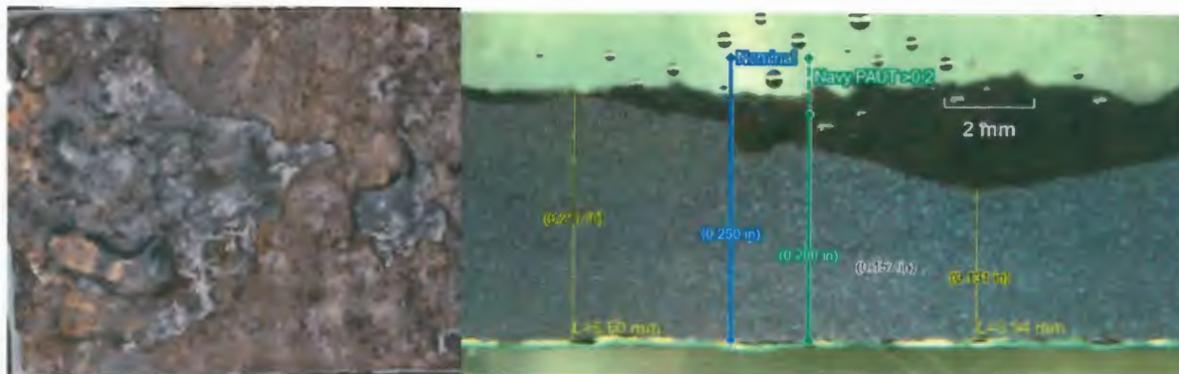
Figure 5 – Destructive Testing Cross-section from Sample 3-3.

This statement is misleading. The location of Coupon 3 needed repair and PAUT was clearly in error. The fact that an adjacent area required repair and that the corrosion under Coupon 3 might have been found through those repair efforts, is irrelevant as the goal of the NDE/DT efforts was to evaluate the accuracy and reliability of the NDE methods for specific coupon areas. The PAUT prove-up step was not only being evaluated against the qualitative findings but also against its quantitative findings. PAUT should have been accurate to within ± 20 mils (0.020 inches) of the actual minimum thickness. However, for Coupon 3, PAUT reported a minimum thickness greater than 0.200 inches and the actual minimum thickness was 0.132 inches, an error more than three times larger than the Navy's stated accuracy objective.

A more graphic illustration of the error in the NDE methodology is shown in Figure 5. The image on the left-hand side of Figure 5 shows the extensive backside corrosion on Coupon 3. The right-hand side of Figure 5 shows the plate's reported thinnest area in cross-section after destructively testing. While it is unclear from the DT and IMR reports, this thinned region

(0.131-inch-thick) was presumably located by CT scanning of the entire coupon. The Navy NDE predicted that this area had little to no backside corrosion.

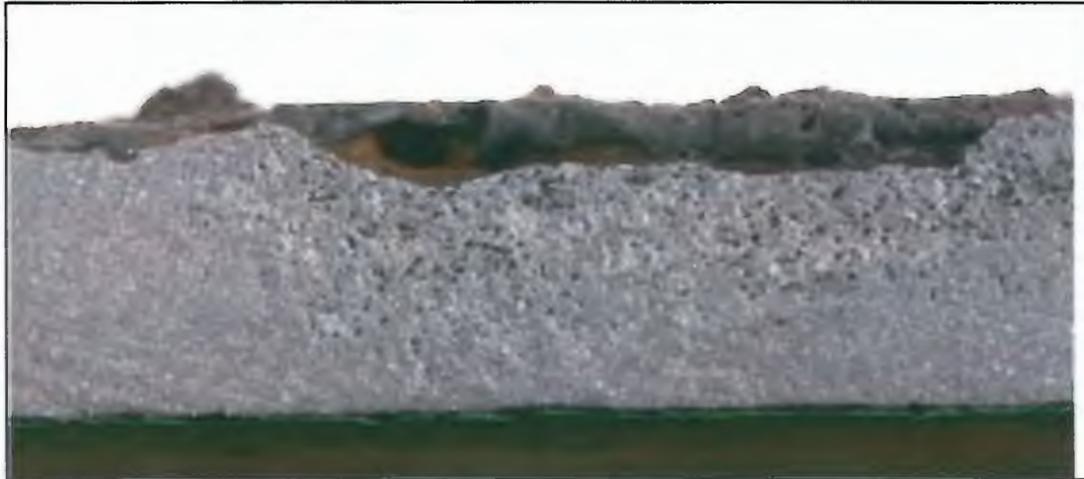
1. There was pitting observed as shown in their Figure A-4
2. It is not surprising that corrosion was not found as this area had been sandblasted.
3. The explanation that the area of concern "had been superficially altered by heat associated with sectioning or some other post-sectioning reaction (atmospheric corrosion or corrosive media attack)" is not credible. Atmospheric corrosion would be uniformly distributed along the cut surface, but the area of concern is localized. Secondly, the porosity is not consistent with heat associated with sectioning. Finally, we are unaware of any corrosive media used during coupon removal that could have locally attacked the edge in the area of concern.

Figure A-4. Detail of the sandblasted edge on 3/20/19 in the same location as shown in the picture below. The sandblasting revealed that the feature was not a corrosion pit, as shiny metal was revealed when the red-colored staining was removed. There was an unusual appearance to the edge in this location, as though the sectioned edge had been superficially altered by heat associated with sectioning or some other post-sectioning reaction (atmospheric corrosion or corrosive media attack). That alteration gave the appearance of a deep corrosion pit.

Because the area of concern has not yet been fully investigated, the BWS requests that it (and the other coupons) be made available for independent analyses. At the very least, BWS requests that these coupon remnants and metallographic mounts be preserved for future examination.

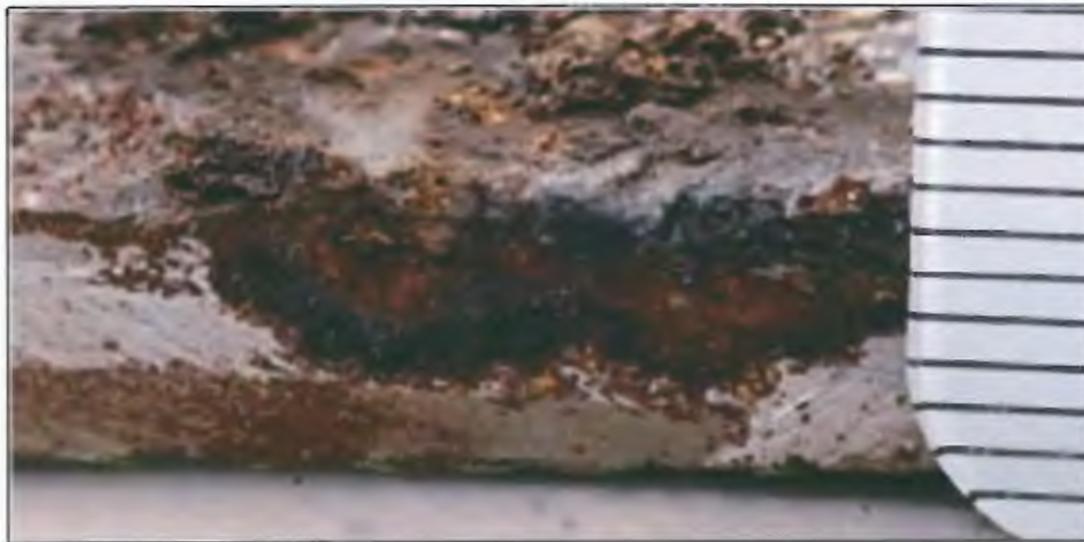
Figure A-5. The same area is shown in an image provided prior to shipping Coupon #7 to IMR (provided to IMR on March 13, 2019). What appeared to be a deep corrosion pit was actually rust-colored staining of the edge surface
