**Section 9**

**RECOMMENDED REPAIRS**

MID ATLANTIC ENVIRONMENTAL	
EMERGENCY REPAIRS FOR RED HILL TANKS	
Tank #8 AS BUILT DRAWINGS	
Repair No.: 001	File: 8R001
UPPER DOME	Quadrant: D
Course: EXTENSION	PLATE: 22
Drawn by: Tom Klitcher	Date: 5/4/98

**Dames & Moore**  
Emergency Repairs For Red Hill Tanks at the Fleet Industrial & Supply Center  
Contract No. N62742-96-C-1356

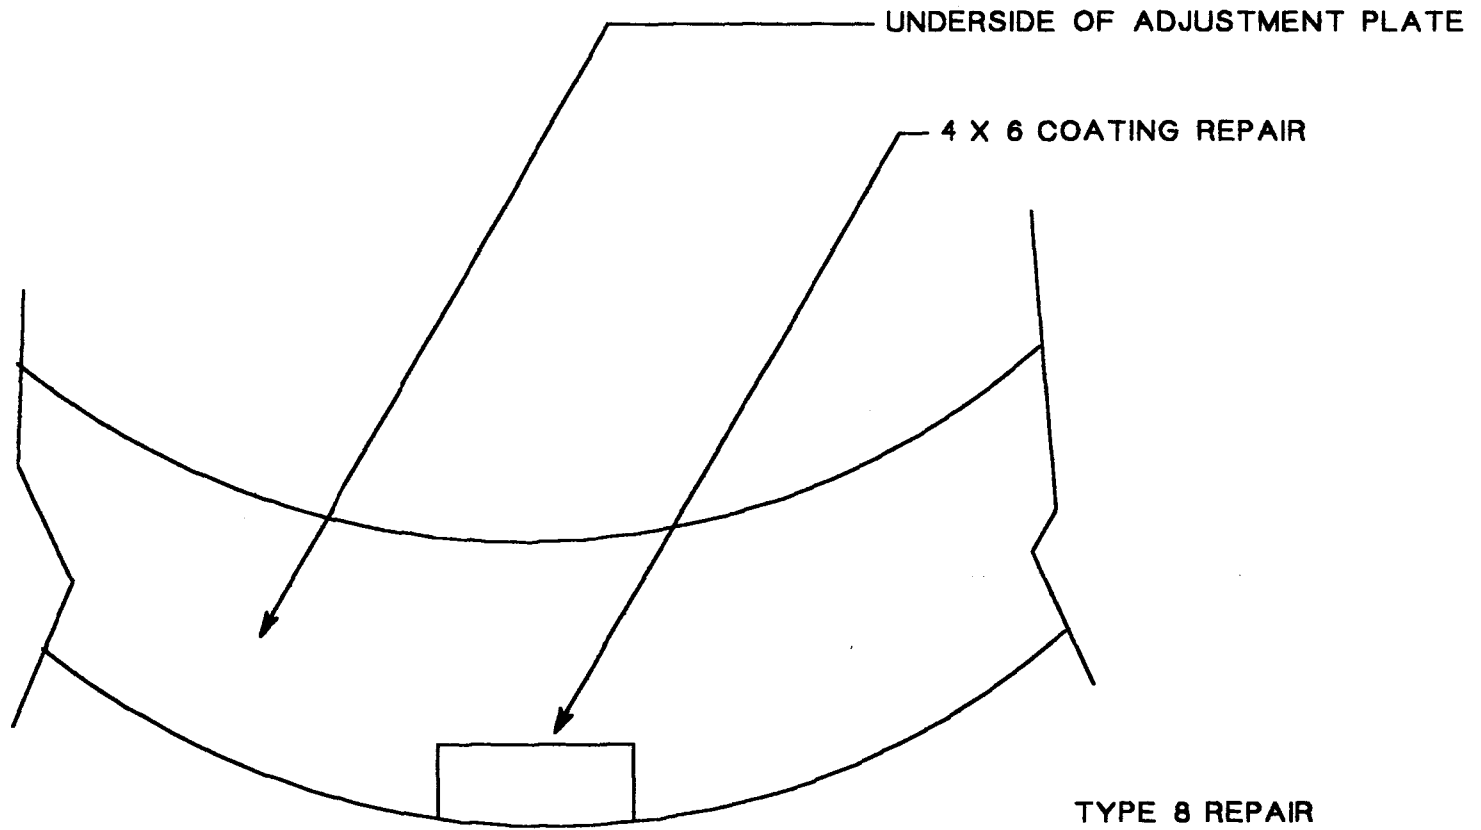
NOTE: AREA ~~EAS~~ FOUND TO BE GROUND TO BARE METAL

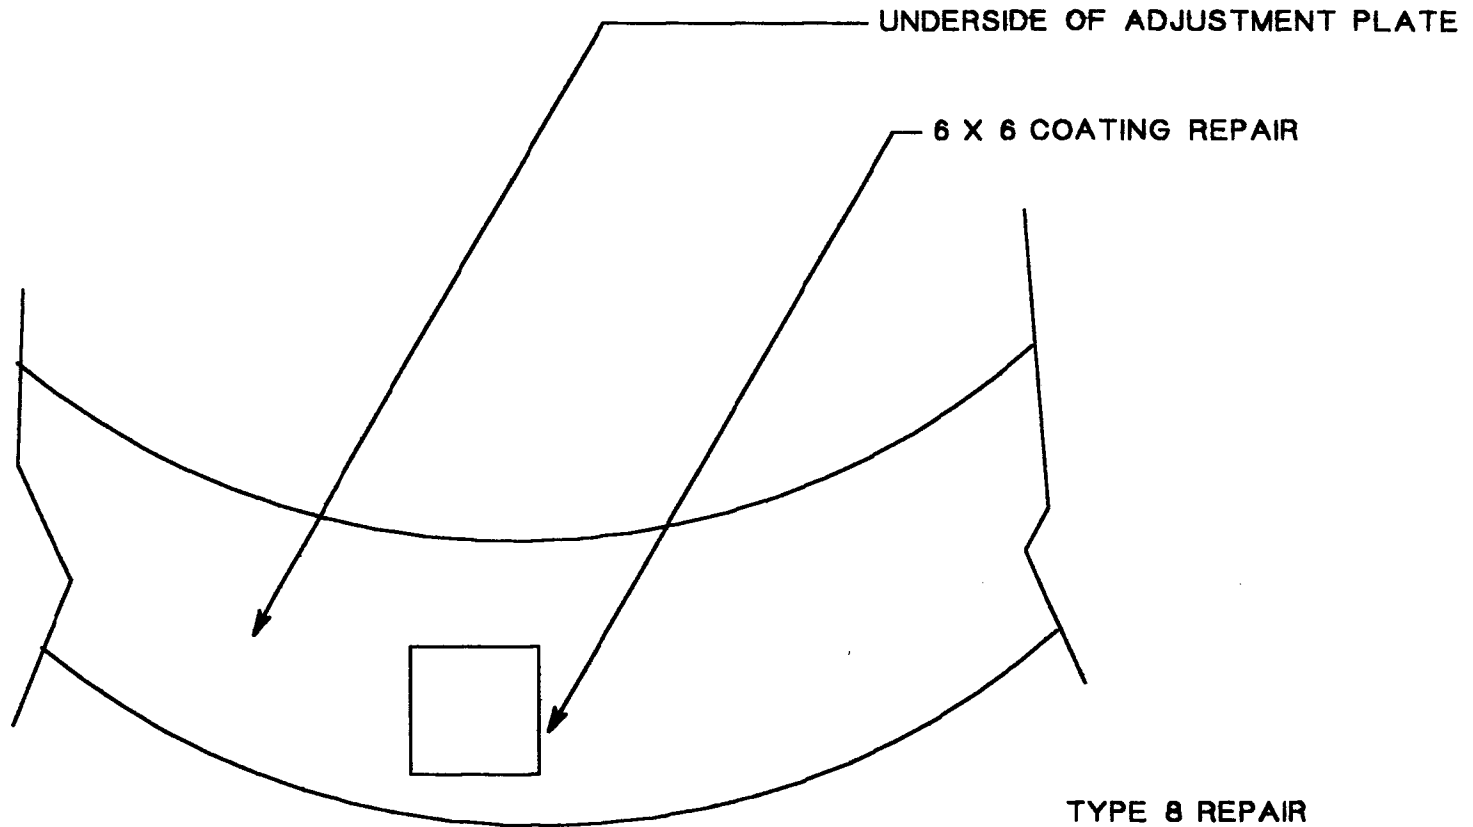
MID ATLANTIC ENVIRONMENTAL	
EMERGENCY REPAIRS FOR RED HILL TANKS	
Tank #8 AS BUILT DRAWINGS	
Repair No.: 002	File: 8R001
UPPER DOME	Quadrant: C
Course: EXTENSION	PLATE: 14
Drawn by: Tom Kitchen	Date: 5/4/98

NOTE: AREA EAS FOUND TO BE GROUND TO BARE METAL

TYPE 8 REPAIR

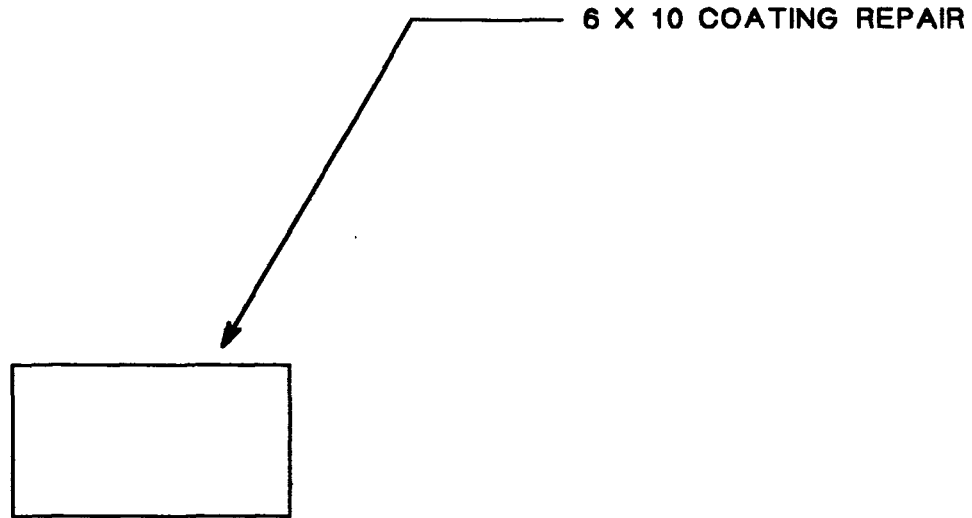
<b>MID ATLANTIC ENVIRONMENTAL</b>	
<b>EMERGENCY REPAIRS FOR RED HILL TANKS</b>	
<b>Tank #8 AS BUILT DRAWING</b>	
<b>Repair No.: 003</b>	<b>File #r003</b>
<b>CYLINDER</b>	<b>Quadrant: D</b>
<b>Course: 19</b>	<b>PLATE: 21</b>
<b>Drawn by: Tom Kitchen</b>	<b>Date: 5/4/98</b>

**TYPE 8 REPAIR**

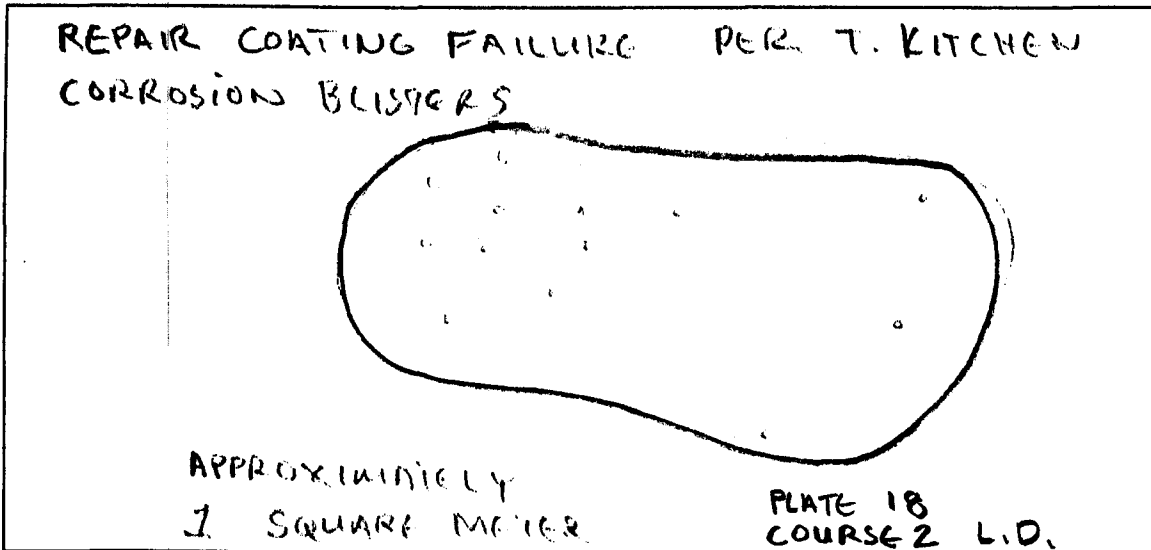
MID ATLANTIC ENVIRONMENTAL	
EMERGENCY REPAIRS FOR RED HILL TANKS	
Tank #8 AS BUILT DRAWING	
Repair No.: 004	File: 8r004
LOWER DOME	Quadrant: B
Course: 2	PLATE: 18
Drawn by: Tom Kitchen	Date: 5/4/98

DEFECT INSPECTED BY TK & JF 3/20/98

30 X 50 COATING REPAIR

TYPE 8 REPAIR

NDT Performed: Visual:  DFT:  Average DFT: 15 mil → 22 mil

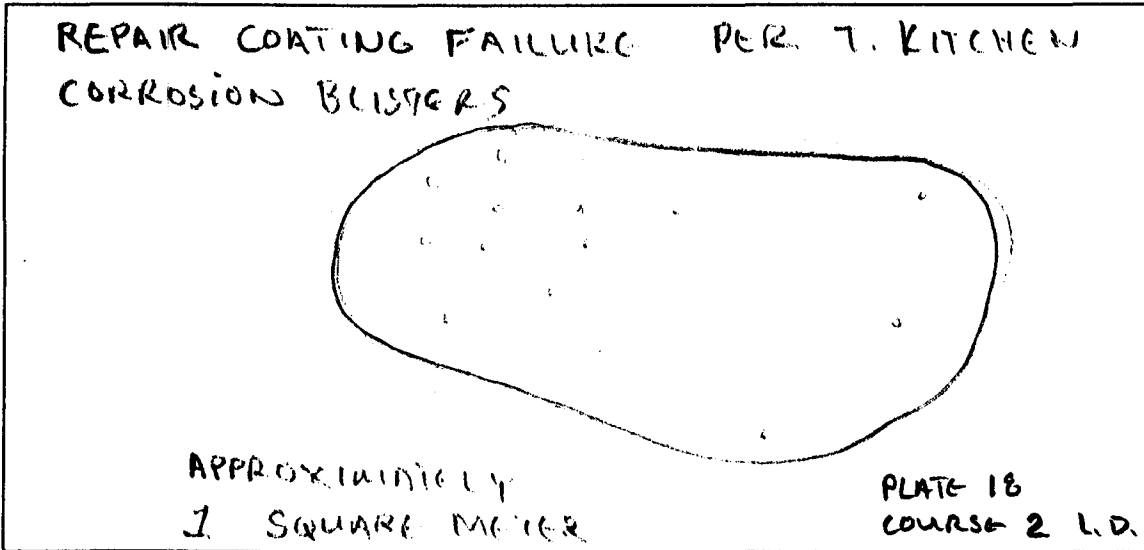
<b>MID ATLANTIC ENVIRONMENTAL</b>	
<b>EMERGENCY REPAIRS FOR RED HILL TANKS</b>	
<b>Tank #8 AS BUILT DRAWING</b>	
<b>Repair No. : 005</b>	<b>File: 8r005</b>
<b>LOWER DOME</b>	<b>Quadrant: D</b>
<b>Course: 2</b>	<b>PLATE: 18</b>
<b>Drawn by: Tom Kitchen</b>	<b>Date: 5/4/98</b>

DEFECT INSPECTED BY TK & JF 3/20/98

30 X 50 COATING REPAIR

**TYPE 8 REPAIR**

NDT Performed: Visual:  DFT:  Average DFT: 15 mil → 22 mil.

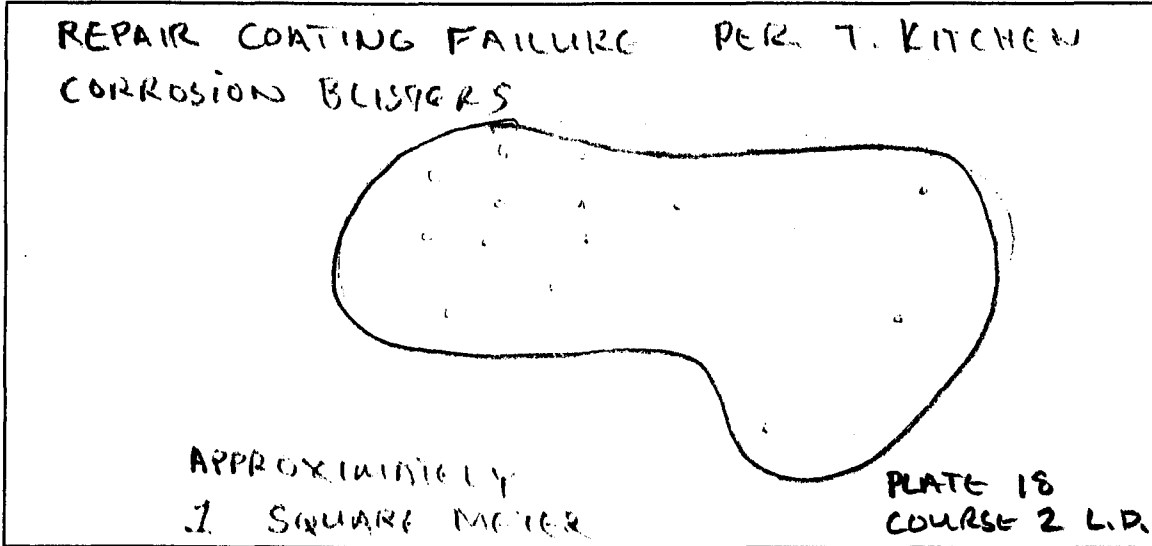
<b>MID ATLANTIC ENVIRONMENTAL</b>	
<b>EMERGENCY REPAIRS FOR RED HILL TANKS</b>	
<b>Tank #8 AS BUILT DRAWING</b>	
<b>Repair No.: 007</b>	<b>File #: 8007</b>
<b>LOWER DOME</b>	<b>Quadrant: C</b>
<b>Course: 2</b>	<b>PLATE: 14</b>
<b>Drawn by: Tom Kitchen</b>	<b>Date: 5/4/98</b>

DEFECT INSPECTED BY TK & JF 3/25/98

30 X 50 COATING REPAIR

**TYPE 8 REPAIR**

NDT Performed: Visual:  DFT:  Average DFT: 15 mil - 22 mil

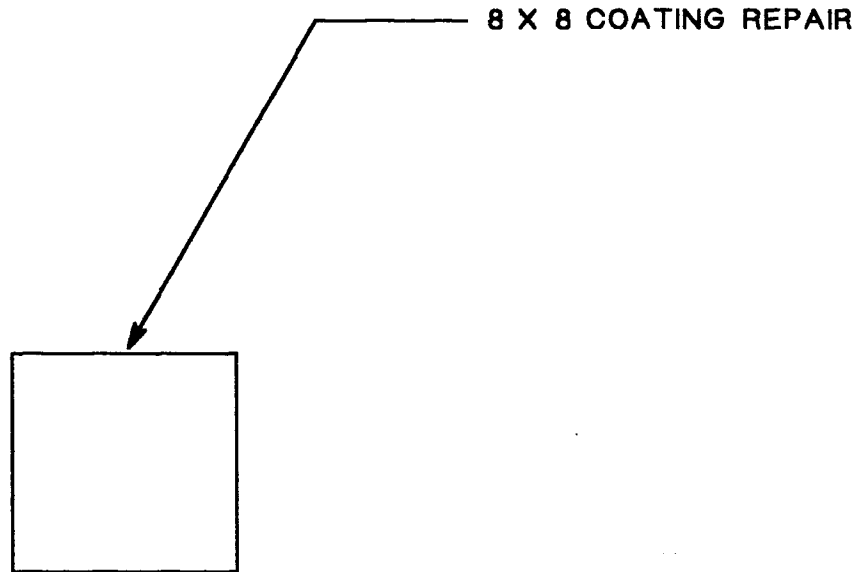
<b>MID ATLANTIC ENVIRONMENTAL</b>	
<b>EMERGENCY REPAIRS FOR RED HILL TANKS</b>	
<b>Tank #8 AS BUILT DRAWING</b>	
<b>Repair No. : 009</b>	<b>File: 8-009</b>
<b>UPPER DOME</b>	<b>Quadrant: B</b>
<b>Course: EXTENSION</b>	<b>PLATE: 11</b>
<b>Drawn by: Tom Kitchen</b>	<b>Date: 5/4/98</b>

DEFECT INSPECTED BY TK & JF 3/16/98

**TYPE 8 REPAIR**

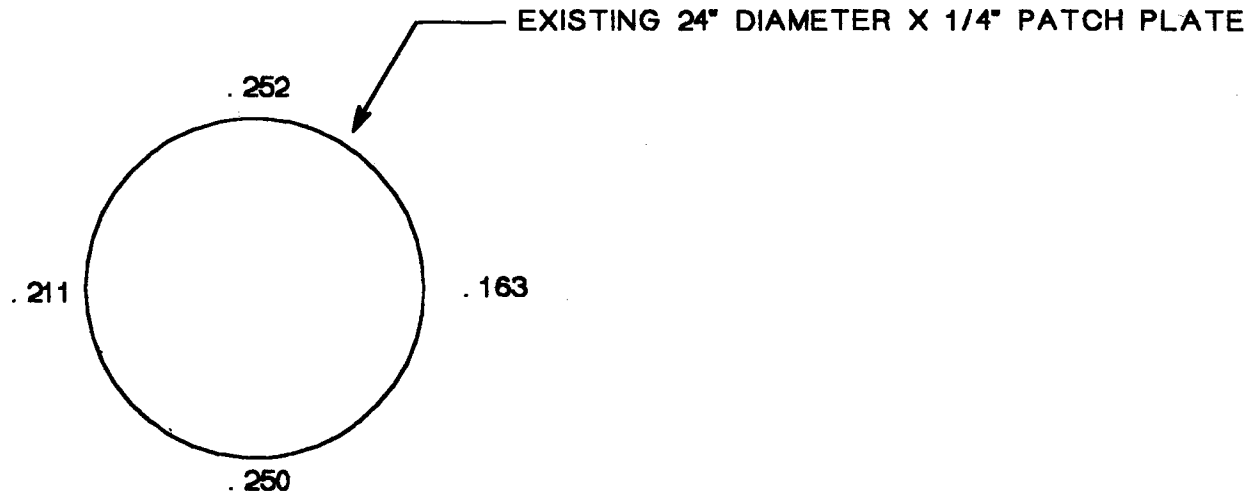
MID ATLANTIC ENVIRONMENTAL	
EMERGENCY REPAIRS FOR RED HILL TANKS	
Tank #8 AS BUILT DRAWING	
Repair No.: 010	File: 8r010
CYLINDER	Quadrant: C
Course: 11	PLATE: 14
Drawn by: Tom Kitchen	Date: 5/4/98

UT READINGS AT EDGE OF PLATE INDICATE GOOD METAL  
NO REPAIR NECESSARY

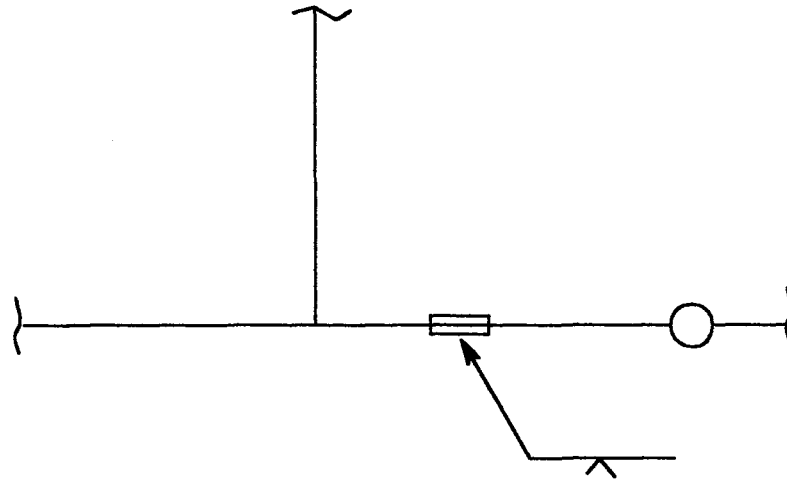
MID ATLANTIC ENVIRONMENTAL	
EMERGENCY REPAIRS FOR RED HILL TANKS	
Tank #8 RECOMMENDED REPAIR DRAWING	
Repair No.: 012	File: 8r012
CYLINDER	Quadrant: B
Course: 9	PLATE: 17
Drawn by: Tom Kitchen	Date: 5/4/98

DEFECT INSPECTED BY TK & JF 3/16/98

TYPE 9 REPAIR

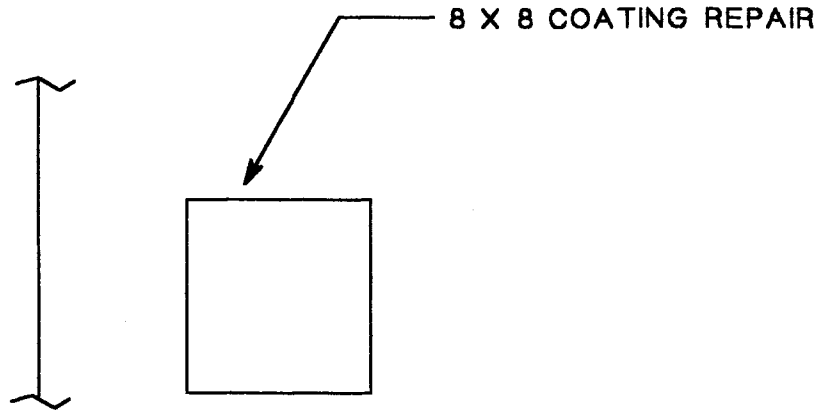
MID ATLANTIC ENVIRONMENTAL	
EMERGENCY REPAIRS FOR RED HILL TANKS	
Tank #8 RECOMMENDED REPAIR DRAWING	
Repair No.: 013	File: 8r013
LOWER DOME	Quadrant: B
Course: 3	PLATE: 11
Drawn by: Tom Kitchen	Date: 5/4/98

DEFECT INSPECTED BY TK & JF 3/16/98

TYPE 9 REPAIR
