LTR	DESCRIPTION	BY	DATE
REVISIONS			
MID ATLANTIC ENVIRONMENTAL EMERGENCY REPAIRS FOR RED HILL TANKS			
Tank #10			
Repair No.:	340	File:	10r340
Lower dome		Quadrant:	A
Course:	1	Plate:	3
Drawn by:	Tom Kitchen	Date:	5/13/98

Dames & Moore
Emergency Repairs For Red Hill Tanks at the Fleet Industrial & Supply Center
Contract No. N62742-96-C-1356

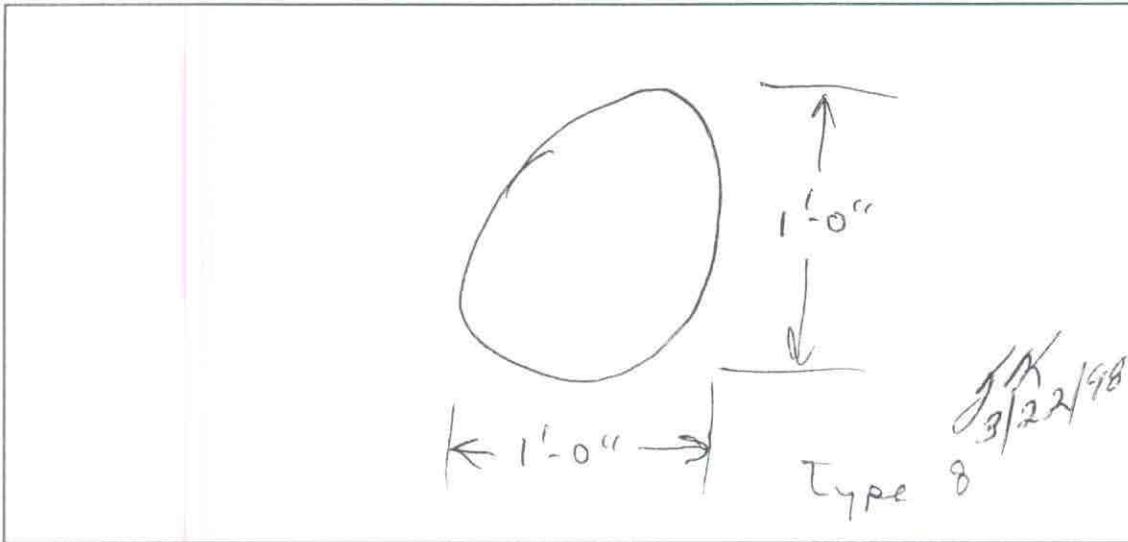
Tank No.: 10 Repair No.: 340 Type: 8 Location: A

12 X 12 COATING REPAIR

TYPE 8 REPAIR

Coating Type: Epoxy

NDT Performed: Visual: DFT: Average DFT: 8 mils - 15 mils

Repair Acceptable: John Zschell Date Accepted: 3-13-98

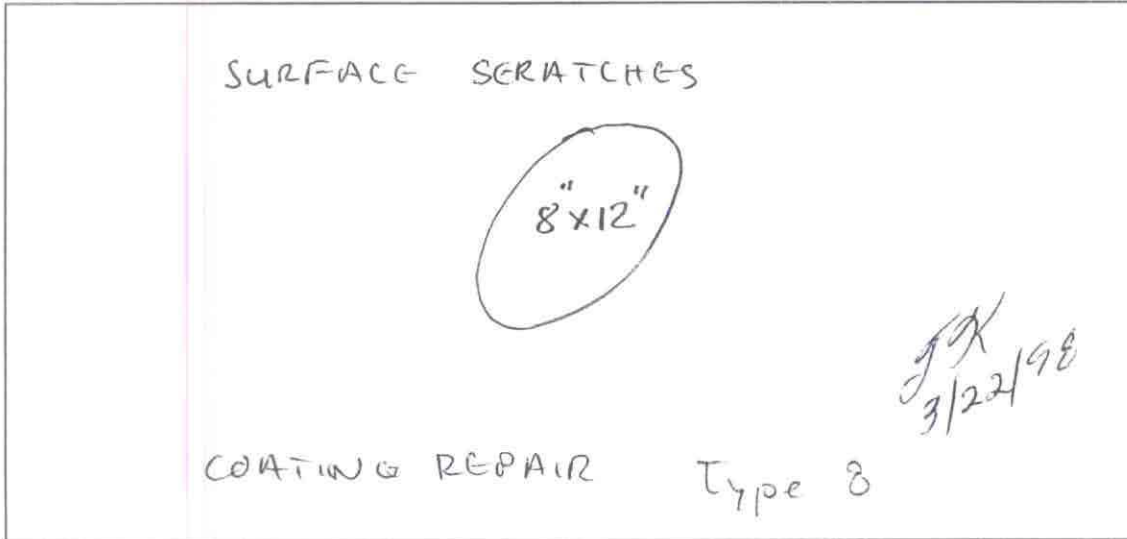
Tank No.: 10 Repair No.: 410 Type: 2 Location: A

8 X 12 COATING REPAIR

NDT Performed: Visual: DFT: Average DFT: 13mils - 20mils

Repair Acceptable: John Zschell Date Accepted: 3-15-98

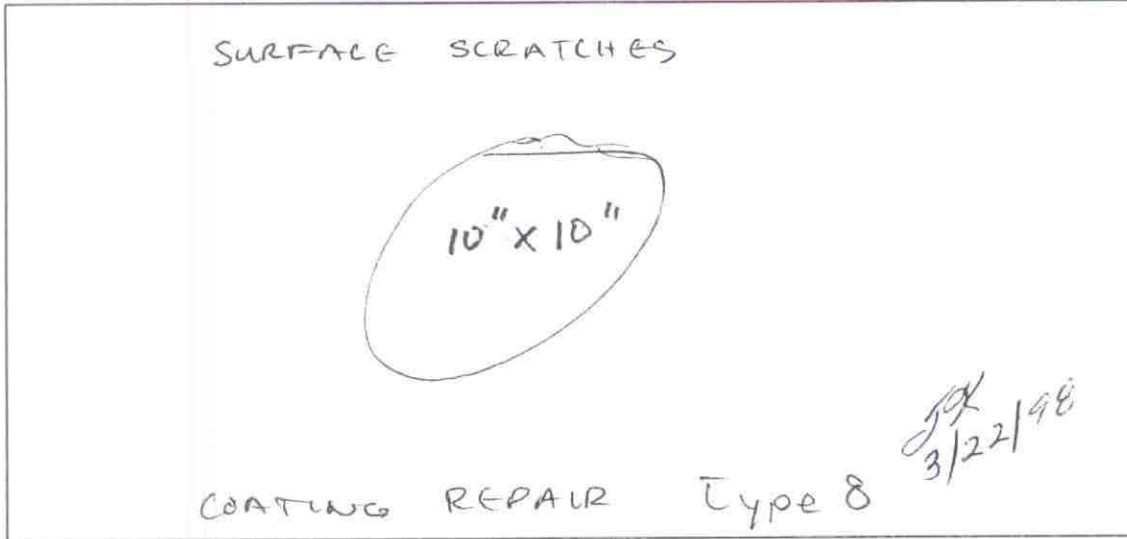
Tank No.: 10 Repair No.: 400 Type: 2 Location: A

10 X 10 COATING REPAIR

NDT Performed: Visual: DFT: Average DFT: 13 mils - 20 mils

Repair Acceptable: John Walsh Date Accepted: 3-13-98

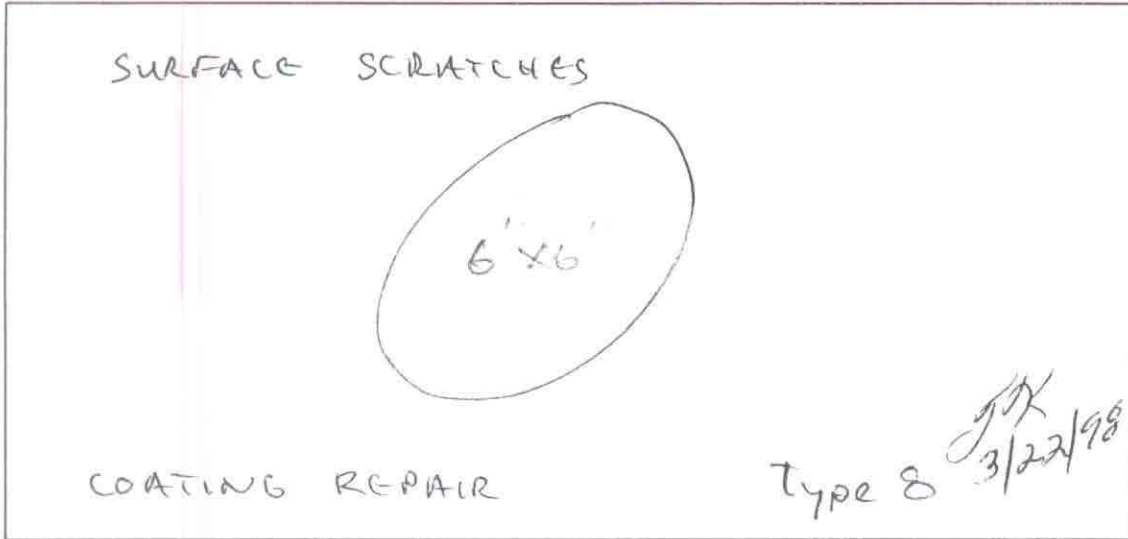
Tank No.: 10 Repair No.: 620 Type: 8 Location: C

6 X 6 COATING REPAIR

NDT Performed: Visual: DFT: Average DFT: 13mils - 20mils

Repair Acceptable: John Zschell Date Accepted: 3-13-98

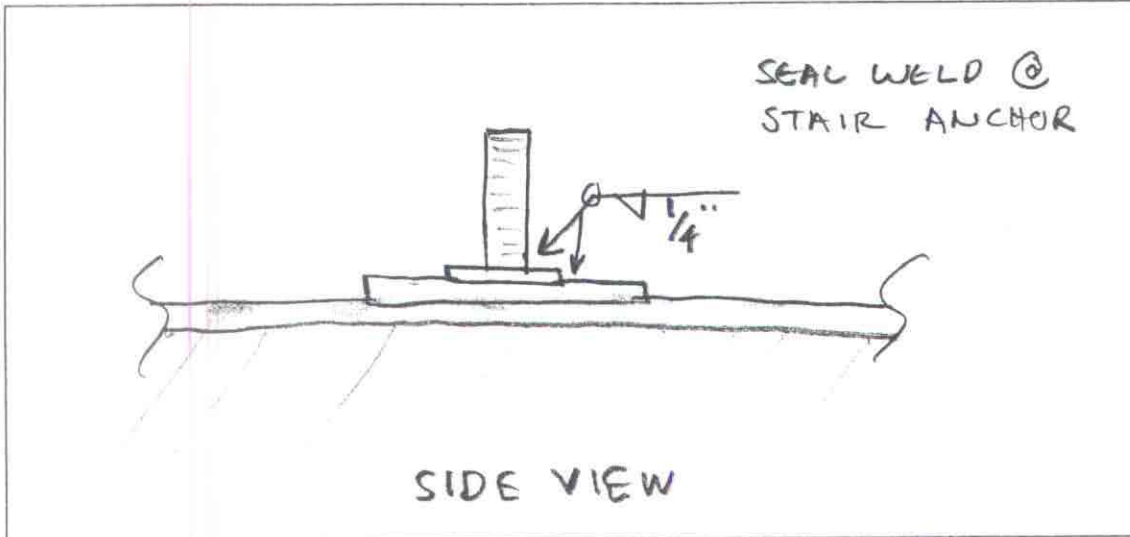
Tank No.: 10 Repair No.: 621 Type: _____ Location: Tank Bottom
@ PL 17/18

TYPE 10 REPAIR

Weld Repair

NDT Performed: Visual Vacuum Box Dye Penetrant _____

Repair Acceptable: John Zickell Date Accepted: 6-10-98
