Audit Report

Department of the Navy Red Hill and Upper Tank Farm Fuel Storage Facilities

N2010-0049
16 August 2010

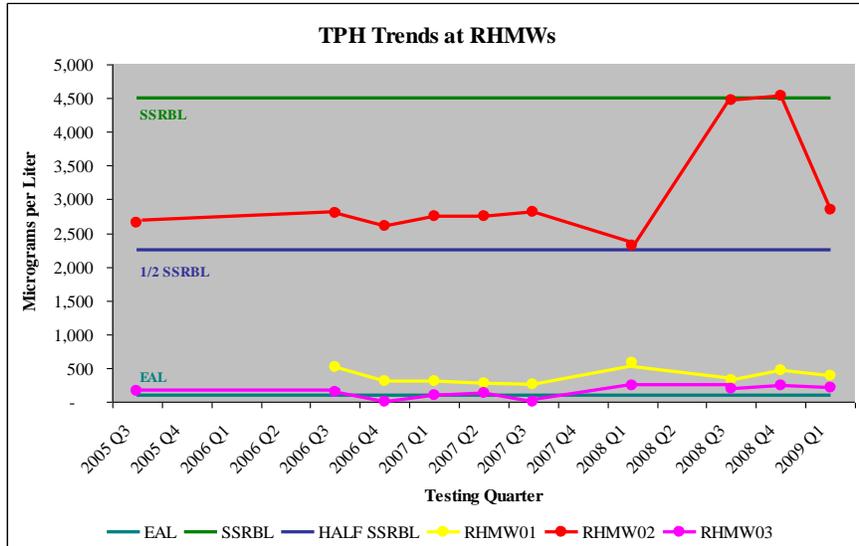
The Navy’s quarterly testing results show that RHMW02, situated in the middle of the RH facility, has consistently exhibited the highest levels of contamination, especially that of TPH. Since studies indicate that TPH is one of the risk drivers for migration of dissolved petroleum, the Navy developed an

additional action level, the SSRBL, which represents the contaminant concentration level at the RHMWs that could potentially impact the Navy Well. As shown in the Figure 1, until 1st quarter 2008, TPH concentration levels at RHMW02 remained relatively stable and below the SSRBL; however, a 97-percent increase in this contaminant occurred between the 1st and 3rd quarters of 2008, causing the level to approach, but not exceed, the SSRBL.

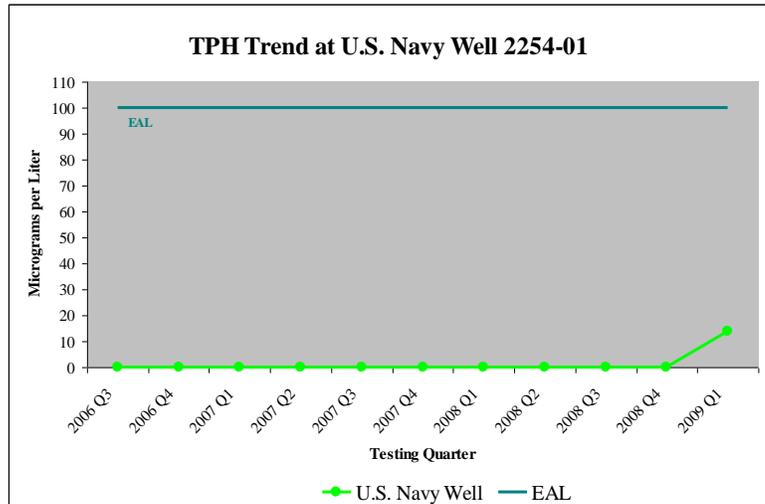
In the 1st quarter of 2009, TPH contaminants were also detected at the Navy Well. Although the concentration that was detected was below the EAL,¹¹ this sampling event was the first time that TPH had been detected since the Navy began testing for the contaminant in 2006. As mentioned above, the recent detection of contaminants at the Navy Well may indicate migration

of fuel released from RH. The detection of contaminants at the Navy Well pumping station poses an immediate risk to the potable water sources in the RH area. If the Navy Well becomes contaminated beyond acceptable levels, the Navy and the island of Oahu could potentially lose an important source of drinking water. If this occurs, the Pearl Harbor Water System would be reduced by approximately 24 percent. Further, the Navy would be responsible for providing an alternate water source at the Navy Well as indicated in the GPP.

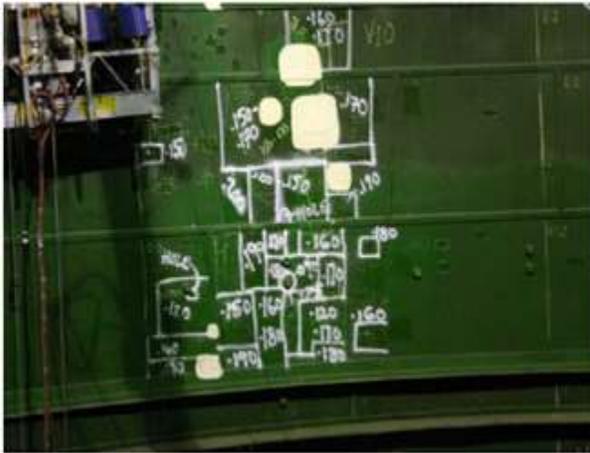
Figure 3: Tank 16 Exterior Corrosion Area

In addition to the defects noted on the interior of the five tanks, the modified-API 653 inspections identified 206 areas of exterior corrosion which had diminished the thickness of the tanks' liners. The corroded areas were caused by groundwater coming in contact with the tanks; however, given that previous inspection methodologies and testing equipment were not sufficient to detect these exterior defects, the corrosion was not previously identified. A NFESC corrosion engineer explained that this corrosion cannot be prevented at RH due to the construction of the tanks. However, inspection reports and subject matter experts indicate that the impact of this corrosion can be mitigated by

Figure 3: The inspection of Tank 16 revealed a cluster of exterior corrosion (23 flaws) and two through-holes within the cluster.

applying patch plates to the interior or by removing the corroded plates (see Figures 3 and 4). Until the current inspection cycle is completed, any previously undetected areas of exterior corrosion may continue to worsen, may cause the remaining tanks to be susceptible to through-holes, and could potentially result in future fuel releases.

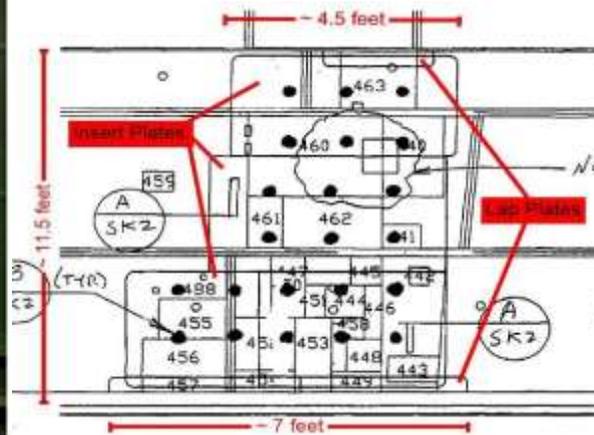
Figure 4: Tank 16 Repair Schematic

Figure 4: Repair schematic displays numbered flaws in figure 3, which required replacing the corroded original plates with four insert plates and three lap plates covering an area approximately 11.5 feet high and between 4.5 to almost 7 feet wide. Anchoring rods (represented by the black dots) are used to connect the plates to the concrete. Note: All insert and lap plates are not depicted in the schematic.
