## IN THE UNITED STATES DISTRICT COURT DISTRICT OF HAWAI'I

# **COMPLAINT**

This case involves tortious conduct by the United States of America, and more specifically, the United States Department of the Navy ("Navy"), in causing and/or allowing contaminant releases to enter O'ahu's EPA-designated sole source aquifer, impacting the water resources upon which the BWS relies and the BWS water distribution system. The Navy has caused, allowed, and/or failed to contain releases into the environment of substantial but indeterminate quantities of jet propellant fuel, per- and polyfluoroalkyl substances ("PFAS"), and other contaminants (collectively, "Contaminants" or "Released Contaminants") that have entered the sole source aquifer ("Contaminant Releases") from which the BWS withdraws potable groundwater for public use and consumption. This complaint seeks to hold the United States and the Navy accountable for its Contaminant Releases of any nature that have impacted and/or threatened the BWS's water supply and caused the BWS both to shut down its impacted infrastructure and to incur fees, costs, and expenses to respond to the Navy's Contaminant Releases, both actual and threatened.

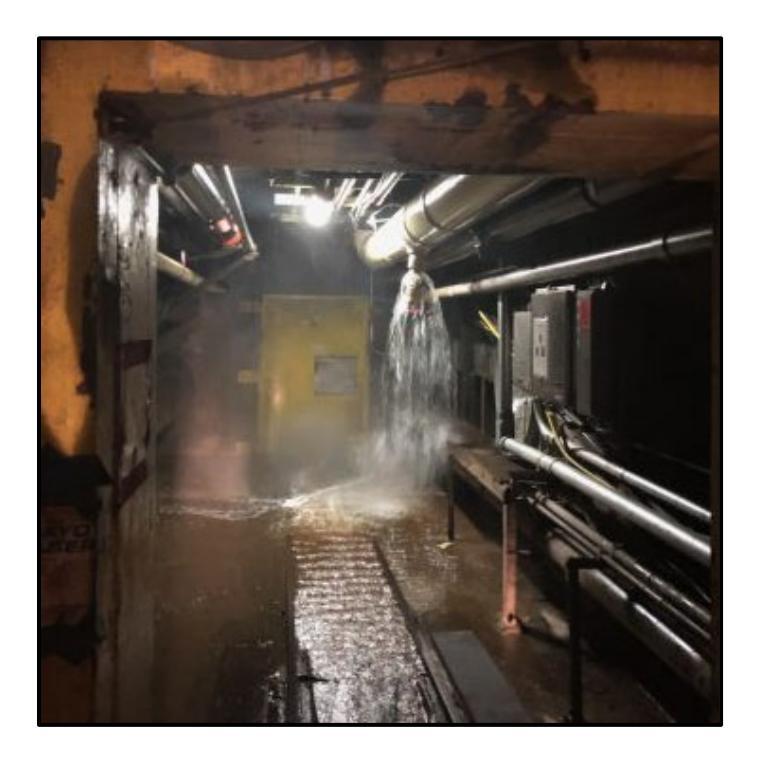
130. On November 20, 2021, another Contaminant Release occurred from the Red Hill Facility ("**November 2021 Release Incident**"). A Red Hill Facility employee operating a 3.5-ton train cart negligently struck the valve of a fire suppression PVC discharge pipe, cracking the valve and spilling approximately 19,000 gallons of JP-5 fuel trapped in the discharge pipe since the May 2021 Release Incident. The released jet fuel traveled along a concrete floor tunnel and collected in a groundwater sump and a sanitary sewer tank. A photo of the release is below.

(Photo located at: <u>https://www.civilbeat.org/2022/07/watch-fuel-spewed-full-blast-into-red-hill-tunnel-in-november/</u>; taken by "rover who hit the Red Hill pipeline valve with a cart"; see video of release at: <u>https://youtu.be/GEGohRlLrSA</u>).

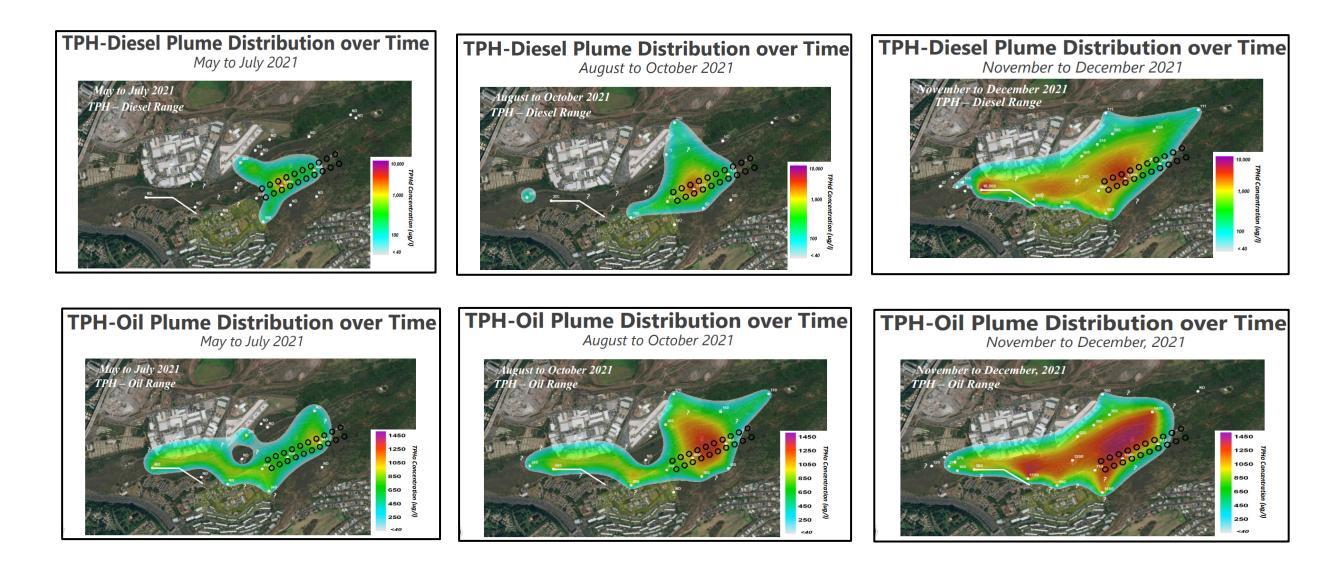
160. In 2022, the DOH captured in plume maps the significant, widespread contamination caused by the November 2021 Release Incident. As seen below, extensive plumes of TPH-contaminated groundwater spread outward from the Red Hill Facility from May to December 2021 (red color indicating higher concentrations of TPH detected).

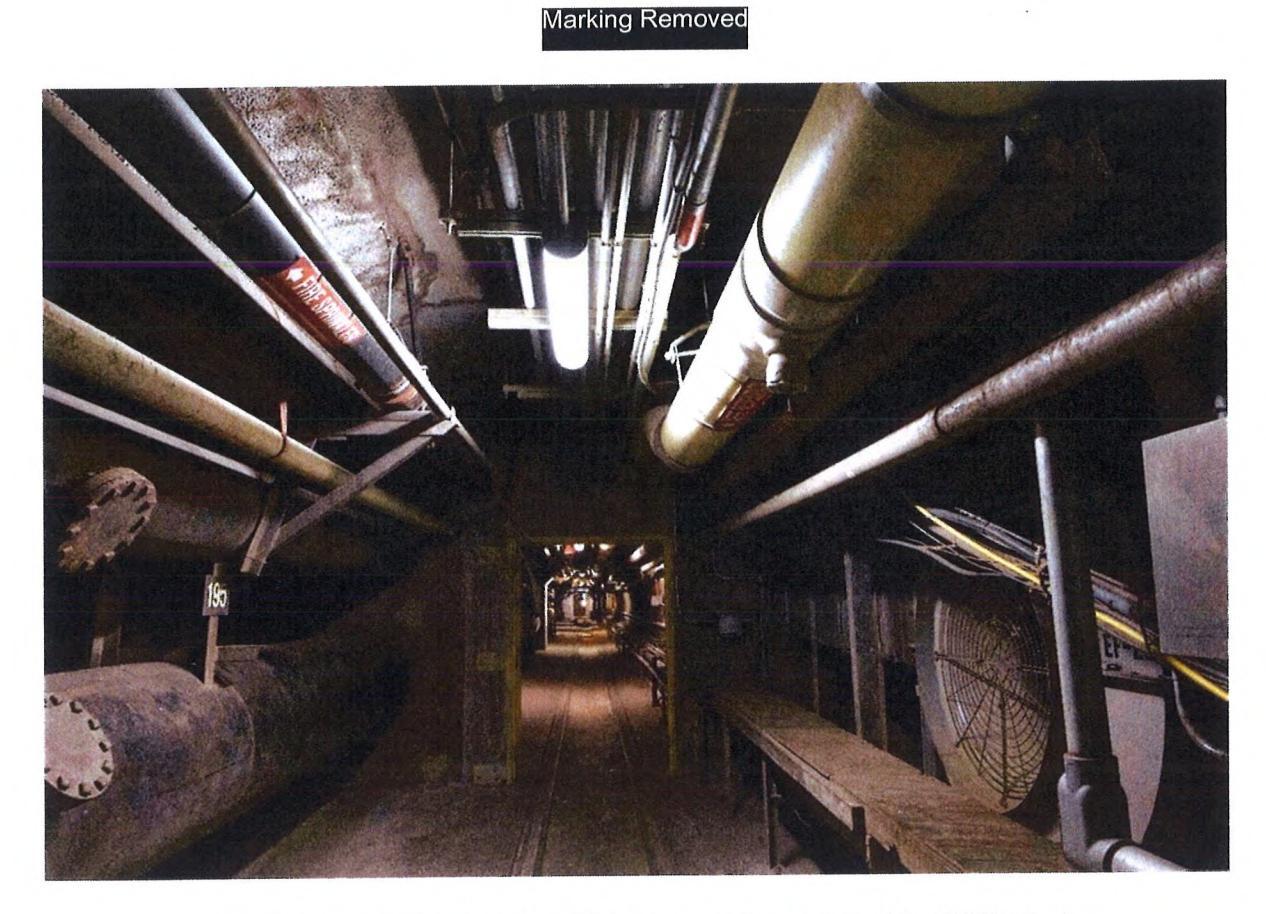
Lower Access Tunnel with AFFF retention line in top right (PVC pipe)

5. The entrance to the pump station is located **(b)(3)(A)** and 380 feet from the site of the ruptured Aqueous Film Forming Foam (AFFF) retention line low point drain inside the Red Hill lower access tunnel. The top of the well shaft is approximately (b)(3)(A) from the entrance of the pump station. [Encls (7), (9)]

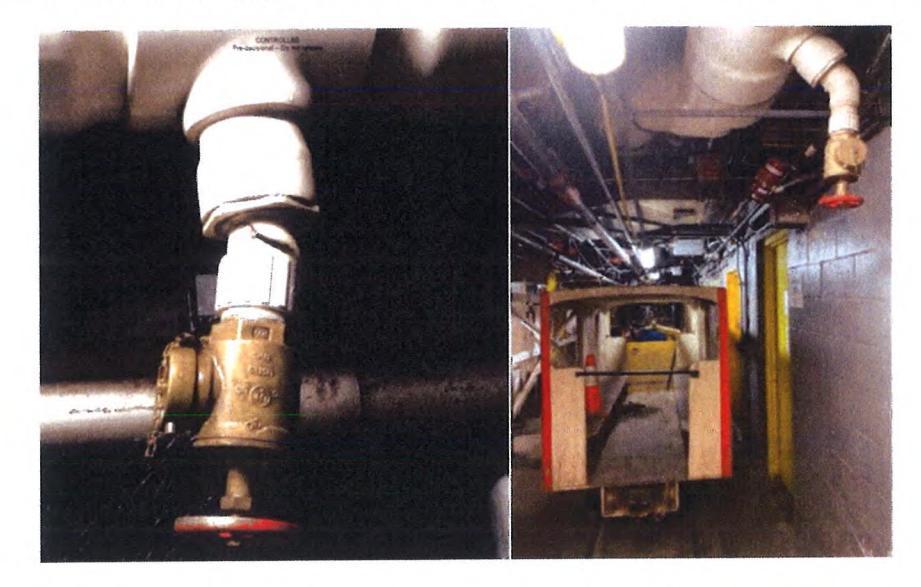
As established in the Cavanaugh Report and updated herein, the AFFF fire suppression system retention line held up to 19,377 gallons of JP-5 fuel from the time of the May spill until the November spill, when a watch stander inadvertently struck a low point drain with the passenger cart of a train, cracking the pipe and spilling the fuel. The below findings of fact focus on the design, installation, induction, and maintenance associated with the AFFF retention line, sump pumps, tank and associated equipment (collectively referred to here as the AFFF waste system).

Cracked Low Point Drain

Train Passenger Cart

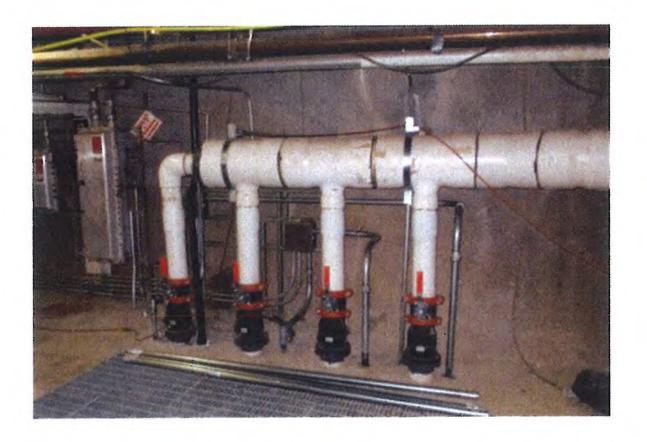
383. On 13 Mar 17, the construction contractor formally notified NAVFAC PAC, in writing, that they constructed the entire AFFF retention line with PVC vice Steel pipe. [Encl (353)]

Original AFFF Retention Line Piping in Immediate Area of an AFFF Sump

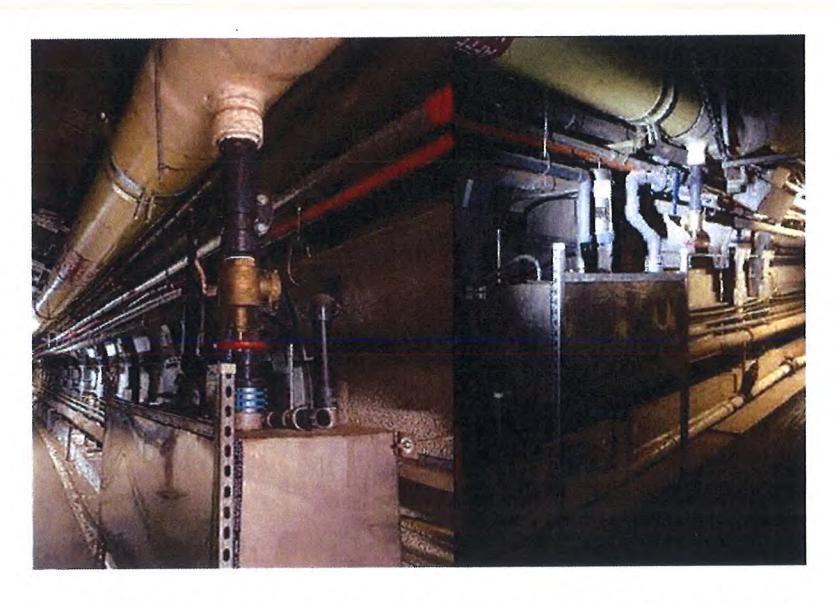
384. On 13 Apr 17, the contractor proposed a revised AFFF retention line low area drain plan which is a self-contained unit with new tank and sump pump to move AFFF retention line

drainage out to a new manual hose connection at the Adit 3 entrance via new 3" PVC piping. This system does not utilize the groundwater sump system. This is the installed configuration today and is in close proximity to the Adit 3 groundwater sump, but does not connect with that sump. This system was not used to drain the AFFF retention line following the November spill. [Encl (354)]

Final Installed Low Point Drain System with PVC Retention Line

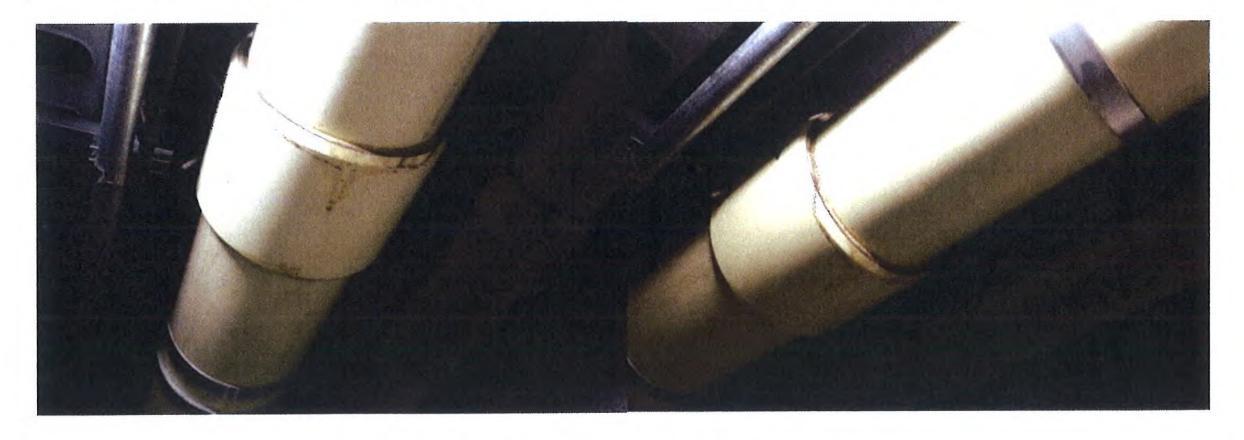
414. On 17 Mar 22, during a walkthrough of Red Hill, the supplement investigation team noted visual evidence of a foreign substance on the outside of the PVC AFFF retention line piping joints that appears to have seeped out.

Installed PVC AFFF Retention Line with Joint Seepage
