**Archaeological Inventory Survey In
Support of the Honolulu Board of
Water Supply's Energy Efficiency
Program, Honolulu (Waikiki)
Ahupua'a, Honolulu (Kona)
District, Island of O'ahu, Hawai'i**

TMKs: (1) 2-1-036: 004 and 005

PRELIMINARY DRAFT REPORT
Archaeological Inventory Survey in Support of the Honolulu Board of Water Supply's Energy
Efficiency Program on Beretania Street,
Honolulu (Waikīkī) Ahupua'a, Honolulu (Kona) District,
Island of O'ahu, State of Hawai'i
TMK (1) 2-1-036:004 and 005.

MANAGEMENT SUMMARY

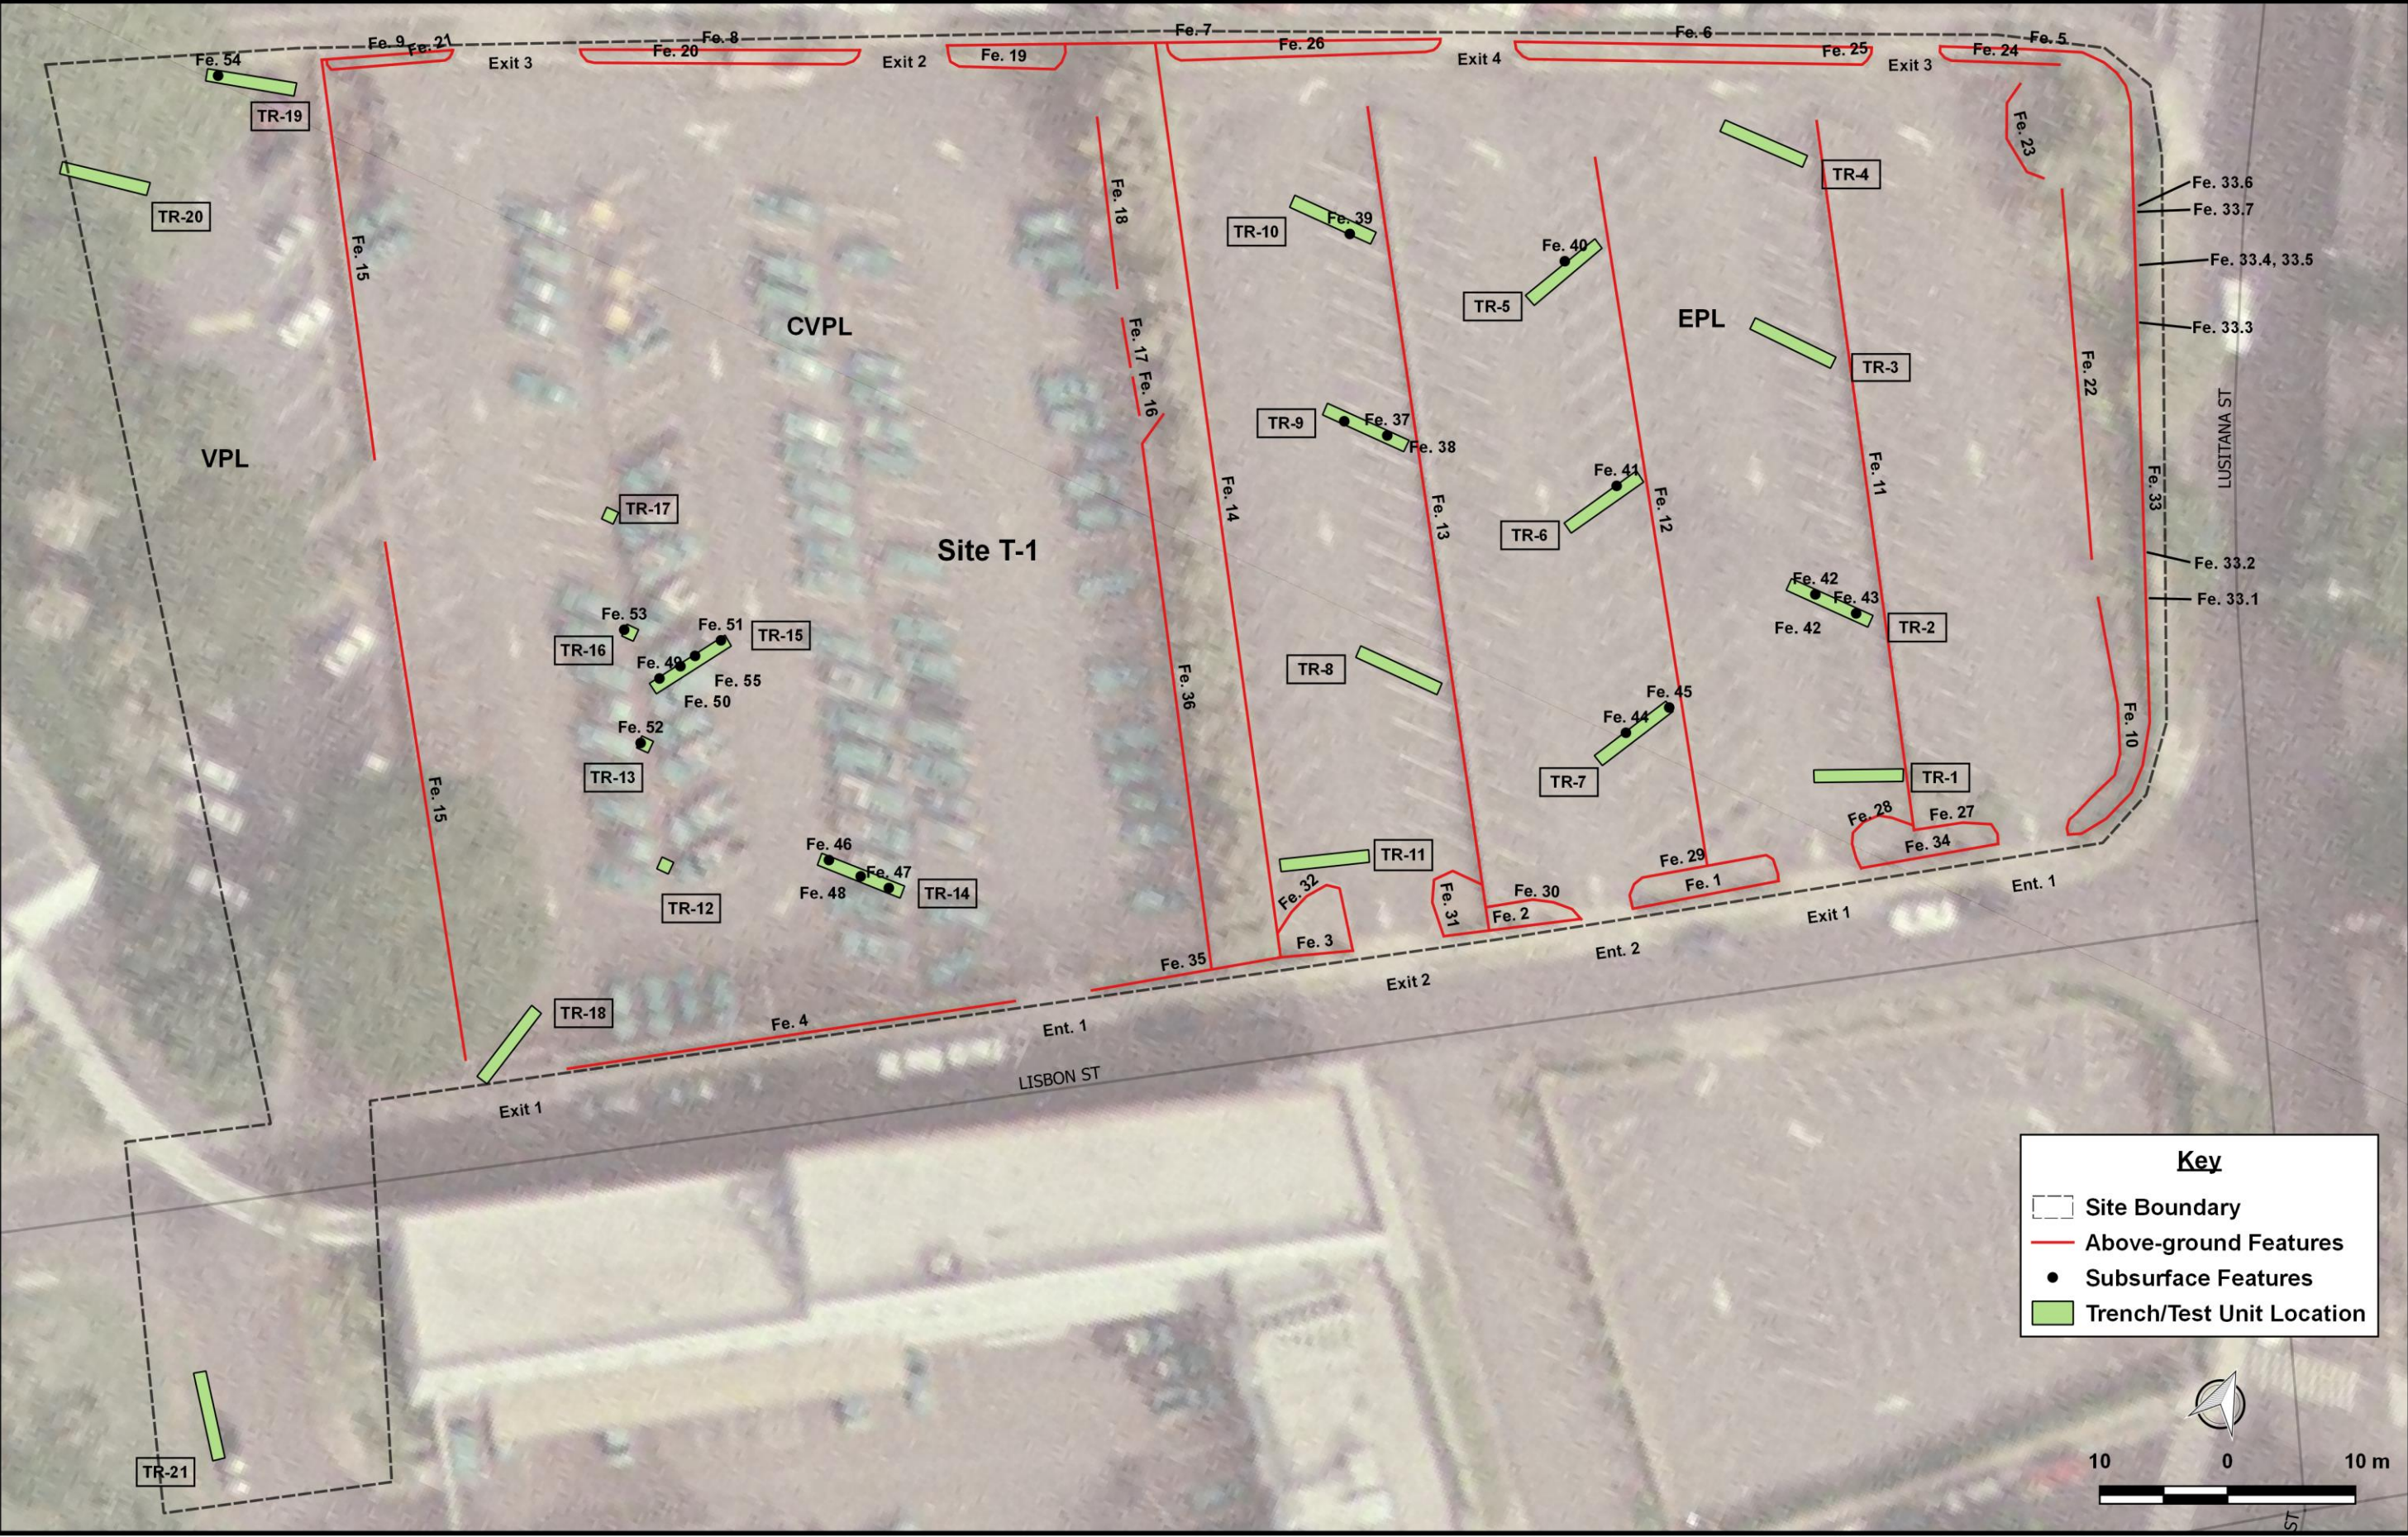
Figure 14. Map Showing Boundaries of Site T-1, Locations of Excavation Trenches, and Locations of Features 1 through 63.

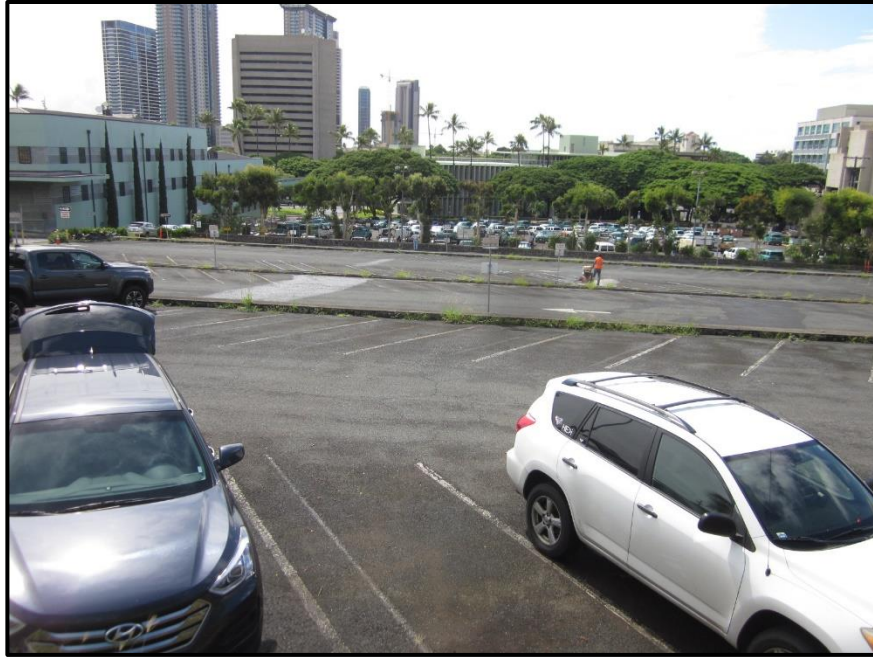
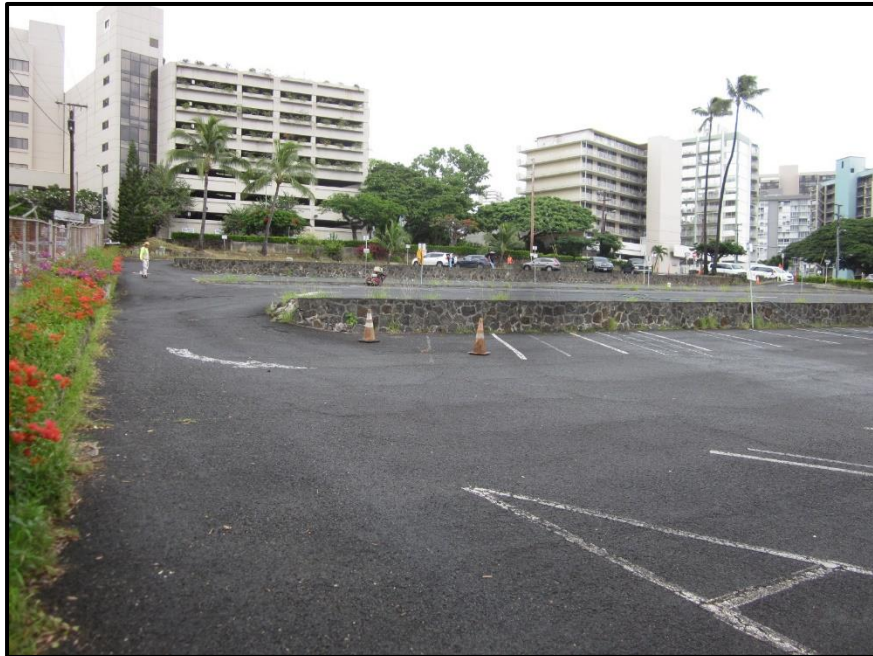
Figure 15. Overview Photographs of the Employee Parking Lot (EPL). Top: View to West with the Company Vehicle Parking Lot (CVPL) in the Background. Bottom: View to North.

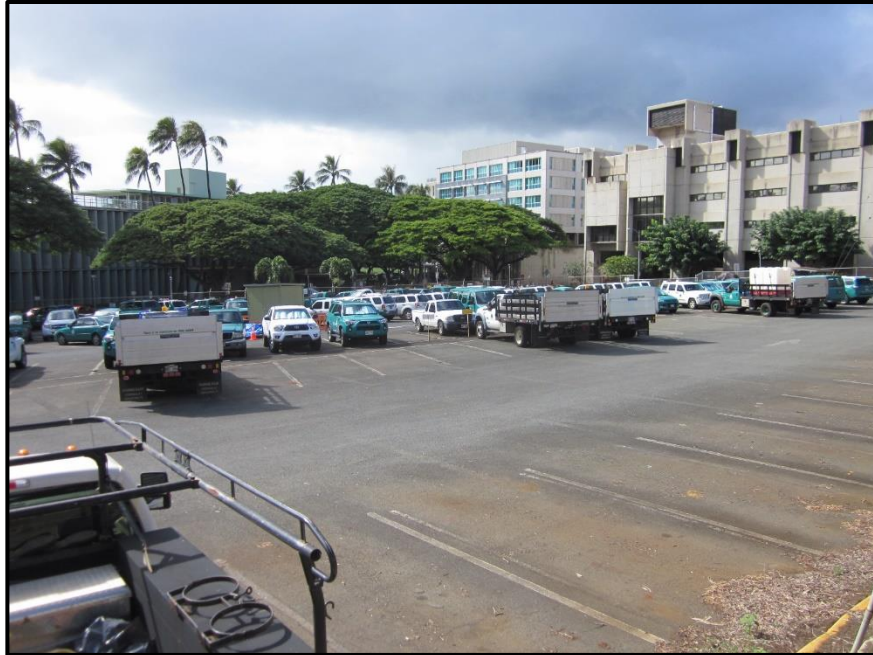
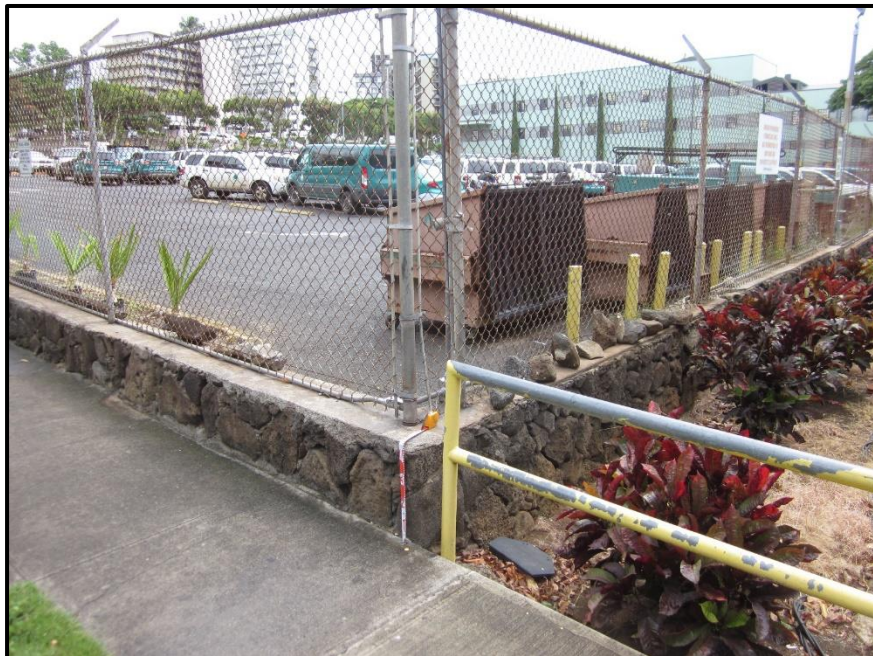
Figure 16. Overview Photographs of the Company Vehicle Parking Lot (CVPL). Top: View to West. Bottom: View to Northeast.

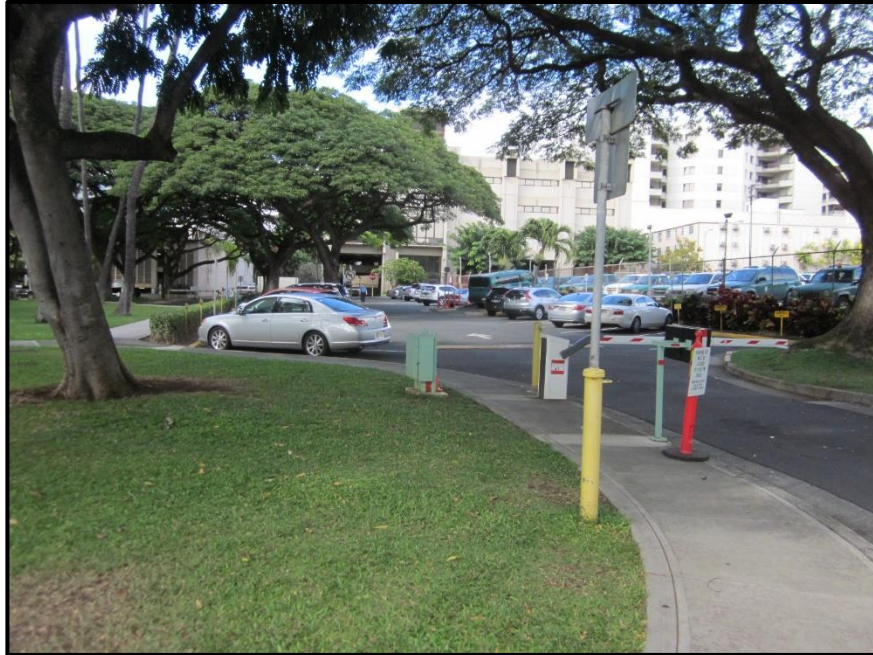
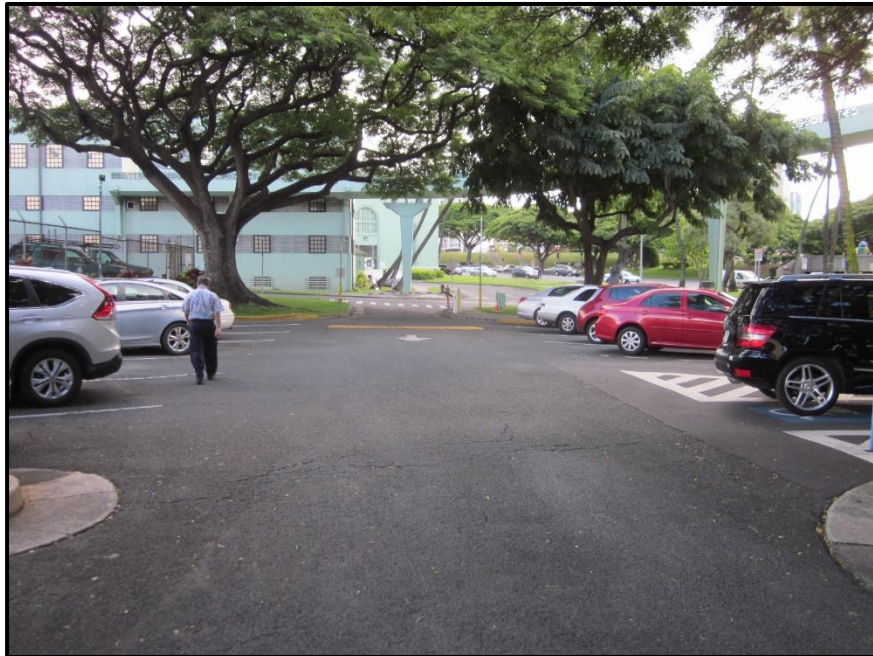
**Figure 17. Overview Photographs of Visitor's Parking Lot.
Top: View to Northwest. Bottom: View to Southeast.**

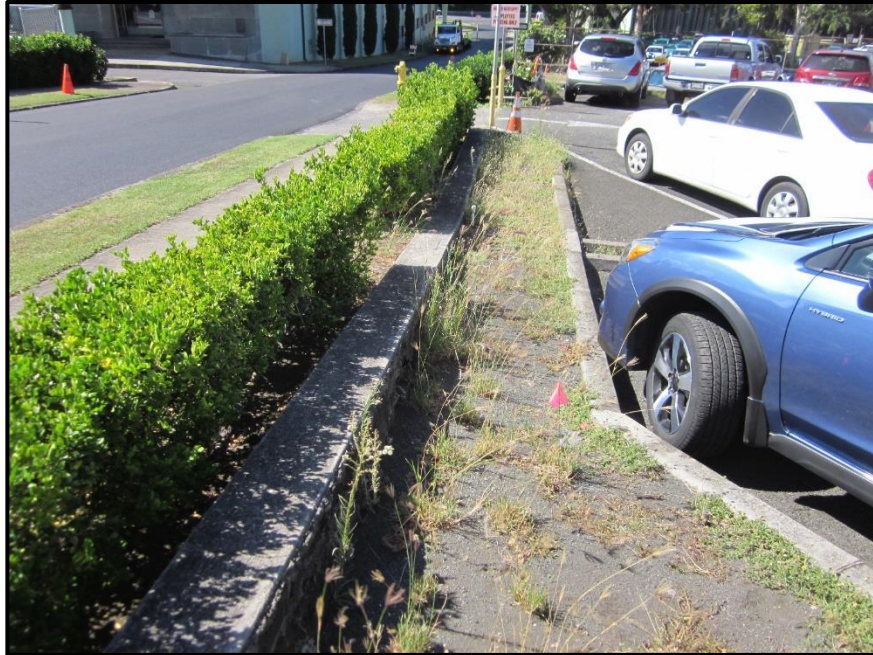
Figure 18 presents photographs of portions of the Feature 1 and Feature 3 walls showing the interior/exterior height differences. Portions of the Feature 3 wall appear to consist of only foundation rocks with the concrete cap situated almost flush to the ground surface (see Figure 18).

Figure 18. Photographs of Site T-1, Feature 1 and 3 Retaining Walls in EPL. Top: View to South with Feature 29 to West. Bottom: Portion of Feature 3 Showing Concrete Cap Nearly Flush to Ground.

Features 1-9 are multiple-stacked with one to five courses of small, angular basalt boulders and large cobbles (lower portions of Feature 2 and 3 walls have only one to two courses of rock). Mortar is used in the interior portions of wall construction, and is often not visible in the wall faces. Where it is visible, the mortar is inset (crude tuckpointing) from the wall faces. The upper horizontal surfaces of Features 1 through 9 are capped with flat, smooth concrete. Figure 19 presents photographs of Feature 4 (southern boundary) and Feature 5 (northeast corner). Little to no mortar is visible on the faces of these two walls.

Generally, a higher percentage of dense, gray to dark gray basalt boulders and cobbles were used in the construction of the Feature 1-9 walls than were used in the construction of older residential boundary walls of this site, which are composed of predominantly reddish-brown vesicular basalt (see Figures 18 and 19). Chain-link fences have been erected on the tops of Features 4, 5, 6, 7, 8, 9, and 15 (see Figures 18 and 19). Figure 20 presents photographs of Features 6, 7, and 8 along Lauhala St. showing automobile exit gates, primarily dark gray basalt rocks in the walls, concrete caps, and chain-link fences (on top of walls) with posts penetrating the concrete caps.

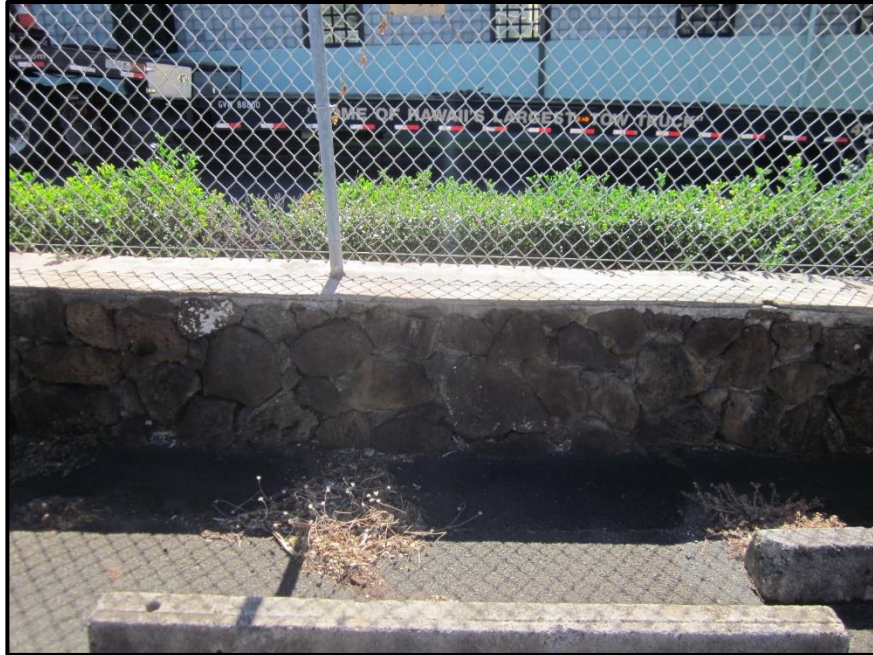
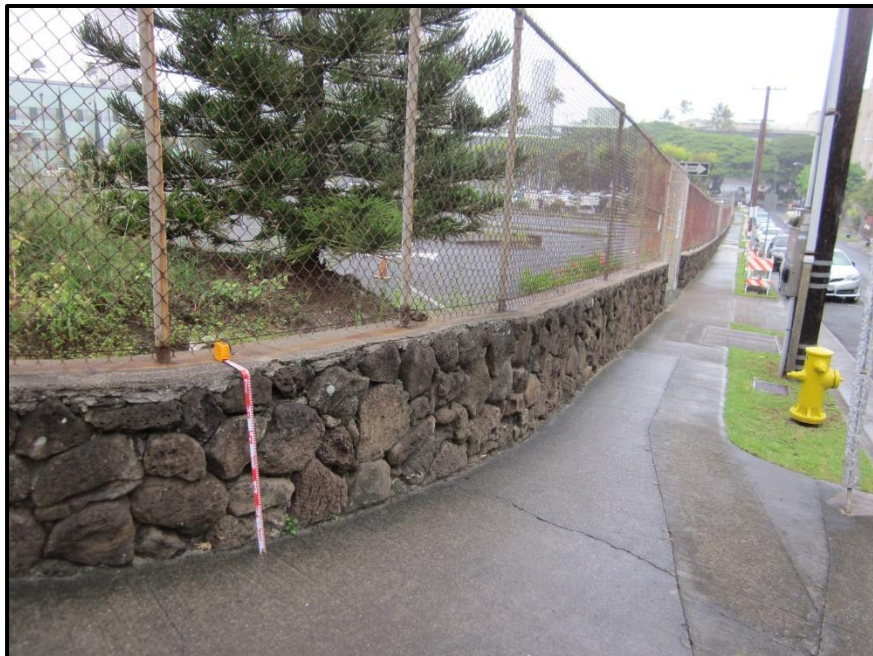
Figure 19. Photographs of Site T-1, Feature 4 and 5, Retaining Walls. Top: Feature 4 in CVPL; View to South. Bottom: Feature 5 (foreground) and Feature 6 (background); View to West.

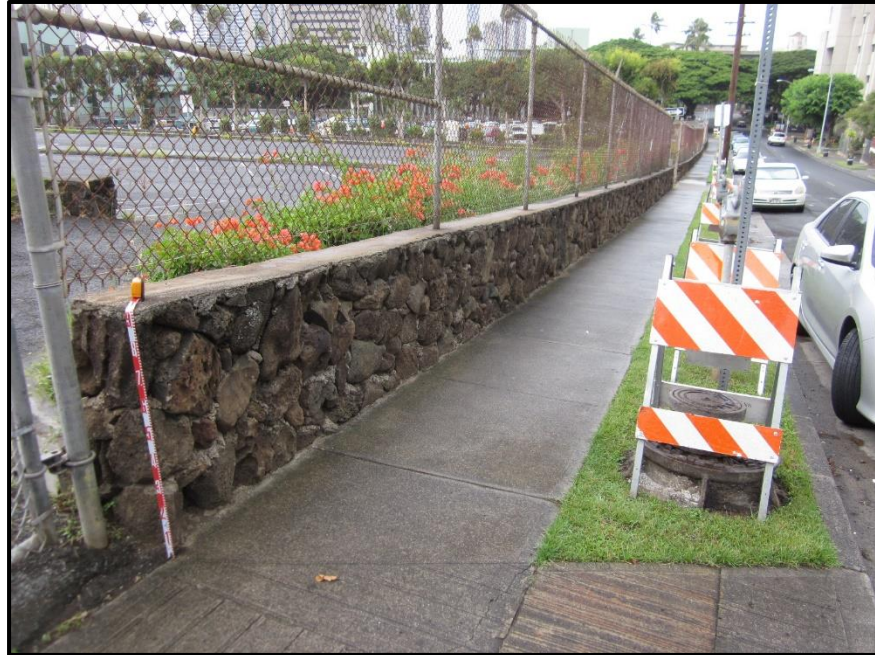
Figure 20. Photographs of Site T-1, Features 6, 7, and 8, Retaining Walls. Top: Features 6 (foreground) and 7 (background); View to South. Bottom: Feature 8 on North Side of CVPL; View to Southwest.

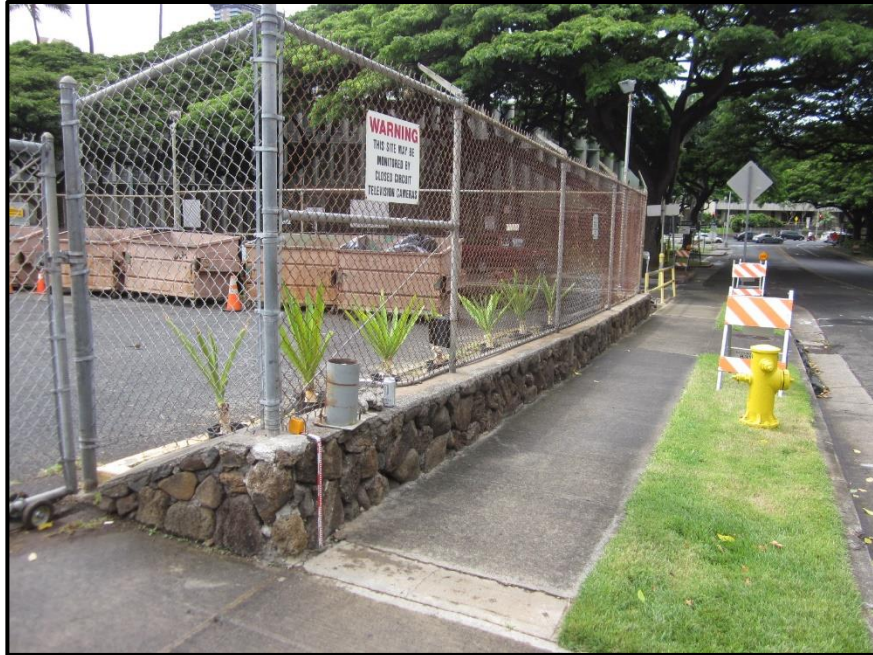
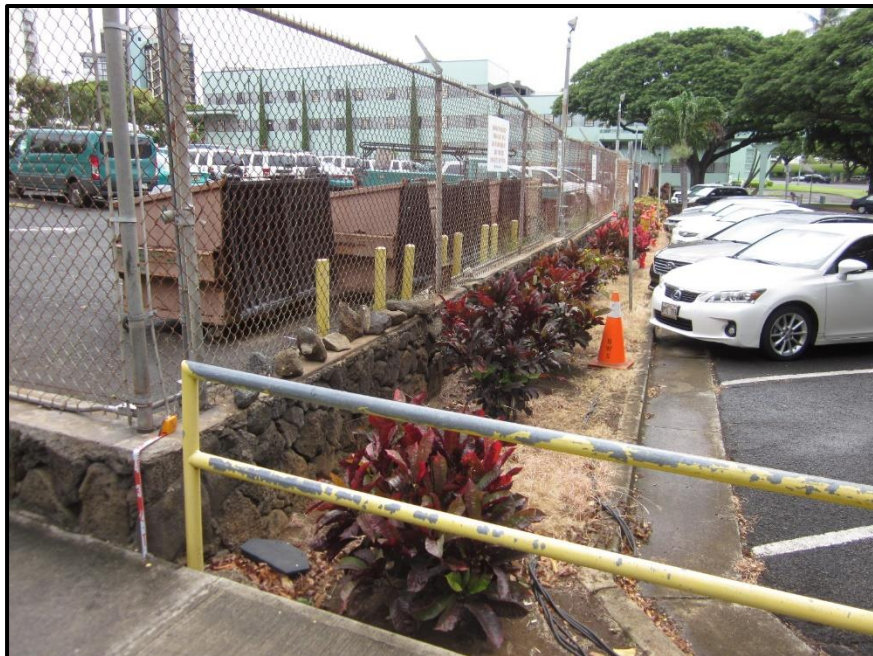
The Feature 9 retaining wall extends along the northern boundary of the CVPL and ends in the northwest corner of the CVPL. Here Feature 9 connects to the Feature 14 retaining wall at the west end of the CVPL. Figure 21 presents photographs of the Feature 9 retaining wall, as well as the north end of the retaining wall of Feature 15 parking lot terrace.

Figure 21. Photographs of Site T-1, Features 9 and 15, Retaining Walls. Top: Feature 9, View to South. Bottom: West End of Feature 9 (left) and South End of Feature 15; View to South.

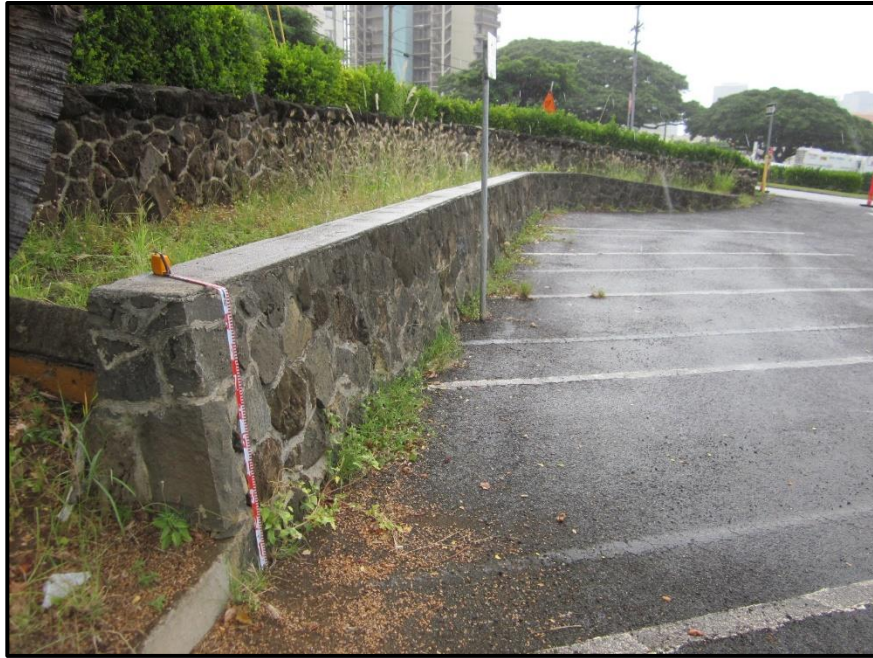
The Feature 10 retaining wall is multiple-stacked with three to four courses of small, angular basalt boulders and large cobbles and mortar. The mortar has been applied flush to the wall faces similar to Feature 33. Feature 10 is capped with thin, leveled (flat) concrete. As with the Feature 1-9 walls, a greater percentage of dark gray basalt boulders and cobbles were used in the construction of Feature 10 than was used to construct Feature 33 (see Figure 22).

Figure 22. Photographs of Site T-1, Feature 10, Terrace. Top: Feature 10 Terrace with Concrete-capped Retaining wall; Feature 33 in the Background; View to South. Bottom: Feature 10 Soil Terrace Showing Curbing on Surface that Defines North End of Terrace; Feature 33 Wall on Left; View to South.

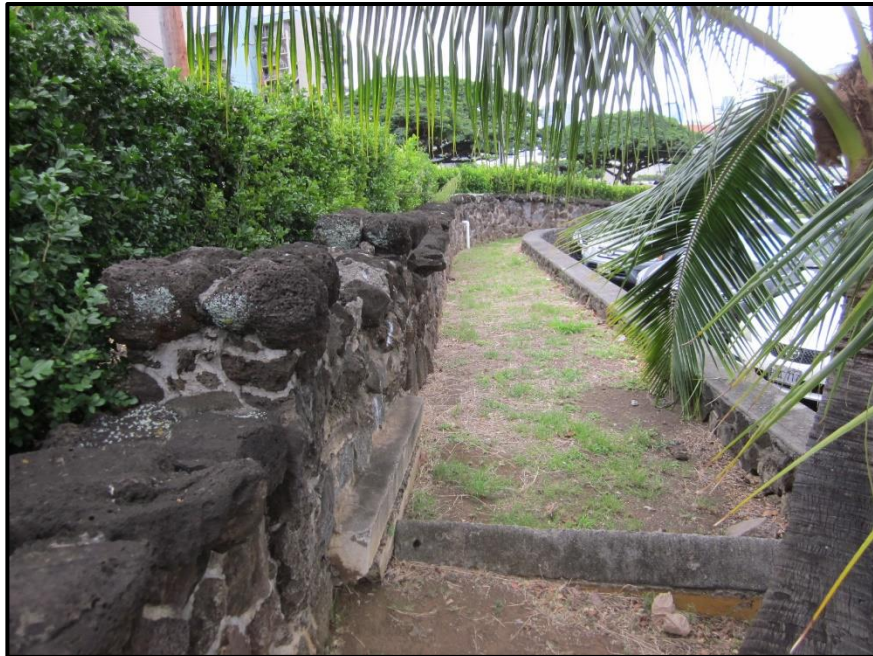
Figure 22 presents photographs of the Feature 10 terrace and retaining wall. After curving to the west, the wall decreases in height from north to south. The upslope height of the retaining wall ranges from .30 m to .27 m and the downslope height ranges from .50 m to .80 m (see Table 2). The soil terrace ranges from 1.3 m to 1.6 m wide.

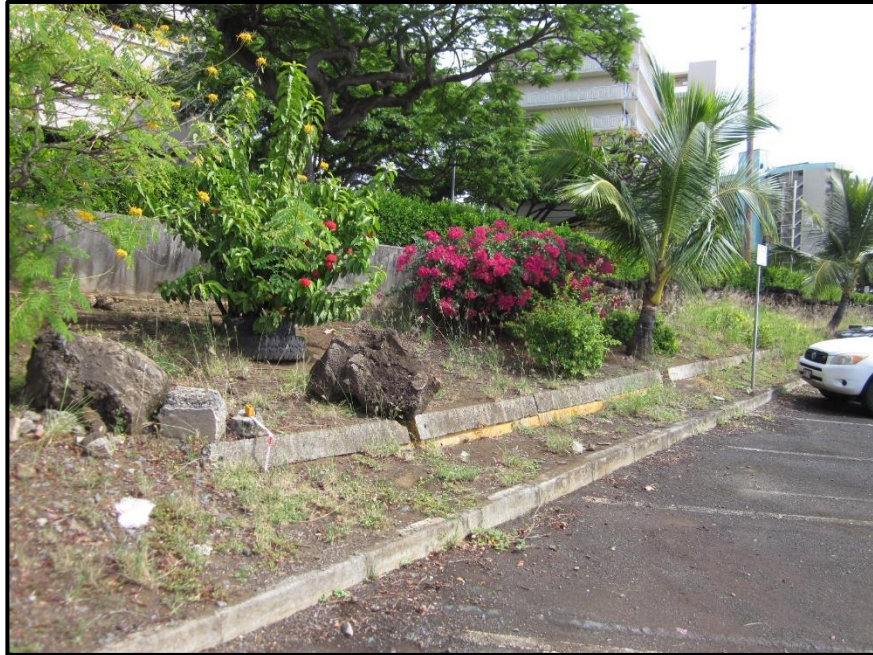
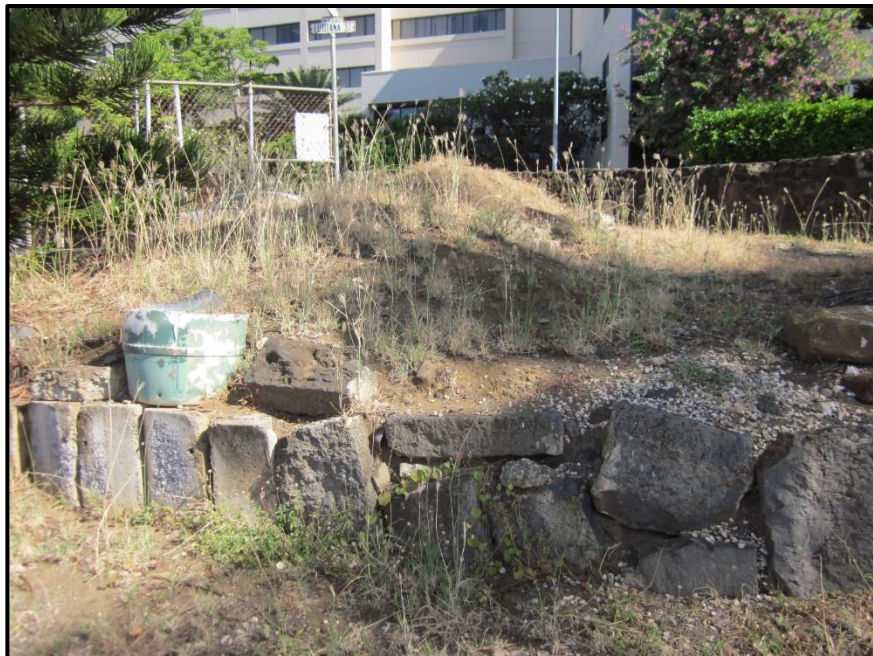
Figure 23 presents a photograph of Feature 22. The upslope height of this retaining face is approximately .05 m and the downslope height ranges from approximately .30 m to .40 m. (see Table 2). The soil terrace ranges from 5 m to 6 m wide, and slopes up to the northeast to Feature 33. The disturbed surface includes several large boulders and is planted with coconut palms, bougainvillea, and Norfolk pines.

Figure 23 presents a photograph of Feature 23. The upslope height of the basalt block/concrete slab retaining wall ranges from .20 m to .30 m and the downslope height ranges from .30 m to .65 m. (see Table 2). The terrace ranges from 7 to 8 m wide, and contains a large, disturbed, soil mound. The terrace slopes up to the east to Feature 33. Sparse grass is growing on the mound's surface.

Figure 23. Photographs of Site T-1, Features 22 and 23, Terraces. Top: Feature 22, View to Southeast. Bottom: Feature 23, View to Northeast.

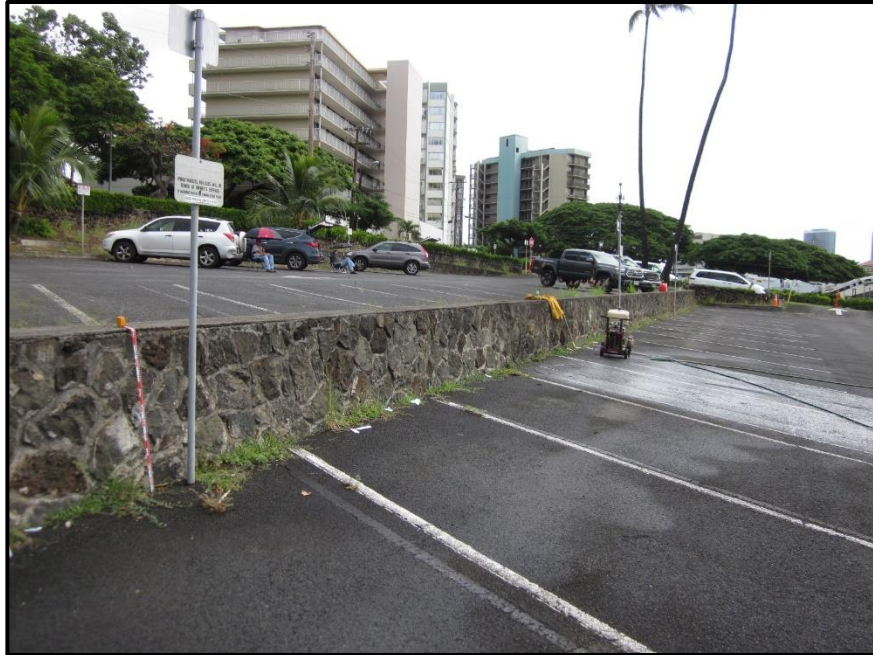
Feature 11 is the uppermost terraced parking area in the EPL (see Figure 14). Figure 24 presents a photograph of Feature 11. The mortared retaining wall is stacked with three to five courses of dark gray vesicular and dense basalt boulders and large cobbles. The mortar is flush with the rock face, and the upper horizontal surface is capped with flat, smooth, concrete. The Feature 11 retaining wall is approximately 55.9 m in length. The terrace (including the wall) ranges from 14.5 m to 17.2 m wide.

Feature 13 is the central parking area in the EPL (see Figure 14). Figure 24 presents a photograph of a portion of Feature 13. The mortared retaining wall is stacked with three to five courses of dark gray vesicular and dense basalt boulders and large cobbles. The mortar is flush with the rock face, and the upper horizontal surface is capped with flat, smooth, concrete. The Feature 13 retaining wall is approximately 65 m in length. The terrace (including the wall) ranges from 33.8 m to 34.2 m wide.

Feature 13 is bisected northwest to southeast by a .15 m to .17 m high concrete block double curb designated as Feature 12 (see Figure 14; see Table 2). The two curbs are approximately 56 m in length and abut a low terrace (Feature 29) at the south end. The parallel curbs are approximately .30 m apart (Figure 24; see Table 2). The curbs are comprised of joined individual concrete blocks measuring approximately 1.8 m long, .15 m wide, and .15 m high.

Figure 24. Site T-1, Features 11 and 13, Parking Lot Terraces, and Feature 12, Double Concrete Curb. Top: Feature 11 (background) and Feature 13 (foreground); View to Southwest. Bottom: Feature 11 (background) and Feature 12 (foreground); View to Southwest.

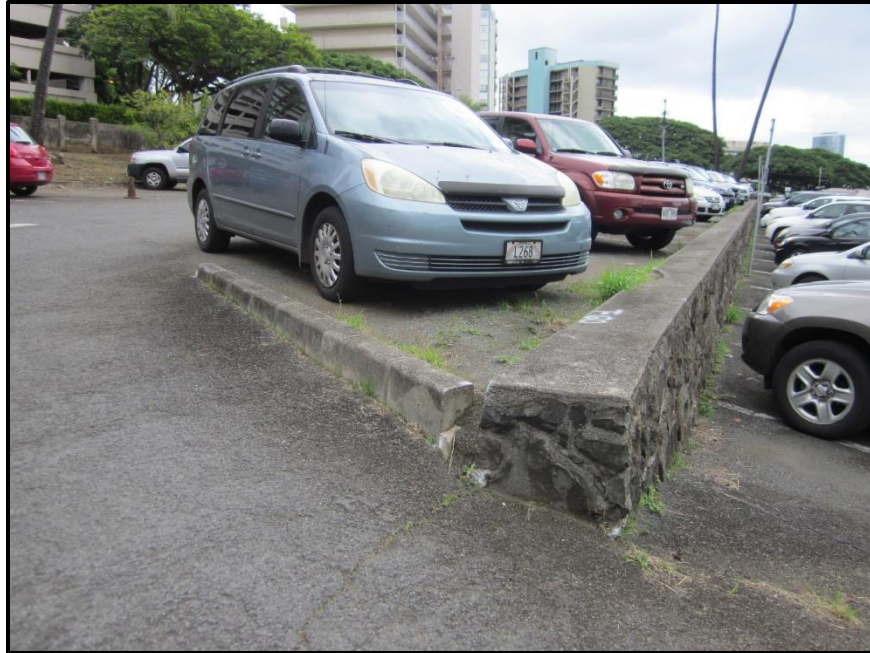
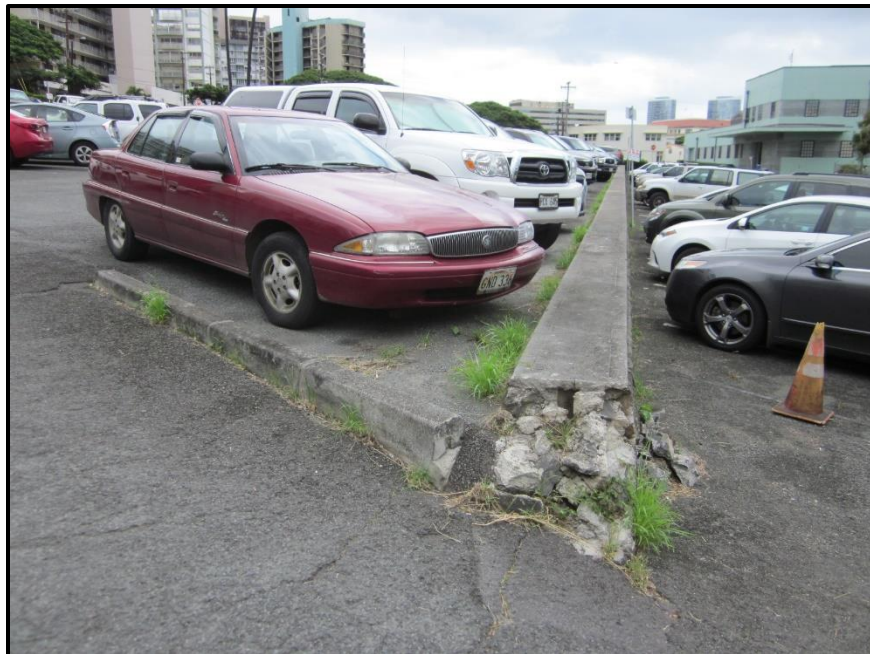
1 At the north end of the Feature 11 and 13 retaining walls are concrete block curbs that
2 abut the walls at an acute angle. These curbs, about 3.8 m in length, mark the end of the
3 northern-most parking stalls for these two parking lot terraces. **Figure 25** presents photographs
4 of these concrete curbs. The curbs are comprised of joined individual concrete blocks
5 measuring approximately .45 m long, .15 m wide, and from .10 m to .26 m high.

Figure 25. Photographs of Site T-1, North End of Features 11 and 13 Parking Lot Terrace Retaining Walls. Top: North end of Feature 11; View to South. Bottom: North end of Feature 13, View to South.

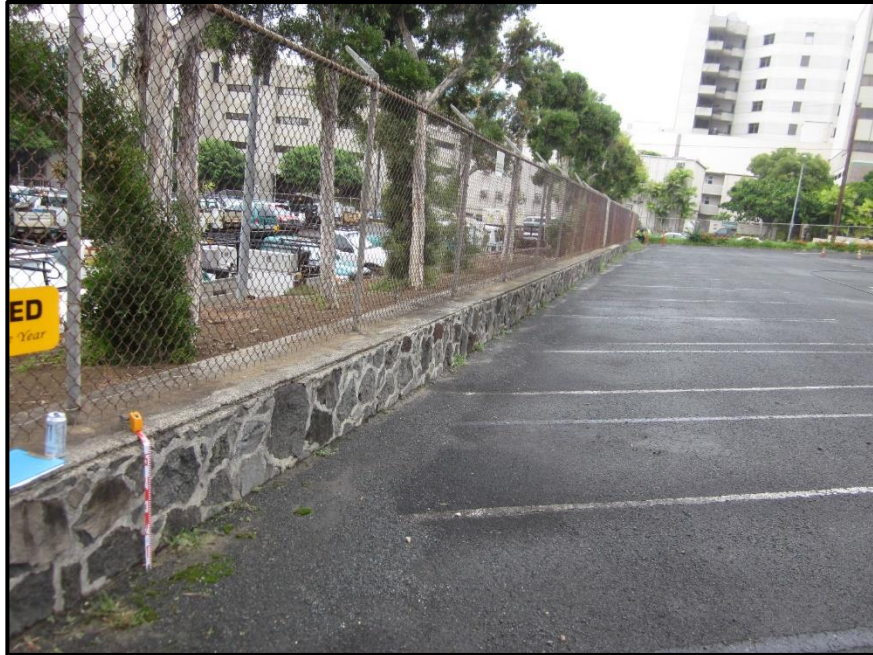
Figure 26. Photographs of Site T-1, Feature 14, Parking Lot Terrace. Top: Feature 14, View to North. Bottom: Feature 14 Showing Two Drainage Pipes, View to Northwest.

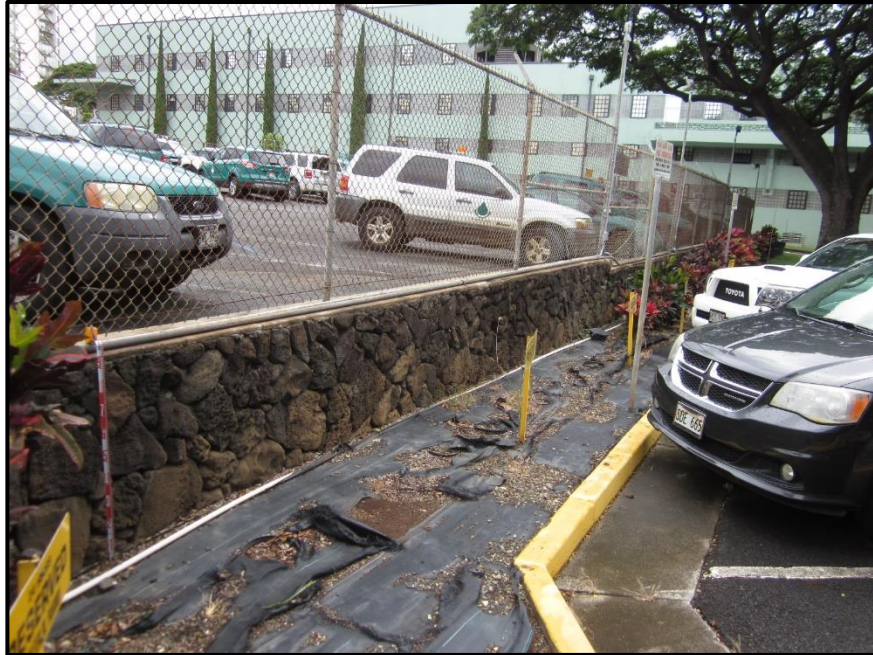
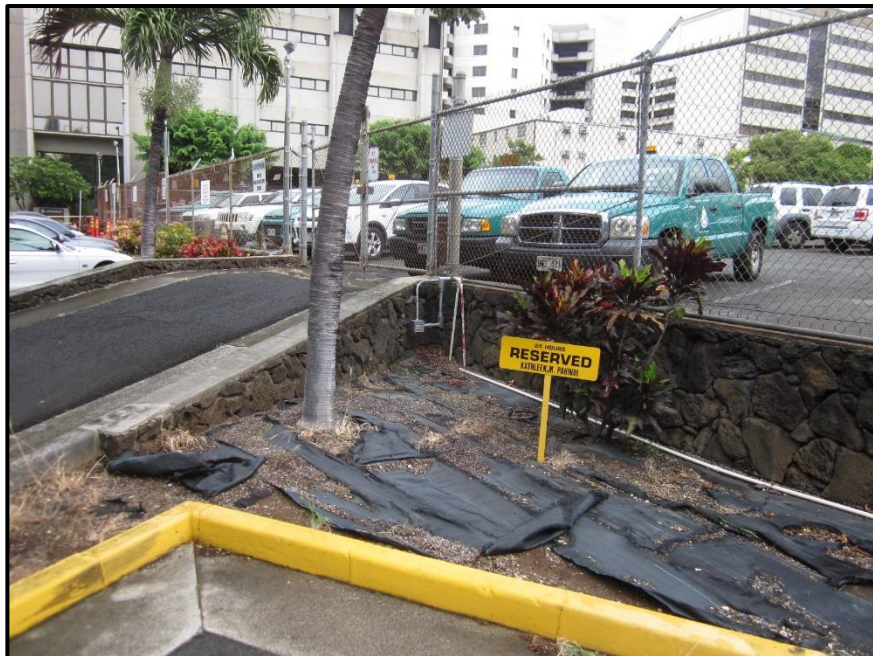
Figure 27. Photographs of Site T-1, Feature 15, Parking Lot Terrace. Top: Feature 15 Retaining Wall, View to South. Bottom: Vehicle Ramp Incorporated into Feature 15, View to Northwest.

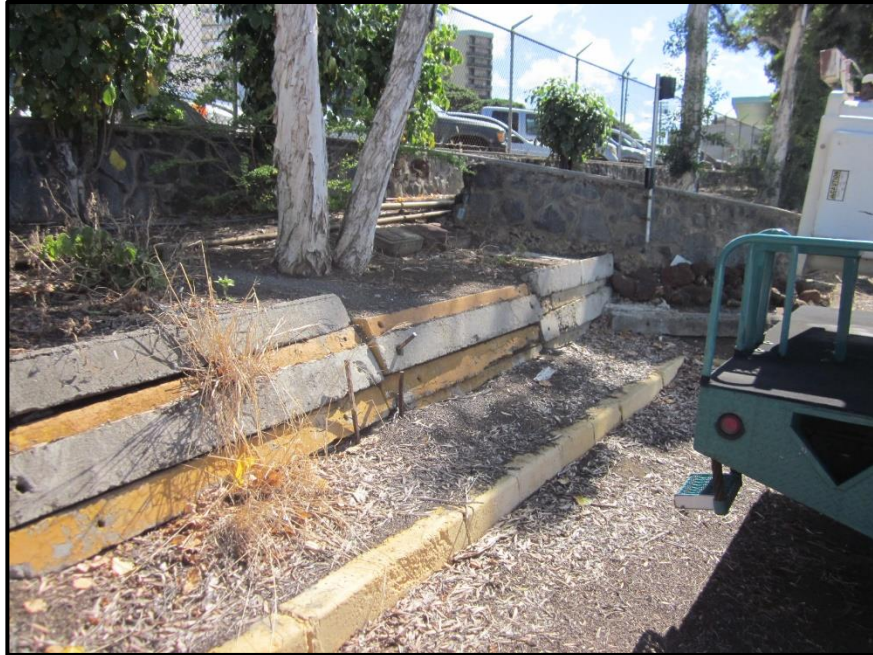
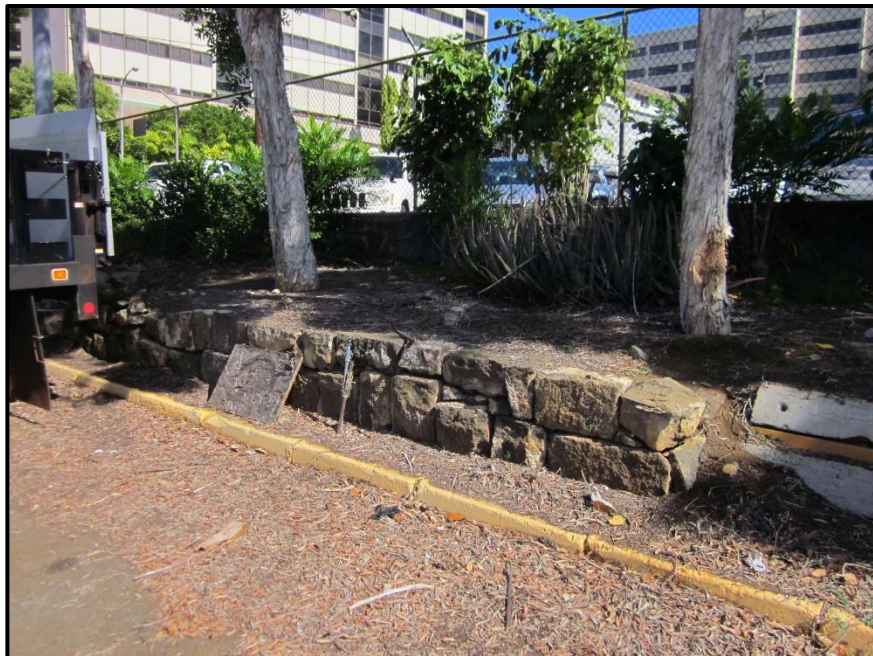
30 Feature 16 is a soil terrace at the eastern end of the CVPL, north of Feature 36 (see
31 **Figure 14**). The terrace is approximately 7.7 m long, 2.5 m wide, and has retaining elements
32 consisting of three to four courses of stacked concrete parking stall bumpers. The downslope
33 height of the retaining wall ranges from .51 m to .74 m (see **Table 2**). **Figure 28** presents a
34 photograph of Feature 16. The level soil terrace appears to be disturbed (mixed), and has been
35 planted with Eucalyptus trees and aloe plants.

36 Feature 17 is immediately north of Feature 16 in the northeastern corner of the CVPL
37 (see **Figure 14 and Table 2**). The terrace is approximately 8.6 m long, 3.2 m wide, and has
38 retaining elements consisting of two courses of cut basalt blocks (**Figure 28**). The downslope
39 height of the basalt block retaining wall ranges from .23 m to .54 m. The disturbed level soil
40 area has been planted with Eucalyptus and Plumeria trees.

Figure 28. Photographs of Site T-1, Features 16 and 17, Terraces. Top: Feature 16, View to Southeast. Bottom: Feature 17, View to Northeast.

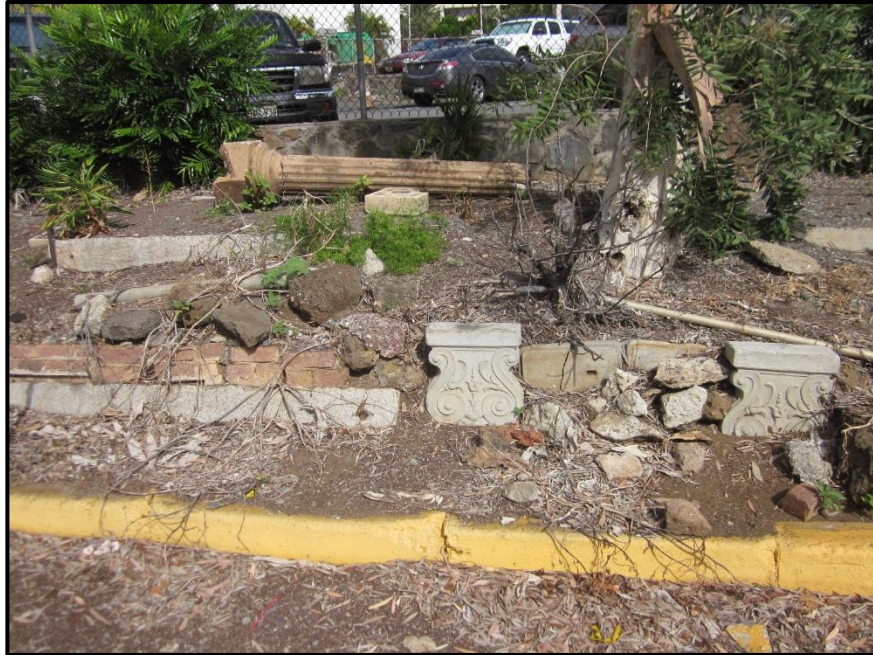
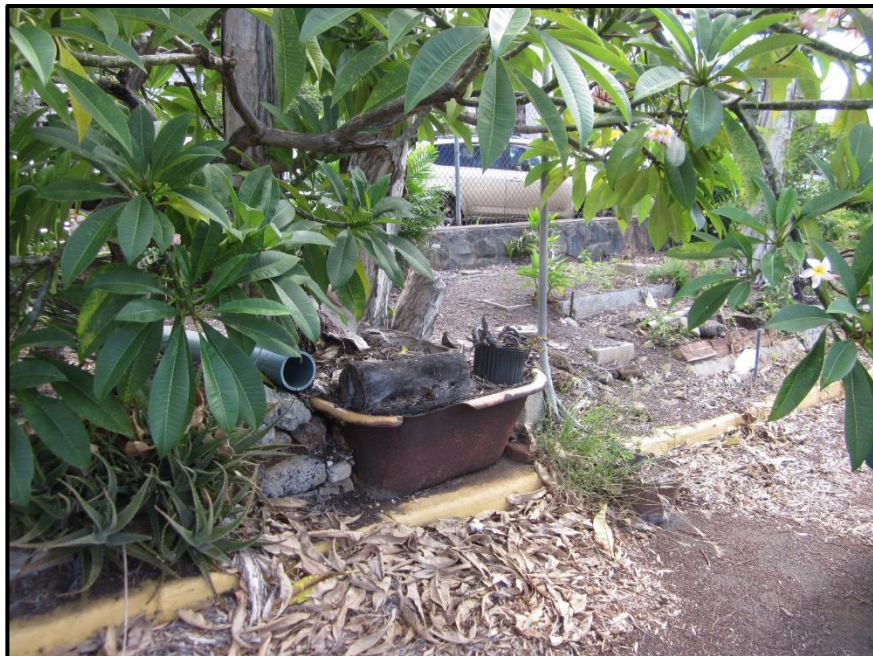
Feature 18 is a soil terrace immediately north of Feature 17 in the northeastern corner of the CVPL (see [Figure 14 and Table 2](#)). The terrace is approximately 18.1 m long, 3.5 m wide, and has retaining elements consisting of concrete slabs, parking stall bumpers, red bricks, decorative concrete blocks, concrete chunks, an iron bed frame, and an old bathtub ([Figure 29](#)). The downslope height of the retaining wall ranges from .80 m to 1.0 m. (see [Table 2](#)). The disturbed soil terrace has been planted with Eucalyptus trees.

Figure 29. Photographs of Site T-1, Feature 18, Terrace. Top: Feature 18, View to East. Bottom: Feature 18, View to Southeast.

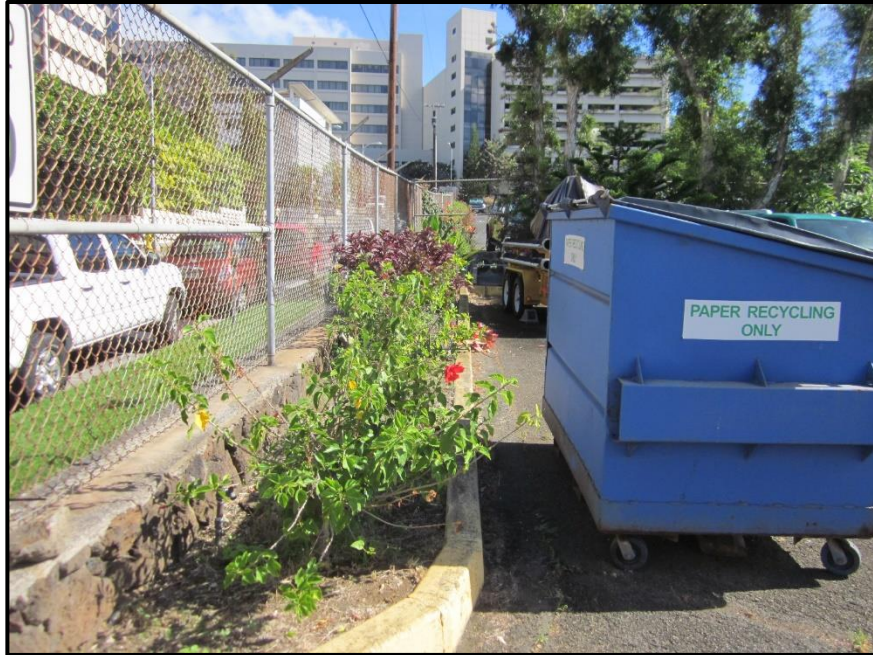
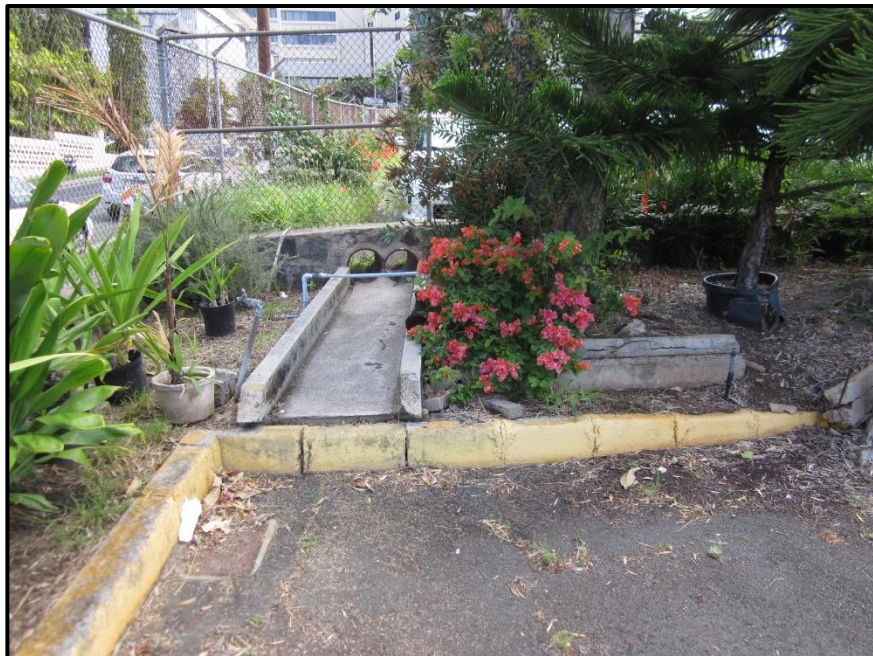
Figure 30. Photographs of Site T-1, Feature 19, Terrace. Top: Feature 19, View to West. Bottom: Feature 19 Terrace (left), North End of Feature 18 (right), View to West.
