**Archaeological Inventory Survey In
Support of the Honolulu Board of
Water Supply's Energy Efficiency
Program, Honolulu (Waikiki)
Ahupua'a, Honolulu (Kona)
District, Island of O'ahu, Hawai'i**

TMKs: (1) 2-1-036: 004 and 005

PRELIMINARY DRAFT REPORT
Archaeological Inventory Survey in Support of the Honolulu Board of Water Supply's Energy
Efficiency Program on Beretania Street,
Honolulu (Waikīkī) Ahupua'a, Honolulu (Kona) District,
Island of O'ahu, State of Hawai'i
TMK (1) 2-1-036:004 and 005.

MANAGEMENT SUMMARY

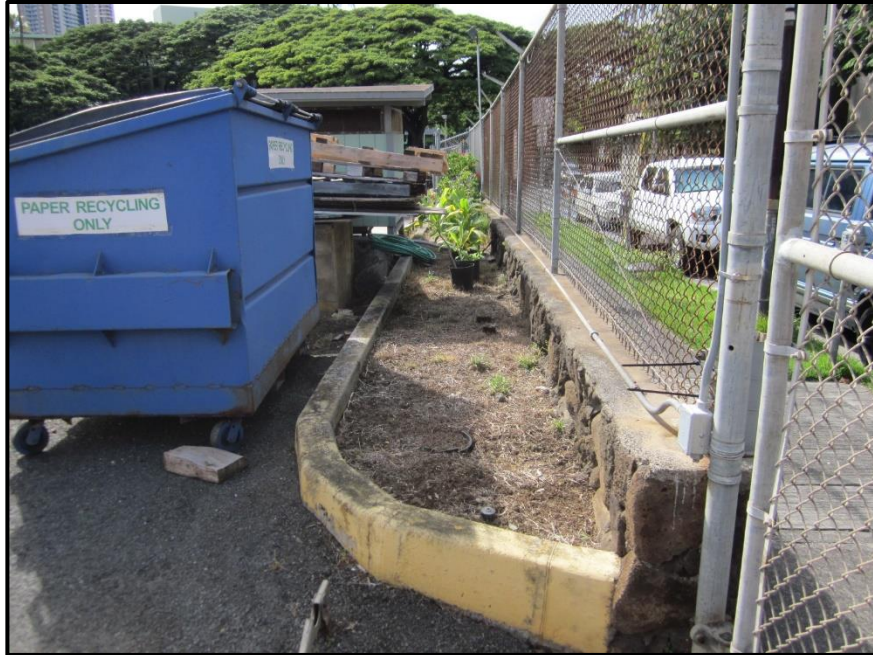
**Figure 31. Photographs of Site T-1, Features 20 and 21, Terraces.
Top: Feature 20, View to West. Bottom Feature 21, View to East.**

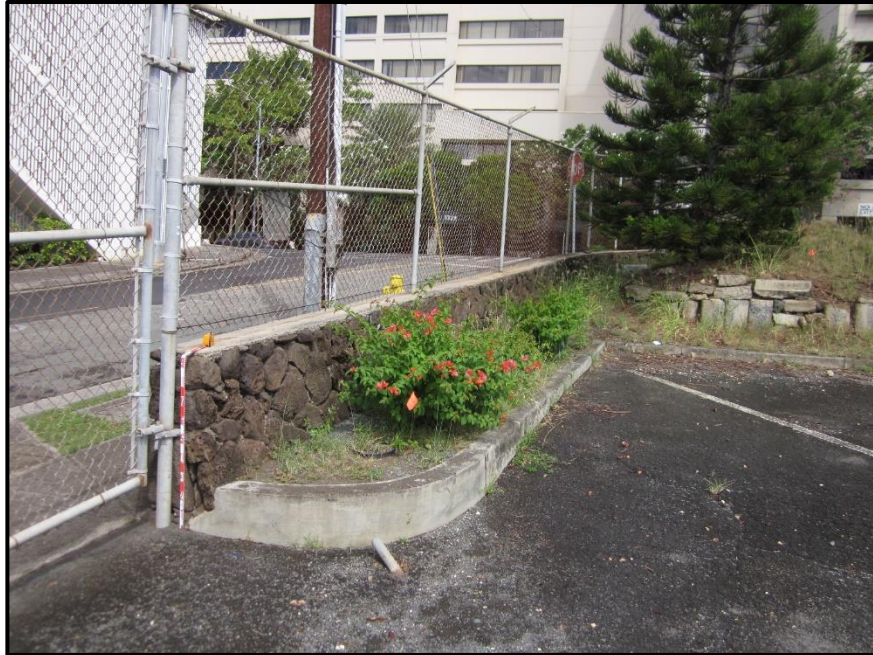
Feature 25 is a terrace in the north-central portion of the EPL (see [Figure 14 and Table 2](#)). The terrace is approximately 29 m long, 1.1 m wide, and is retained by a .20 m to .86 m concrete wall on the south and Feature 6 on the north. The soil terrace is planted with bougainvillea and other exotic plants ([Figure 32](#)).

Figure 32. Photographs of Site T-1, Features 24 and 25, Terraces. Top: Feature 24, View to Northeast. Bottom: Feature 25, View to Northeast.

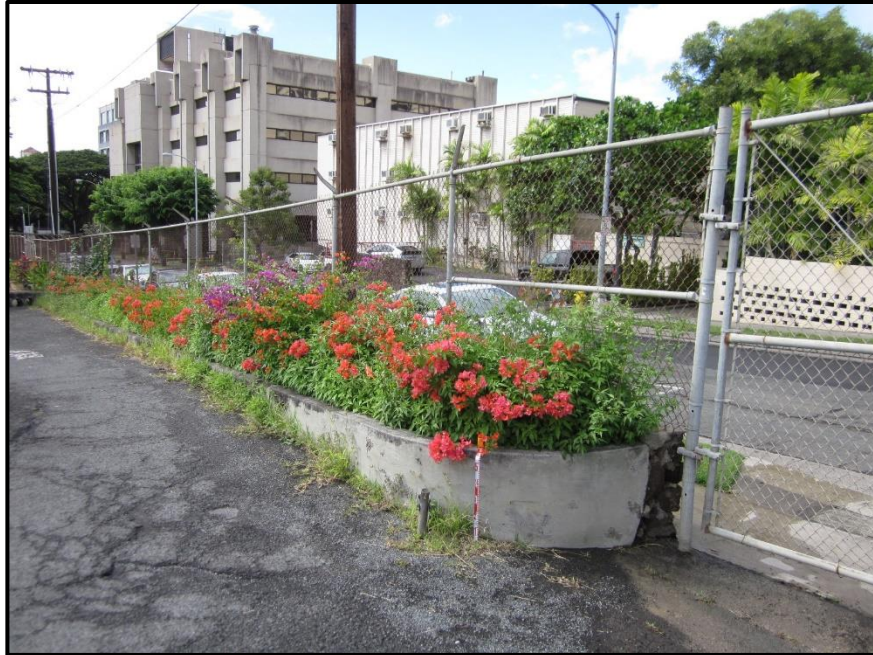
Feature 26 is a terrace in the northwest corner of the EPL (see [Figure 14 and Table 2](#)). The terrace is approximately 22.7 m long, 1.9 m wide, and is retained by a .16 m to .60 m high wall on the south and Feature 7 on the north. The soil terrace is planted with bougainvillea and exotic grasses ([Figure 33](#)).

Figure 33. Photographs of Site T-1, Feature 26, Terrace. Top: Feature 26, View to Southwest. Bottom: Feature 26, View to Northeast (after landscape maintenance).

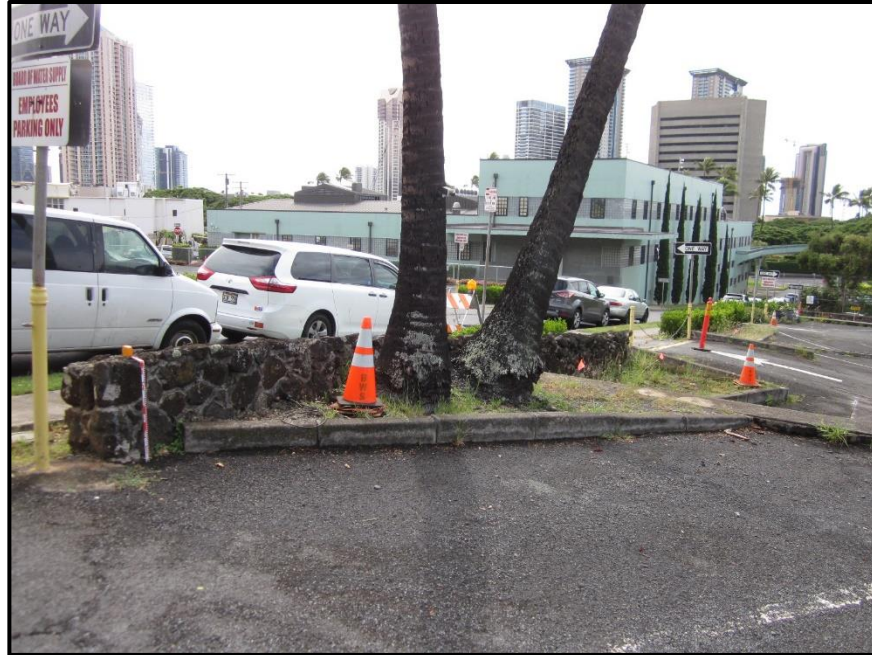
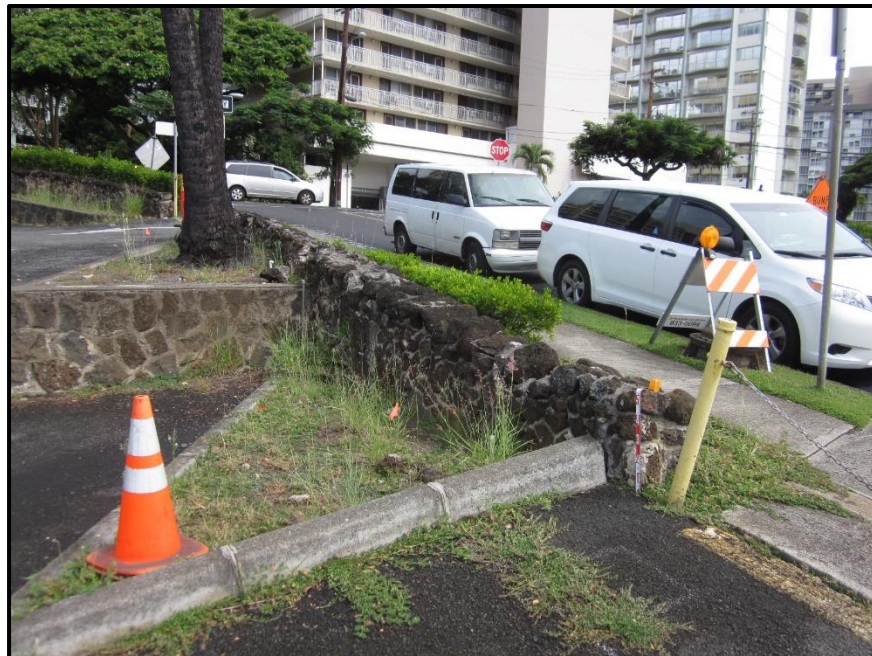
Figure 34. Photographs of Site t-1, Features 27 and 28, Terraces. Top: Feature 27 Abutting Feature 34 (left) and Top of Feature 11 Wall, View to South. Bottom: Feature 28 Abutting Feature 34 (right) With Feature 11 Wall and Feature 27 in background, View to Northeast.

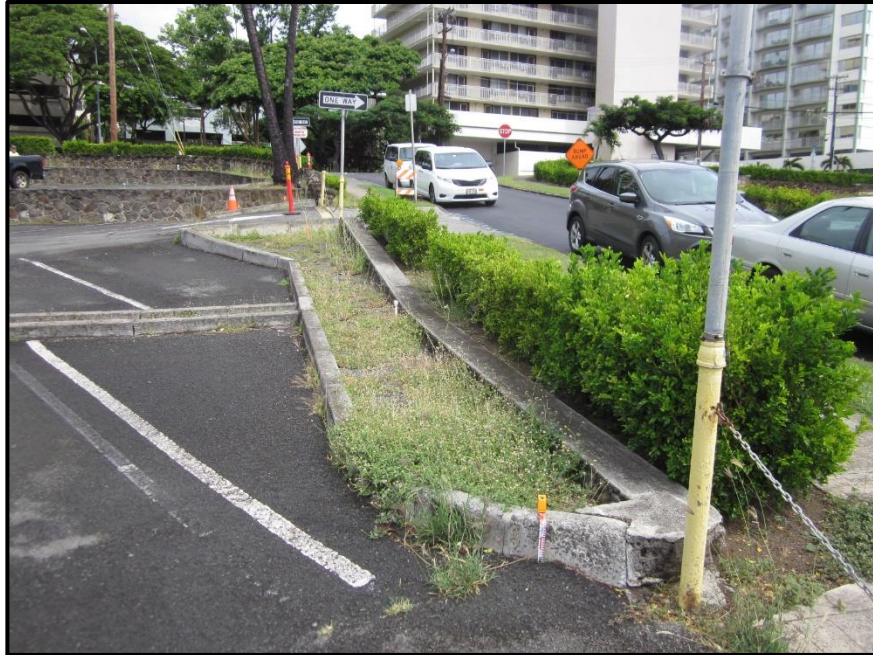
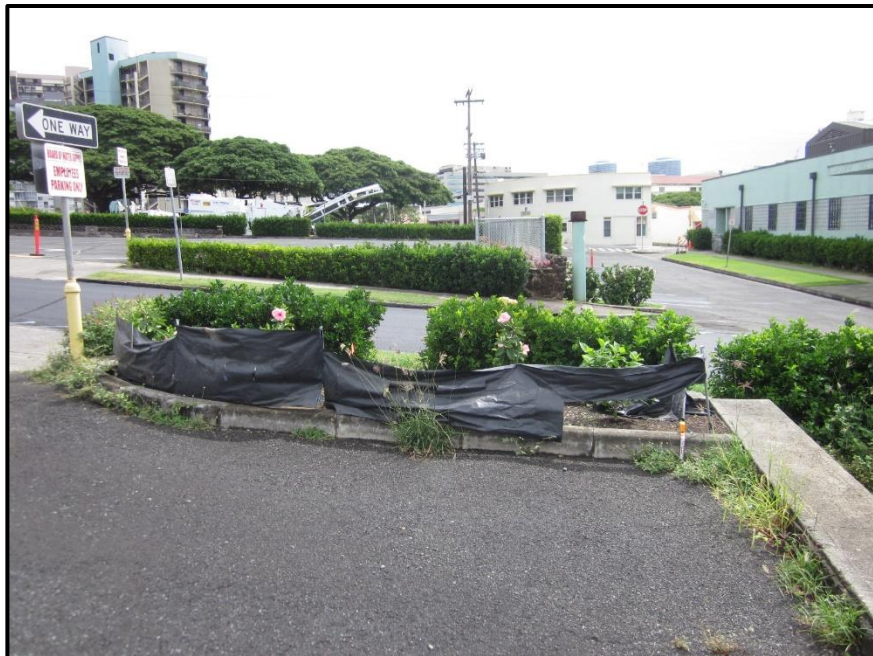
Figure 35. Photographs of Site T-1, Features 29 and 30, Terraces. Top: Feature 29, View to East. Bottom: Feature 30, View to Northwest.

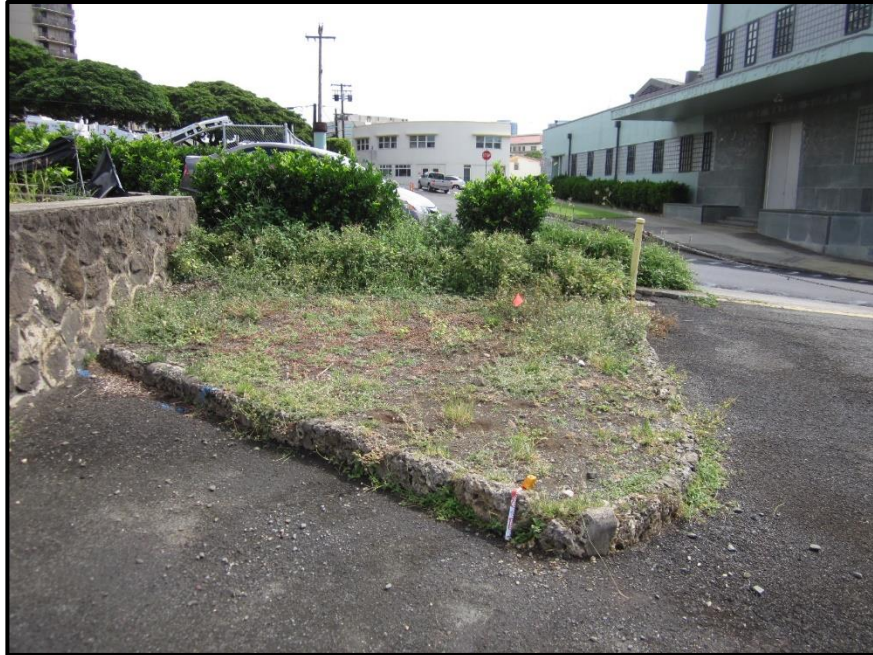
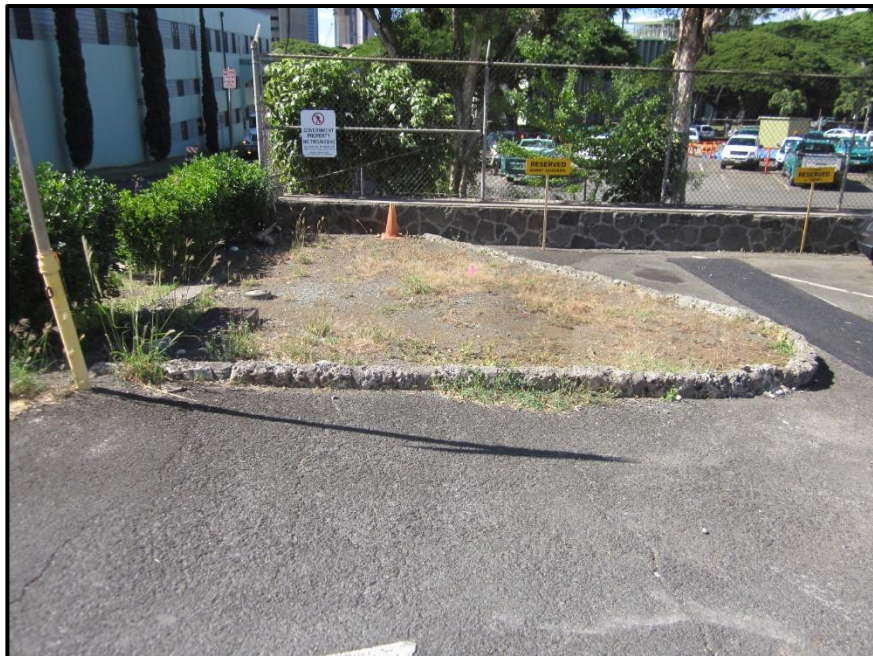
**Figure 36. Photographs of Site T-1, Features 31 and 32, Terraces.
Top: Feature 31, View to South. Bottom: Feature 32, View to
West.**

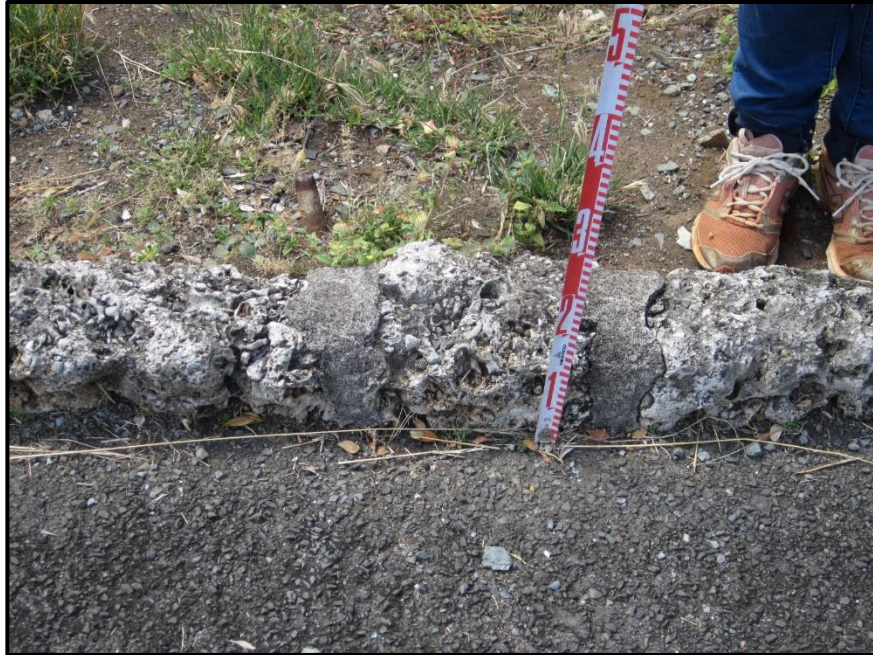
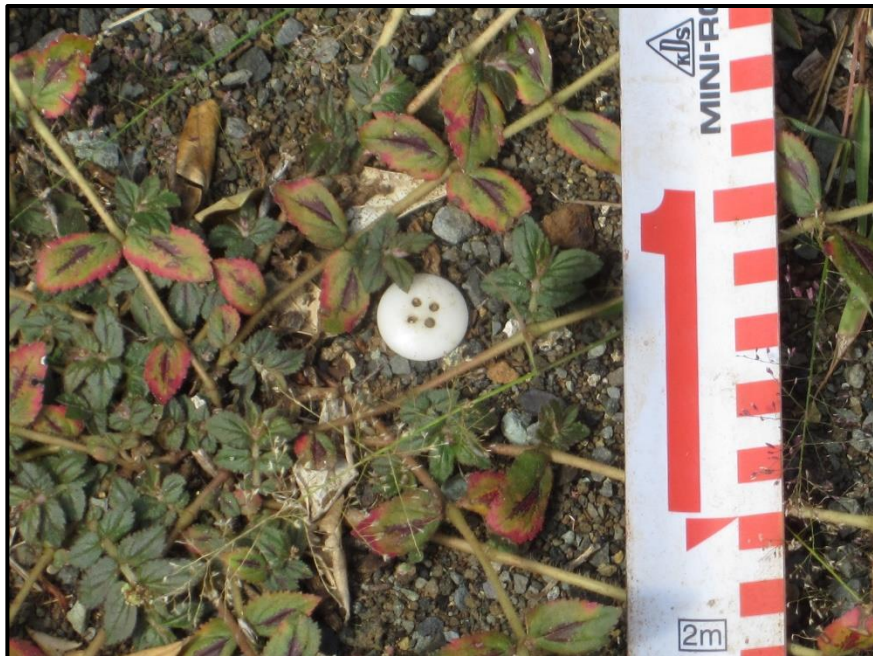
Figure 37. Photographs of Feature 32, Cut Coral Curb and Surface Artifact. Top: Feature 32 Cut Coral Blocks, View to West. Bottom: Button Recorded on the Surface of Feature 32, View to West.

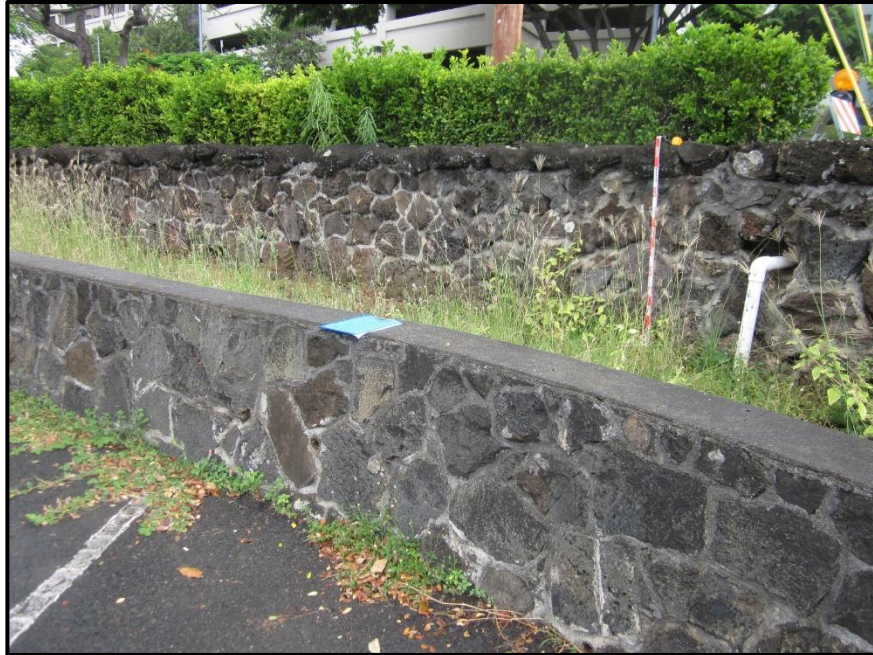
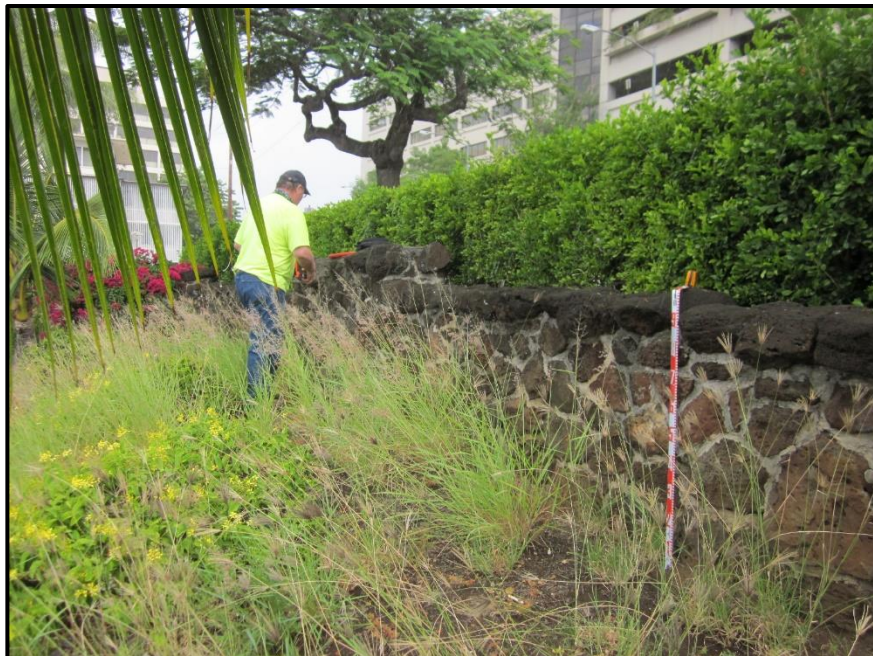
Figure 38. Photographs of Site T-1, Southern Portion of Feature 33, Retaining Wall. Top: Feature 33 (background) Showing Boulder Cap and Feature 10 (foreground); View to North. Bottom: Feature 33 Boulder Cap; View to Northeast.

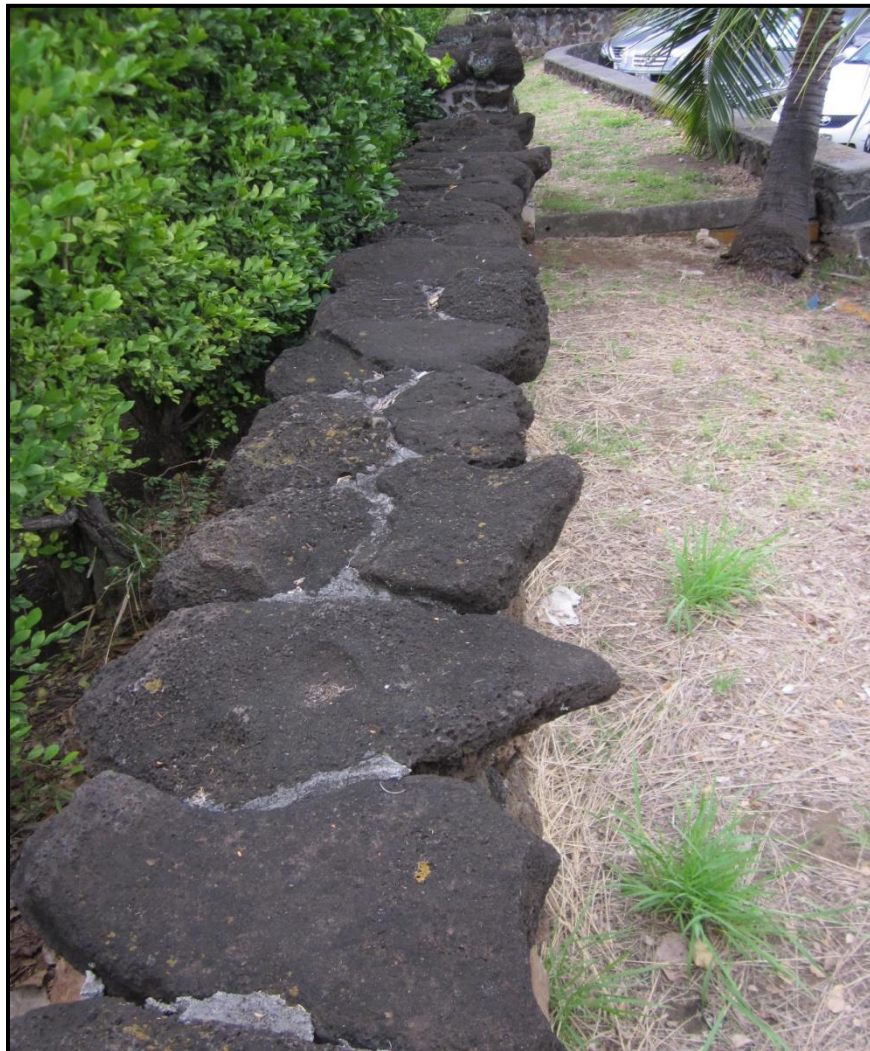
Figure 39. Photograph of Site T-1, Feature 33, Top of Retaining Wall Showing Boulder Cap, View to South.

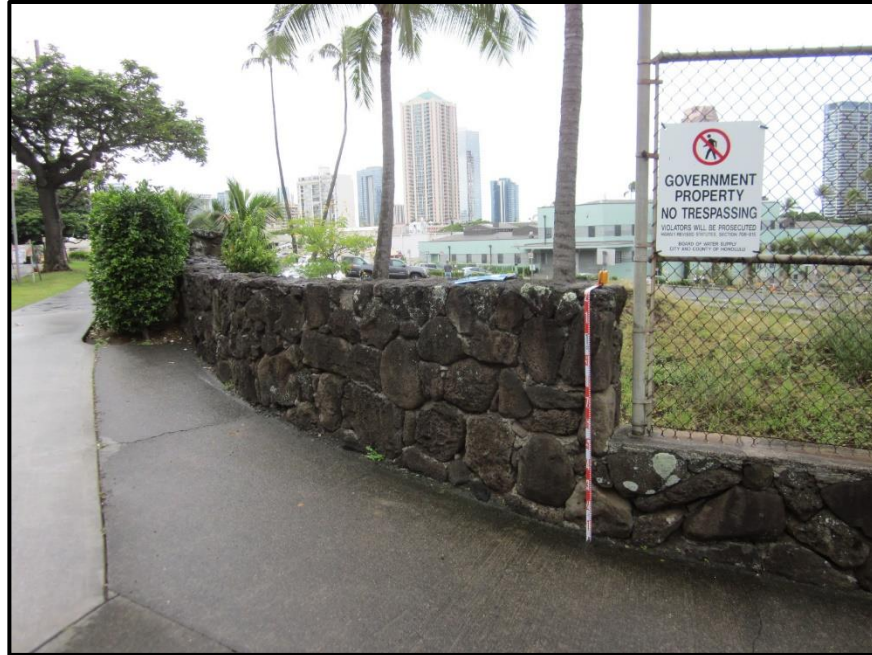
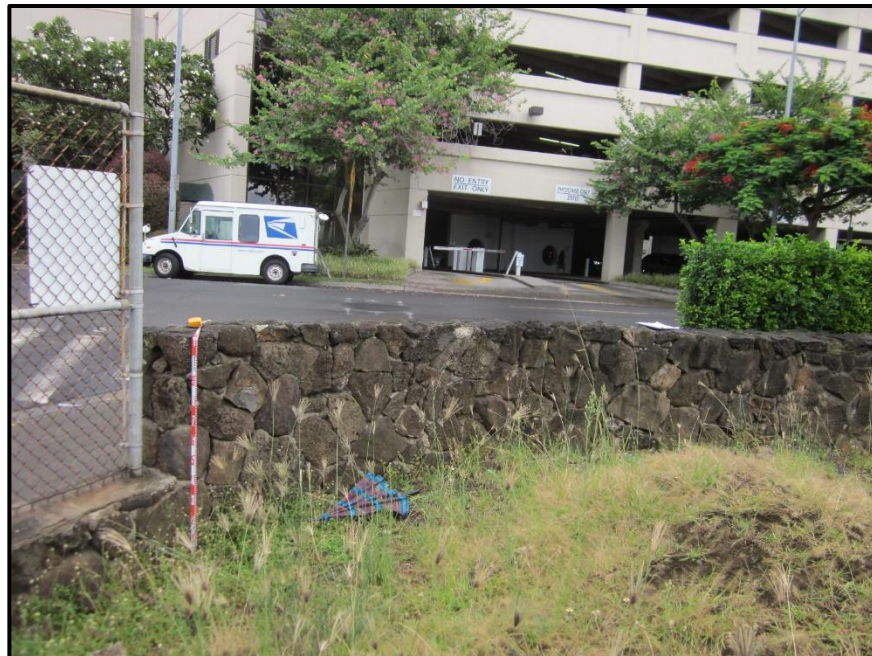
Figure 40. Photographs of Site T-1, Northern Portions of Feature 33 Retaining Wall. Top: Feature 33 North End Exterior Abutting Feature 5 Wall with Chain-link Fence, View to South. Bottom: Feature 33 North End Interior Abutting Feature 5 Wall with Chain-link Fence, View to West.

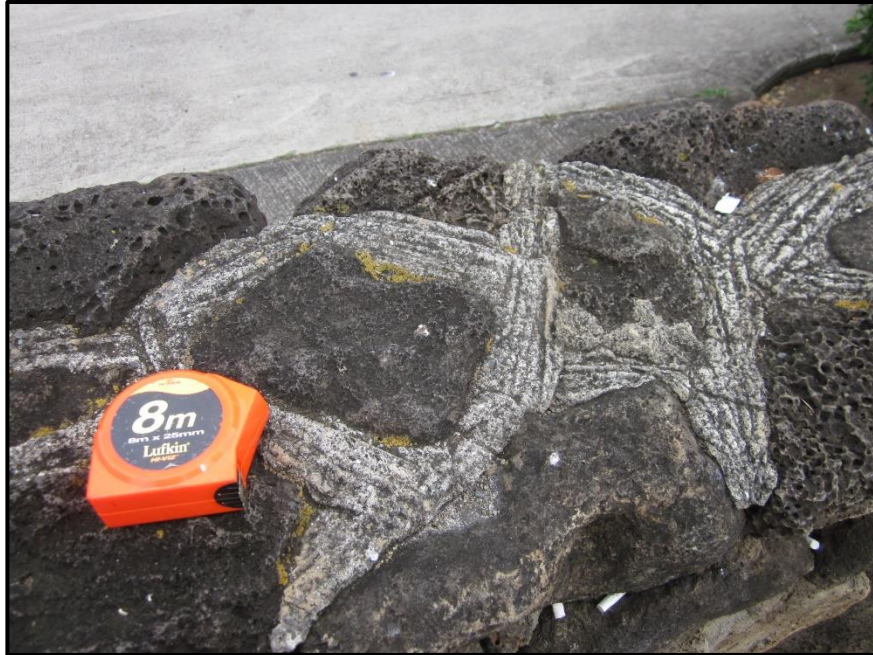
Figure 41. Photographs of the Top of Feature 33 Retaining Wall and Feature 33.1 Entry Pier. Top: North End of Feature 33 Showing Grooved Mortar, View to East. Bottom: Feature 33.1 Top of North Entry Pier Showing Mortar and Concrete Boulder Cap, View to South.

34 The rock piers are similar in construction to the Feature 33 wall, and were constructed
35 using four to five courses of mortared, reddish brown, small basalt boulders and large cobbles.
36 They are roughly square in cross-section, measuring .45 m wide on a side and 1.10 m high.
37 Each pier is capped with small basalt boulders that are mortared in place (see Figure 41).

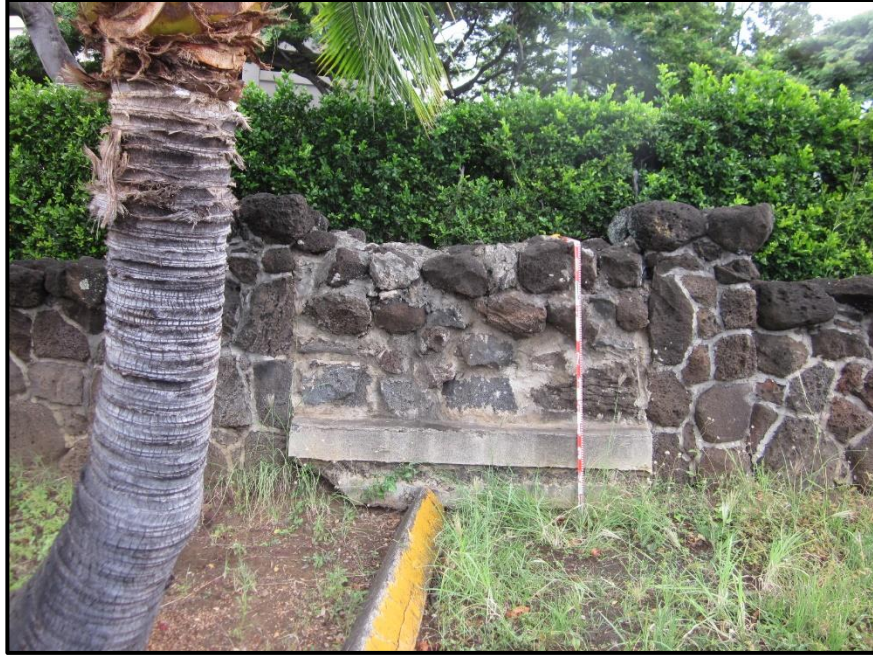
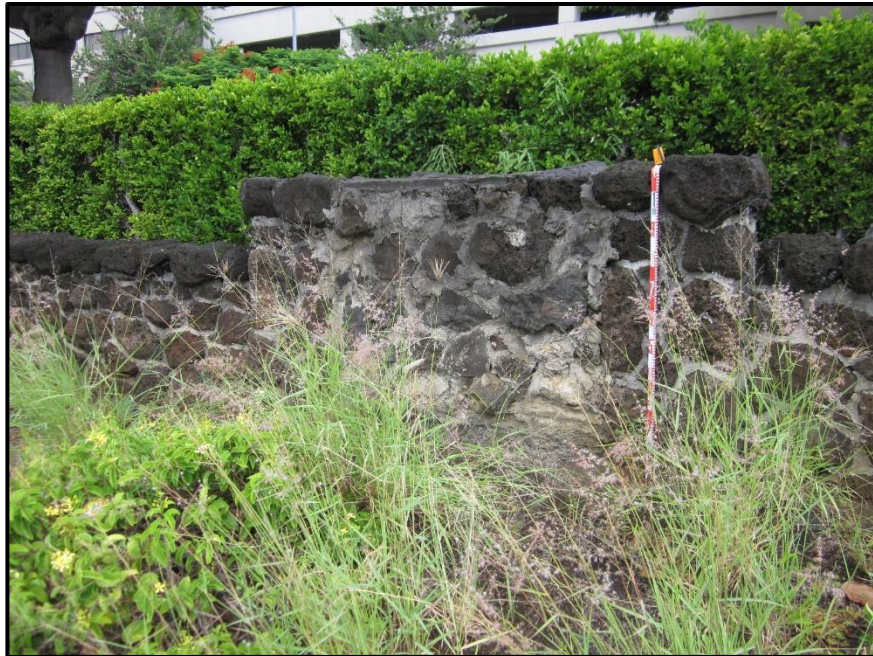
Figure 42. Photographs of Site T-1, Features 33.1 and 33.2, Sealed Entry Gates. Top: Feature 33.1, Sealed Entry with Basalt Entry Piers and Concrete Threshold, View to East. Bottom: Feature 33.2 Sealed Entry with Rock Piers, View to West.

38 The upper courses of rock that comprise the sealed portion of Feature 33.1 appear to
39 have been removed, while the upper portion of the sealed portion of Feature 33.2 is flush with
40 the top of the rock piers (see Figure 42).

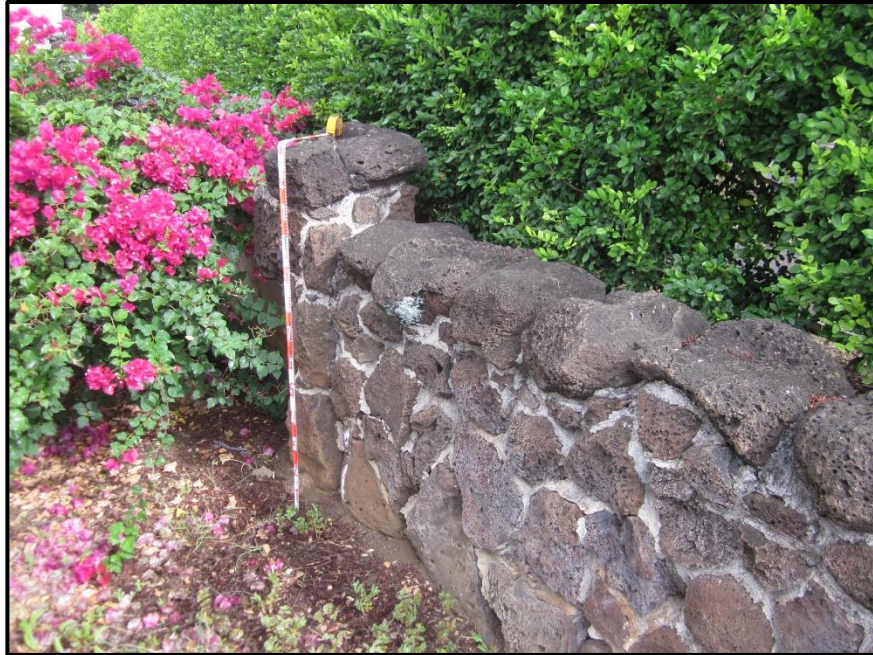
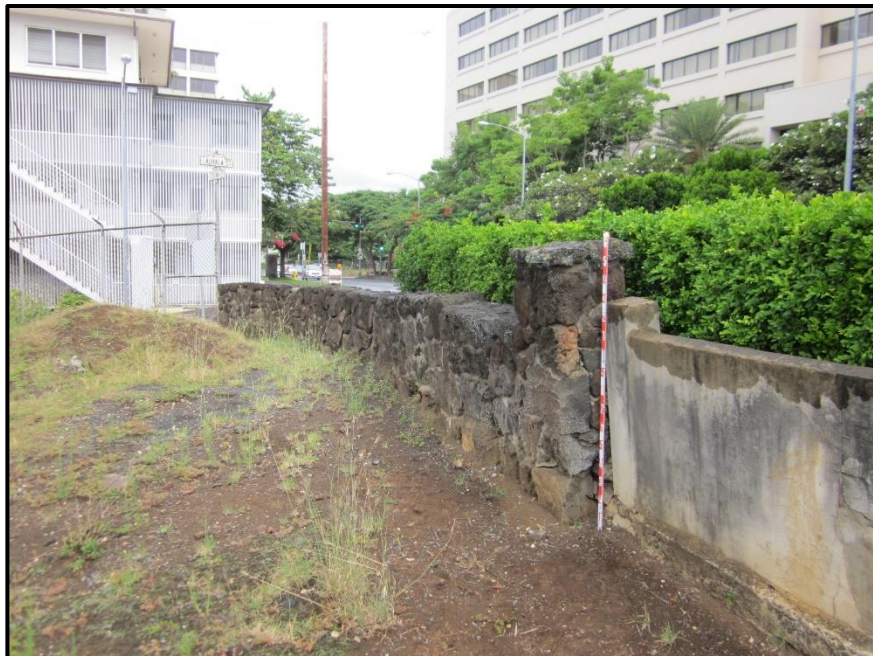
Figure 43. Photographs of Site T-1, Features 33.3 and 33.7, Rock Piers in Feature 33. Top: Feature 33.3, View to North. Bottom: Feature 33.7, View to Northwest.

Features 33.3 and 33.7 are single basalt piers located on either end of a concrete retaining wall segment (Feature 33.4) (see Figure 14). These piers are similar in construction and size to the piers bordering Features 33.1 and 33.2, exhibiting rock and mortar construction with boulder caps (see Table 2). Feature 33.7 is the tallest pier (1.6 m downslope height) present in the Feature 33 wall (Figure 43).

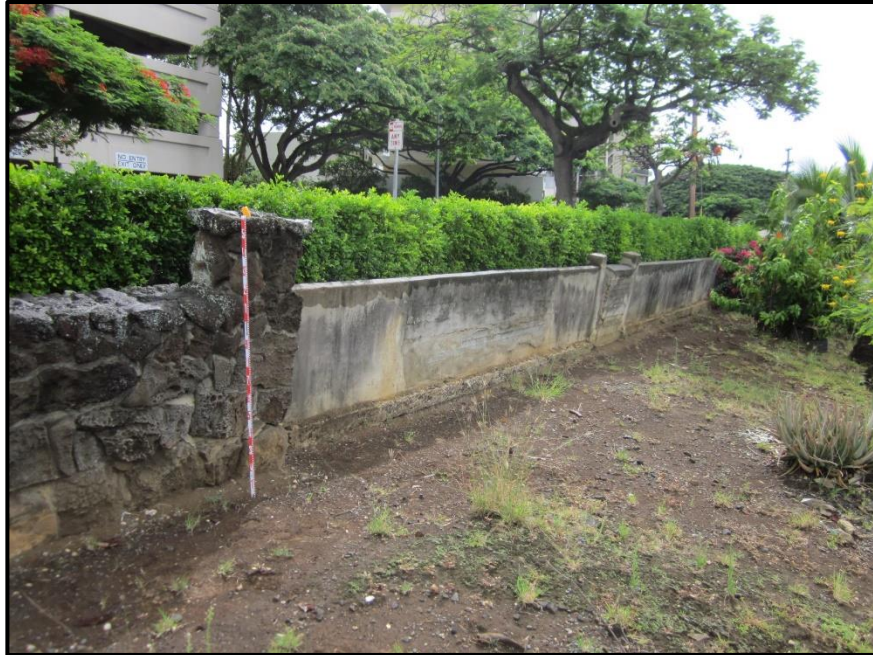
Figure 44. Photographs of Site T-1, Feature 33.4 Concrete Wall Segment. Top: Feature 33.4 (Concrete Retaining Wall) and Feature 33.5 (Sealed Entry), View to East. Bottom: Feature 33.4, View to North.

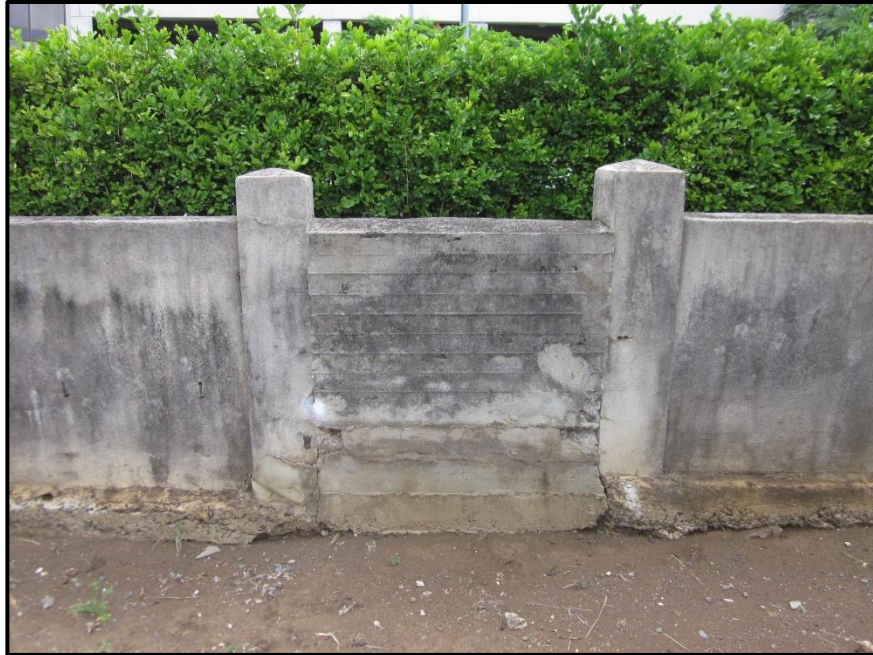
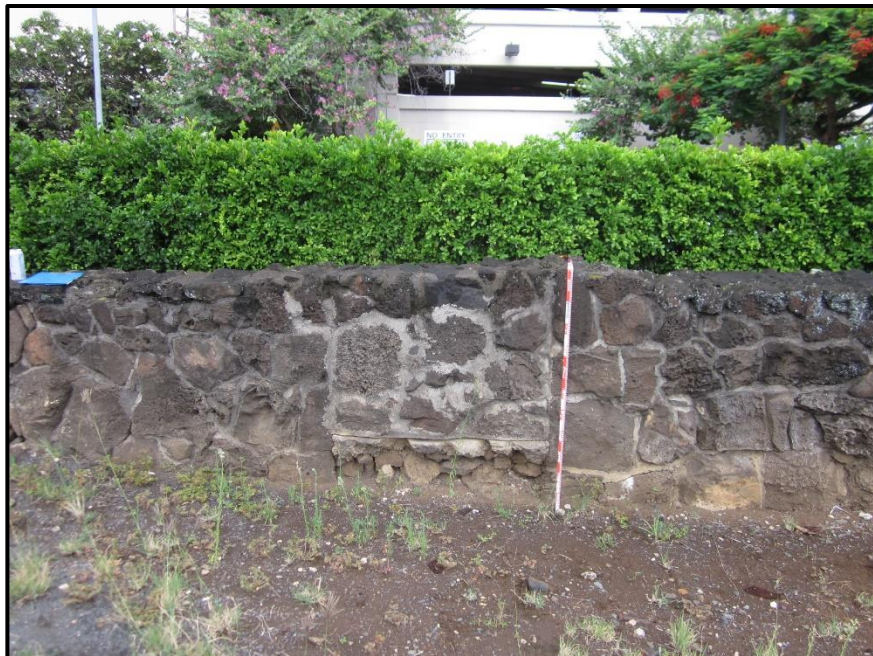
Feature 33.8 appears to be a repaired section of the northern portion of the Feature 33 retaining wall located approximately 5.0 m north of the Feature 33.7 basalt rock pillar (see Table 2; see Figure 14). The repaired section consists of four to five courses of small vesicular basalt boulders and large cobbles, and measures approximately 1.10 m by 1.10 m (see Figure 45).

Figure 45. Photographs of Feature 33.5 Sealed Concrete Gate and Feature 33.8 Repaired Section of Feature 33 Retaining Wall. Top: Feature 33.5, View to East. Bottom: Feature 33.8, View to East.

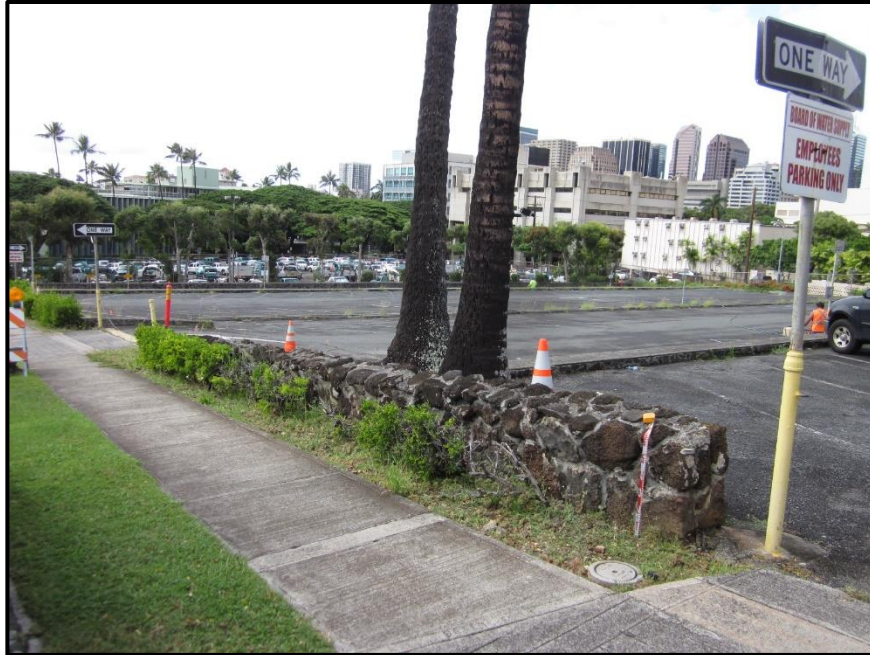
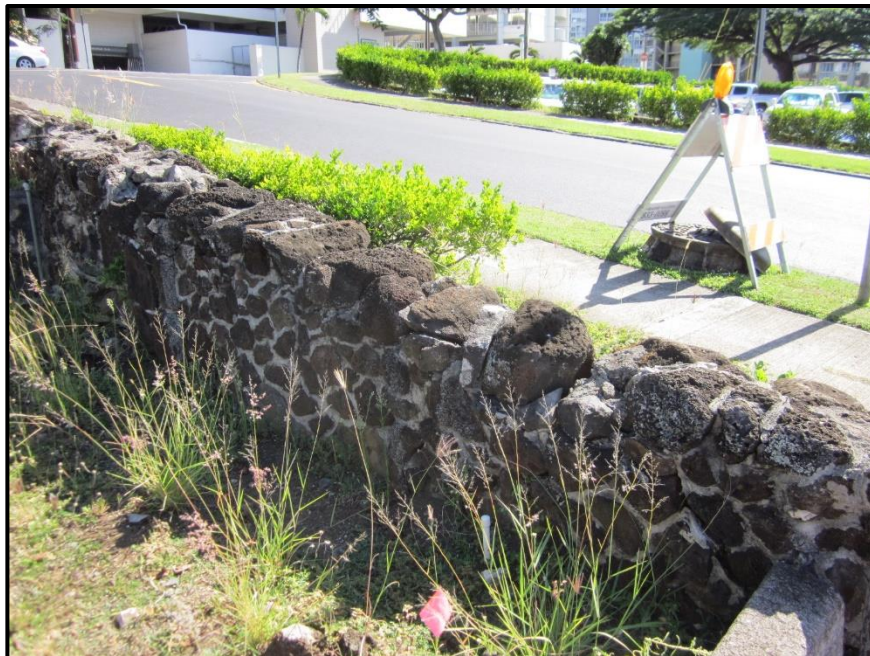
**Figure 46. Photographs of Site T-1, Feature 34, Retaining Wall.
Top: Feature 34, View to West. Bottom: Feature 34 Showing Top of
Wall Capped with Boulders. View to East.**

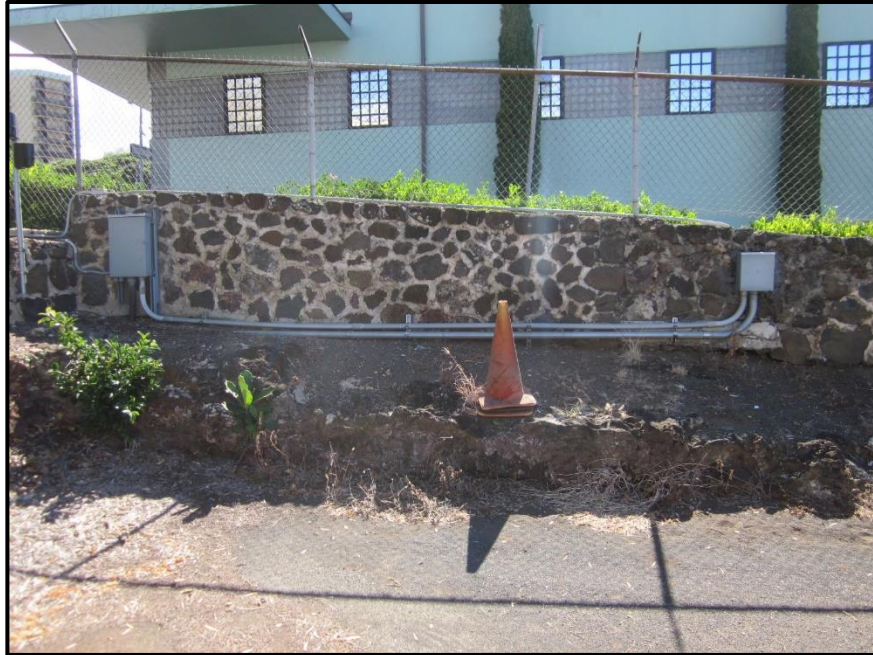
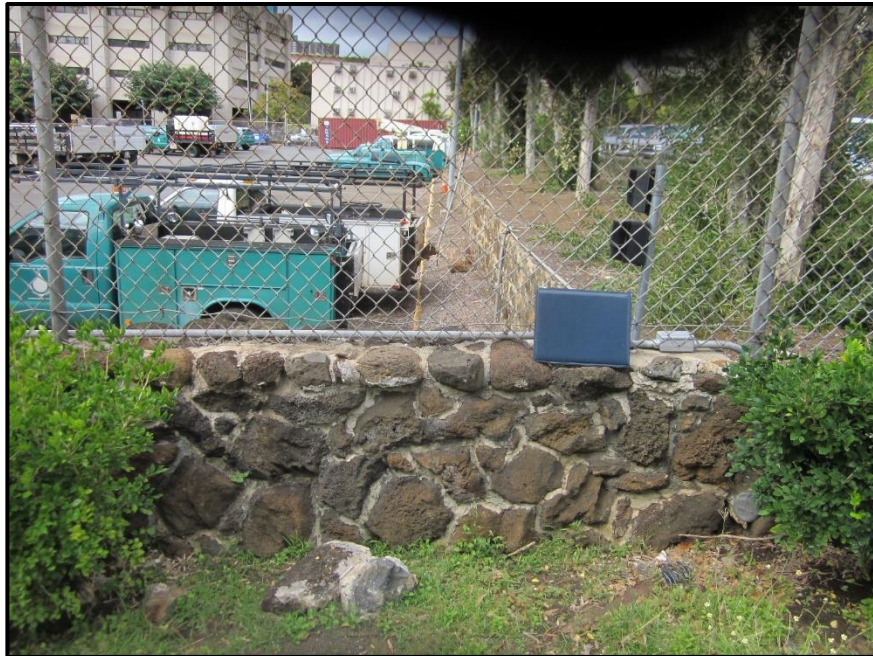
Figure 47. Photographs of Site T-1, Feature 35 Retaining Wall. Feature 35 (interior), View to Southeast. Bottom: Feature 35 (exterior), View to North.

Feature 35 is a retaining wall built parallel to Lisbon Street that extends from the Feature retaining wall to Entrance 1 of the CVPL (see Table 2; see Figure 14). Like Feature 34, this wall exhibits the same construction technique and materials as the Feature 33 wall. Figure 47 presents photographs of the Feature 35 wall. This wall measures 14.8 m in length and .40 in width. The upslope (exterior) height ranges from 60 to 80 cm; downslope height ranges from 80 to 95 cm.

top of the Feature 35 wall is capped with basalt boulders mortared in place (see Figure 47). A chain-link fence has been erected on top of the Feature 35 wall.

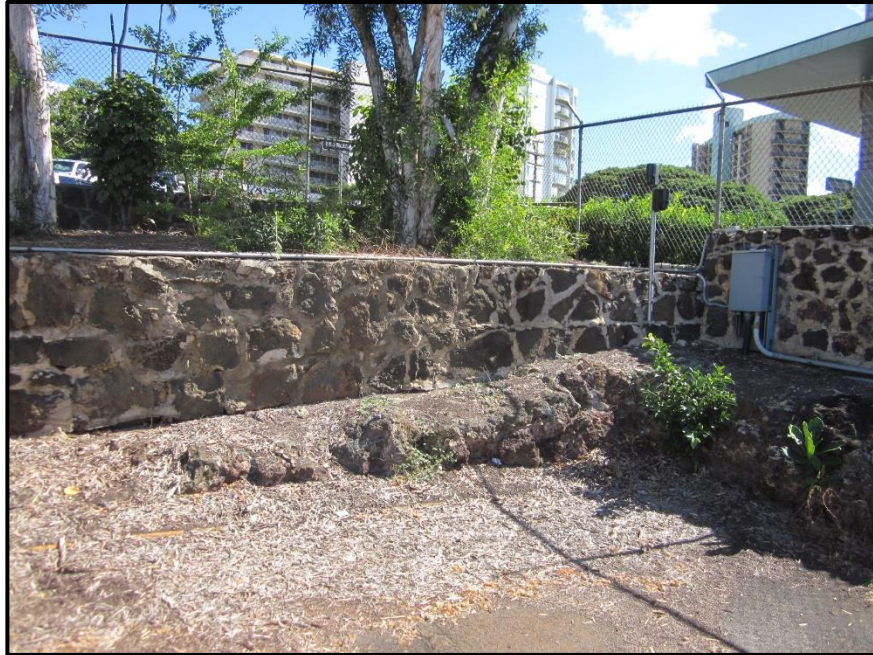
Figure 48. Photographs of Site T-1, Southern and Central Portions of Feature 36, Terrace. Top: Feature 36 South End (on basalt bedrock), View to Southeast. Bottom: Feature 36, View to North.

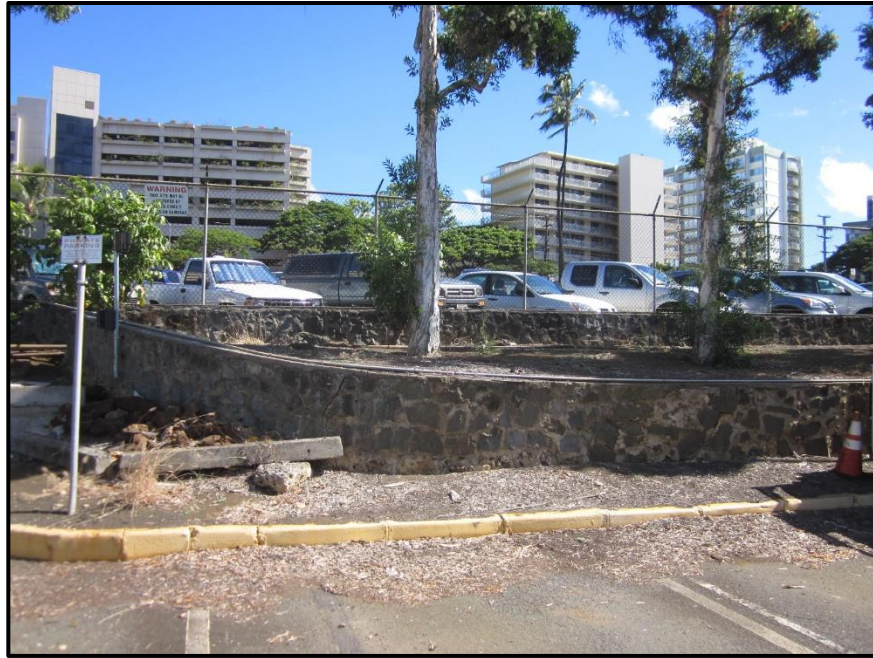
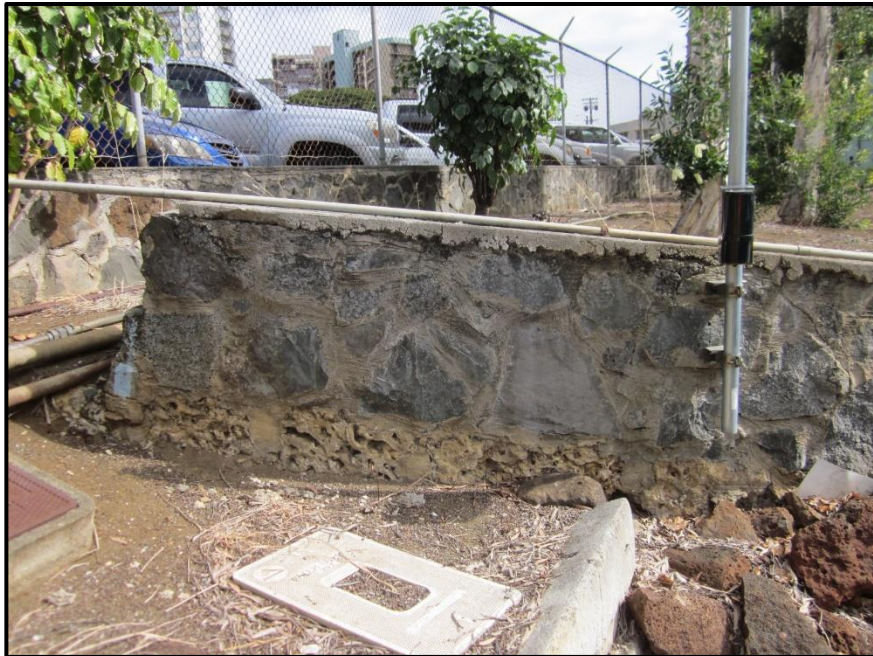
Figure 49. Site T-1, North End of Feature 36, Terrace. Top: Feature 36, North End Showing Curve in Wall, View to Northeast. Bottom: North End of Feature 36 Showing Coralline Limestone at Base of wall, View to East.

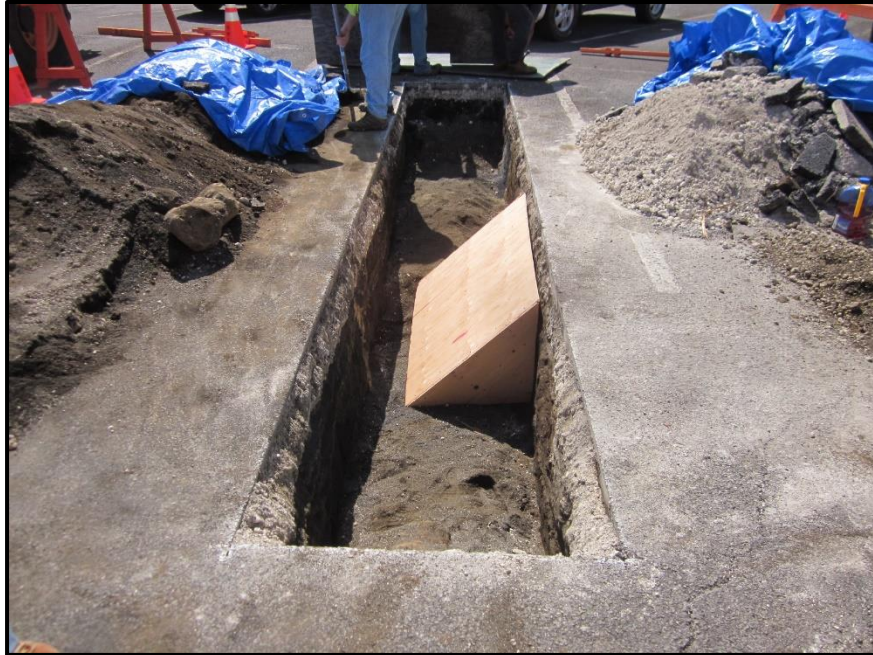
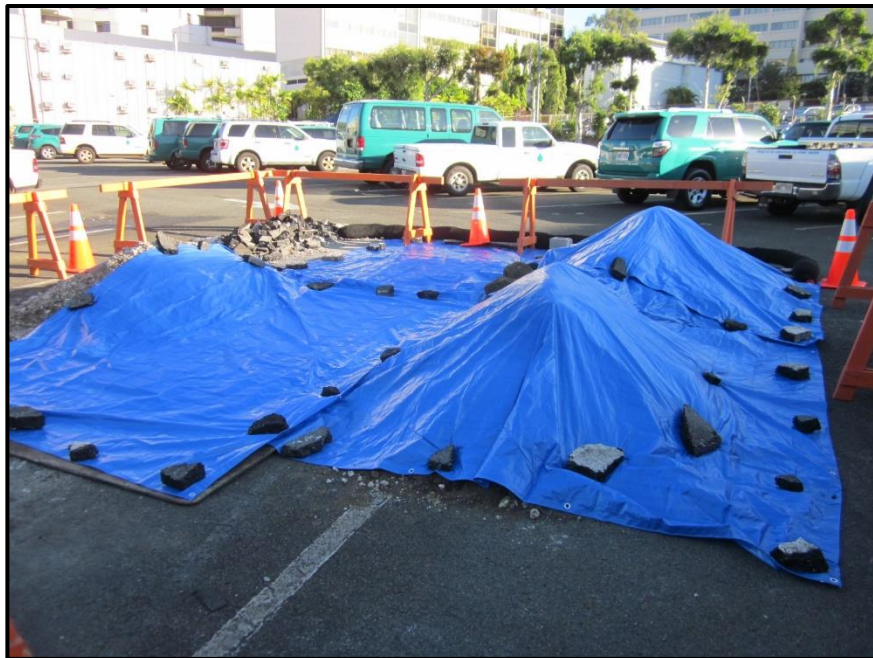
Figure 50. Photographs of Site T-1, Protective Measures for Feature 55 Human Burial. Top: TR15 post excavation with Wooden Protective Box over Feature 55, View to Southwest. Bottom: Feature 55 Showing Tarps Covering TR15 and Backdirt Piles, View to North.

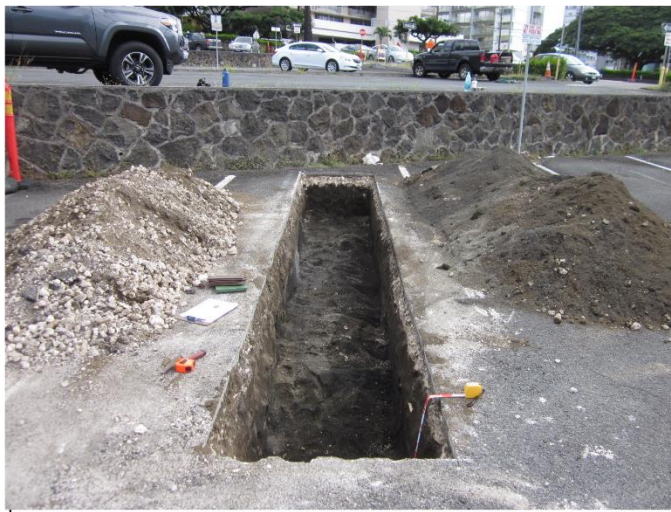
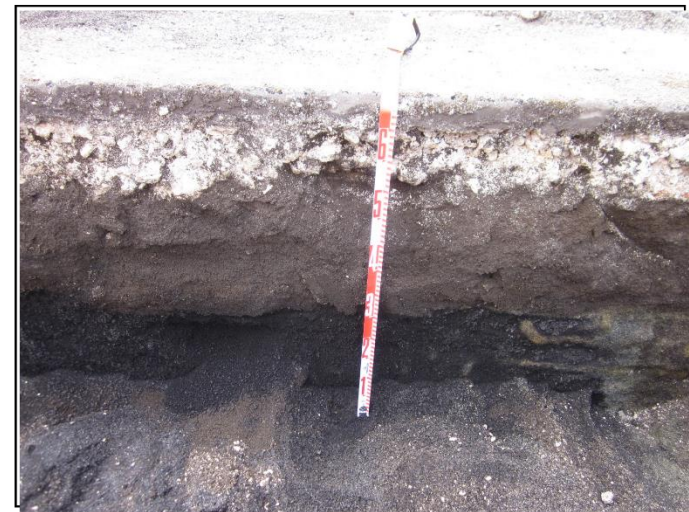
Figure 58. Trench 8 (TR8) North Face Profile and Photographs.

TR8 Overview, View to Northeast.

Inset Photograph: TR8, North Face.

Three stratigraphic layers, designated as Fill A, Layer I, and Layer II, were identified in TR8. A partial glass bottle, a ceramic bowl fragment, and a piece of cut mammal bone were recovered from Fill A deposits in this trench. Layer I, the cultural layer, was found in the second stratigraphic position, directly underlying Fill A. Layer II, the black cinder sand layer, was found directly underlying Layer I. Figure 58 presents a stratigraphic profile drawing of the south face of TR8, with a photograph. No archaeological materials were recovered from Layer I in TR8.

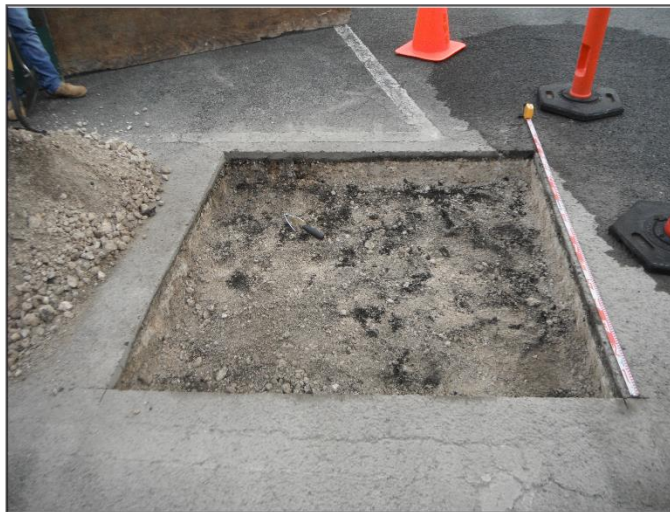
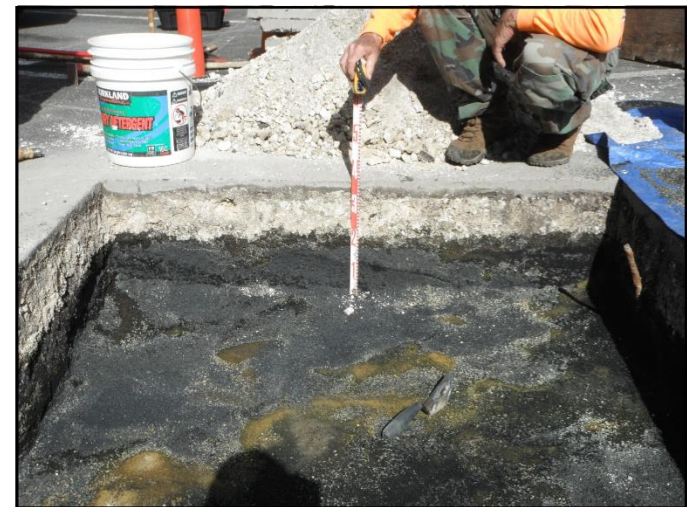
Figure 62. Trench 12 (TR12) SW Face, NW Face, and NE Face Profile and Photographs.

TR12 Overview, View to West

Inset Photograph: TR12 NW Face

Three stratigraphic layers, designated as Fill A, Layer I, and Layer II, were identified in TR12. Layer I, the cultural layer, was present in the second stratigraphic position, but this layer was thin (3-5 cm thick), and discontinuously present, suggesting that upper portions of Layer I were removed before the deposition of Fill A. [Figure 62](#) presents a stratigraphic profile drawings of the northwest, northeast, and southwest faces of TR12, with photographs.
