**Archaeological Inventory Survey In
Support of the Honolulu Board of
Water Supply's Energy Efficiency
Program, Honolulu (Waikiki)
Ahupua'a, Honolulu (Kona)
District, Island of O'ahu, Hawai'i**

TMKs: (1) 2-1-036: 004 and 005

PRELIMINARY DRAFT REPORT
Archaeological Inventory Survey in Support of the Honolulu Board of Water Supply's Energy
Efficiency Program on Beretania Street,
Honolulu (Waikīkī) Ahupua'a, Honolulu (Kona) District,
Island of O'ahu, State of Hawai'i
TMK (1) 2-1-036:004 and 005.

MANAGEMENT SUMMARY

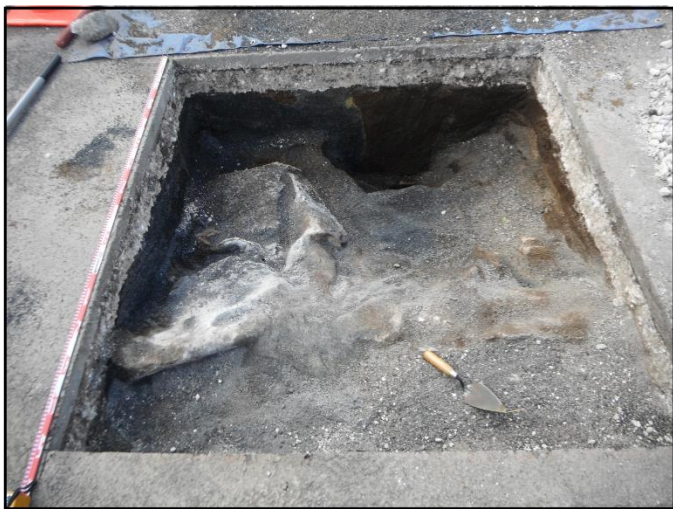
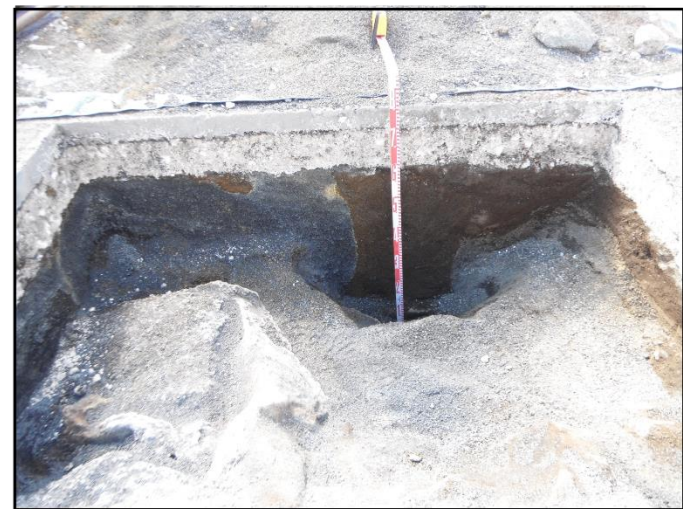
Figure 63. Trench 13 (TR13) SW Face and NW Face Profiles and Photographs.

TR13 Overview, View to West

TR13 Feature 53

Excavations in TR13 exposed relatively shallow basalt bedrock. Three stratigraphic layers, designated as Fill A, Layer I, and Layer II, and a pit feature, designated as Feature 52, were identified in TR13. Fill A was found directly overlying both Layer I and basalt bedrock. Layer I was present in the second stratigraphic position, but was discontinuously present. Layer II was found directly underlying Layer I and Fill A, and directly overlying bedrock. [Figure 63](#) presents stratigraphic profile drawings of the southwest and northwest faces of TR13, with a photograph showing Feature 52

Feature 52 is a pit with nearly vertical sides and a flat base directly overlying basalt bedrock (see [Figure 63](#)). The feature fill of this pit consisted of very dark brown silty sands. The width of Feature 52 ranges from 0.36 to 0.78 m; it ranges in depth from 18 (top) to 68 (base) cmbs.

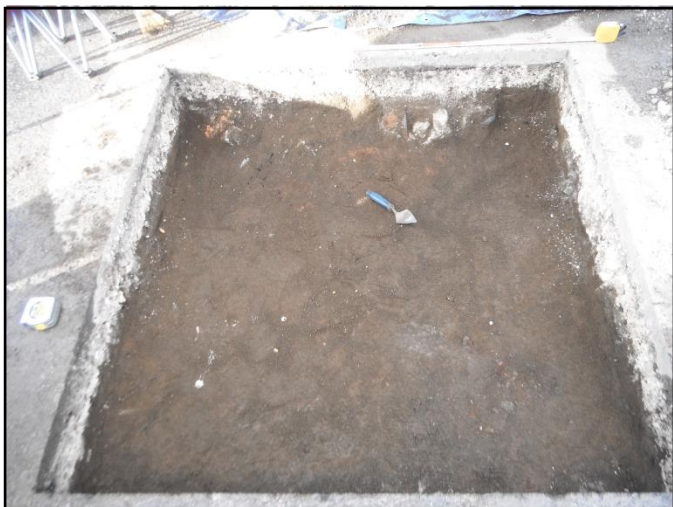
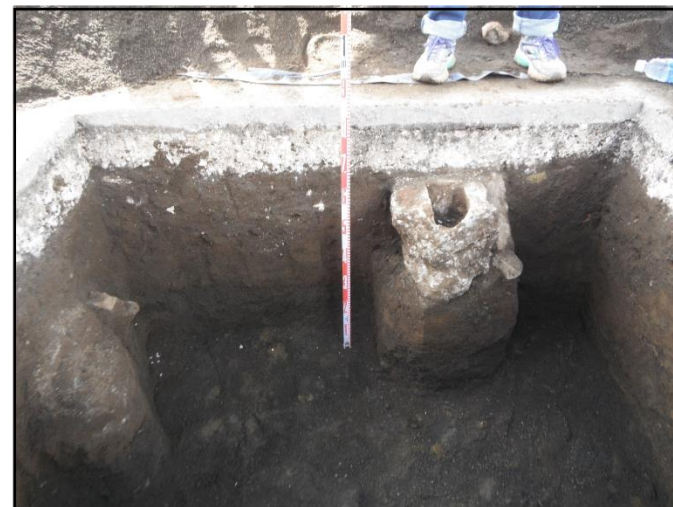
Figure 66. Trench 16 (TR16) SE, SW Face, and NW Face Profiles and Photographs.

TR16 Overview, View to West

TR16 Feature 53

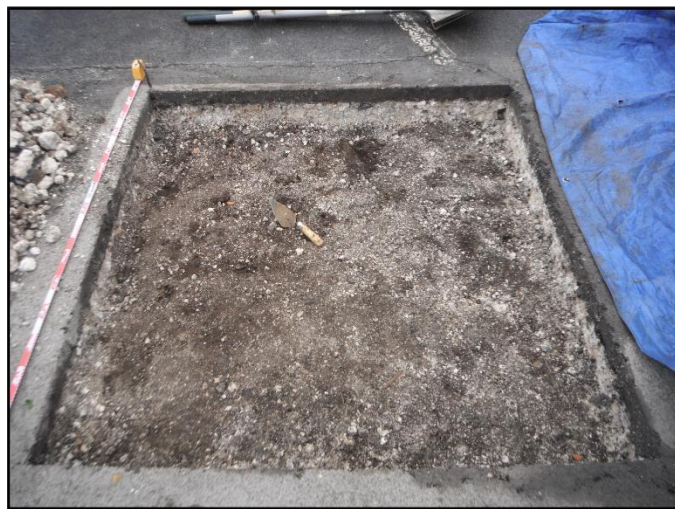
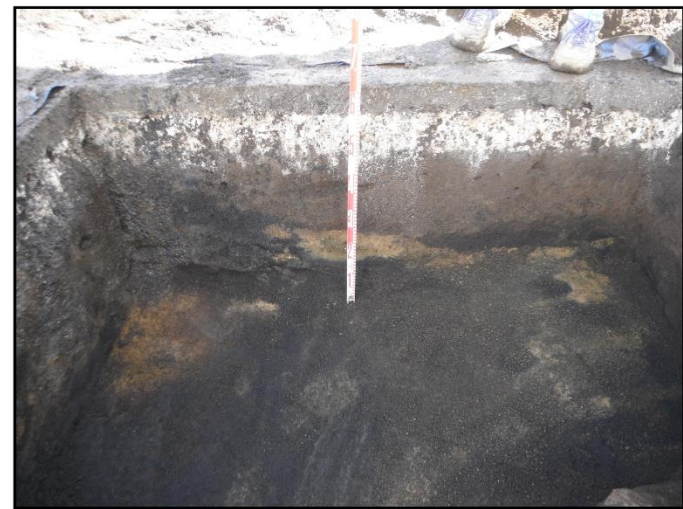
Figure 67. Trench 17 (TR17) SE Face, SW Face, and NW Face Profiles and Photographs.

TR17 Overview, View to North

TR17 Southeast Face

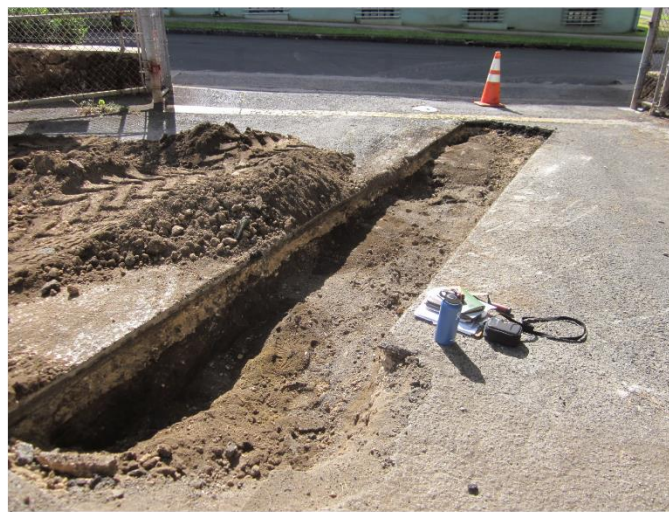
Figure 68. Trench 18 (TR18) East Face Profile and Photographs.

TR18 Overview, View to South

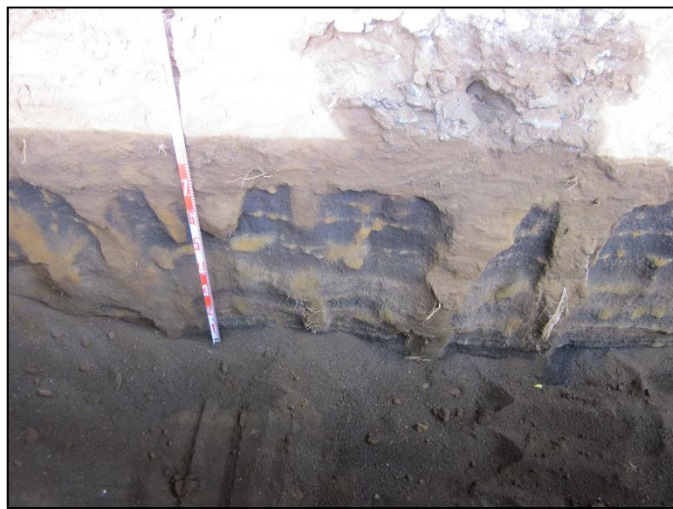
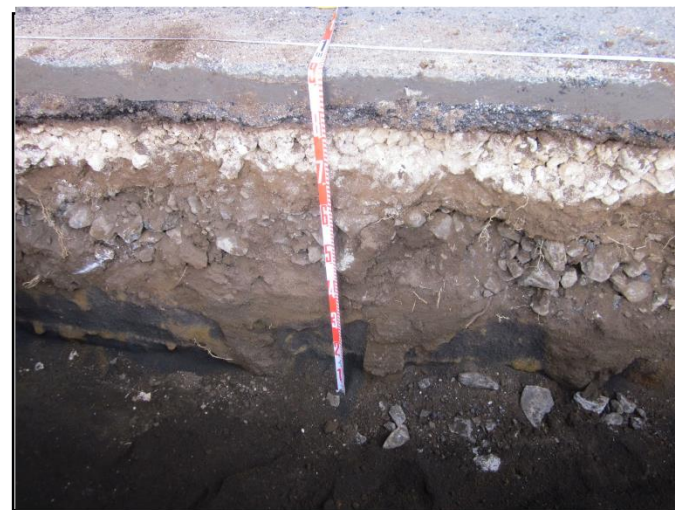
Figure 69. Trench 19 (TR19) North Face Profile and Photographs.

Inset Photograph 1: TR19 North Face

Inset Photograph 2: TR19 Feature 54

Feature 54 was encountered in central portions of TR19. This is a cobble/pebble concentration with a roughly flat base (see Figure 69). The fill of this feature consisted of dark reddish gray, very cobbly, pebbly, sandy clay. Feature 54 measures 3.15 m in width, and ranged in depth from 30 (top) to 50 (base) cmbs.

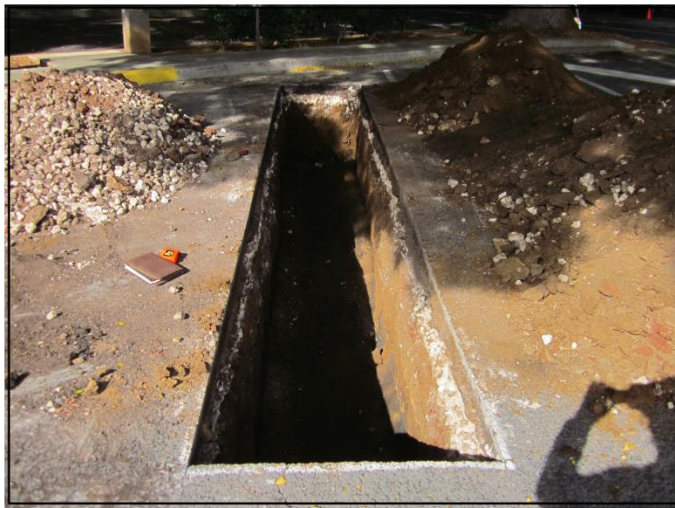
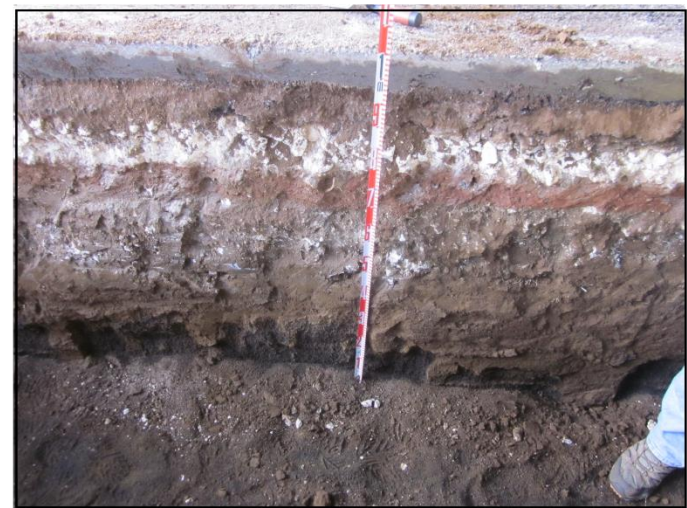
Figure 70. Trench 20 (TR20) North Face Profile and Photographs.

TR20 Overview, View to West

Inset Photograph: TR20, East Face

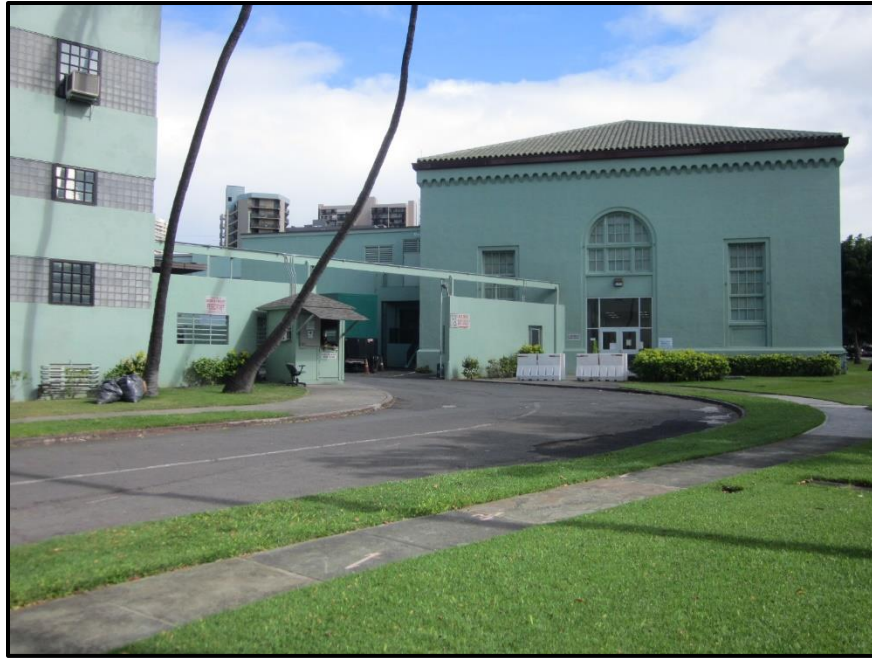
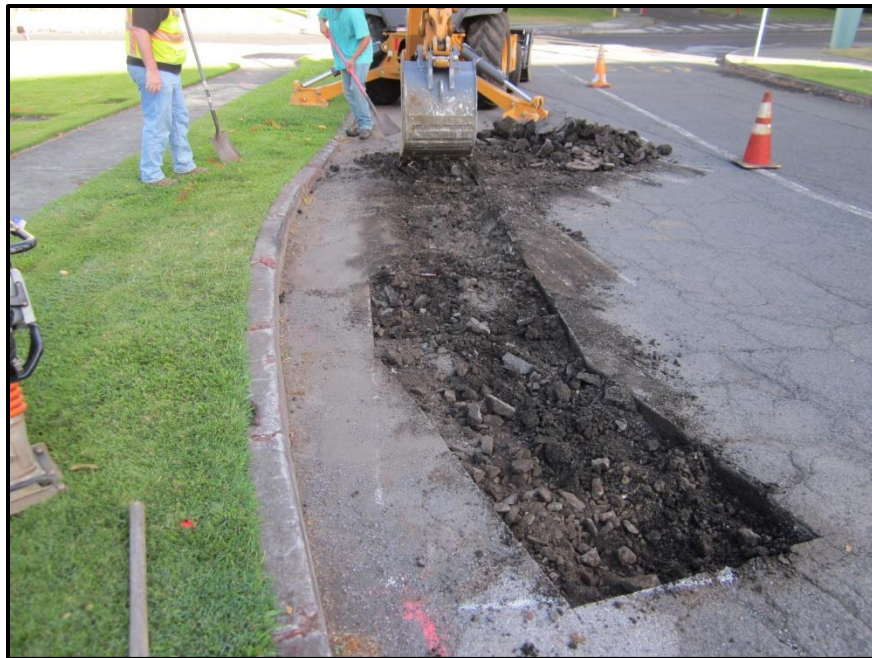
Figure 71. Photographs of TR21 in Paved Access Road leading to the Engineering Building in BWS Site 7. Top: TR21 Post Excavation, View to East. Bottom: TR21 Removal of Asphalt, View to West.

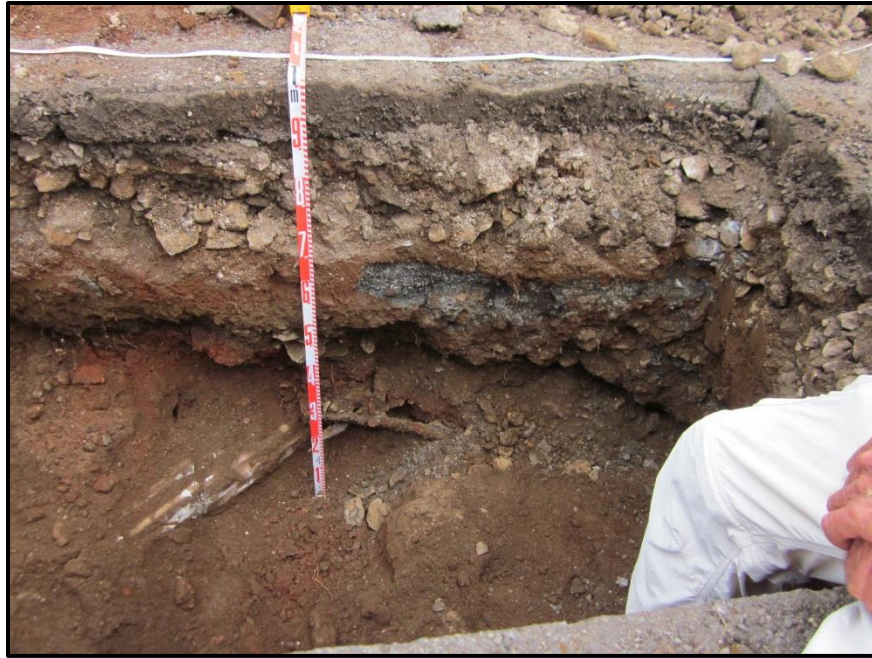
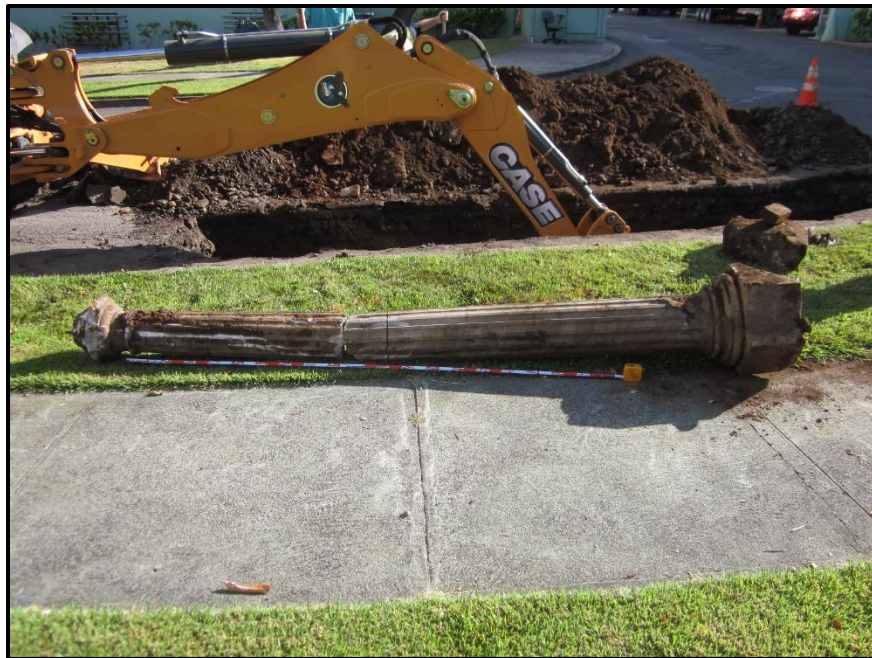
Figure 72. Photographs of Lamp Post Recovered in Trench 21. Top: TR21 Post Excavation Showing In Situ Lamp Post Sections within Layer I, View to East. Bottom: Lamp Post Removed from TR21; View to East.

Layer I, the cultural layer, exhibited color and texture variations in TR21 that were not observed in TR1-20 in the EPL, CVPL, and VPL. In TR21, Layer I in TR21 is a reddish brown (5YR 4/3, m.) silt loam that was disturbed (mixed). During excavations in Layer I, four sections of old metal lamp posts were exposed; two were removed while other sections extended into the faces of TR21. Figure 72 presents photographs of the two sections that were removed and two sections still in situ. Layer II, the black cinder sand layer, was found directly underlying Layer I. Figure 73 presents a stratigraphic profile drawing of the east face of TR21, with a photograph.

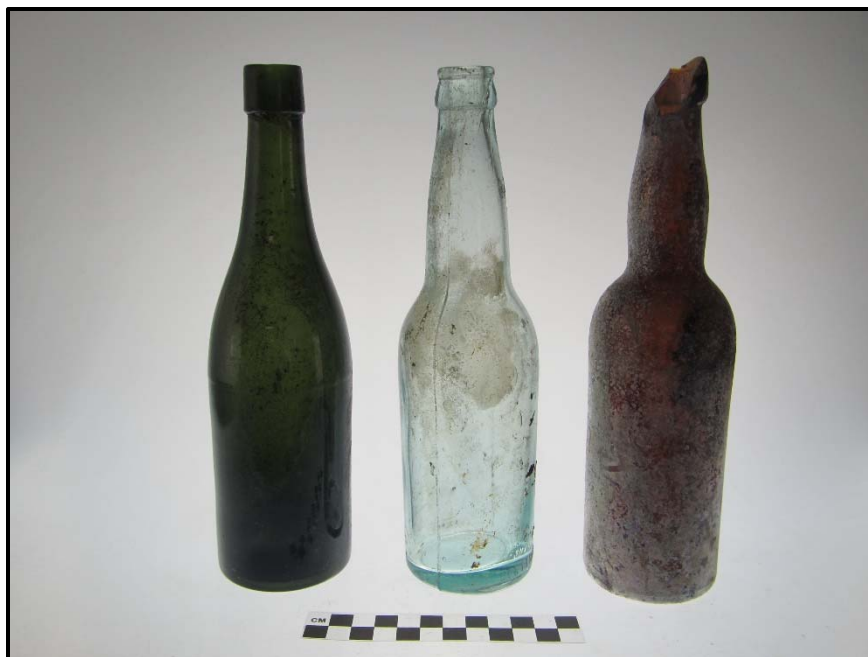
Figure 74. Photograph of Mold-Blown Alcoholic Beverage Bottles, Artifact 2.25 (left), Artifact 29.1 (center) and Artifact 2.26 (right).

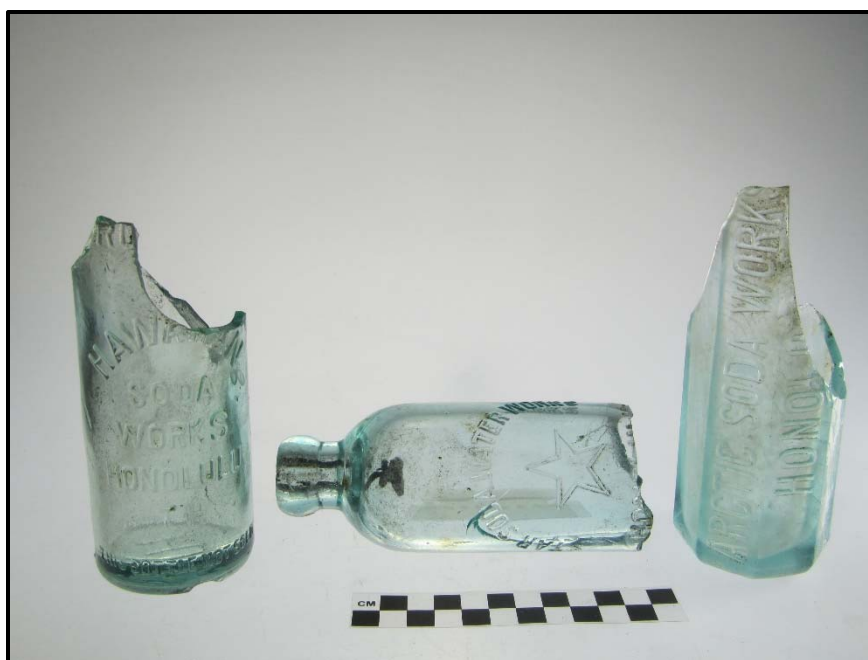
Figure 75. Photograph of Mold Blown Soda Bottles, Artifact 28.2 (left), Artifact 25.2 (center), Artifact 6.1 (right).

Artifact 25.2 is an aqua bottle which was blown into a hinged, cup-bottom mold. This bottle exhibits mold seams that extend up the sides and shoulder to below the finish (Munsey 1970:44). The bottle finish is a hand tooled blob top which accommodated a Hutchinson stopper which is still present in the closure (see Figure 75). "STAR SODA WATER WORKS HONOLULU" is embossed on the body of the bottle. This bottle was in use around 1900 (Elliot and Gould 1988:119 #265).

Artifact 6.1 is an aqua glass bottle blown into a cup-bottom mold producing seams around the heel and up the sides of the bottle. This distinctive octagonal bottle is known to have utilized a Hutchinson stopper (see Figure 75). "ARTIC SODA WORKS HONOLULU" is embossed vertically on the body of the bottle. This bottle was in use between 1902 and 1903 (Elliot and Gould 1988:77).

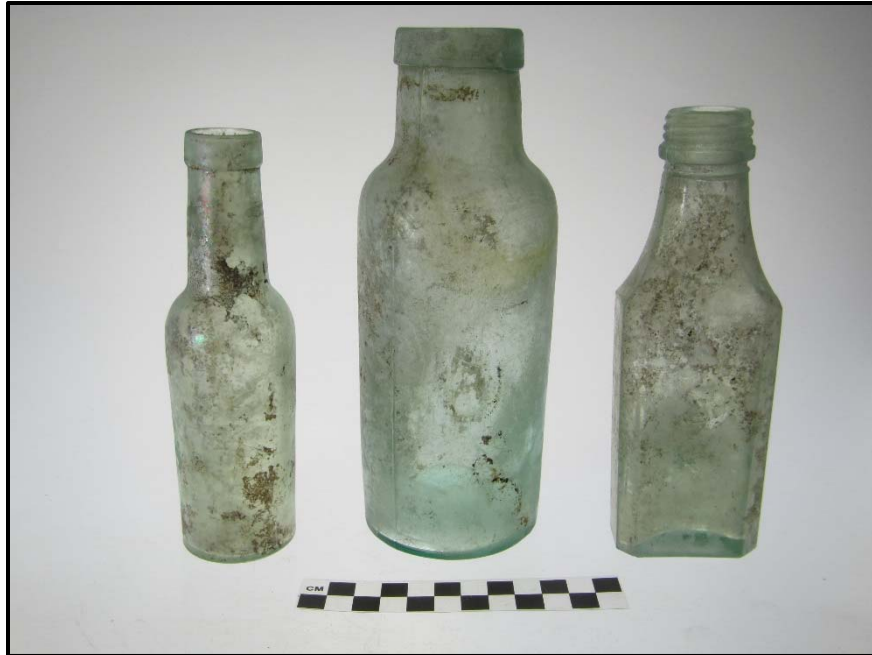
Figure 79. Photograph of Mold Blown Condiment Bottles, Artifact 25.5 (left), Artifact 28.1 (center) and Artifact 22.2 (right).

Artifact 28.1 is also a generic condiment bottle which had a paper label. This cylindrical bottle was blown into a cup-bottom mold and exhibits seams around the heel and up two sides to just below the finish (see Figure 79). The "Packer" finish is an applied collar of glass (Fike 1987:8). Similar bottles contained preserved olives, fruit, or pickles (Zumwalt 1980:206).

Artifact 22.2 is a rectangular bottle fashion from aqua glass. This bottle was blown into a full-height cup bottom mold. The crude thread closure is formed in the mold (see Figure 79). Mold seams extent around the heel, up two corners of the body and through the threaded

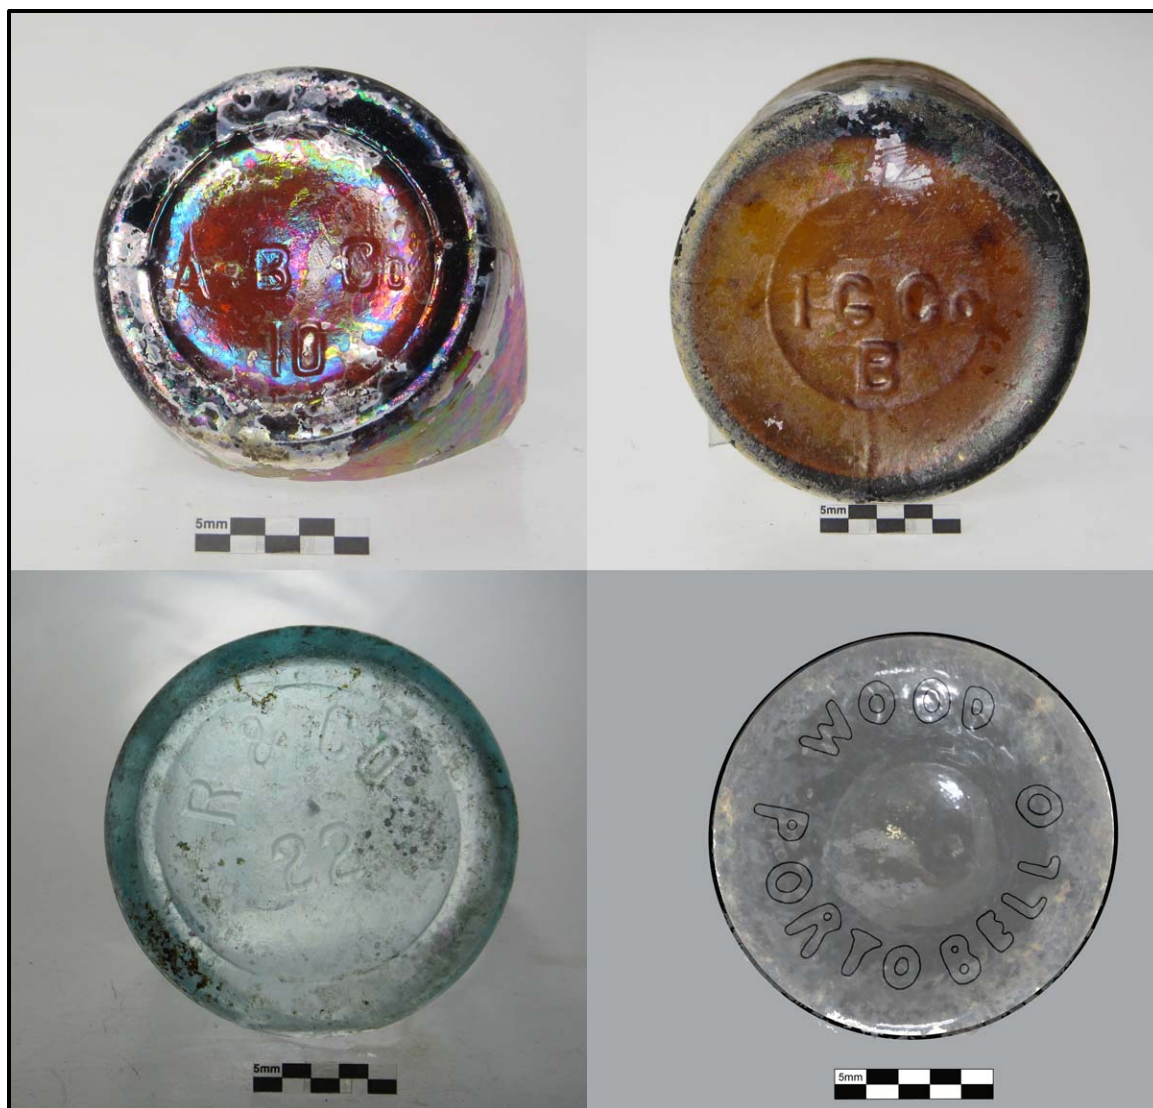
Figure 80. Photographs of Makers Marks on Mold Blown Bottles, Artifact 33.2 (upper left), Artifact 2.9 (upper right), Artifact 3.11 (lower left) and Artifact 37.2 (lower right).
