# FINAL- 2009 - BIENNIAL TANK INTEGRITY TESTING REPORT (CDRL A001) BFCUST #14 (RPI# - PRL-341) *at* FISC RED HILL PEARL HARBOR, HI

**FINAL 2009 BIENNIAL INTEGRITY TESTING REPORT**

**BFCUST # 14**

**FISC RED HILL – PEARL HARBOR, HI**

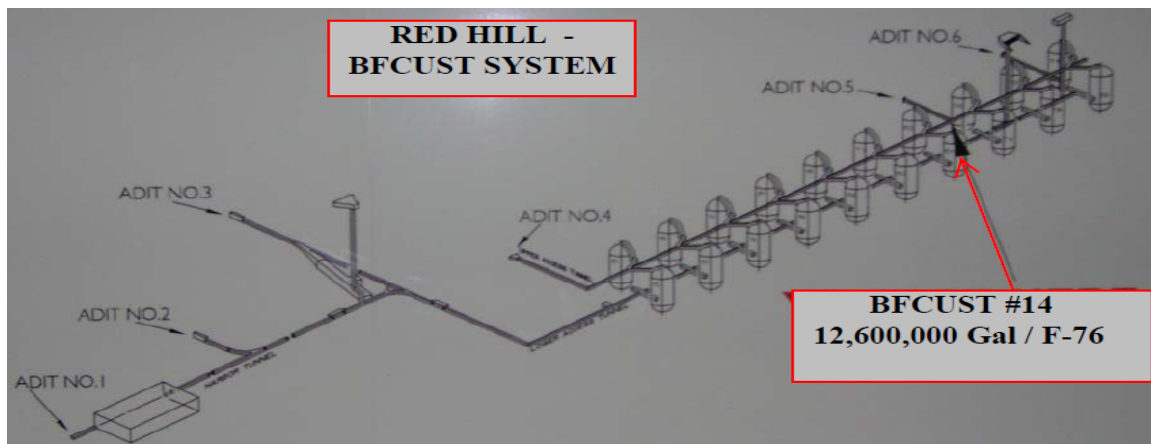
**Figure 1: RED HILL – BFCUST SYSTEM – BFCUST # 14**

Figures 1-3 show details of the Red Hill system and typical tank access points.

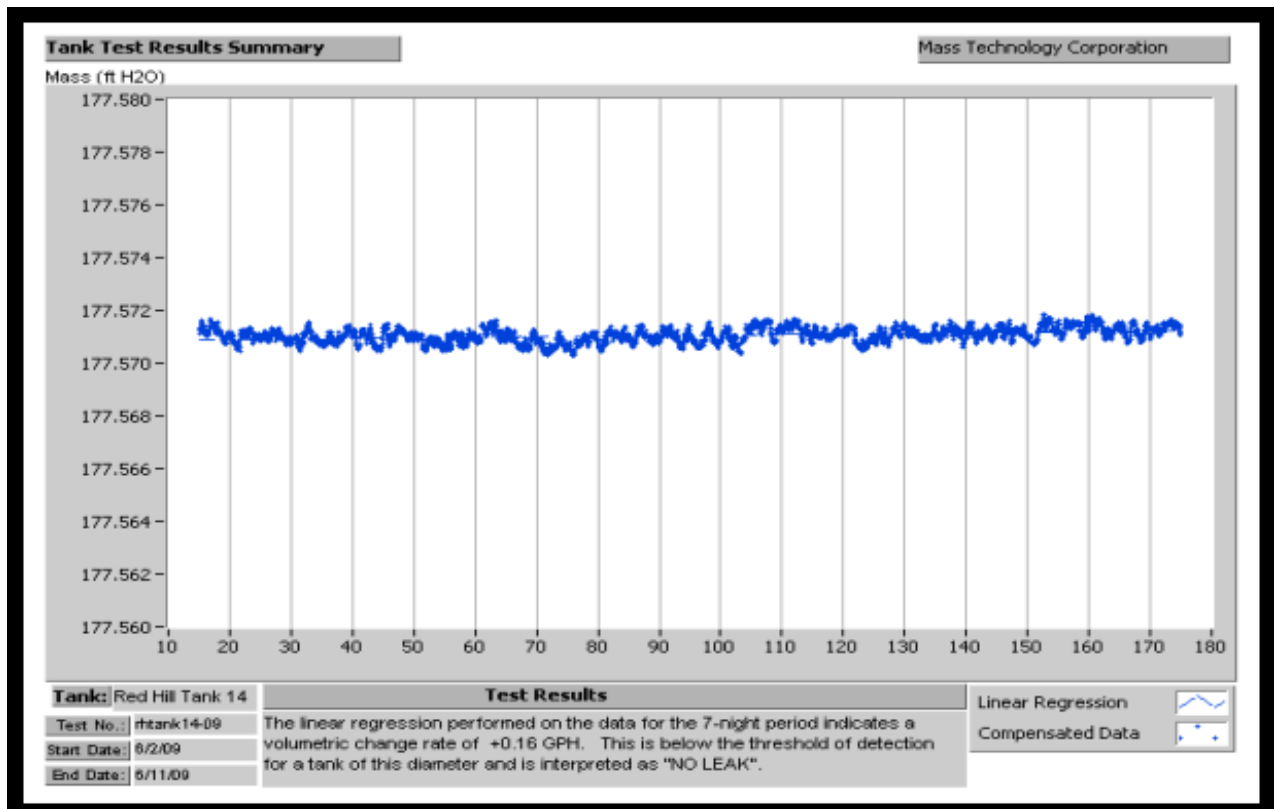
The fluid mass data was recorded over a 168-hour period. A linear regression of the recorded fluid mass data resulted in a leak rate detected below the minimum detection level of 0.7 gallons per hour. All tank valves were adequately secured such that any fluid loss was isolated to leakage. Therefore, the containment integrity of the tank was not compromised and the test is considered conclusive.
