WATER FOR LIFE Sufe, dependable, and affordable water now and into the future Meeting Objectives A Receive updates regarding the BWS Seek your input on straw man financial policies Identify typical customer types for rate impact evaluation Review Kalanianaole main break and relevance to pipeline replacement strategy

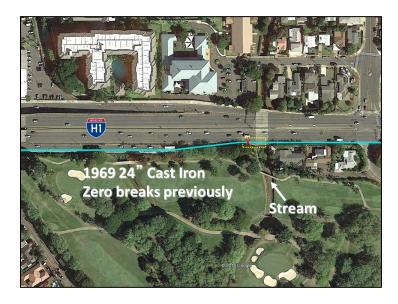
- The pipe failed catastrophically,
- Work required excavating 20-ft deep as the break was at a point where the pipe turned downward to get under a stream.

The break was in a really bad location, near the off-ramp from H1 to Kal Hwy and on-ramp from Kilauea to Kal Hwy.

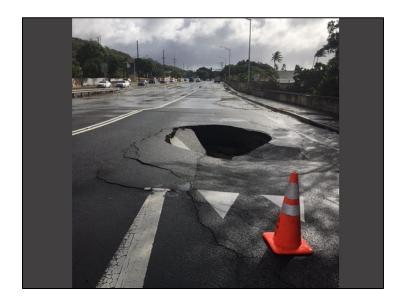
The Honolulu Police Department (HPD) discovered the leak.

They closed H-1 and notified BWS immediately. This photo shows the hole in the pavement above the break, after the water was cleared from the area.

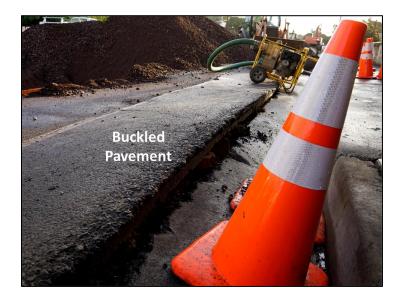
The force of the water had buckled the pavement, between 6 inches and more than a foot.

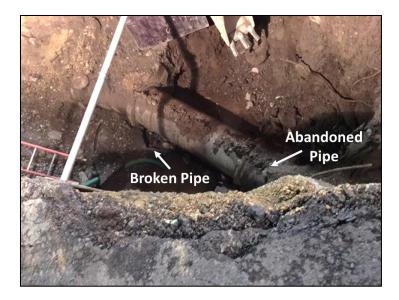
An abandoned pipe was found crossing the broken pipe at a higher elevation. This limited access to the broken pipe.

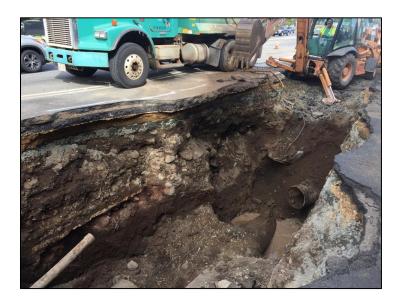
Given the depth of excavation that would be necessary, a trench box was ordered. This would keep the soil from caving in. Work on site continued through the night.

As is shown here, absent the trench box installation, the sides of the hole would be subject to caving in.

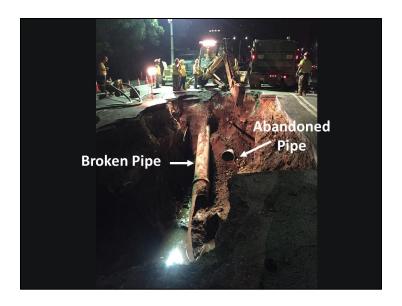
The trench box was so large it was necessary to bring in a larger-than-usual excavator. This further delayed excavation.

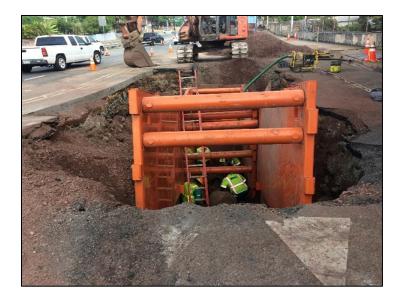
Once the trench box was in place, hand excavation got underway as the only feasible digging option.
