Tank 17 Removal Action Report Red Hill Fuel Storage Facility Pearl Harbor, Oahu, Hawaii Latitude: 21°22'15" N Longitude: 157°53'33" W

DOH Facility ID No. 9-102271 DOH Release ID No. 99051, 010011, 020028

September 2008

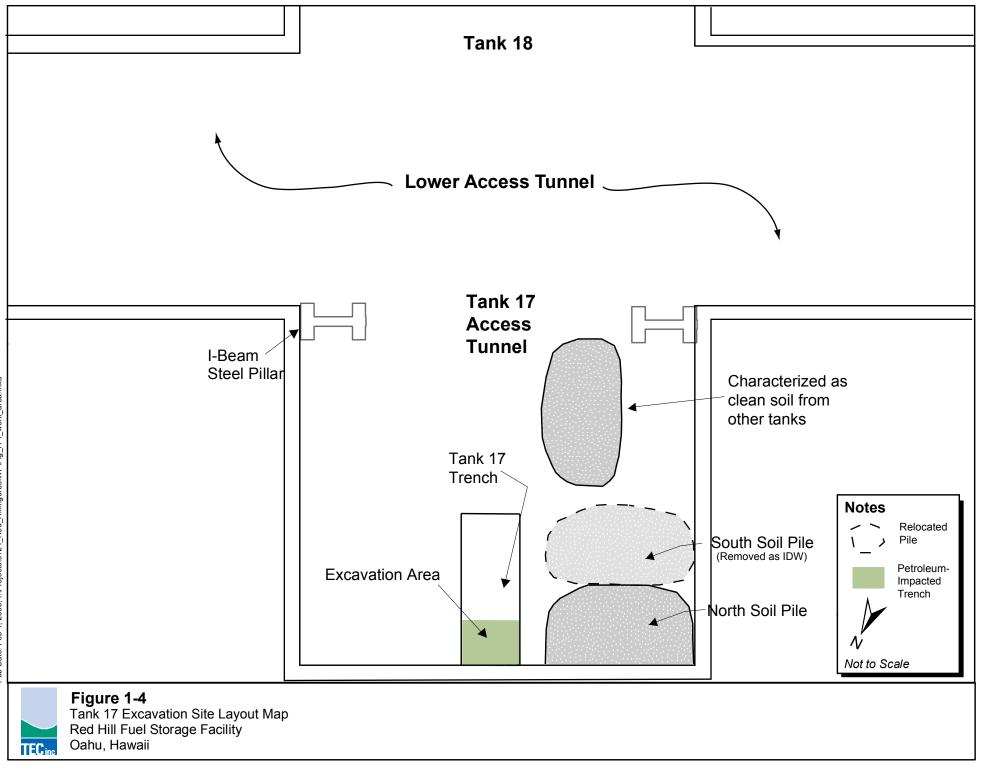
On March 4, 2008, the sample line to the bottom of Tank 17 in the lower access tunnel leaked JP-5 fuel. The leak was associated with the repair of this sample pipeline. The sample line that was responsible for the leak had trapped JP-5 that was inadvertently released. Once the sample line was cleared, no more JP-5 fuel was released. The duration of the JP-5 release was approximately 20 seconds resulting in an estimated three to four gallons spilled onto an excavated pile of soil and rubble that had been covered with plastic sheeting. The fuel migrated off the sheeting, onto the concrete floor of the tunnel and into an open trench that was being prepared for soil vapor monitoring points (SVMPs) associated with Tank 17. The bottom of the trench contained both consolidated and unconsolidated bedrock. FISC site personnel (Ryan Gilla and Neal Horimoto) initiated immediate spill response measures that included the placement of absorbent pads on the floor and surrounding soil/rock to recover as much JP-5 as possible. The estimated quantity of JP-5 recovered by the absorbent pads was one to two gallons while the remainder of the fuel most likely infiltrated into the adjacent trench. Initial spill response actions by FISC personnel did not include removal of liquid or contaminated soil other than what was removed in the absorbent material. Figure 1-4 shows the Tank 17 site layout and features.

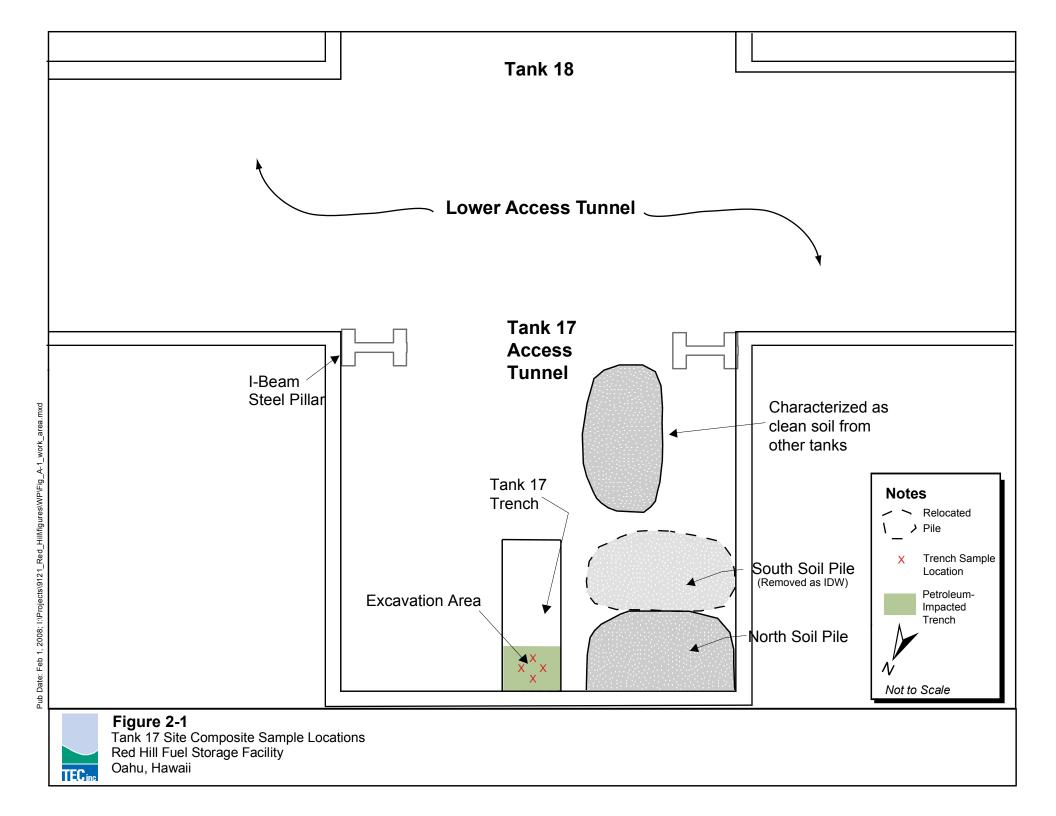
Composite samples were analyzed by SGS Environmental Services, Inc. in Anchorage, Alaska for TPH-DRO by EPA Method 8015B, TPH-GRO and VOCs by EPA Method 8021, PAHs by EPA Method 8270C SIM, and flashpoint for disposal.

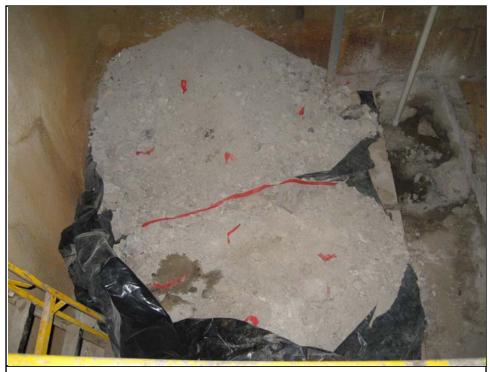
Photo 1

Locations of PID measurements from the soil stockpile that was under the release. The stockpile was mostly covered in plastic.

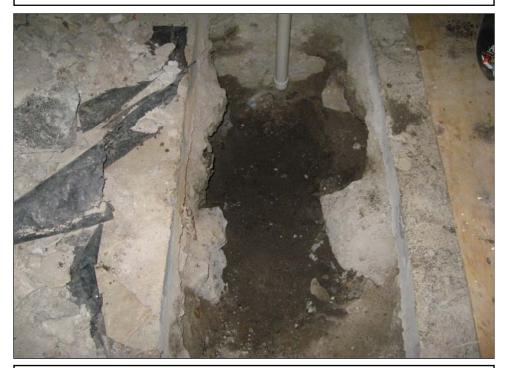
Photo 2 Impacted bedrock in trench before excavation. **Tank 17 Excavation**

At a depth of one foot below the original surface, petroleum (presumably JP-5) was observed to pool within the low points of the excavation. TEC personnel used a vacuum to remove the pooled fluid to the extent practical. Fluid increased with depth to a total depth of 1.5 feet below the original grade. The excavation was advanced by breaking fragments of the bedrock using the pneumatic jackhammer then removing the material with a shovel or by hand. The excavated material consisted of solid rock (basalt with very small vesicles less than 2 millimeters (mm) in diameter). During the use of the demolition hammer, strong fuel odor was coming from the trench and one breathing zone reading was approximately 25 ppmv. Work continued using full-faced respirators. The trench was excavated to dimensions of approximately 2 feet long by 1.7 inches wide by 1.5 feet deep. Excavation activities ceased once TEC personnel reached the depth where the demolition hammer was no longer effective.

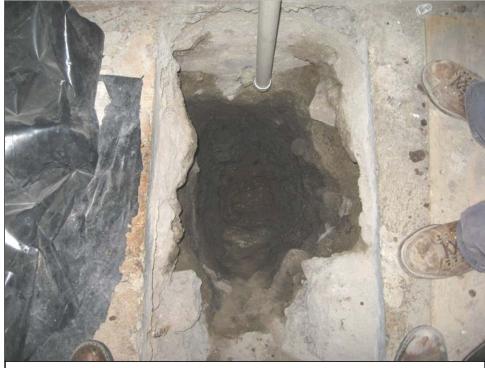
Photo 3

Excavation extents adjacent to Tank 17 bulkhead (5 ft below surface)
Tank 17 Excavation
June 17, 2008

It is recommended that no further action be taken to remove or destroy the remaining JP-5 due to the insignificant risk and technical difficulty associated with additional excavation adjacent to the wall of the Tank 17 access tunnel. It is further recommended that the trench excavation be completed as follows:

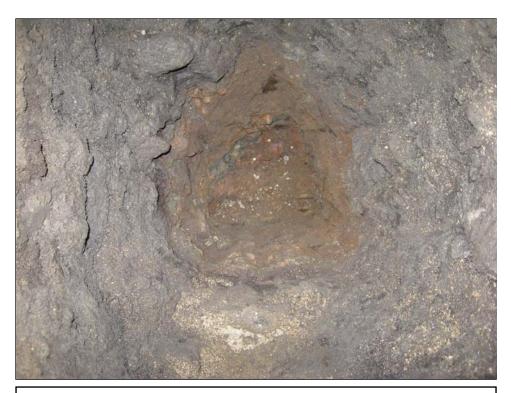
Photo 4 Excavation extents adjacent to Tank 17 bulkhead (Close-up). Tank 17 Excavation June 17, 2008
