**Headquarters, Joint Task Force-Red Hill Public Affairs Office
Ford Island Conference Center
Joint Base Pearl Harbor-Hickam**

PRESS RELEASE

May 5, 2023

**Joint Task Force – Red Hill Announces AFFF Investigation Findings and Publishes
Video Footage**

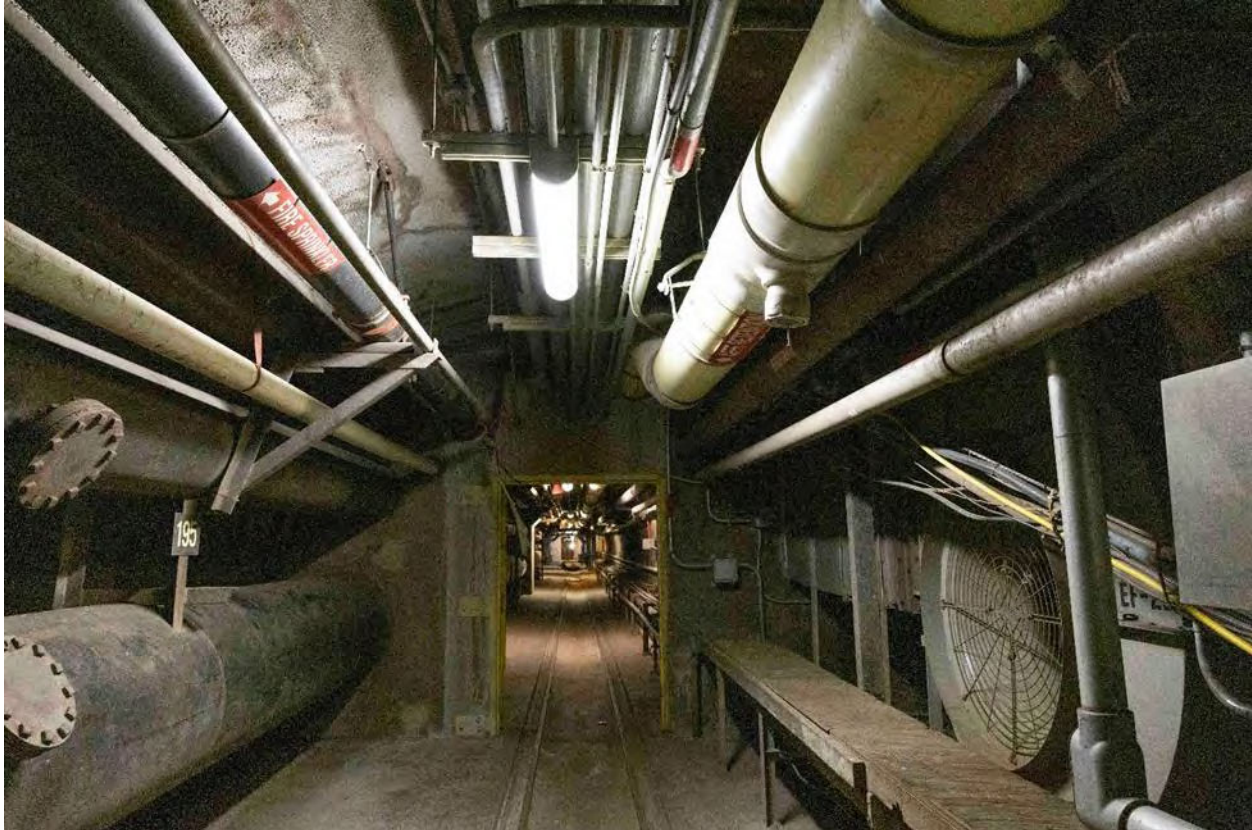
Lower Access Tunnel with AFFF retention line in top right (PVC pipe)

5. The entrance to the pump station is located (b)(3)(A) and 380 feet from the site of the ruptured Aqueous Film Forming Foam (AFFF) retention line low point drain inside the Red Hill lower access tunnel. The top of the well shaft is approximately (b)(3)(A) from the entrance of the pump station. [Encls (7), (9)]
6. Water is pumped from a 110-foot deep vertical well shaft with a bottom elevation of (b)(3)(A) sea level. [Encl (12)]
7. The well includes a horizontal water tunnel, known alternatively as a development tunnel or infiltration gallery, which is connected approximately 100 feet down the vertical well shaft. This horizontal developmental tunnel extends across the water table (b)(3)(A). [Encls (4), (12)]
8. The bottom of the development tunnel is 3 feet below sea level and is 18 feet high by 6 feet wide. (b)(3)(A) [Encl (12)]

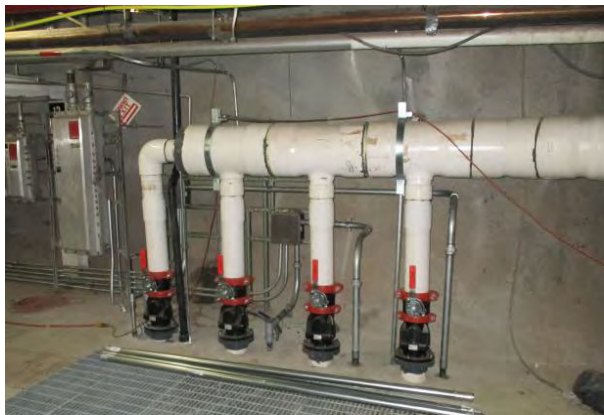
383. On 13 Mar 17, the construction contractor formally notified NAVFAC PAC, in writing, that they constructed the entire AFFF retention line with PVC vice Steel pipe. [Encl (353)]

Original AFFF Retention Line Piping in Immediate Area of an AFFF Sump

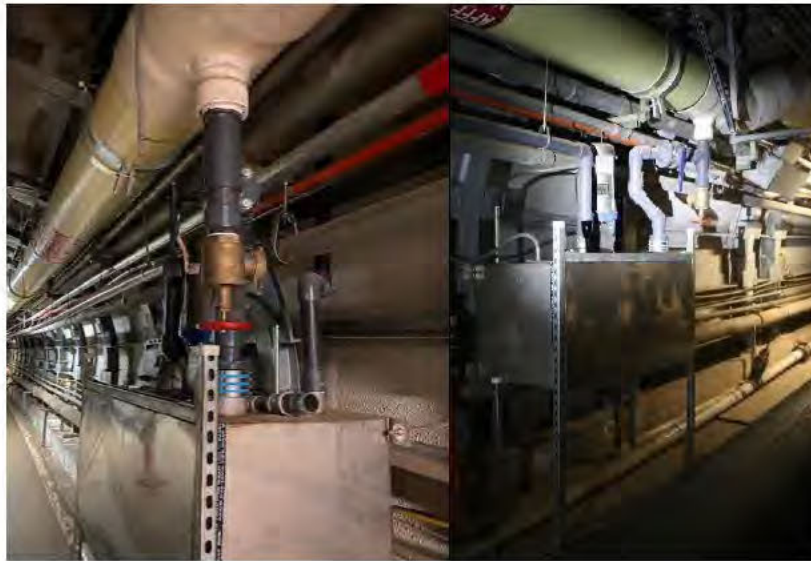
drainage out to a new manual hose connection at the Adit 3 entrance via new 3” PVC piping. This system does not utilize the groundwater sump system. This is the installed configuration today and is in close proximity to the Adit 3 groundwater sump, but does not connect with that sump. This system was not used to drain the AFFF retention line following the November spill. [Encl (354)]

Final Installed Low Point Drain System with PVC Retention Line

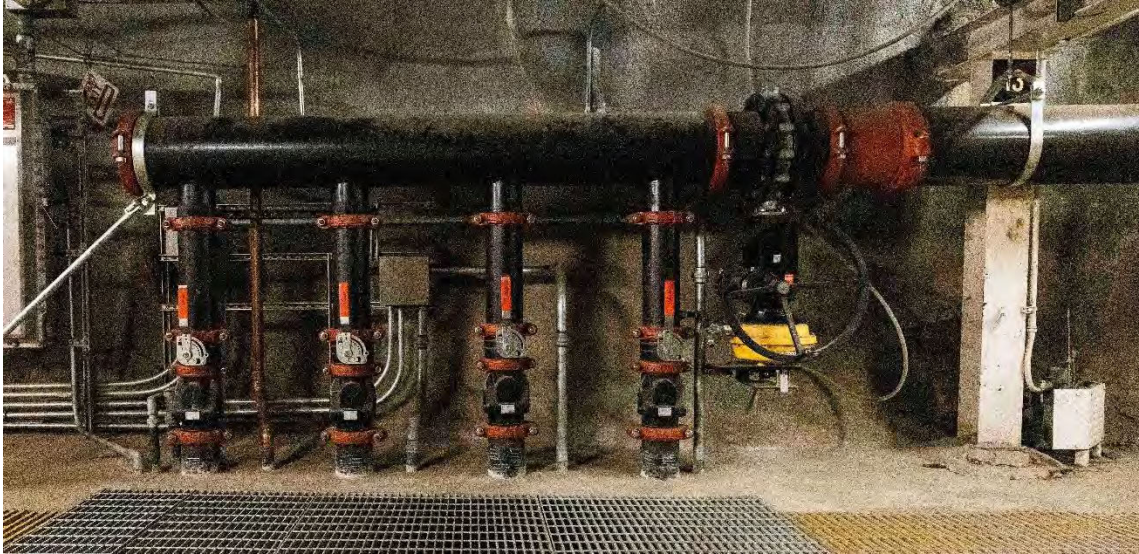
405. On 19 Jun 19, Change R was completed by the construction contractor. This is the configuration today. Commissioning testing was not performed again on the AFFF waste system. However, servicing was performed on the sump pumps (grease, rotation, cleaning) during connection of the new steel piping in the immediate area of the pumps. It was noted at the time that some of the pumps were seized due to lack of preventative maintenance, but were operational at the completion of servicing. [Encls (332), (362), (364)]

Final Change R Piping in Immediate Area of an AFFF Sump

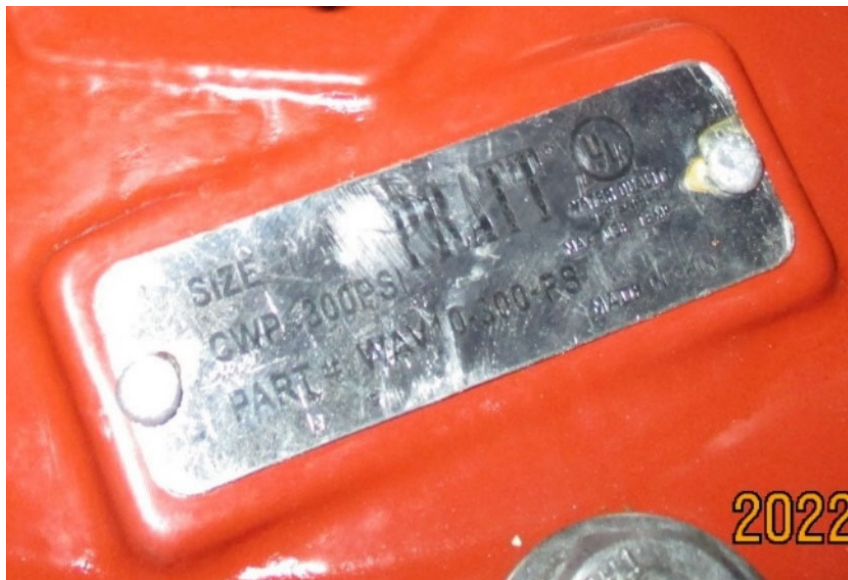
IMG_3158.JPG – Cropped/Enlarged image of Air Vacuum Valve Nameplate

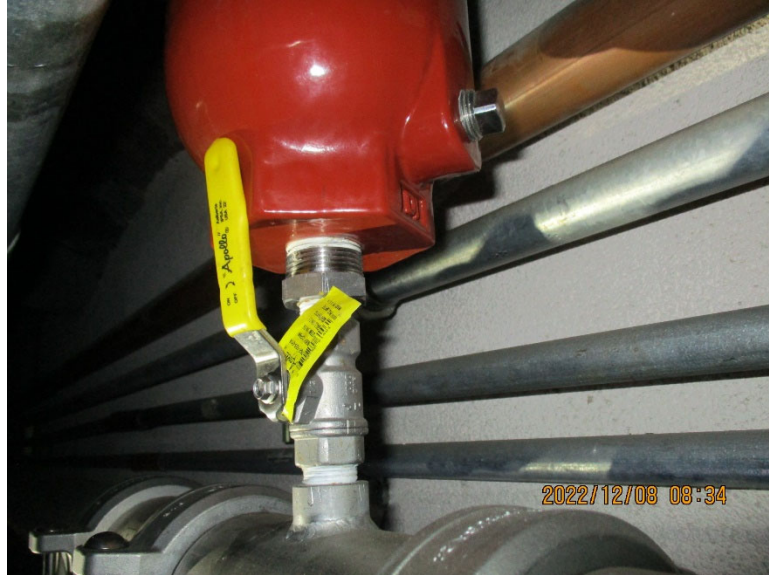
IMG_3150.JPG, taken by author on 8 Dec 2022 – Connection of Air Vacuum Valve to concentrate piping

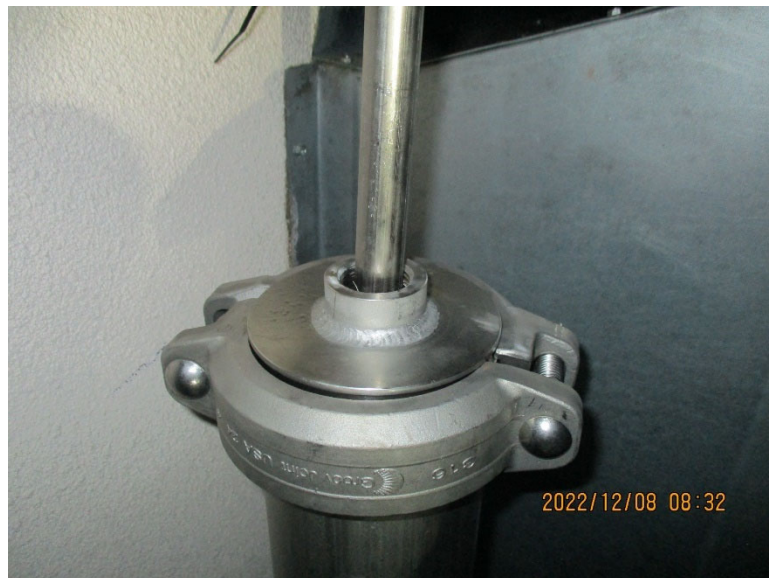
IMG_3143.JPG, taken by author on 8 Dec 2022 – Drain piping connection to drain containment vessel

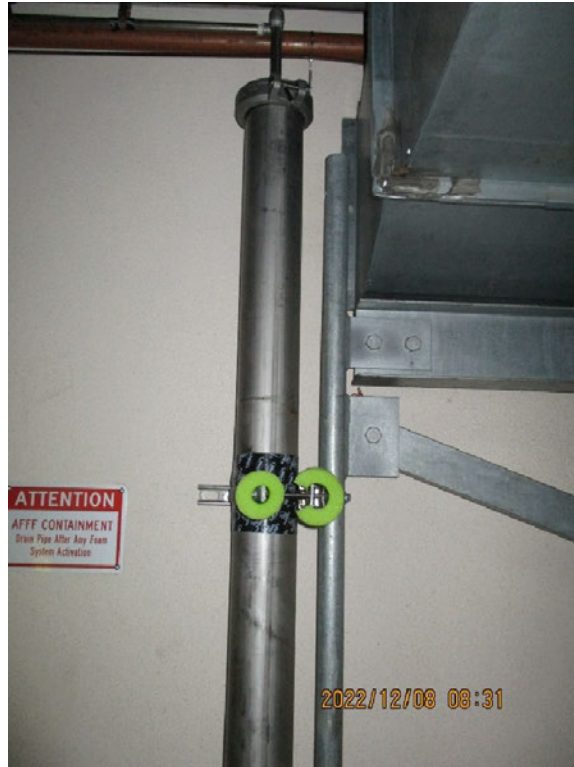
IMG_3139.JPG, taken by author on 8 Dec 2022 – Drain Containment Vessel

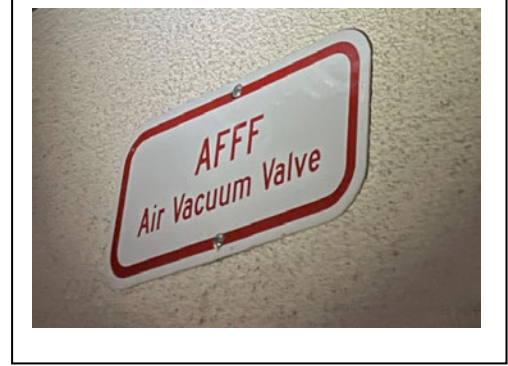
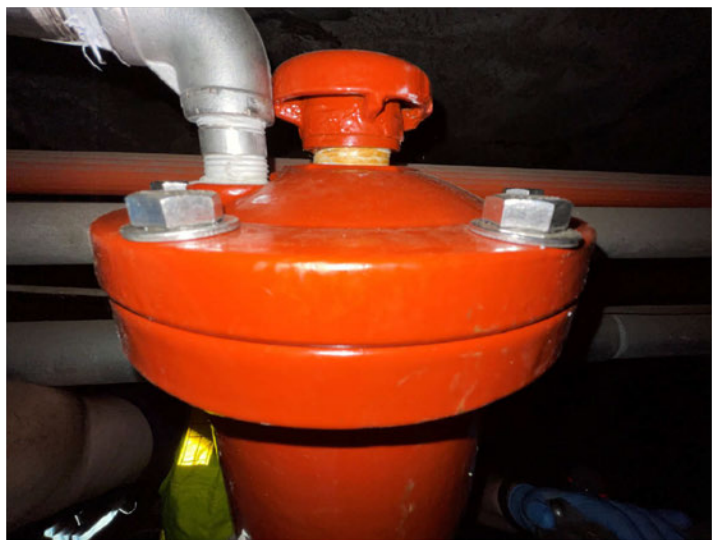
Adit 6 - Air vacuum valve with vent piping connected to flush inlet connection instead of air vent connection (occupied by mushroom)

Adit 6 - Air vacuum valve, back view.

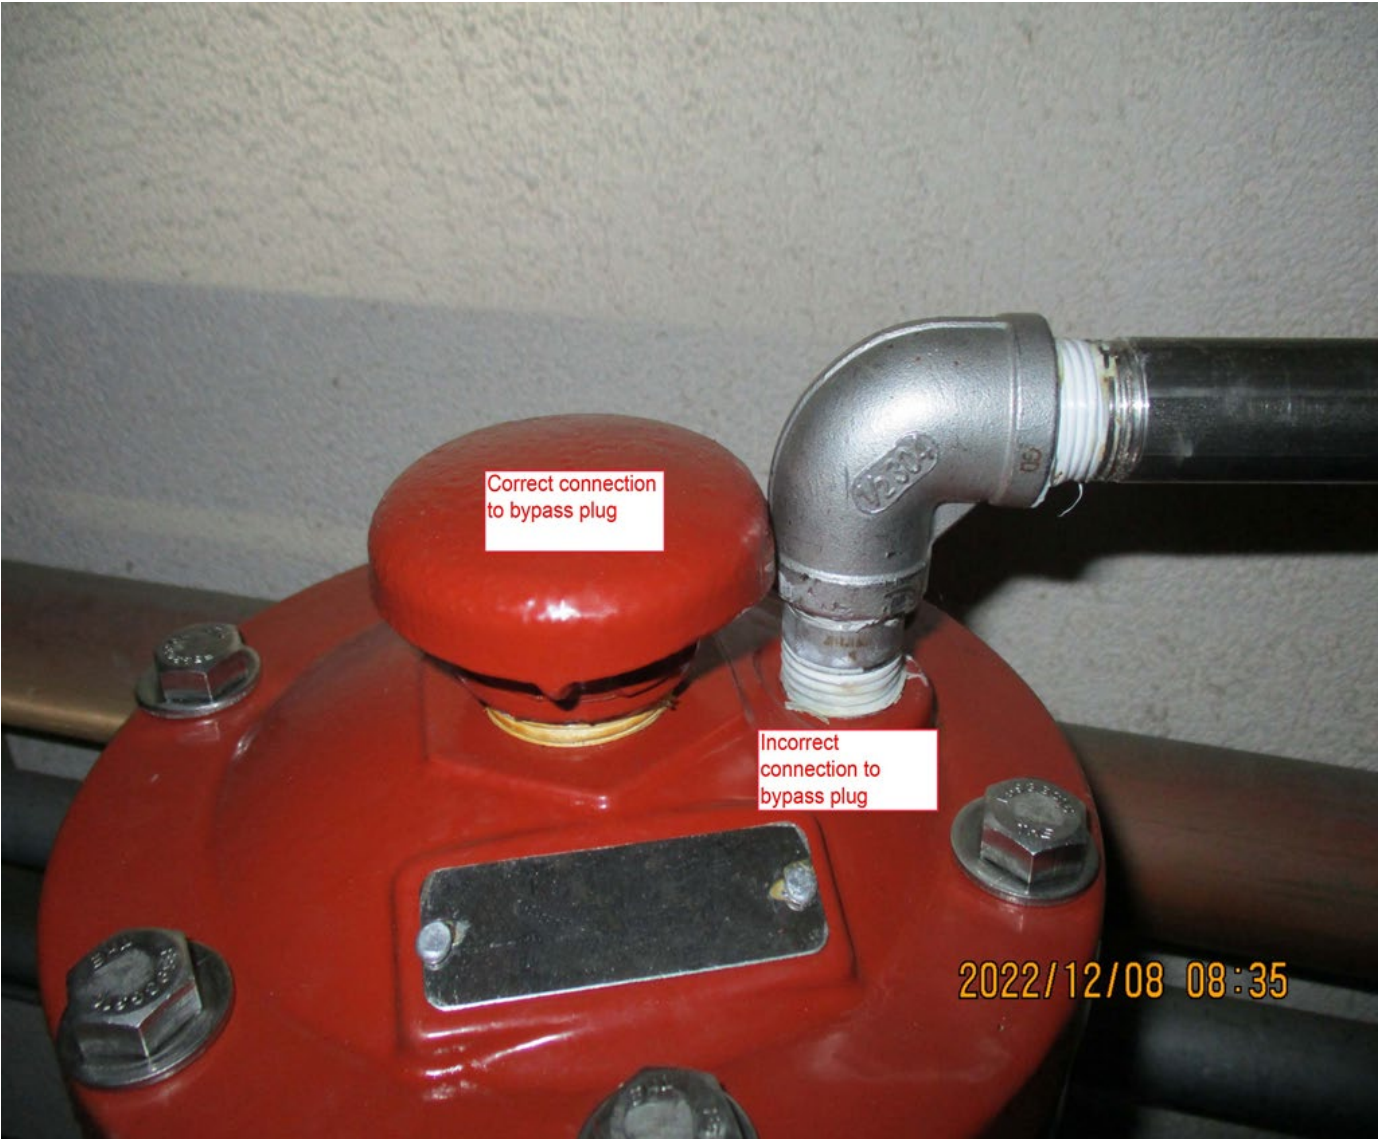
Incorrect Air Vacuum Valve Installation

- Modification included check valve, air vacuum valve and containment vessel
- Air vacuum valve installed improperly

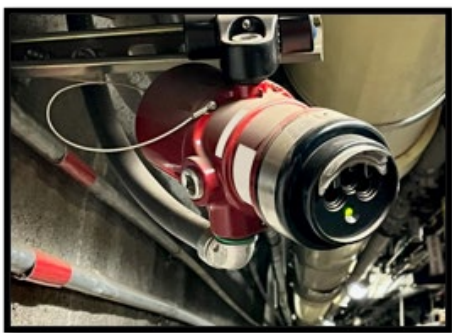
29 November... Inadvertent Discharge

Contractor conducts test of IR sensor... sends signal to AFFF concentrate pumps

Improperly installed air vacuum valve created a bypass filling, then overflowing the containment standpipe with AFFF concentrate
