Section 9

RECOMMENDED REPAIRS

Dames & Moore
Emergency Repairs For Red Hill Tanks at the Fleet Industrial & Supply Center
Contract No. N62742-96-C-1356

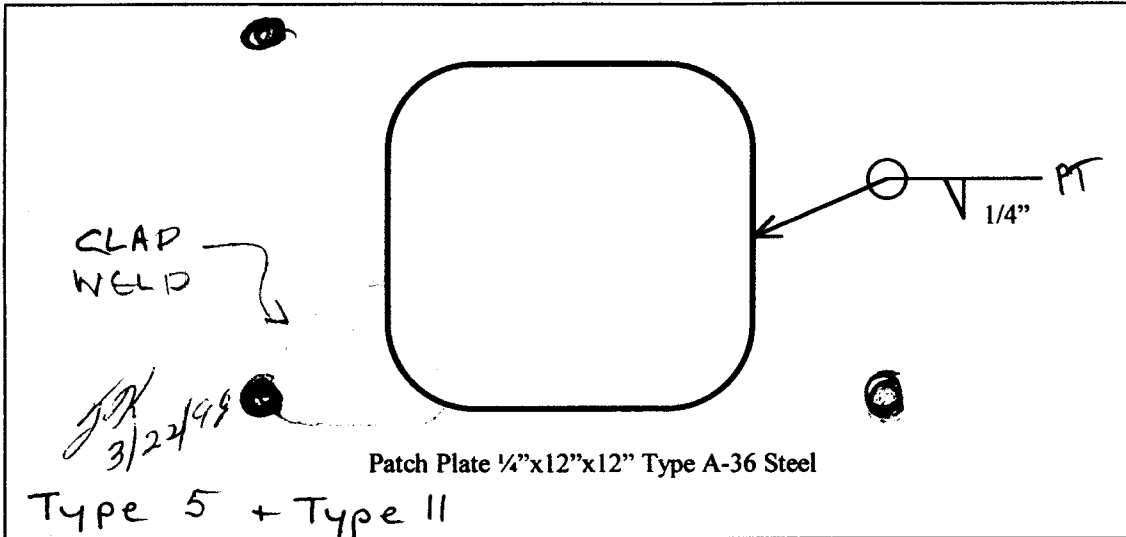
Tank No.: 10 Repair No.: ~~003~~ ⁰⁰⁵ Type: 5 Location: C

Repair type 5			
LTR	DESCRIPTION	BY	DATE
REVISIONS			
MID ATLANTIC ENVIRONMENTAL			
EMERGENCY REPAIRS FOR RED HILL TANKS			
Tank #10			
Repair No.: 005		File: 10r005	
Upper dome		Quadrant: D	
Course: B		Plate: 24	
Drawn by: Tom Kitchen		Date: 4/28/98

Repair Acceptable: John Zschell Date Accepted: 3-13-98

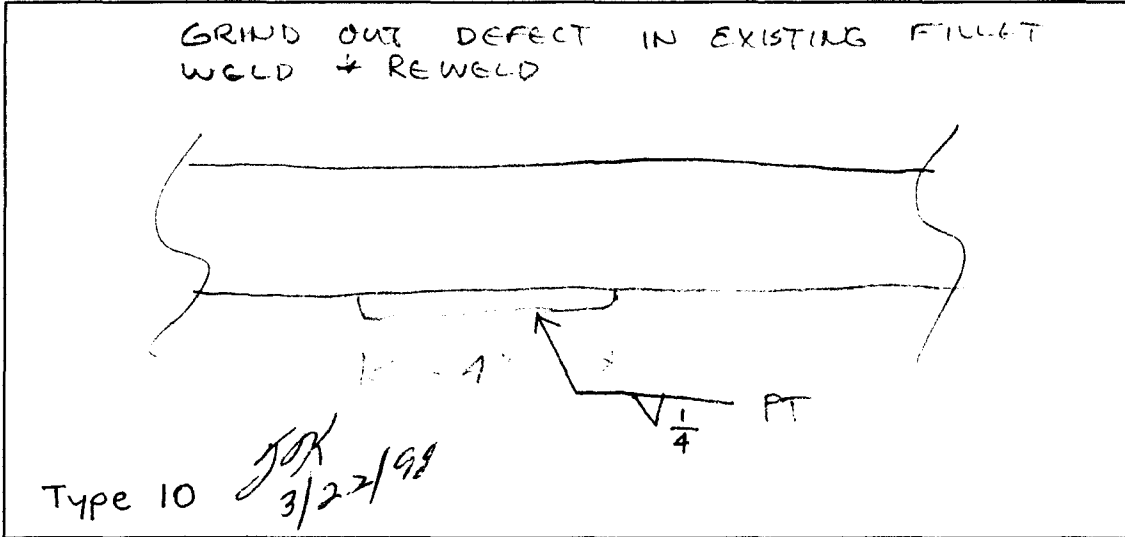
Tank No.: 10 Repair No.: 006 Type: 3 Location: C

LTR	DESCRIPTION	BY	DATE
REVISIONS			
MID ATLANTIC ENVIRONMENTAL			
EMERGENCY REPAIRS FOR RED HILL TANKS			
Tank #10			
Repair No. : 006	File:10r006		
Upper dome	Quadrant: C		
Course: EXTENSION	Plate: 15 & 16		
Drawn by: M. Moulton	Date: 12/19/97

Repair Acceptable: John Zschell Date Accepted: 3-4-98

Repair Acceptable: John Zschell Date Accepted: 3-13-98

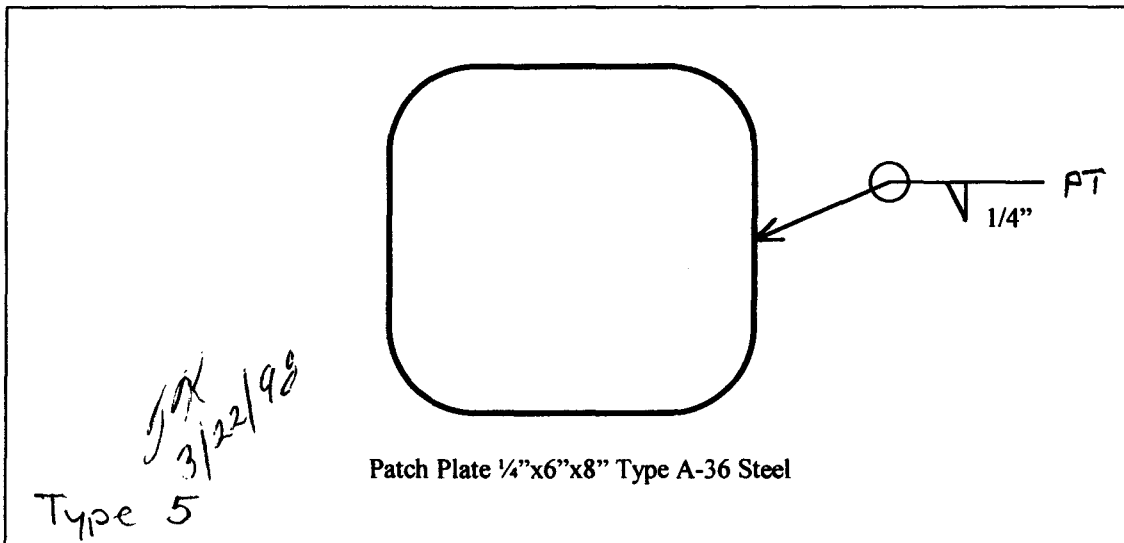
Tank No.: 10 Repair No.: 008 Type: 5 Location: C-EXT

LTR	DESCRIPTION	BY	DATE
REVISIONS			
MID ATLANTIC ENVIRONMENTAL			
EMERGENCY REPAIRS FOR RED HILL TANKS			
Tank #10			
Repair No. 008	File 10r008		
Upper dome	Quadrant C		
Course EXTENSION	Plate 18		
Drawn by Tom Kitchen	Date 4/28/98

Repair Acceptable: John Zschell Date Accepted: 3-4-98

Repair Acceptable: John Zschell Date Accepted: 3-13-98

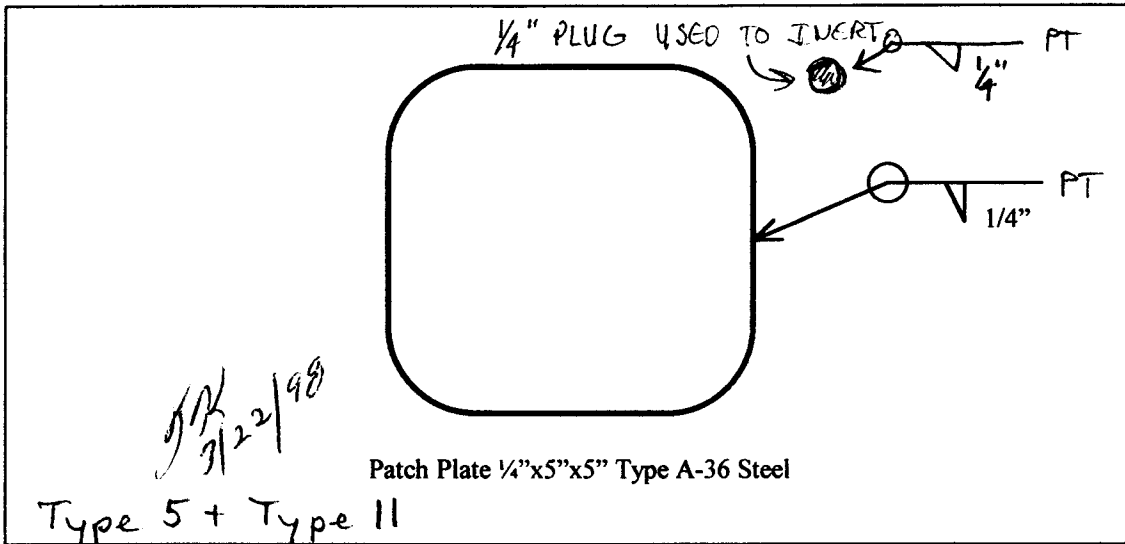
Tank No.: 10 Repair No.: 009 Type: 5 Location: C

LTR	DESCRIPTION	BY	DATE
REVISIONS			
MID ATLANTIC ENVIRONMENTAL			
EMERGENCY REPAIRS FOR RED HILL TANKS			
Tank #10			
Repair No. 009	File 10r009		
Upper dome	Quadrant C		
Course EXTENSION	Plate 17		
Drawn by Tom Kitchen	Date 4/28/98

Repair Acceptable: John Zschell Date Accepted: 3-4-98

Repair Acceptable: John Zschell Date Accepted: 3-13-98

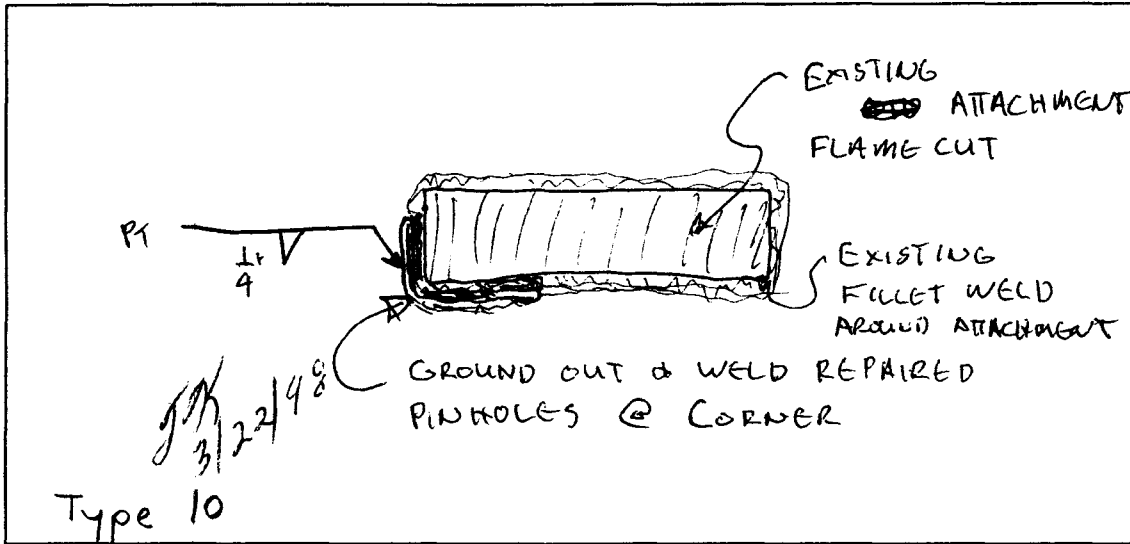
Tank No.: 10 Repair No.: 010 Type: 1 Location: A

01	ORIGINAL ISSUE	MM	2/20/98
LTR	DESCRIPTION	BY	DATE
REVISIONS			
MID ATLANTIC ENVIRONMENTAL			
EMERGENCY REPAIRS FOR RED HILL TANKS			
Tank #10			
Repair No.:	010	File:	10r010
Upper dome		Quadrant:	A
Course:	C	Plate:	1
Drawn by:	M. Moulton	Date:	2/20/98

Repair Acceptable: John Zschell Date Accepted: 2-24-98
