Section 9

RECOMMENDED REPAIRS

Dames & Moore
Emergency Repairs For Red Hill Tanks at the Fleet Industrial & Supply Center
Contract No. N62742-96-C-1356

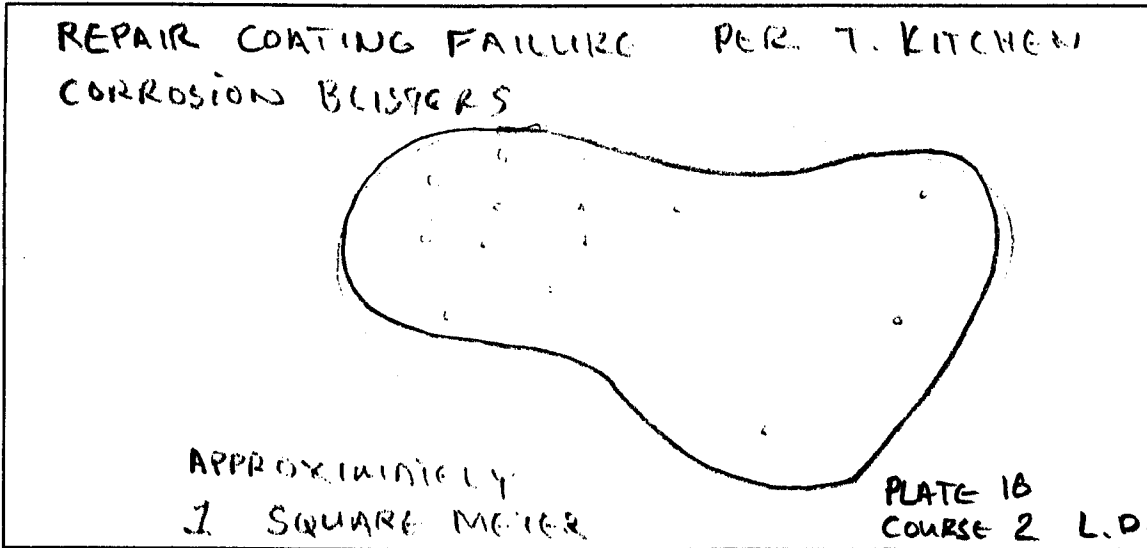
Tank No.: 8 Repair No.: 006 Type: 8 Location: D

DEFECT INSPECTED BY TK & JF 3/25/98

30 X 50 COATING REPAIR

Repair Acceptable: [Signature] Date Accepted: 3-27-98
