2.1 Mid Atlantic Environmental, Inc. conducted an inspection on Tank #8 at the Red Hill Underground Storage Facility, Pearl Harbor, Hawaii. This inspection was conducted in accordance with the scope of work identified by Contract Number N00604-97-R-0013, PRL 96-21, titled "Emergency Repair for Red Hill Tanks."

RED HILL TANK NO. 8
PRODUCT: DFM

OI		TK	
LTR	DESCRIPTION	BY	DATE
REVISIONS			
MID ATLANTIC ENVIRONMENTAL			
EMERGENCY REPAIRS FOR RED HILL TANKS			
Tank #8			
Floor Layout		File: 8filo	
Tank bottom			
Drawn By: T. Kitchen		Date: 7/20/98

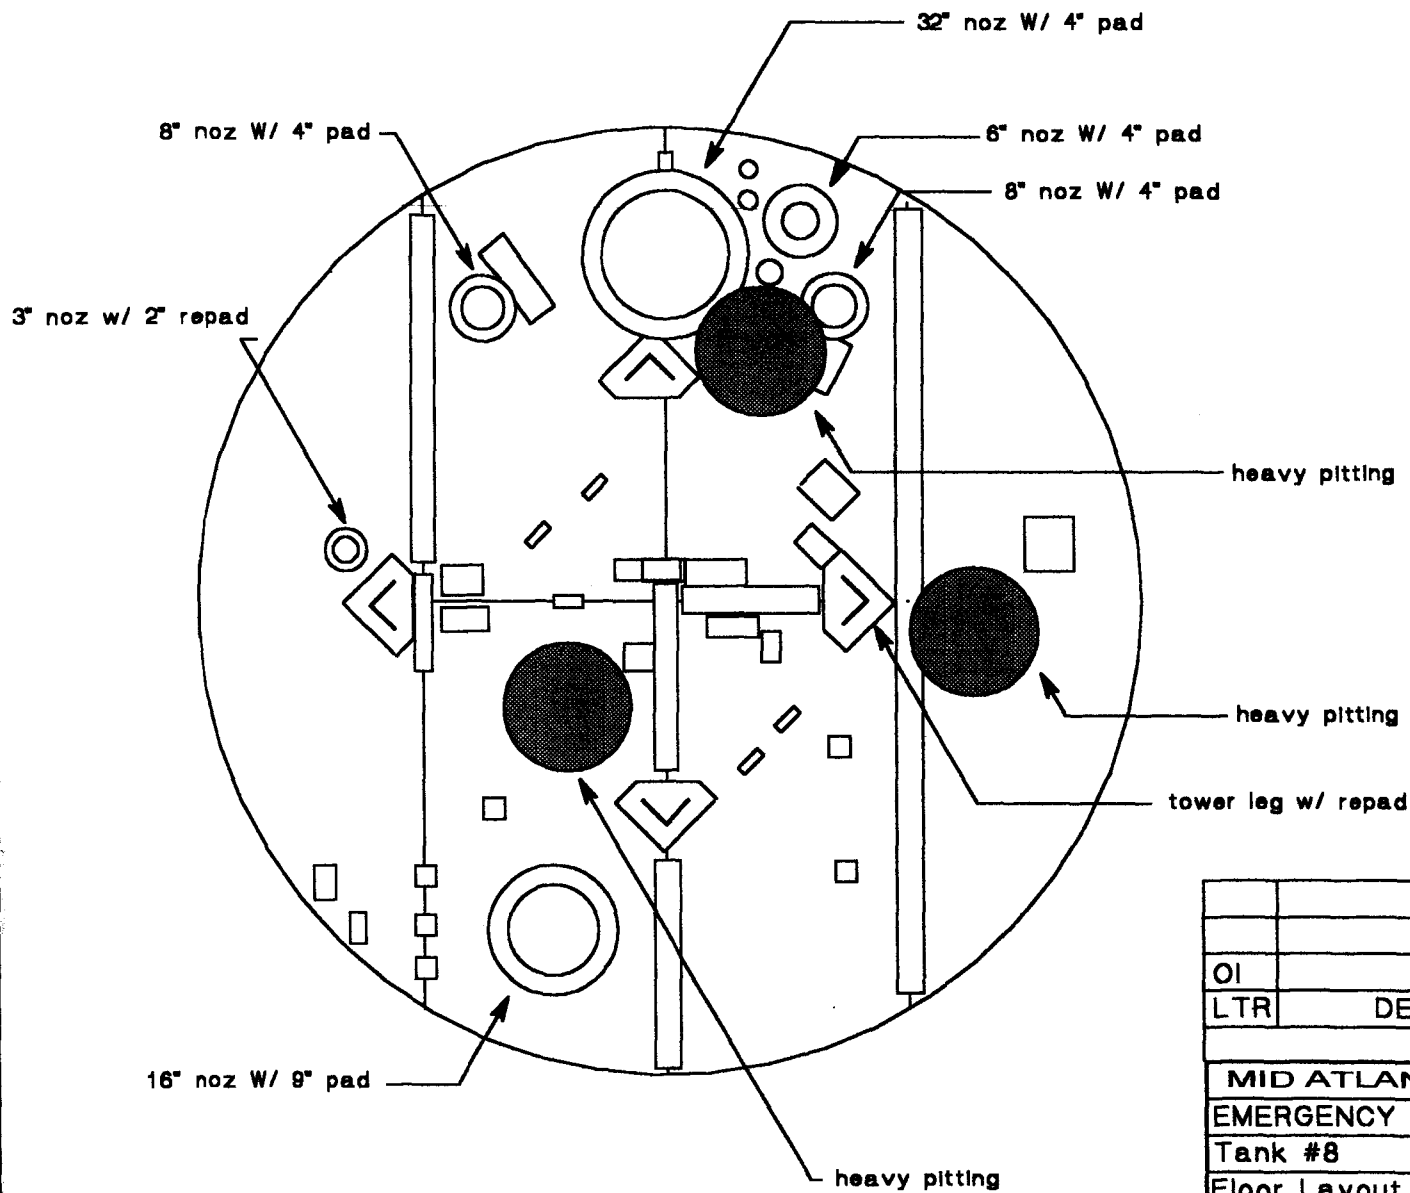
Drawing Title: **Bottom Layout & Thickness Measurements**

7.2.1 The original bottom thickness was determined to be 0.500 inches and the first ascending plate to be 0.250 inches. The ultrasonic thickness measurements taken determined that backside corrosion in this area is not a problem. Pitting on the bottom plates is widespread and the enclosed drawing shows that many patch plates had been added in the past. Although pitting is widespread it is not a problem since the remaining metal thickness is well within the 0.10 inches of metal required by API Standard 653 by the next inspection. Also the coating to be applied to the tank bottom should prevent any increase in pit depth. Although pitting is not a problem with regard to structural integrity, it did present a problem regarding the coating to be applied. Pictures of this pitting are included with this report. The surface contamination test results yielded 0% ferrous salts, 32 ppm NaCl and a pH level of 7. These results are within the limits set forth in the KTA SCAN Kit technical data and the NACE technical committee report on Surface Preparation of Contaminated Steel Surfaces. The Caustic Soda test of the tank bottom indicated that all Flame Sprayed Aluminum had been removed. By visual inspection, scattered pitting was observed on the tank bottom and first ascending plates. The deeper pits were measured and recorded on the Bottom Layout With Pit Indications drawing.

Remarks/Legend: Pitting was general over 30% of bottom

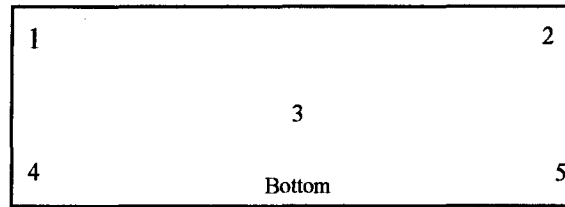
Lower Dome

Plate Number	Thickness Measurements (in inches)					Plate Type
	Point Numbers					
	1	2	3	4	5	
1	0.260	0.286	0.250	0.256	0.255	E
2	0.268	0.266	0.255	0.262	0.267	E
3	0.252	0.254	0.259	0.271	0.255	E
4	0.255	0.256	0.248	0.251	0.251	E
5	0.255	0.255	0.256	0.261	0.271	E
6	0.261	0.256	0.261	0.263	0.256	E
7	0.258	0.256	0.260	0.261	0.264	E
8	0.251	0.253	0.253	0.249	0.252	E
9	0.248	0.254	0.244	0.258	0.253	E
10	0.253	0.245	0.246	0.255	0.247	E
11	0.261	0.259	0.256	0.260	0.261	E
12	0.259	0.251	0.251	0.278	0.287	E
13	0.247	0.246	0.255	0.253	0.264	E
14	0.251	0.251	0.250	0.260	0.266	E
15	0.262	0.255	0.247	0.261	0.273	E
16	0.256	0.254	0.251	0.261	0.250	E
17	0.252	0.249	0.251	0.252	0.248	E
18	0.246	0.251	0.246	0.251	0.256	E
19	0.249	0.250	0.274	0.251	0.256	E
20	0.254	0.252	0.251	0.274	0.258	E
21	0.262	0.261	0.254	0.268	0.271	E
22	0.278	0.258	0.260	0.261	0.269	E
