SUBJECT: DESTRUCTIVE ANALYSIS OF 10 STEEL COUPONS REMOVED FROM RED HILL FUEL STORAGE TANK NO. 14, PURSUANT TO SECTION 5.3 OF THE ADMINISTRATIVE ORDER ON CONSENT STATEMENT OF WORK, RED HILL BULK FUEL STORAGE FACILITY, JOINT BASE PEARL HARBOR-HICKAM, OAHU, HAWAII

Destructive Analysis of 10 Steel Coupons Removed from Red Hill Fuel Storage Tank #14

REPORT No. 201801967

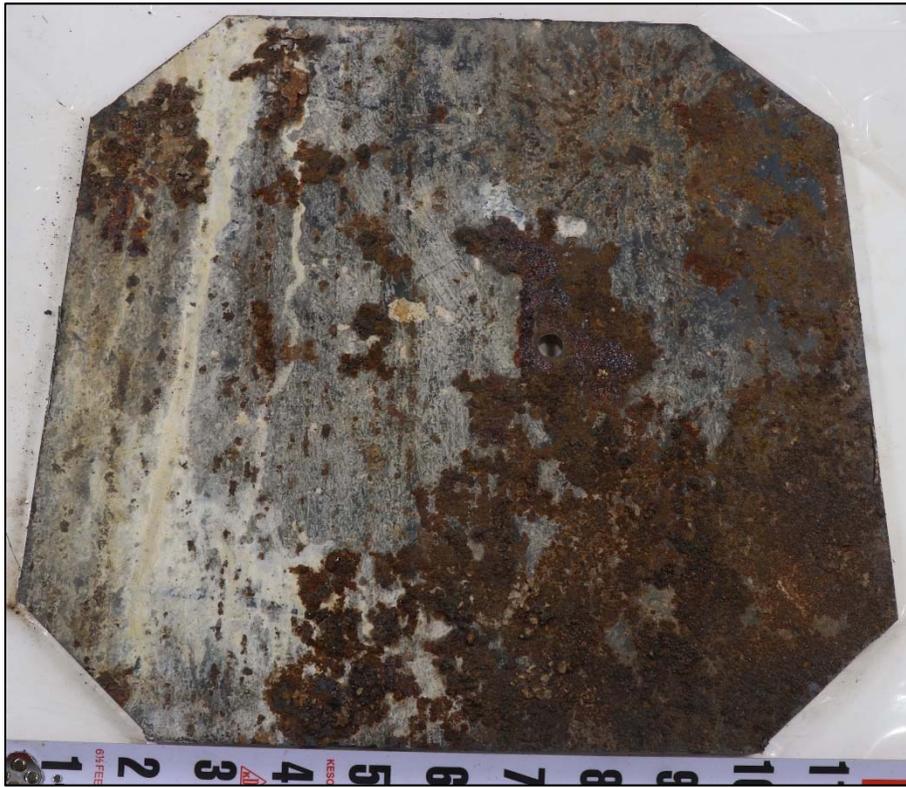
Figure 1. An image of the interior surface of Coupon 1 in the as-received condition.

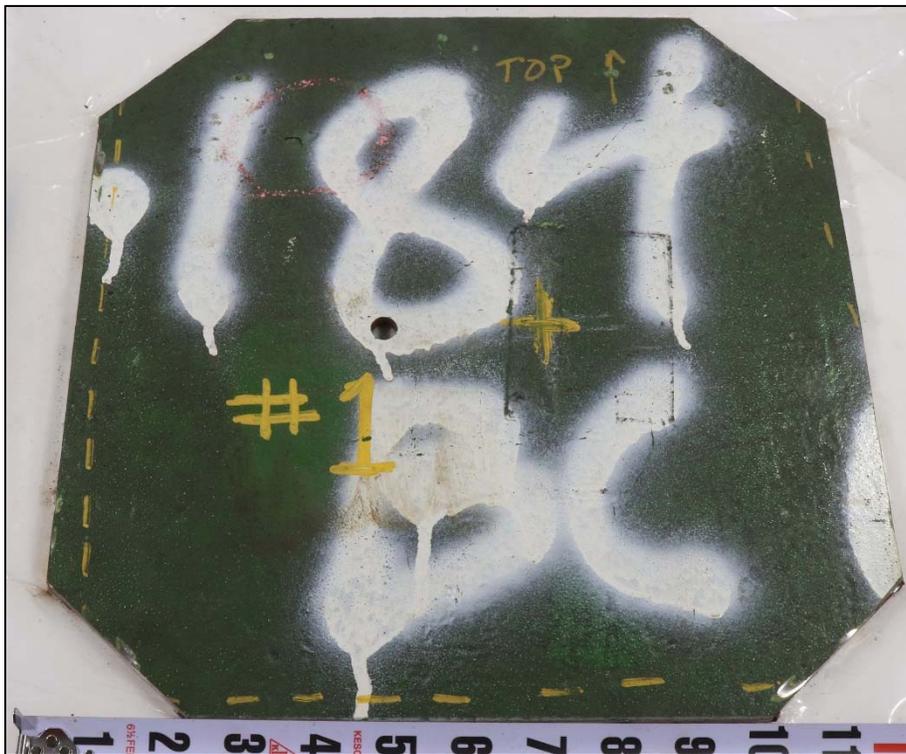
Figure 2. An image of the exterior surface of Coupon 1 in the as-received condition.

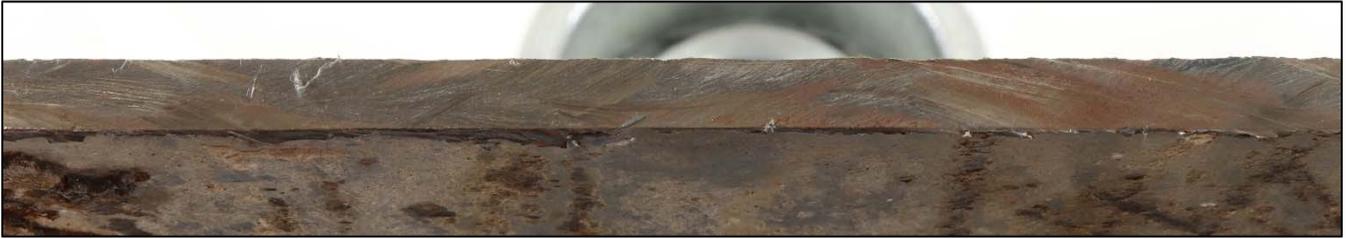
Figure 3. An image of a representative edge of Coupon 1 in the as-received condition.

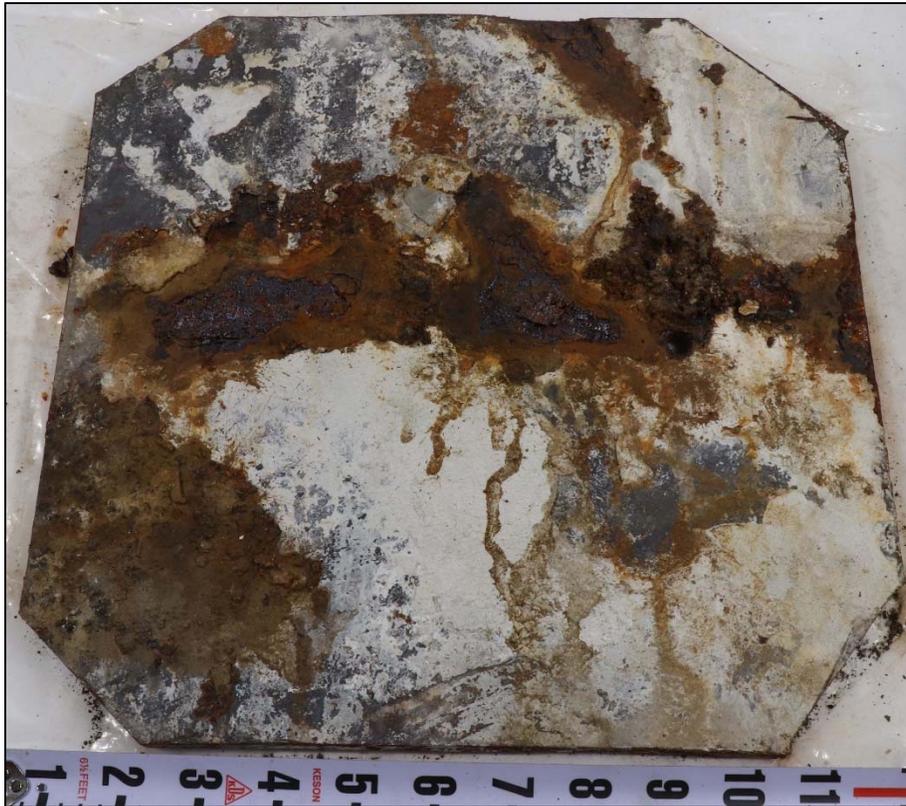
Figure 4. An image of the interior surface of Coupon 2 in the as-received condition.

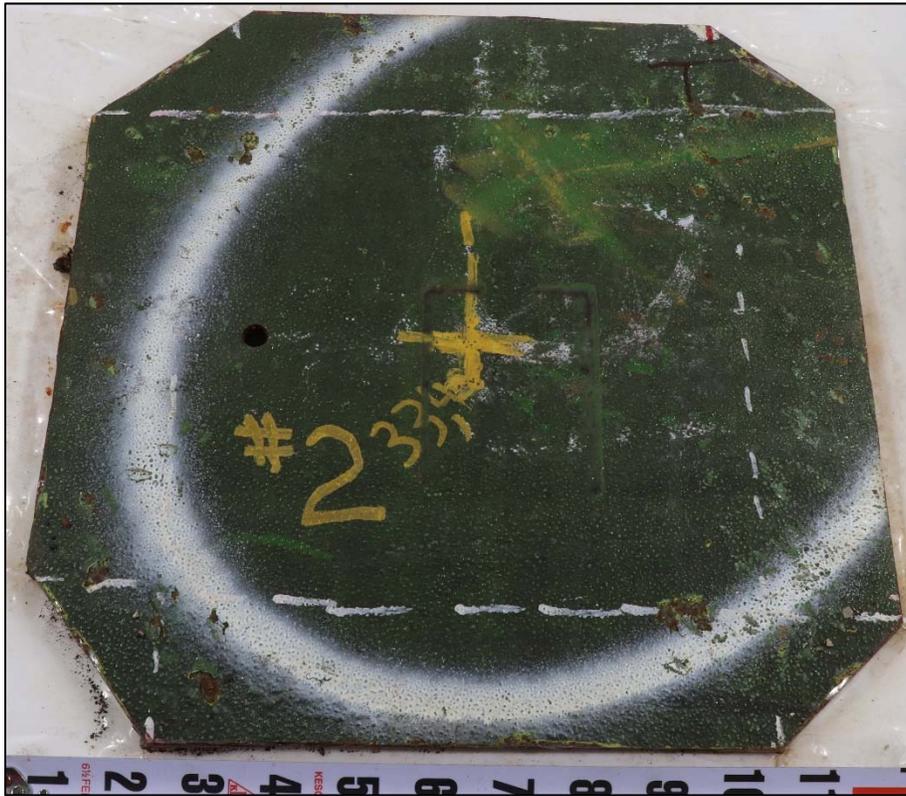
Figure 5. An image of the exterior surface of Coupon 2 in the as-received condition.

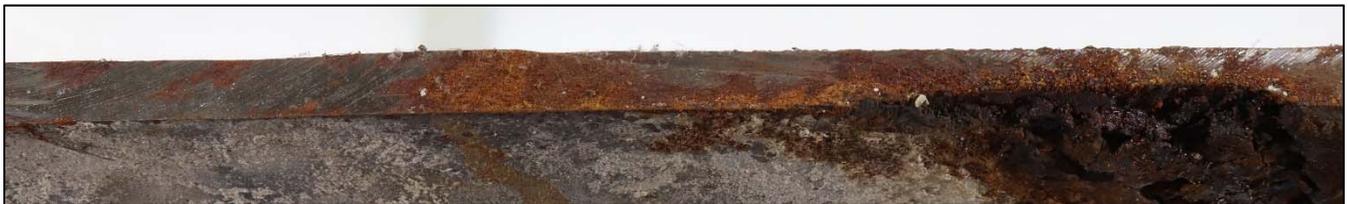
Figure 6. An image of a representative edge of Coupon 2 in the as-received condition.

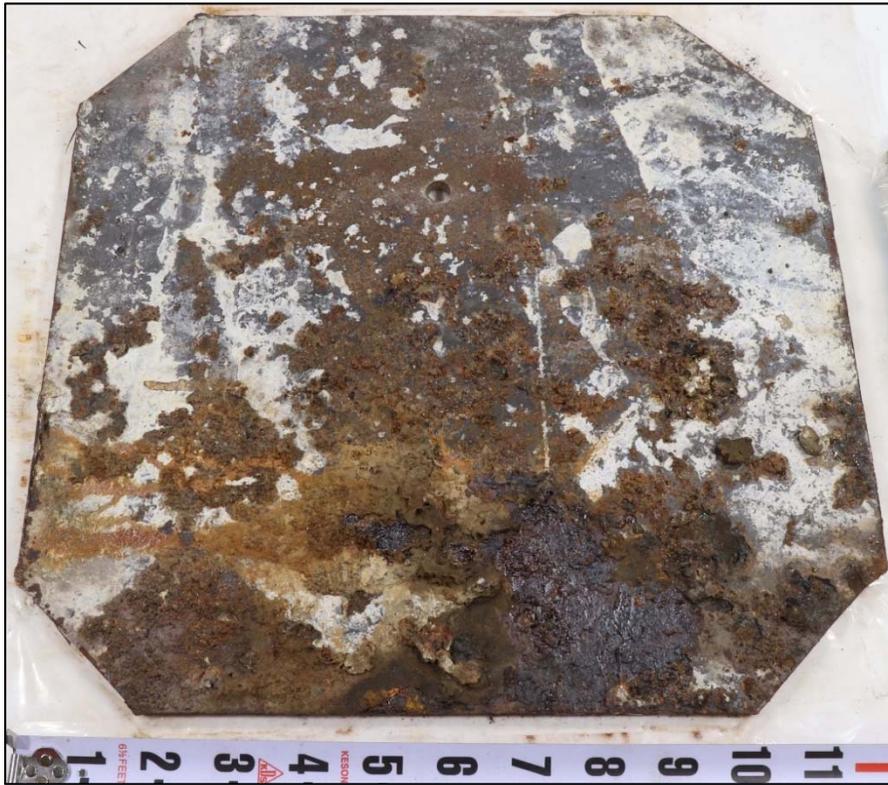
Figure 7. An image of the interior surface of Coupon 3 in the as-received condition.

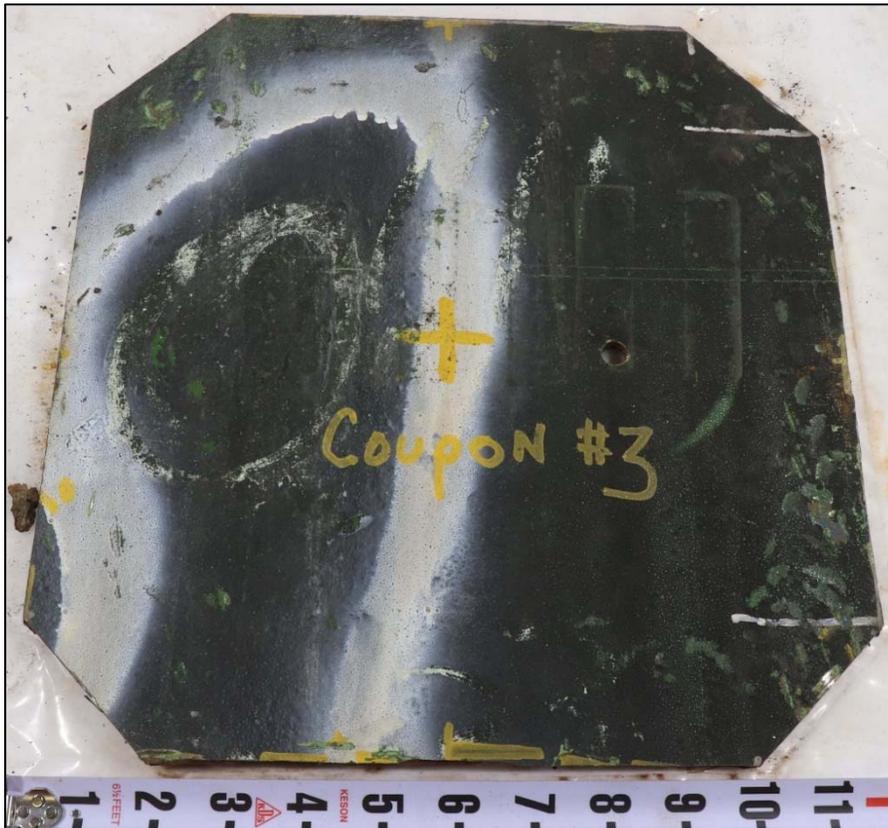
Figure 8. An image of the exterior surface of Coupon 3 in the as-received condition.

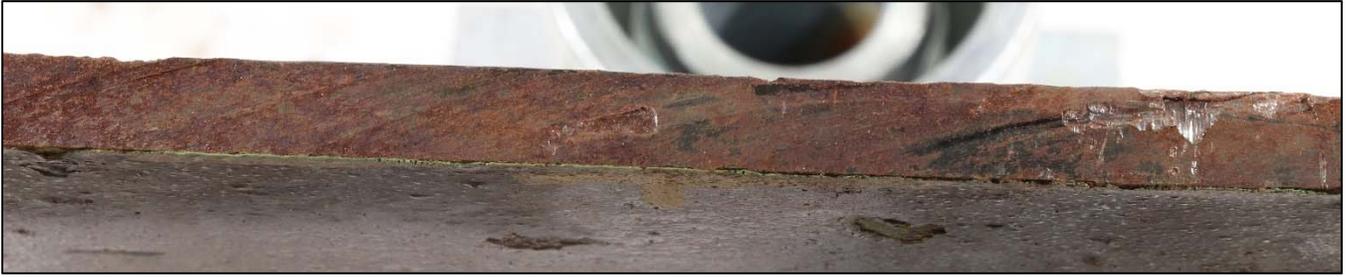
Figure 9. An image of a representative edge of Coupon 3 in the as-received condition.

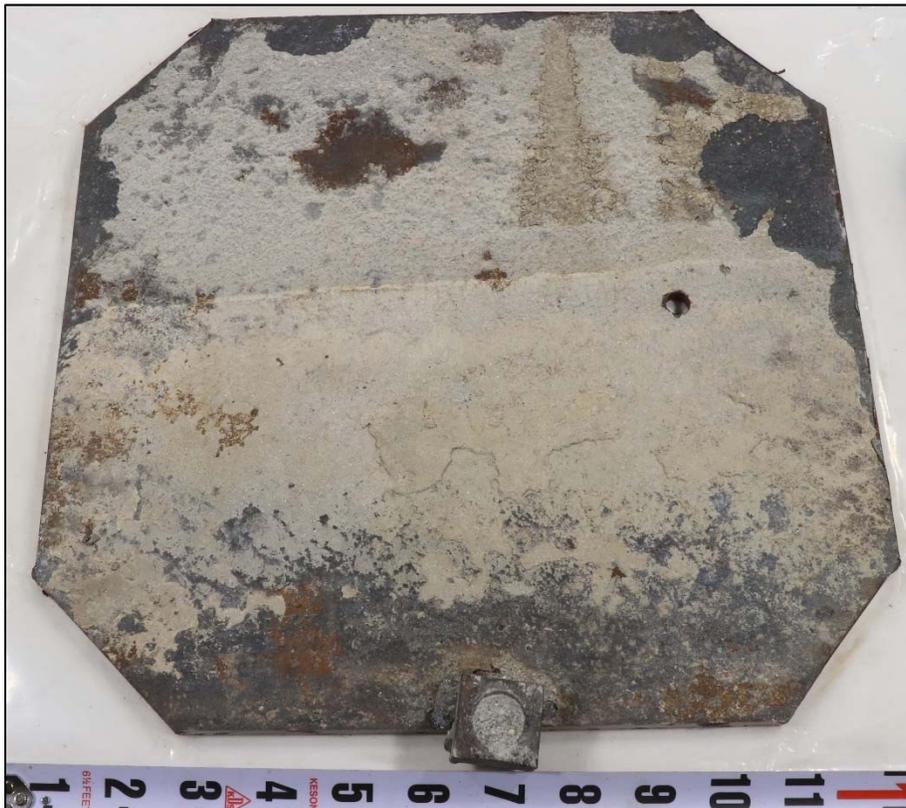
Figure 10. An image of the interior surface of Coupon 5 in the as-received condition.

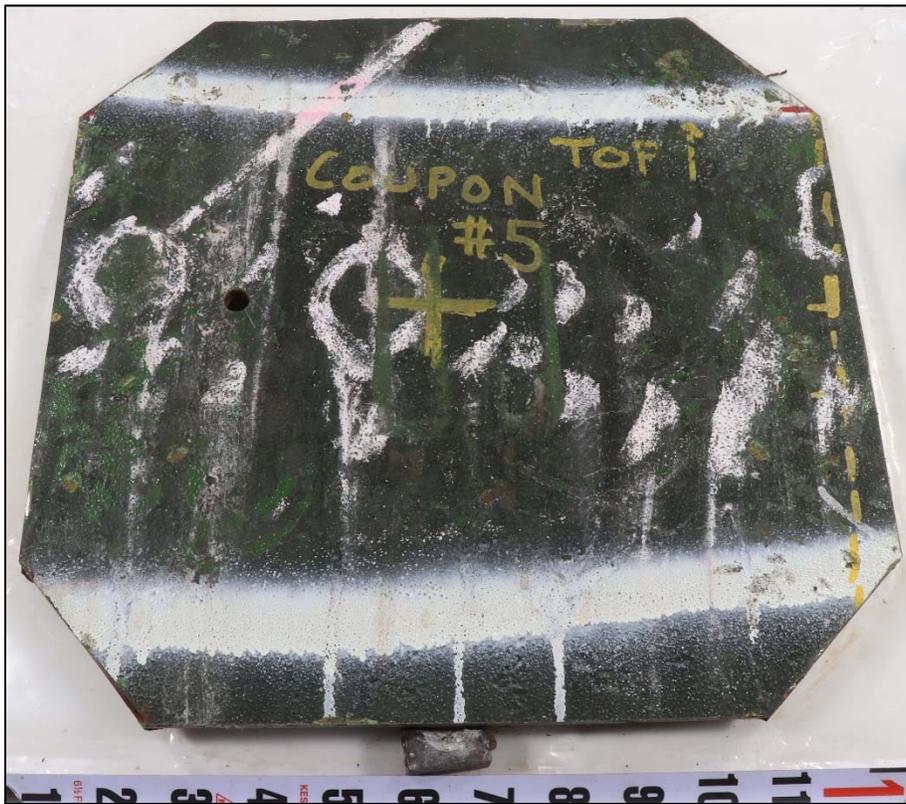
Figure 11. An image of the exterior surface of Coupon 5 in the as-received condition.

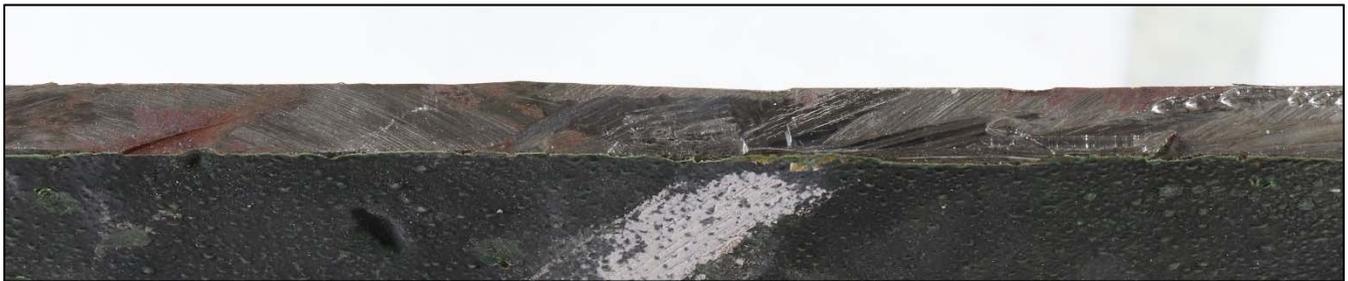
Figure 12. An image of a representative edge of Coupon 5 in the as-received condition.

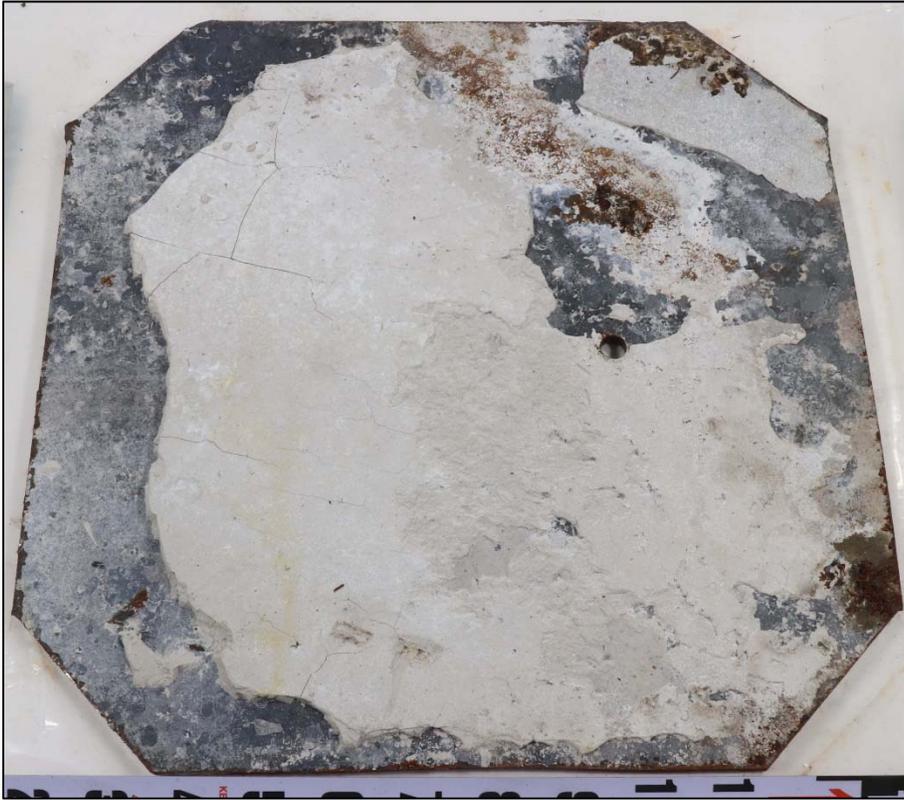
Figure 13. An image of the interior surface of Coupon 6 in the as-received condition.

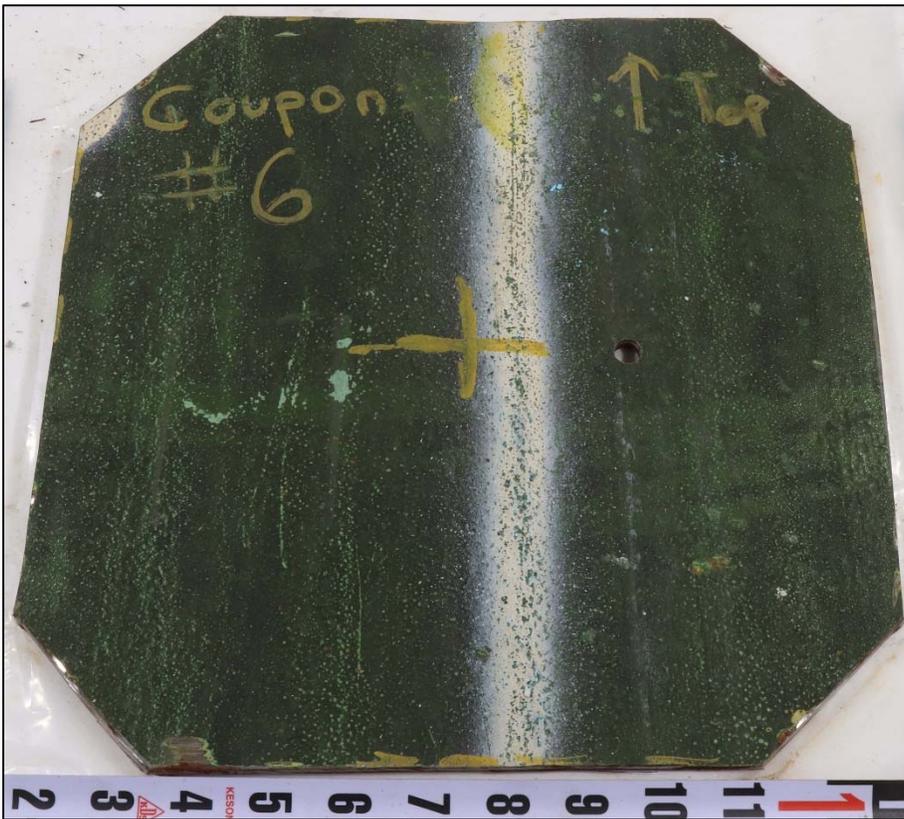
Figure 14. An image of the exterior surface of Coupon 6 in the as-received condition.

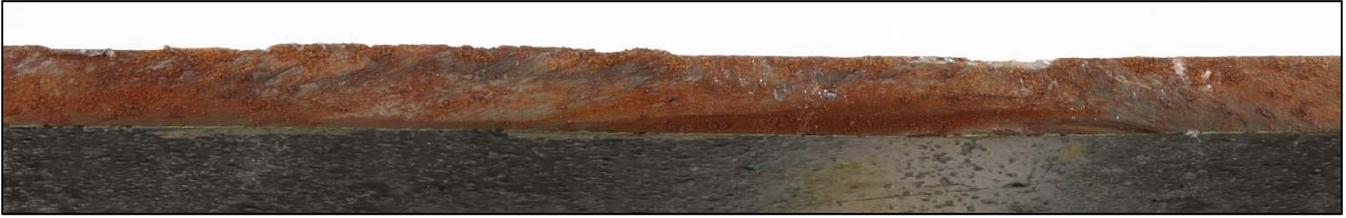
Figure 15. An image of a representative edge of Coupon 6 in the as-received condition.

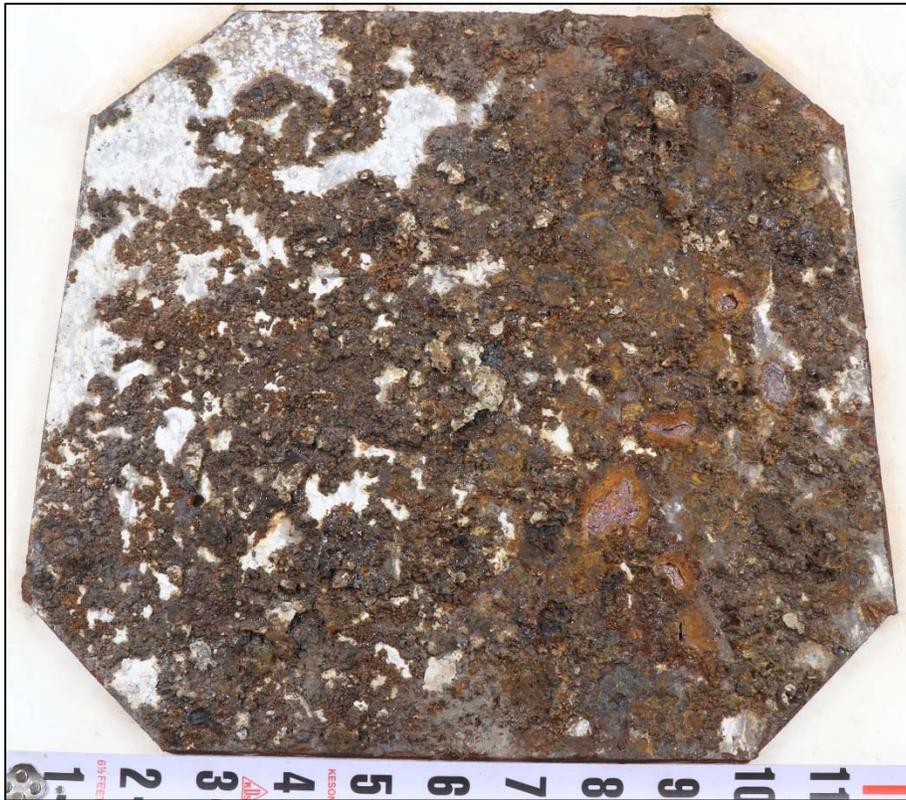
Figure 16. An image of the interior surface of Coupon 7 in the as-received condition.

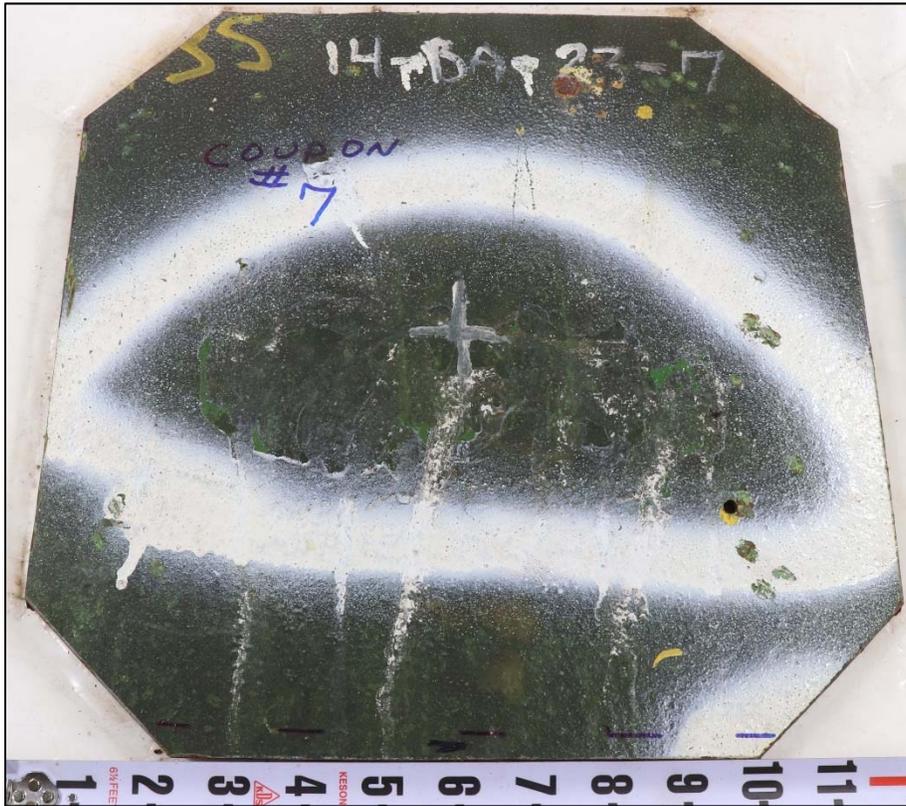
Figure 17. An image of the exterior surface of Coupon 7 in the as-received condition.

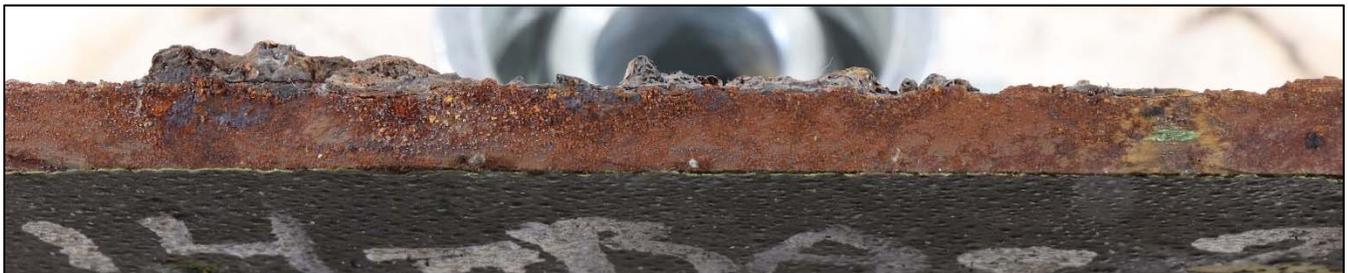
Figure 18. An image of a representative edge of Coupon 7 in the as-received condition.

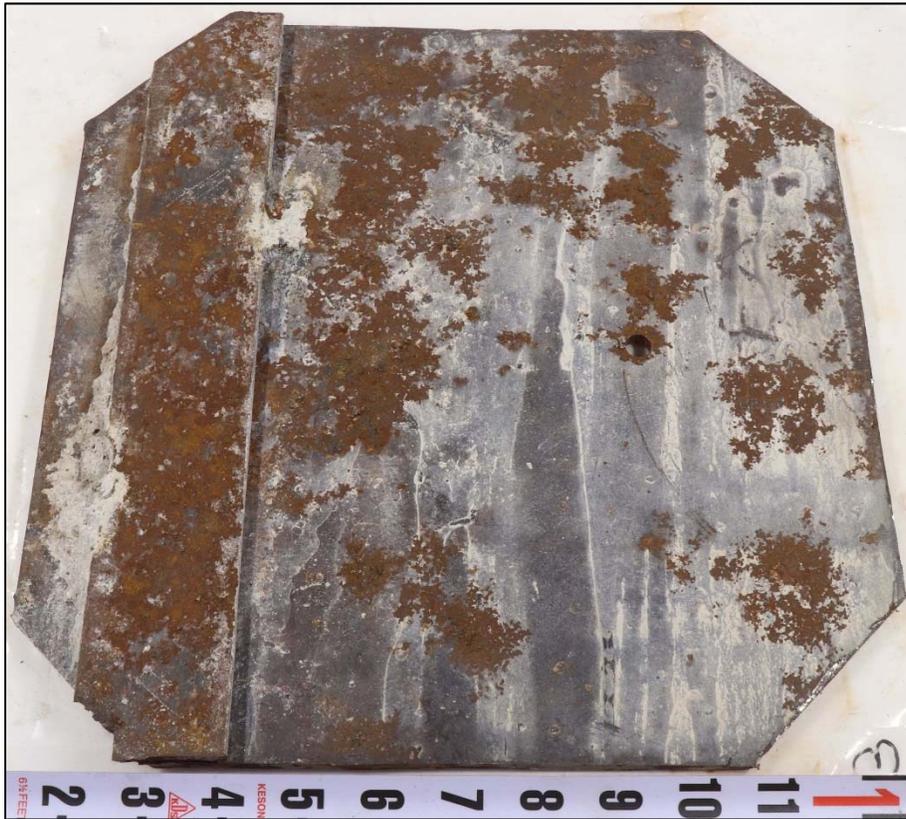
Figure 19. An image of the interior surface of Coupon 8 in the as-received condition.

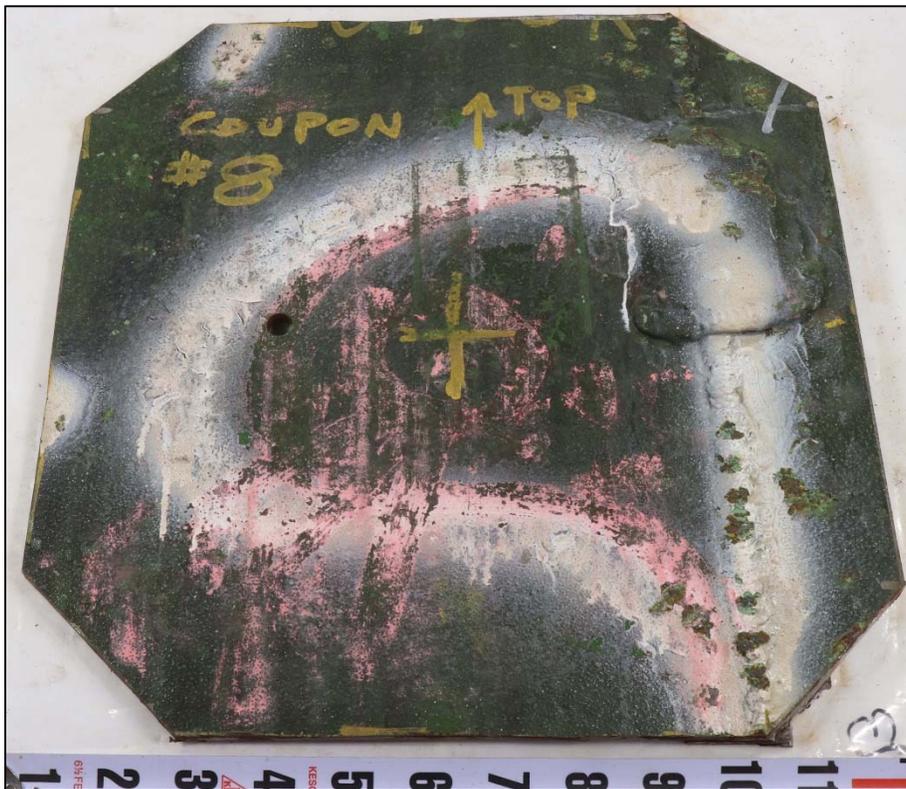
Figure 20. An image of the exterior surface of Coupon 8 in the as-received condition.

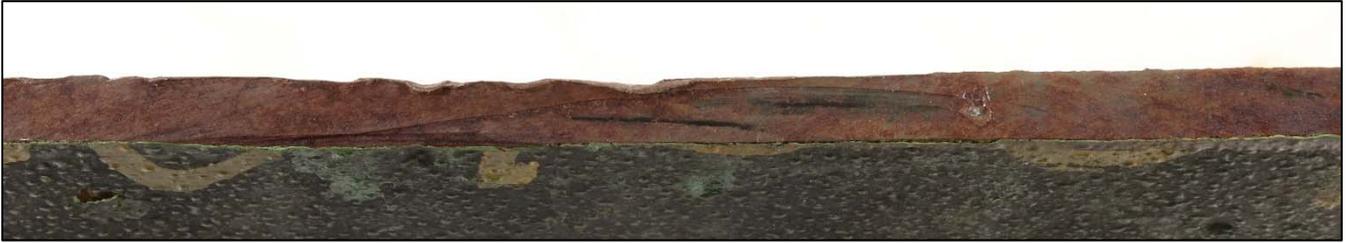
Figure 21. An image of a representative edge of Coupon 8 in the as-received condition.

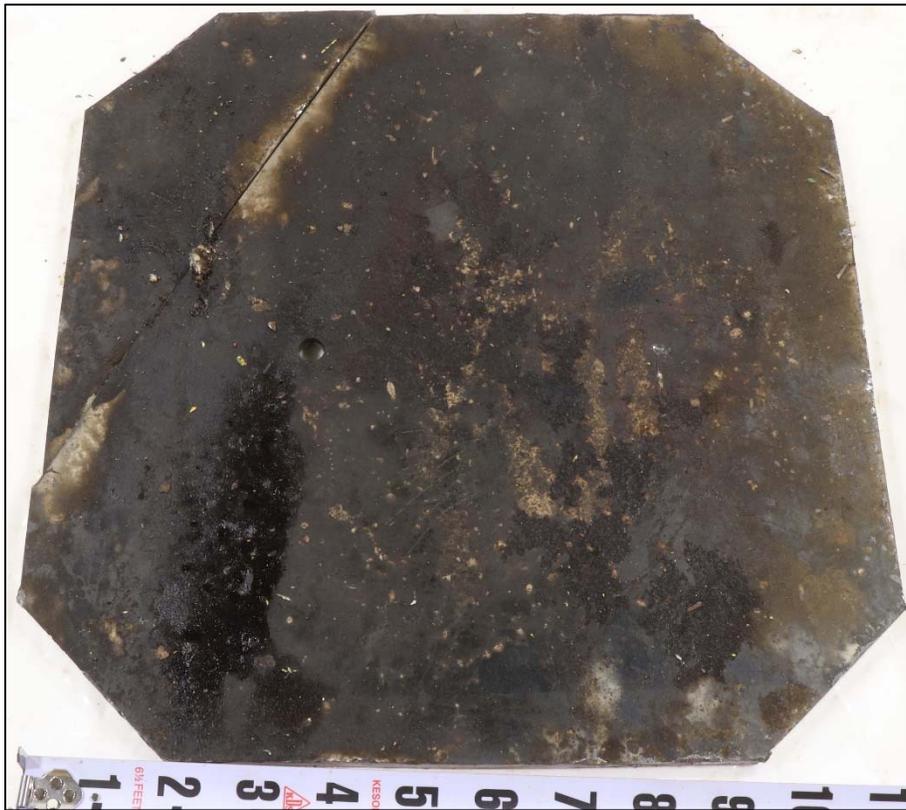
Figure 22. An image of the interior surface of Coupon 10 in the as-received condition.

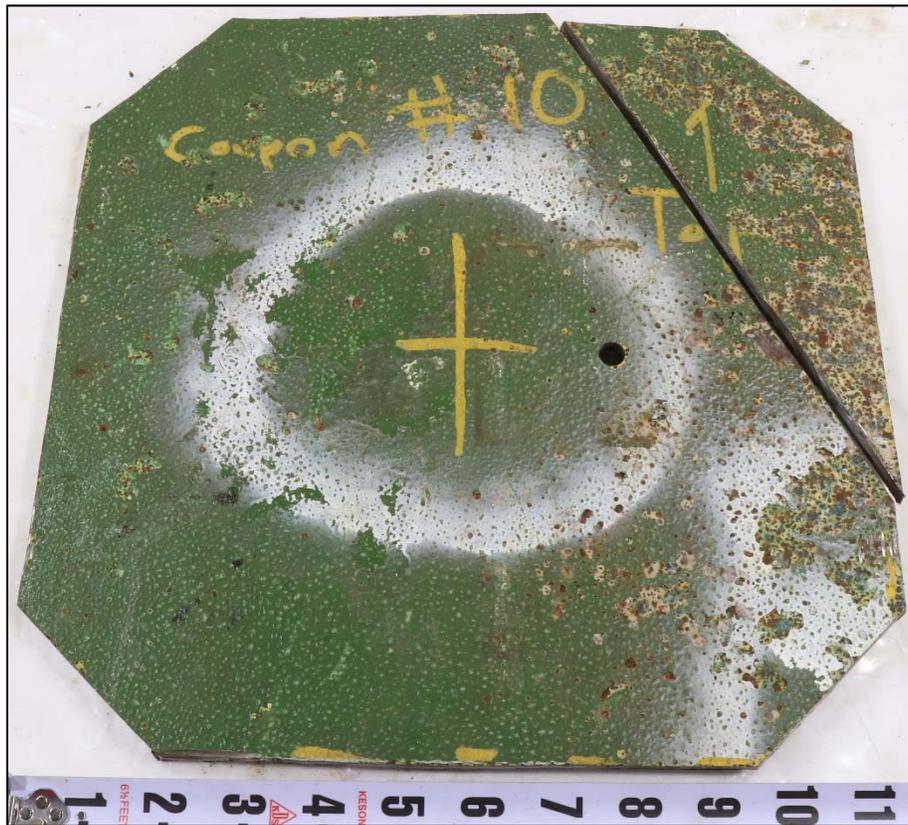
Figure 23. An image of the exterior surface of Coupon 10 in the as-received condition.

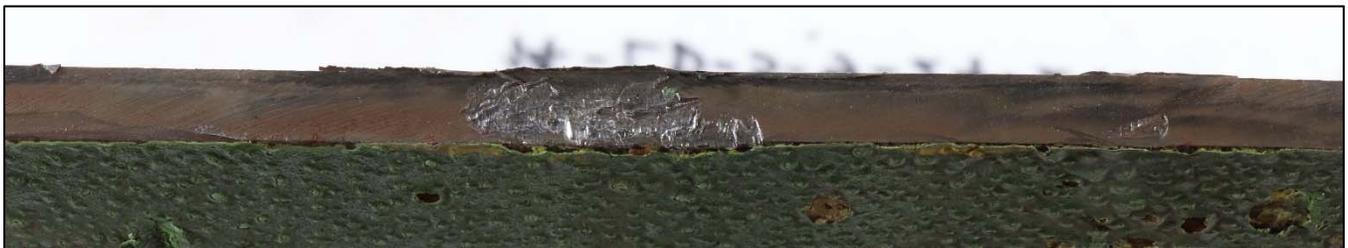
Figure 24. An image of a representative edge of Coupon 10 in the as-received condition.

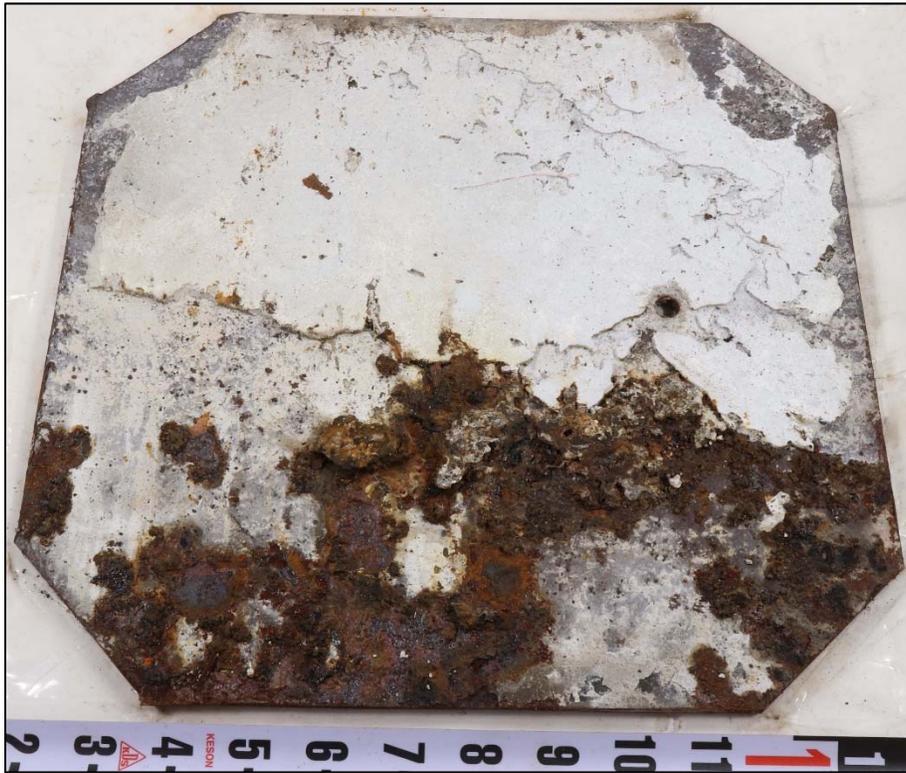
Figure 25. An image of the interior surface of Coupon A1 in the as-received condition.

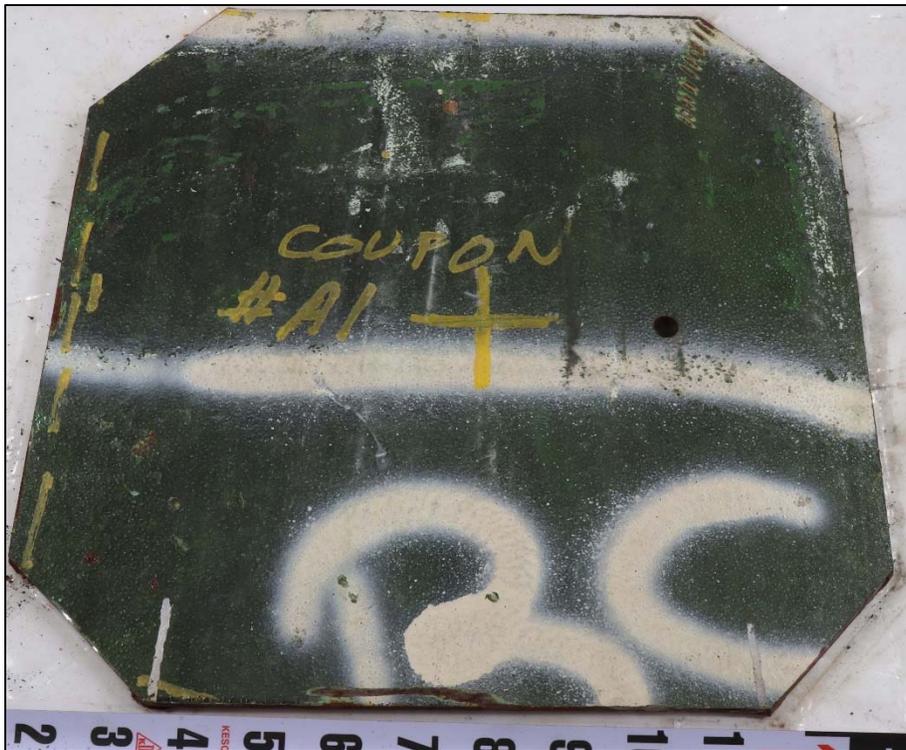
Figure 26. An image of the exterior surface of Coupon A1 in the as-received condition.

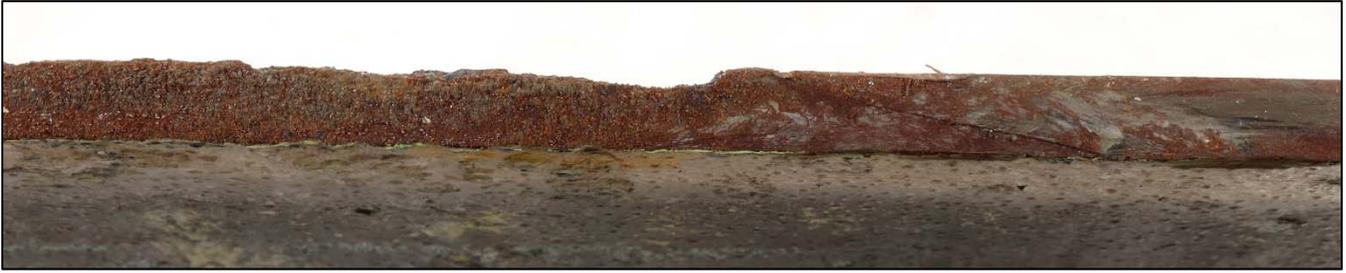
Figure 27. An image of a representative edge of Coupon A1 in the as-received condition.

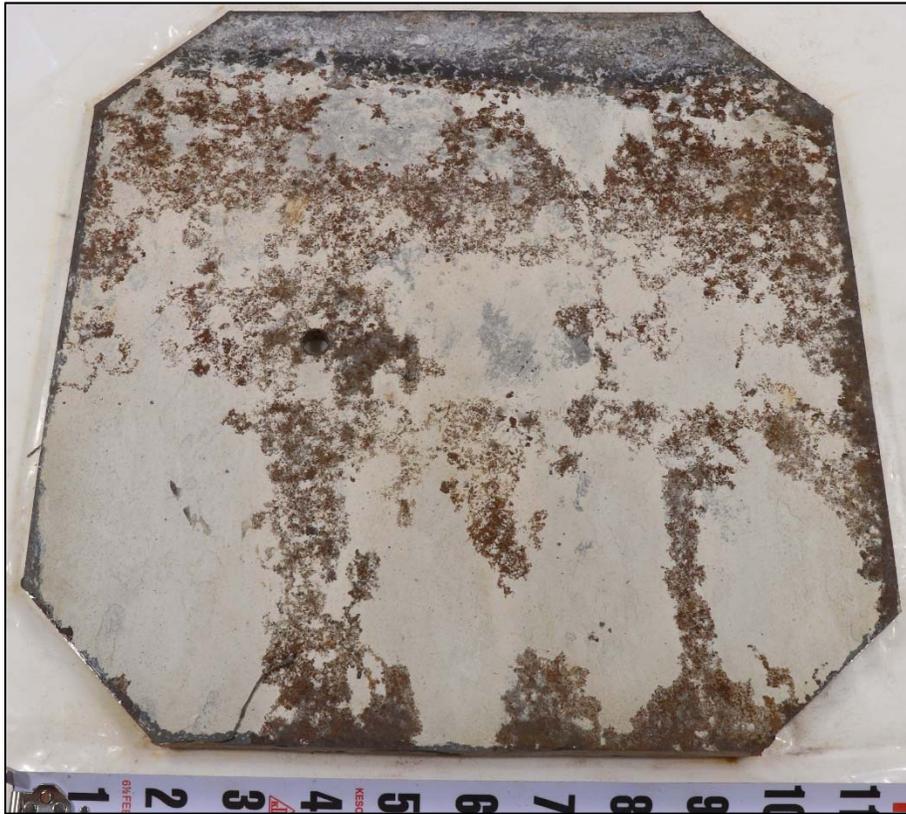
Figure 28. An image of the interior surface of Coupon A2 in the as-received condition.

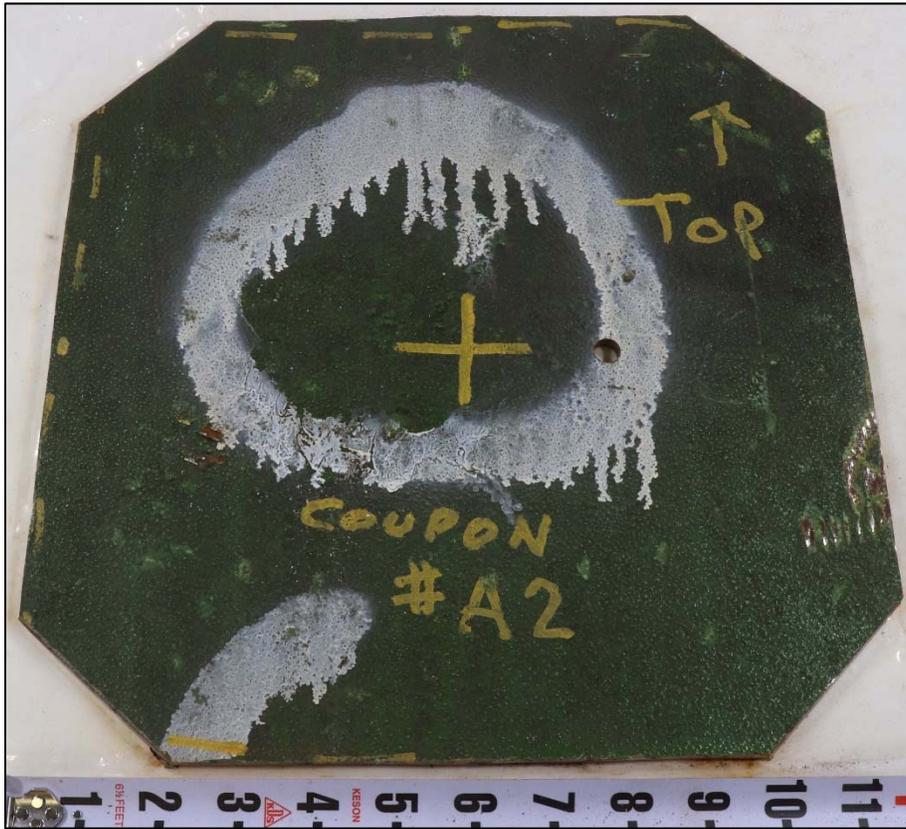
Figure 29. An image of the exterior surface of Coupon A2 in the as-received condition.

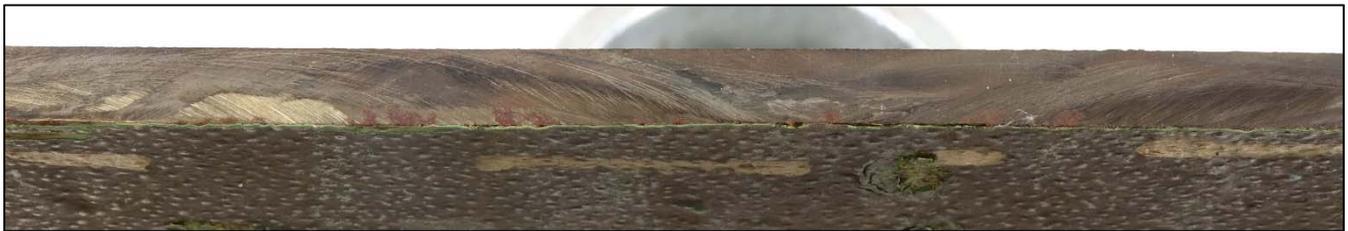
Figure 30. An image of a representative edge of Coupon A2 in the as-received condition.

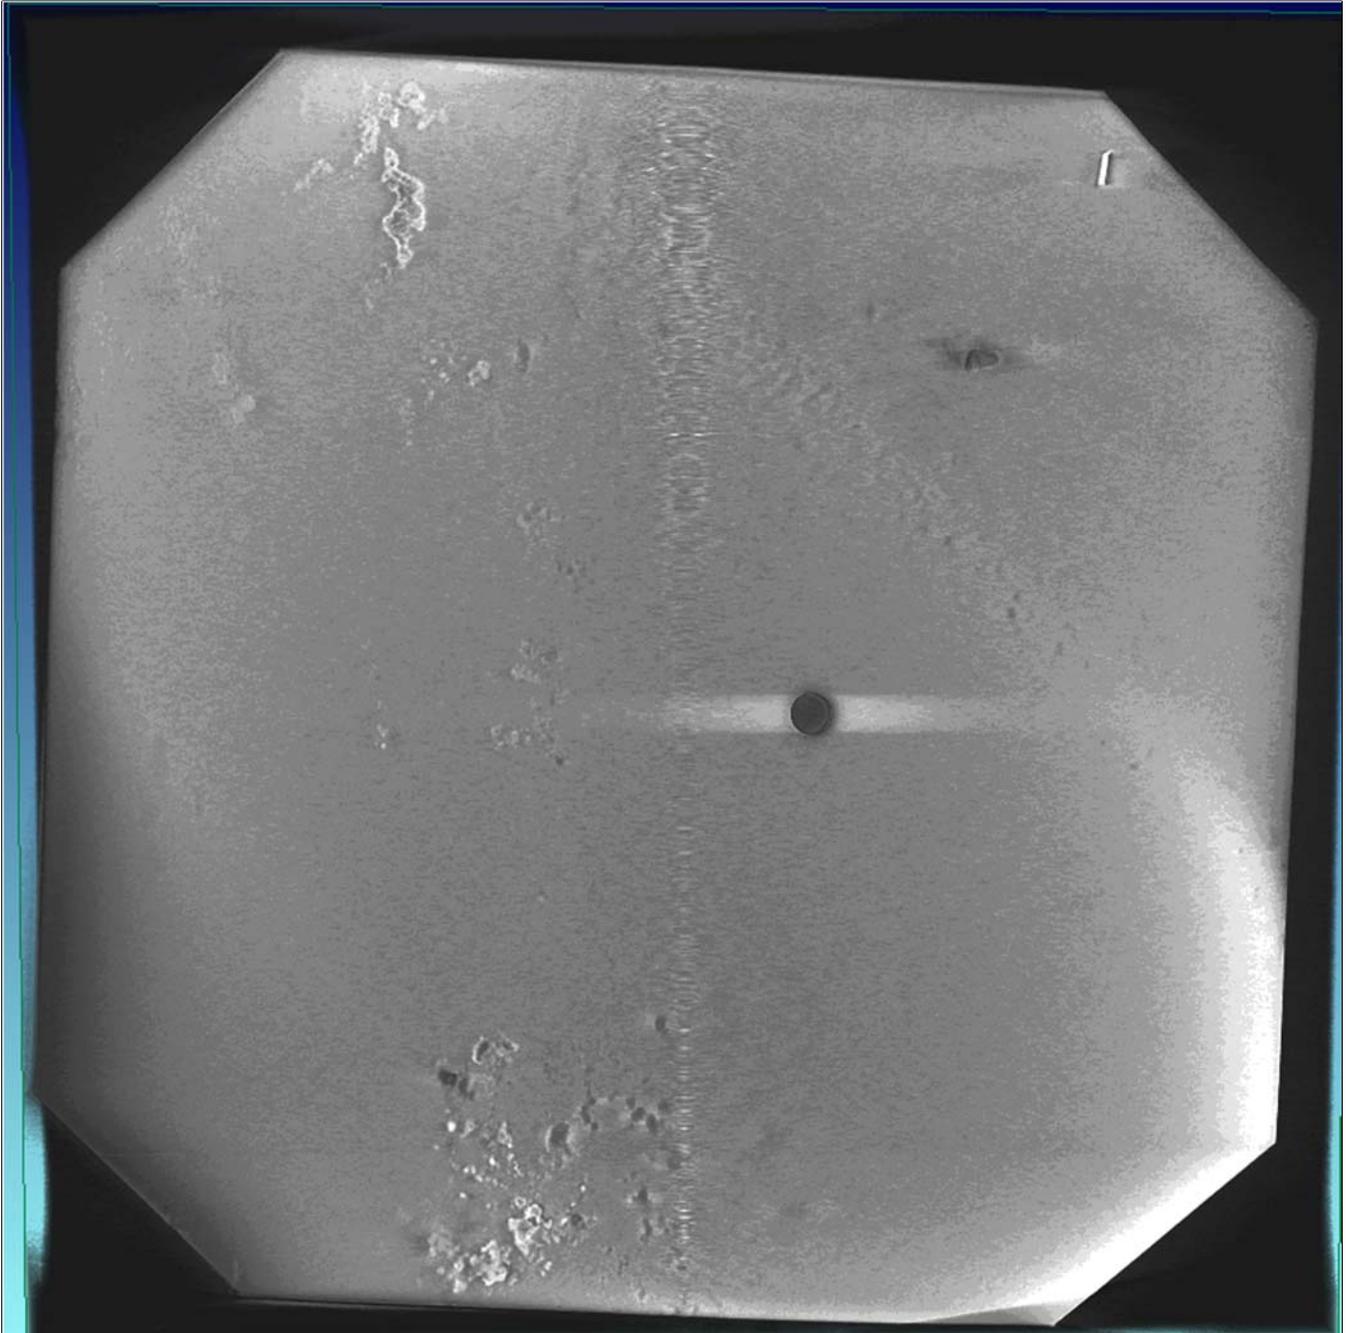
Figure 31. A representative screenshot of the CT scan performed on Coupon 1.

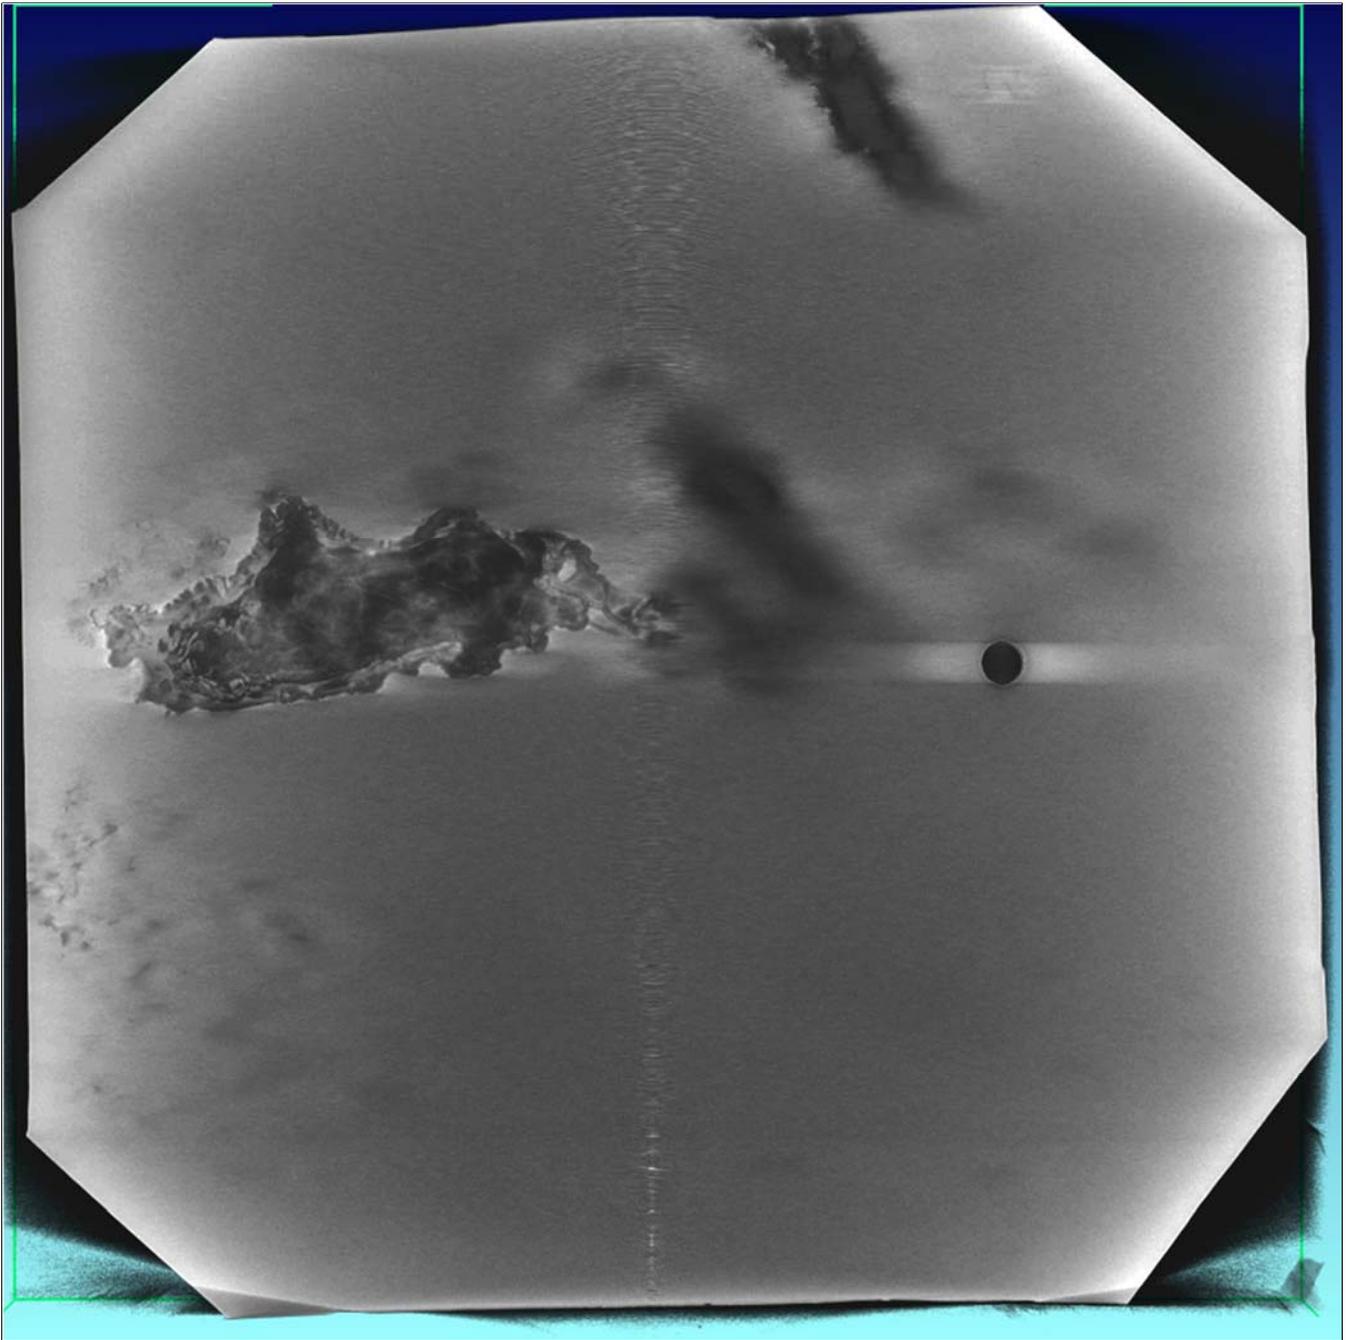
Figure 32. A representative screenshot of the CT scan performed on Coupon 2.
