SUBJECT: DESTRUCTIVE ANALYSIS OF 10 STEEL COUPONS REMOVED FROM RED HILL FUEL STORAGE TANK NO. 14, PURSUANT TO SECTION 5.3 OF THE ADMINISTRATIVE ORDER ON CONSENT STATEMENT OF WORK, RED HILL BULK FUEL STORAGE FACILITY, JOINT BASE PEARL HARBOR-HICKAM, OAHU, HAWAII

Destructive Analysis of 10 Steel Coupons Removed from Red Hill Fuel Storage Tank #14

REPORT No. 201801967

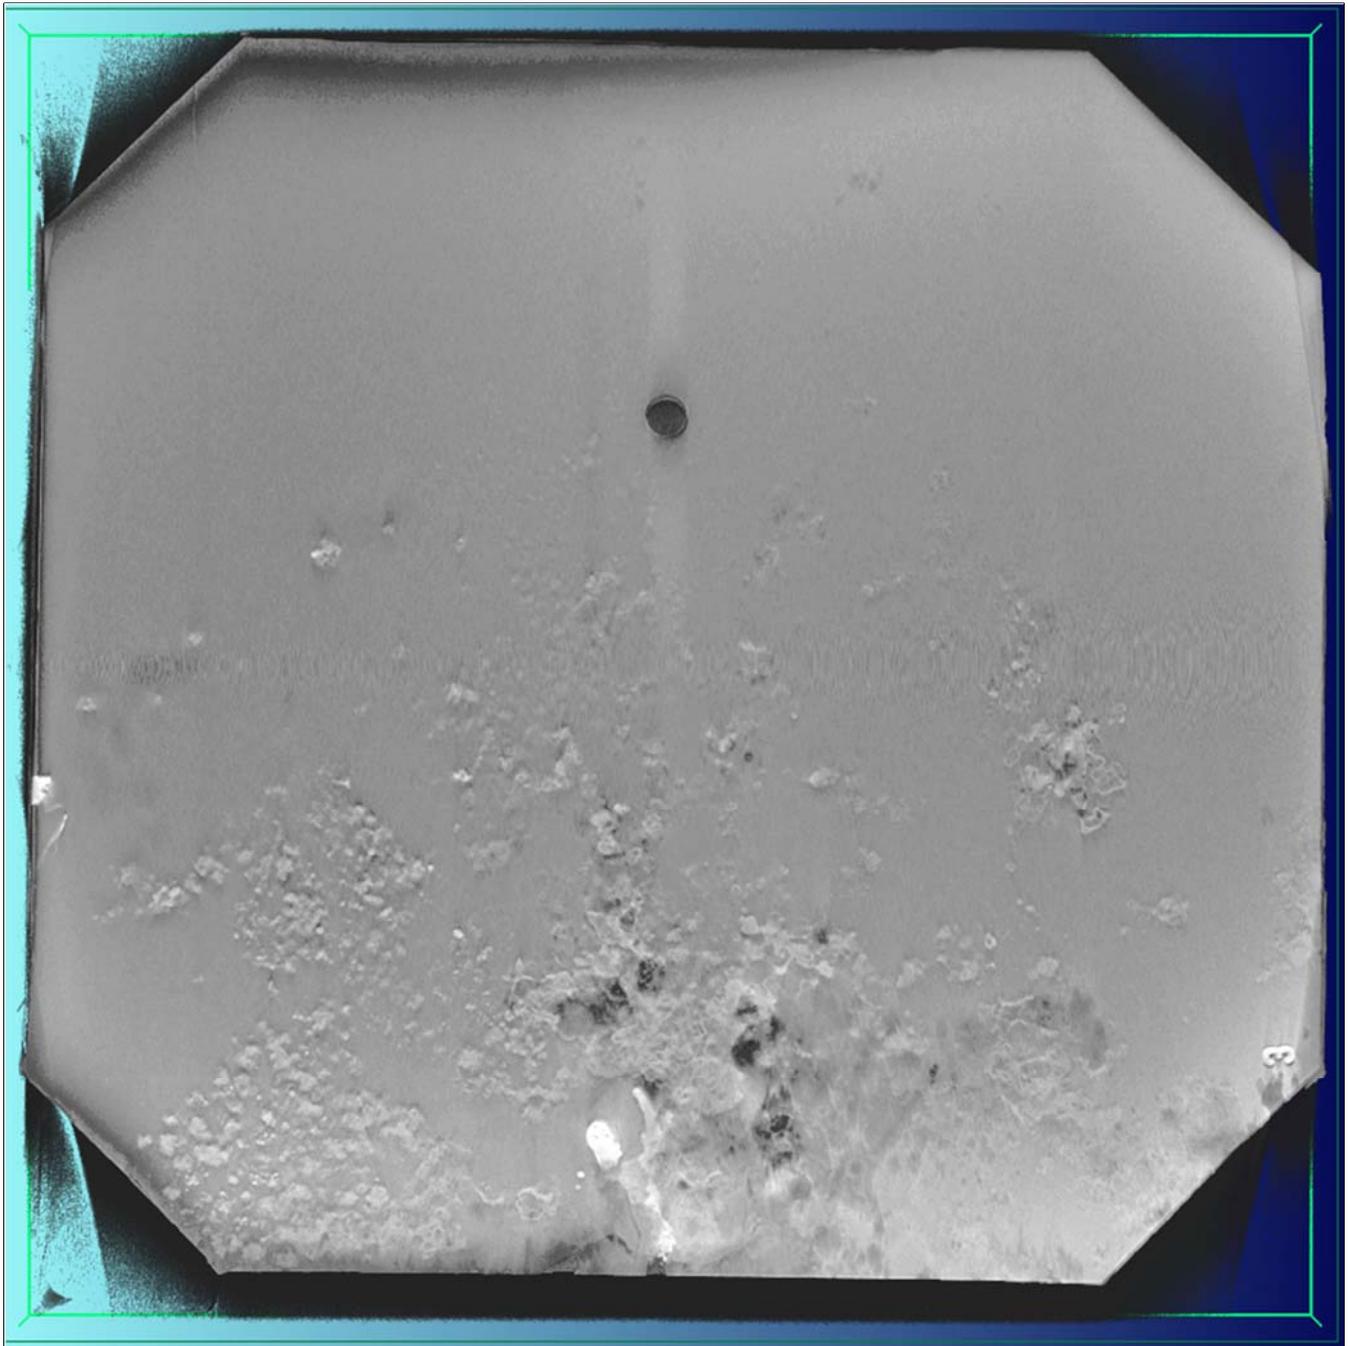
Figure 33. A representative screenshot of the CT scan performed on Coupon 3.

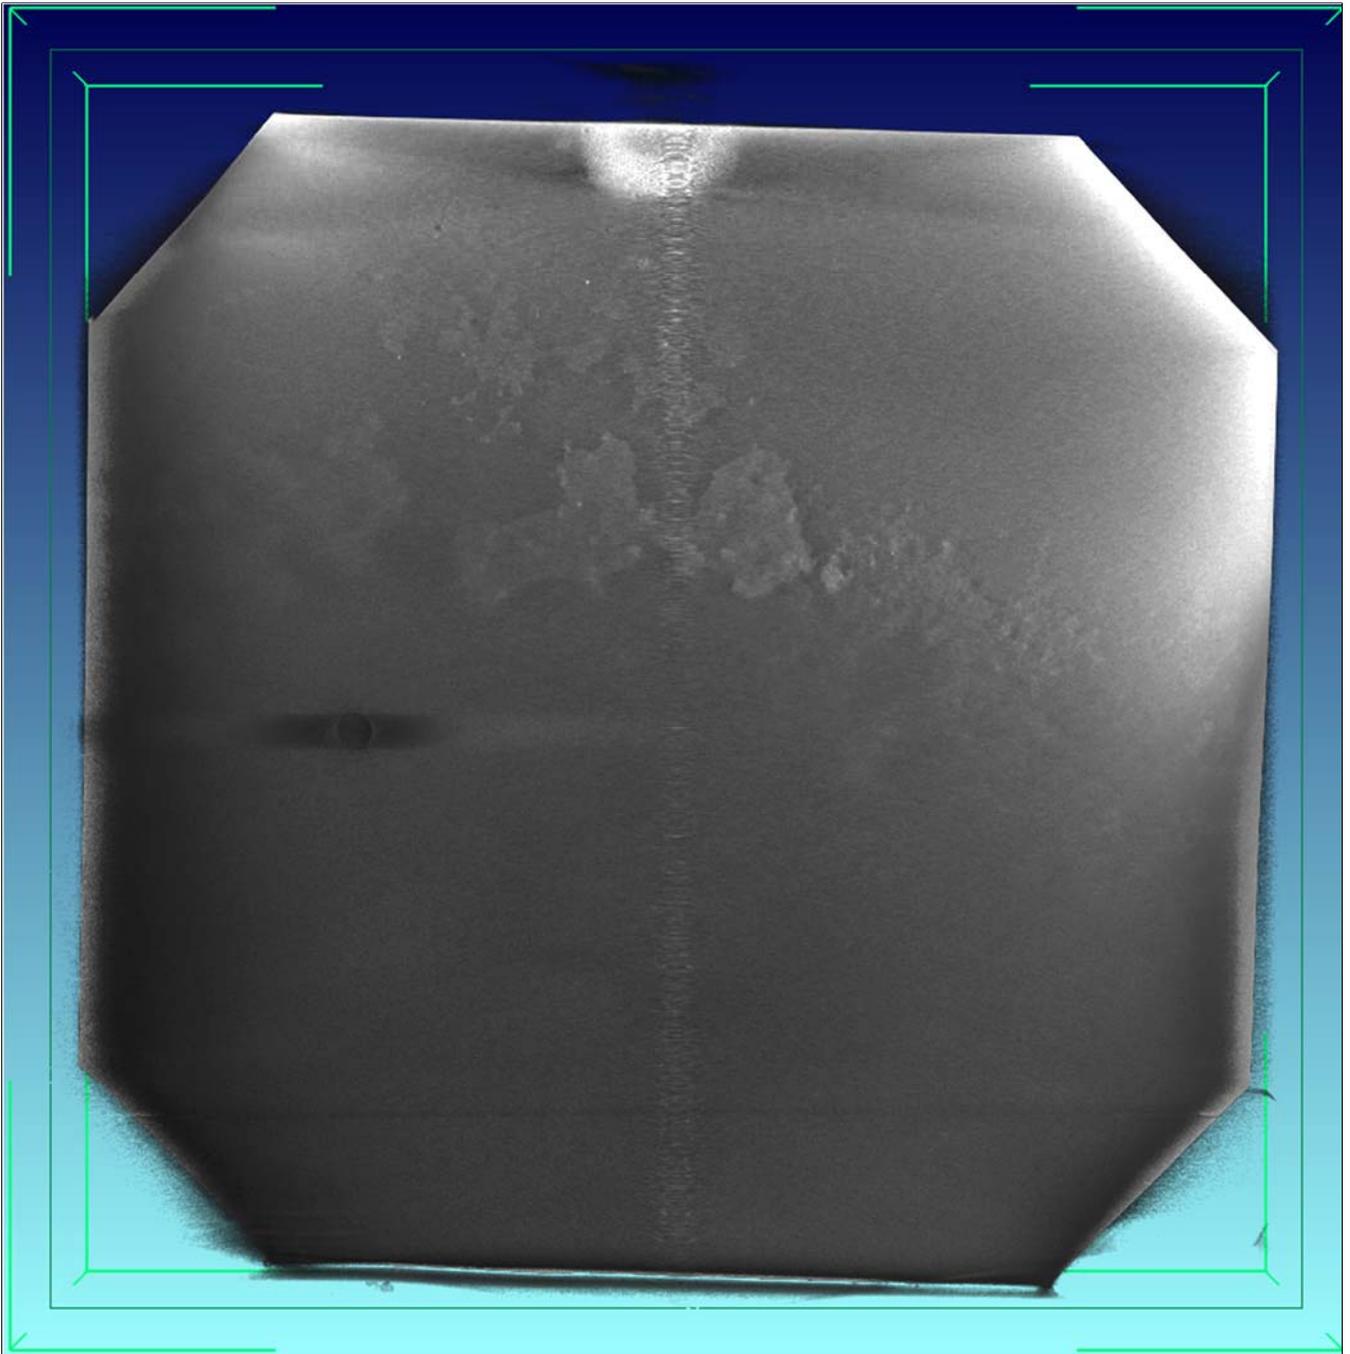
Figure 34. A representative screenshot of the CT scan performed on Coupon 5.

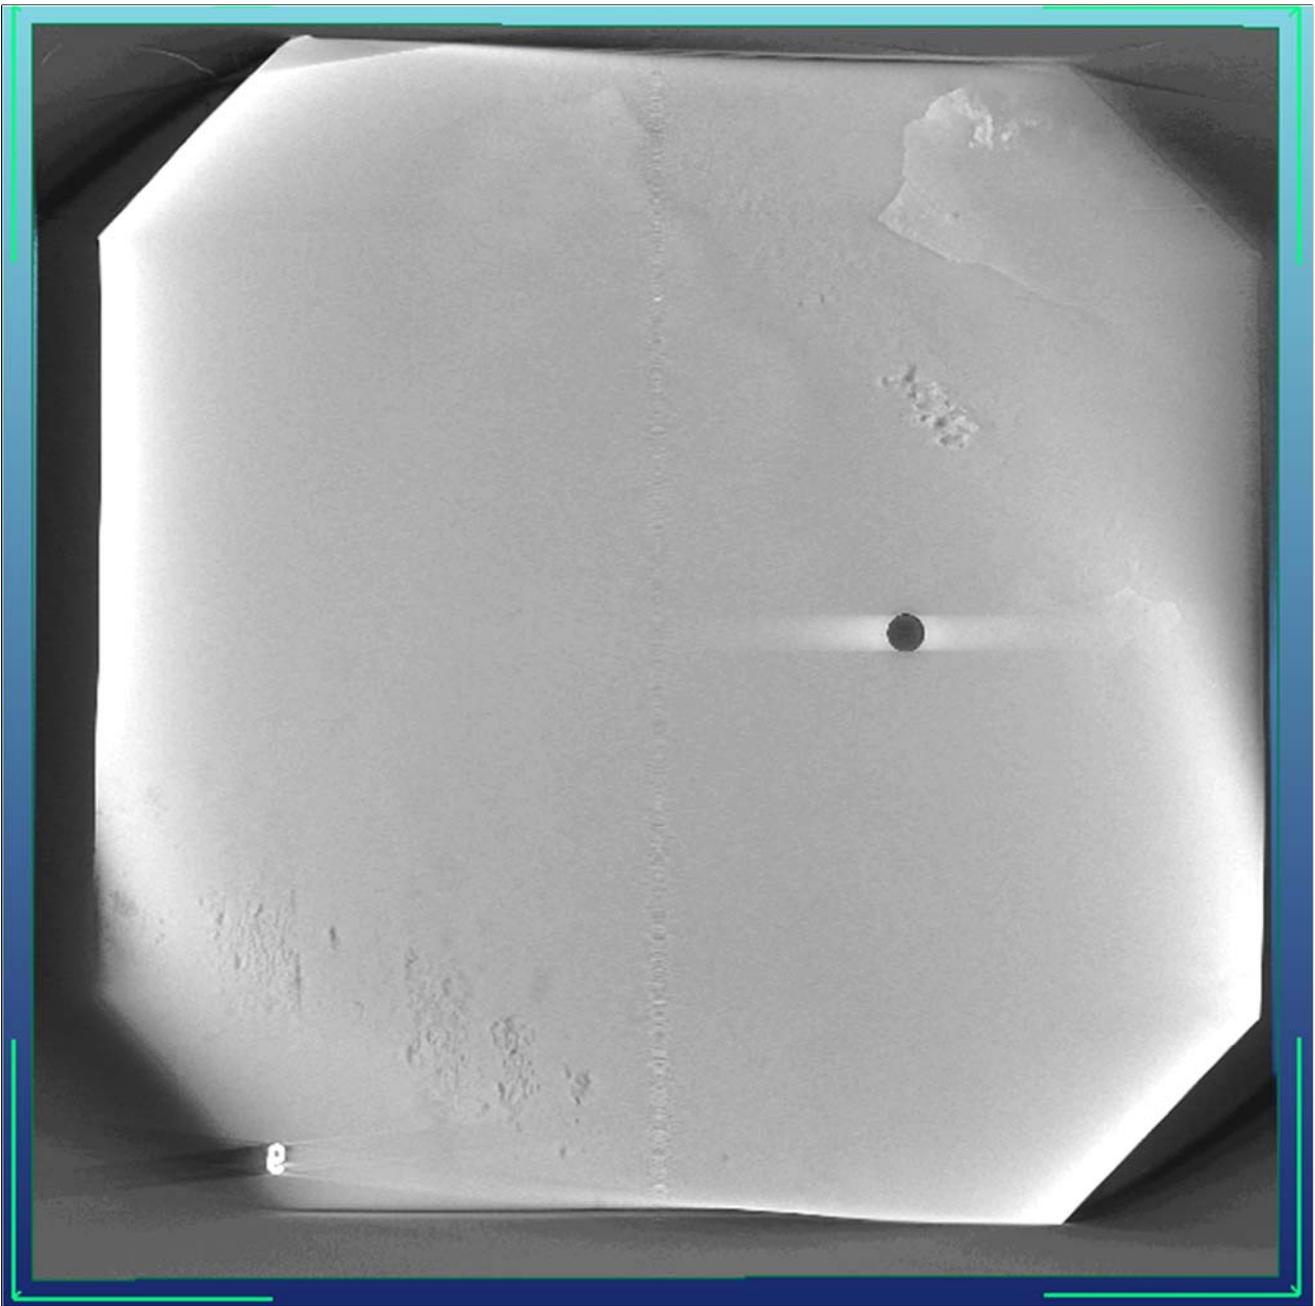
Figure 35. A representative screenshot of the CT scan performed on Coupon 6.

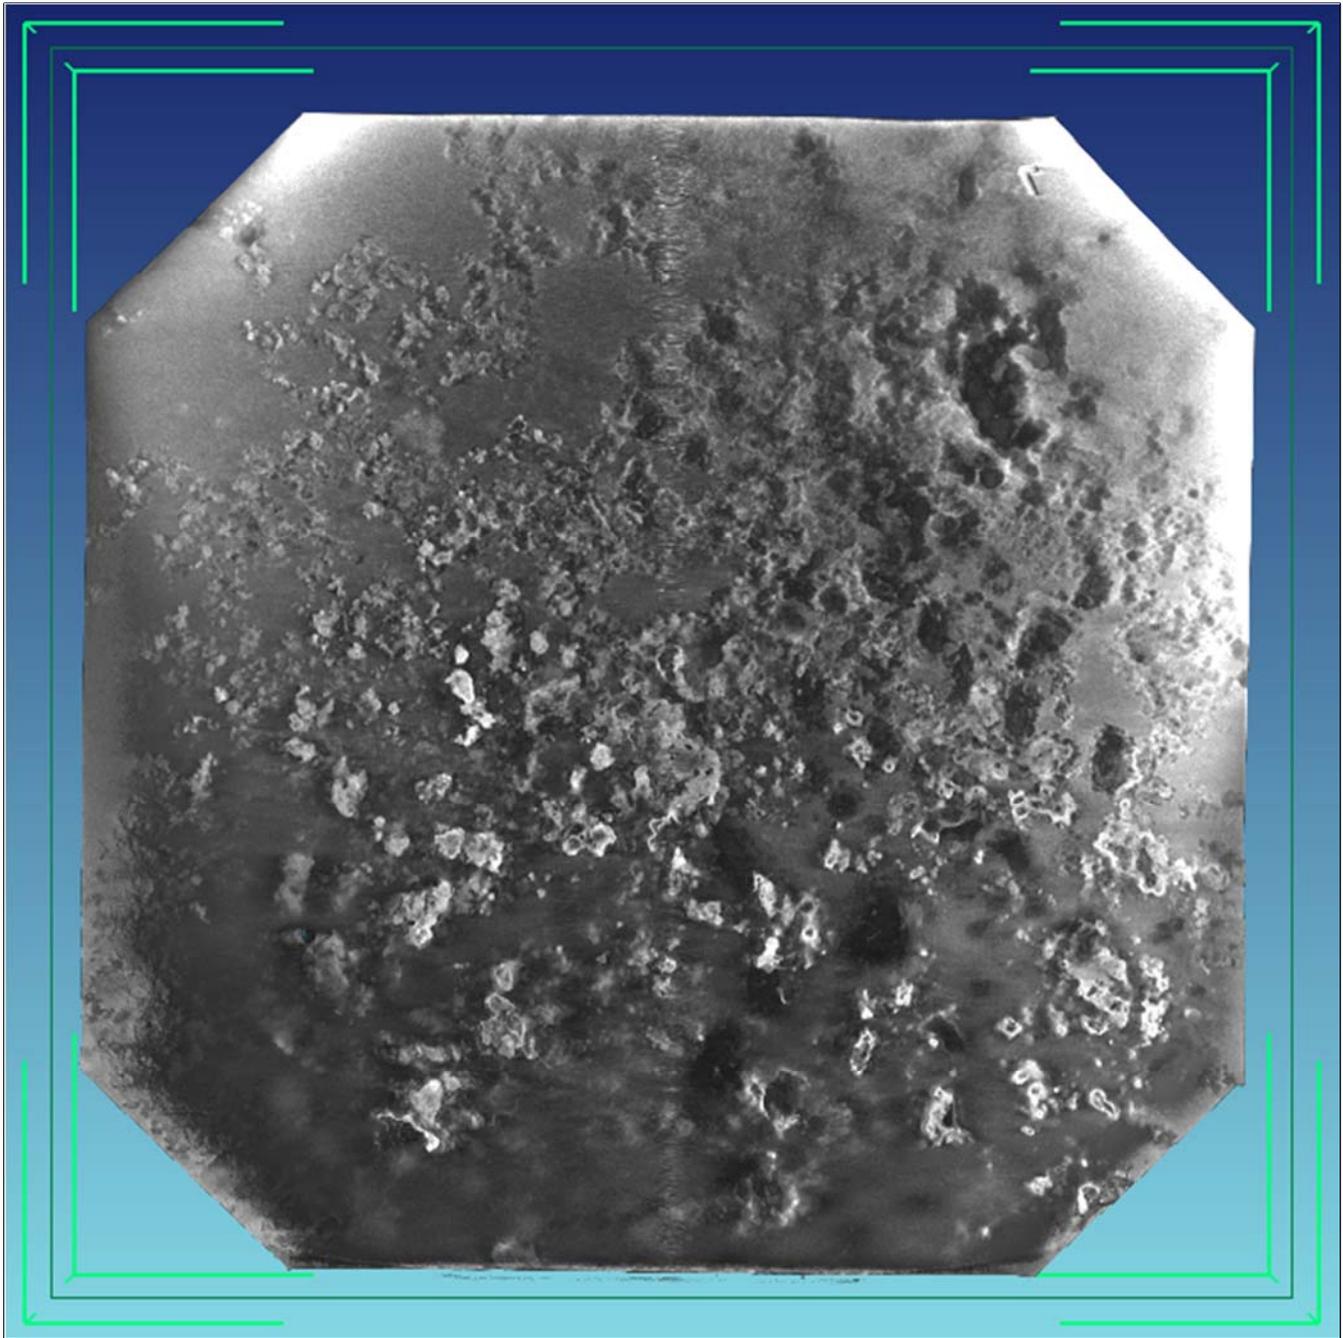
Figure 36. A representative screenshot of the CT scan performed on Coupon 7.

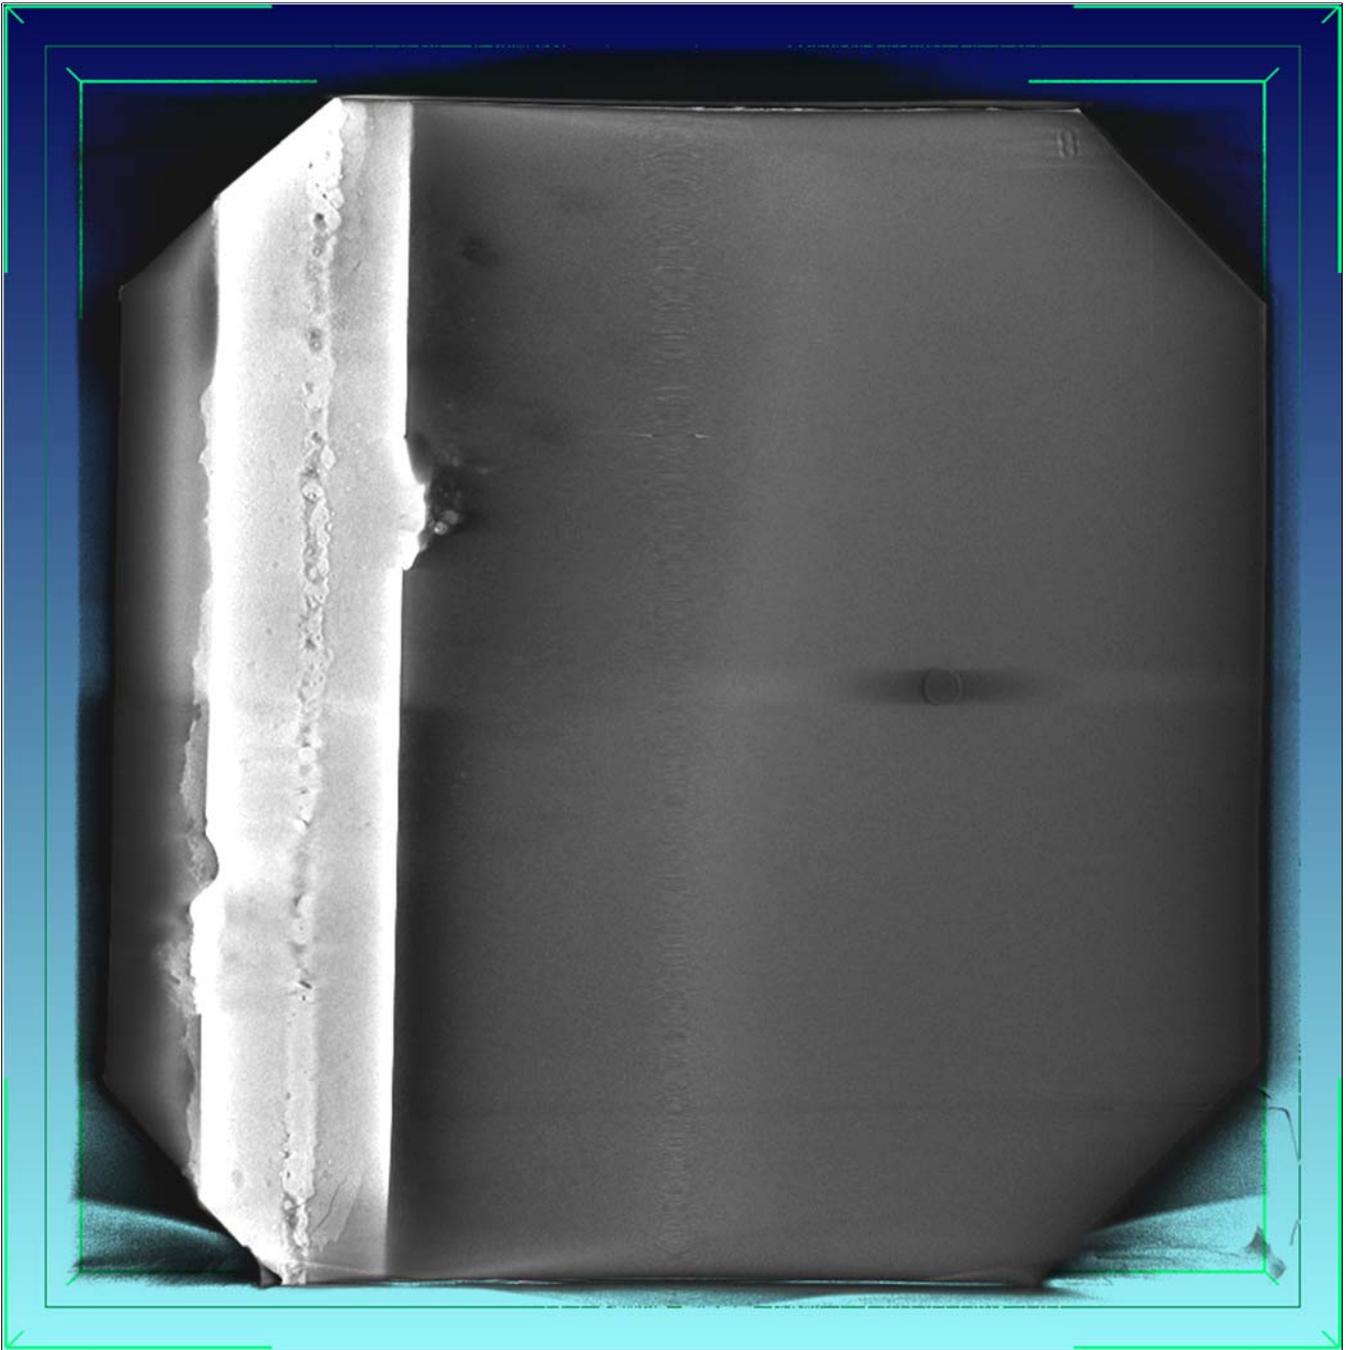
Figure 37. A representative screenshot of the CT scan performed on Coupon 8.

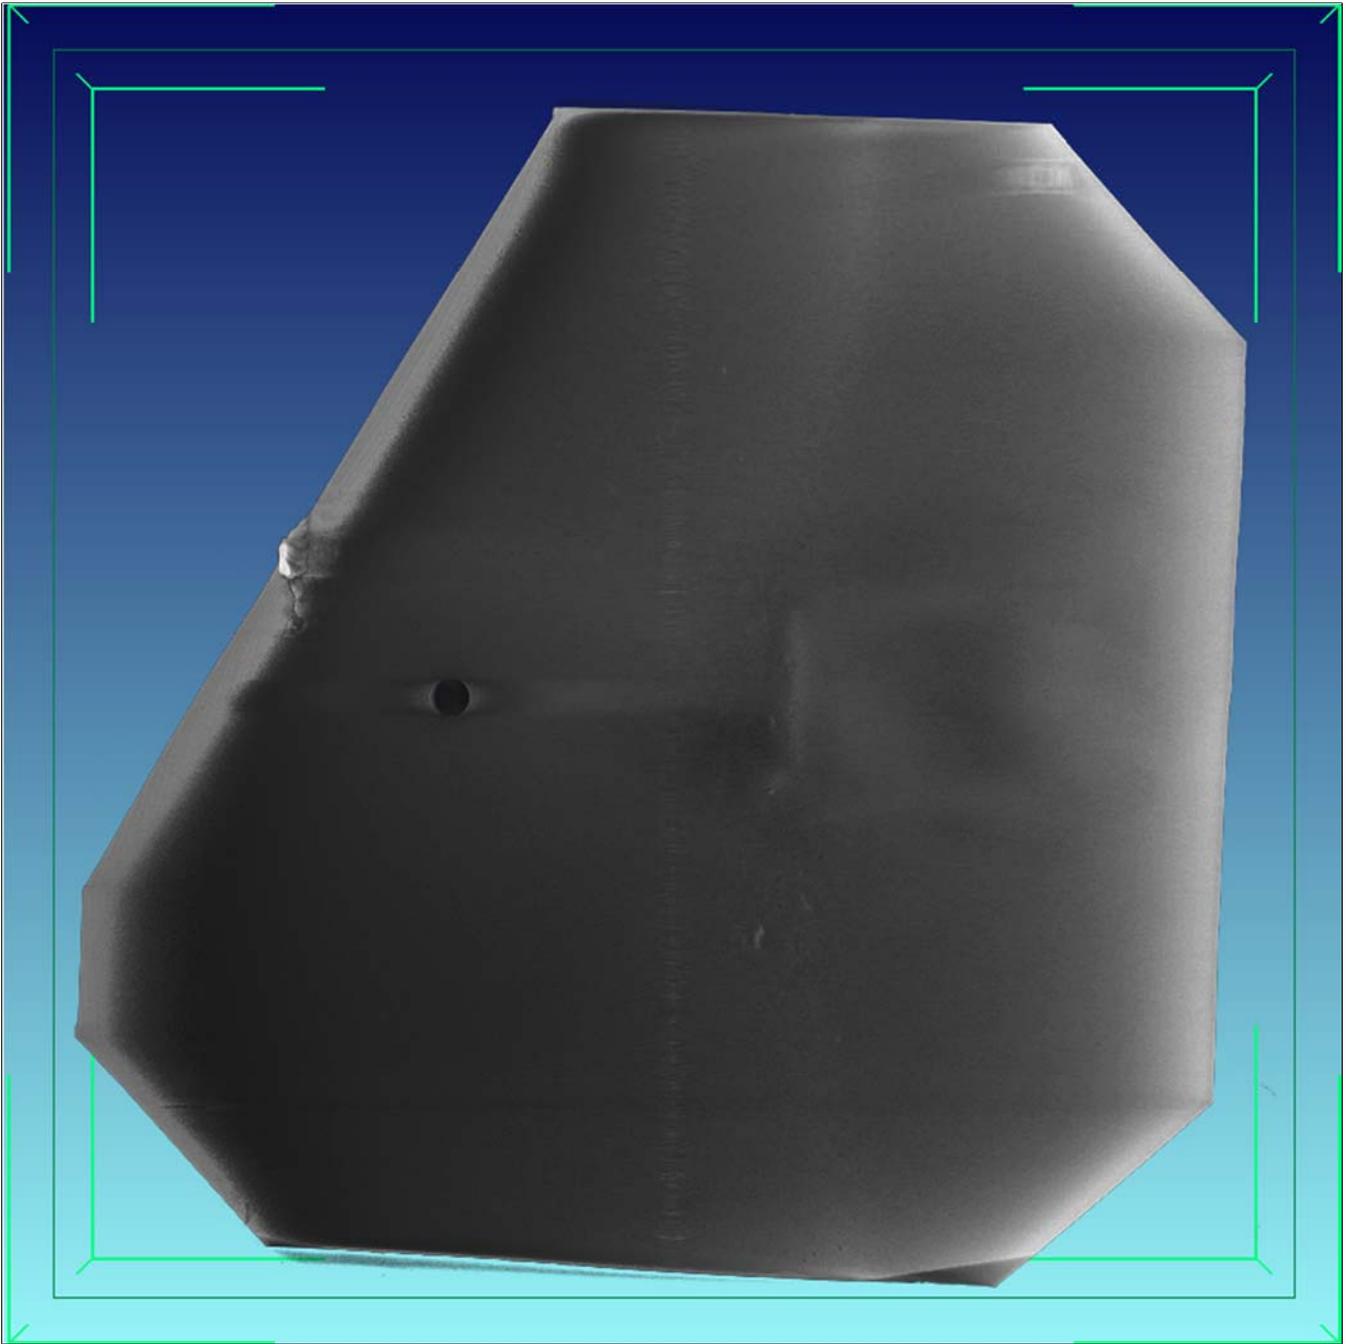
Figure 38. A representative screenshot of the CT scan performed on Coupon 10.

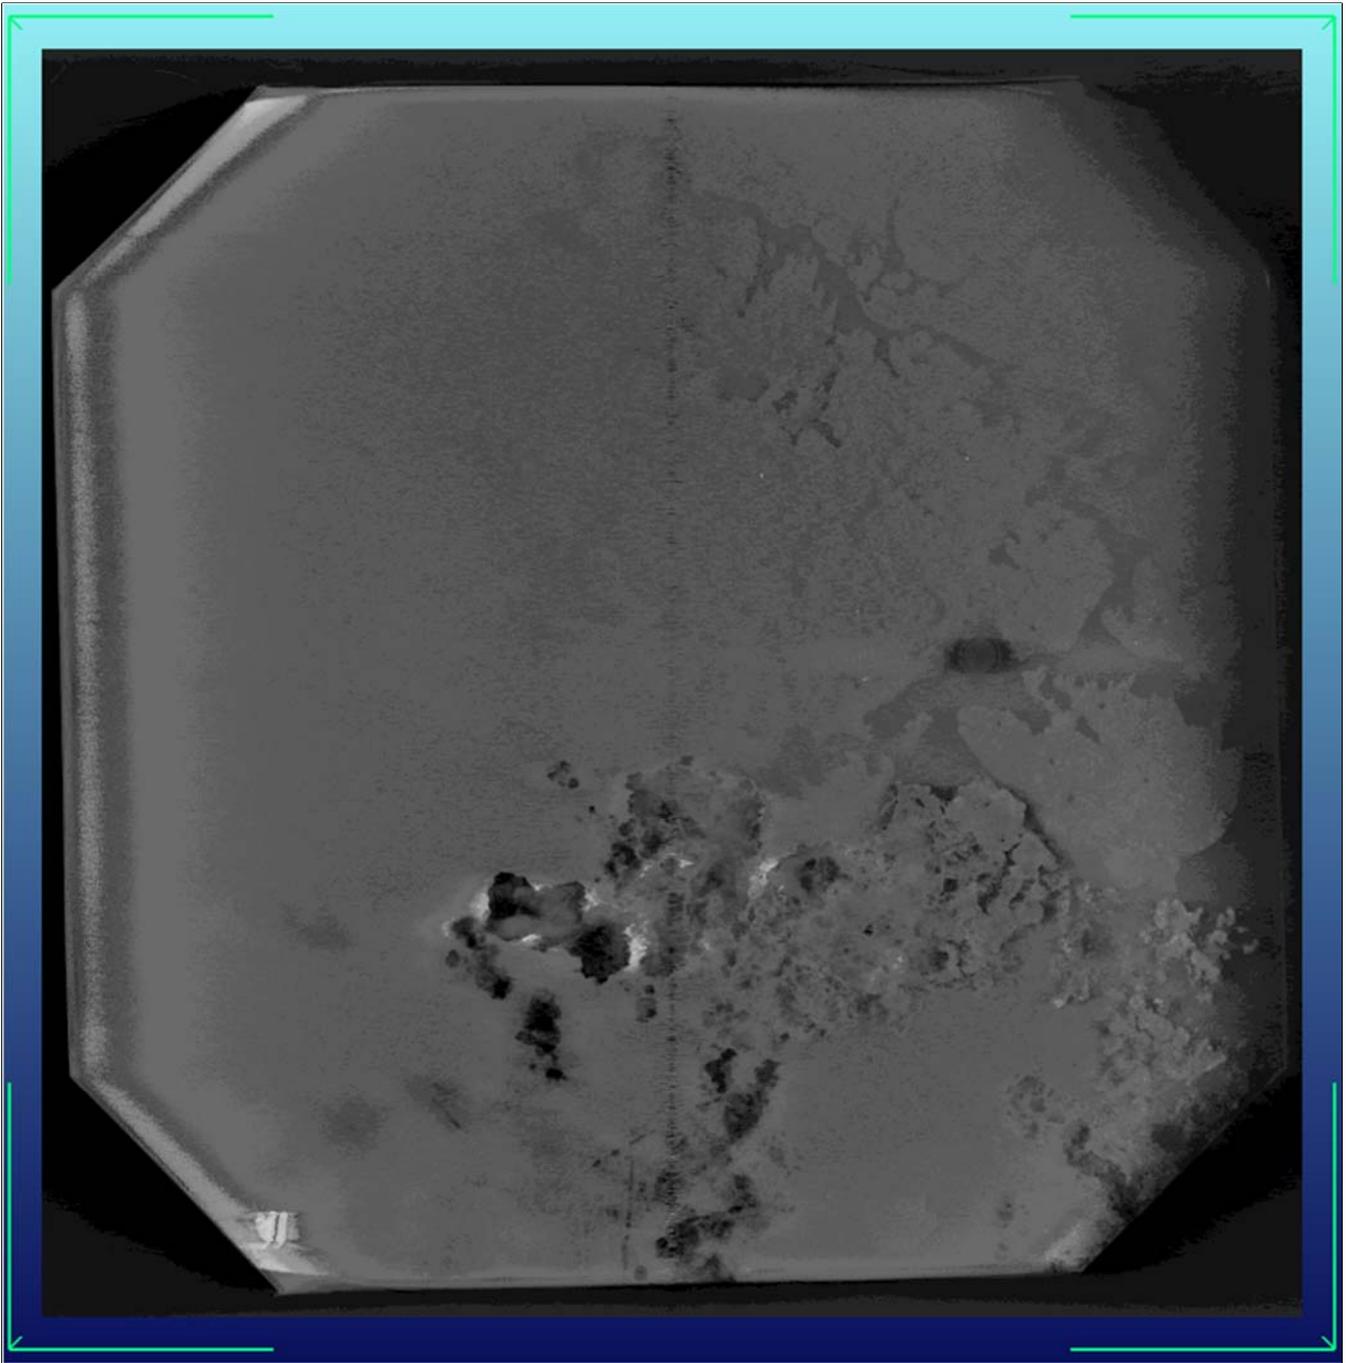
Figure 39. A representative screenshot of the CT scan performed on Coupon A1.

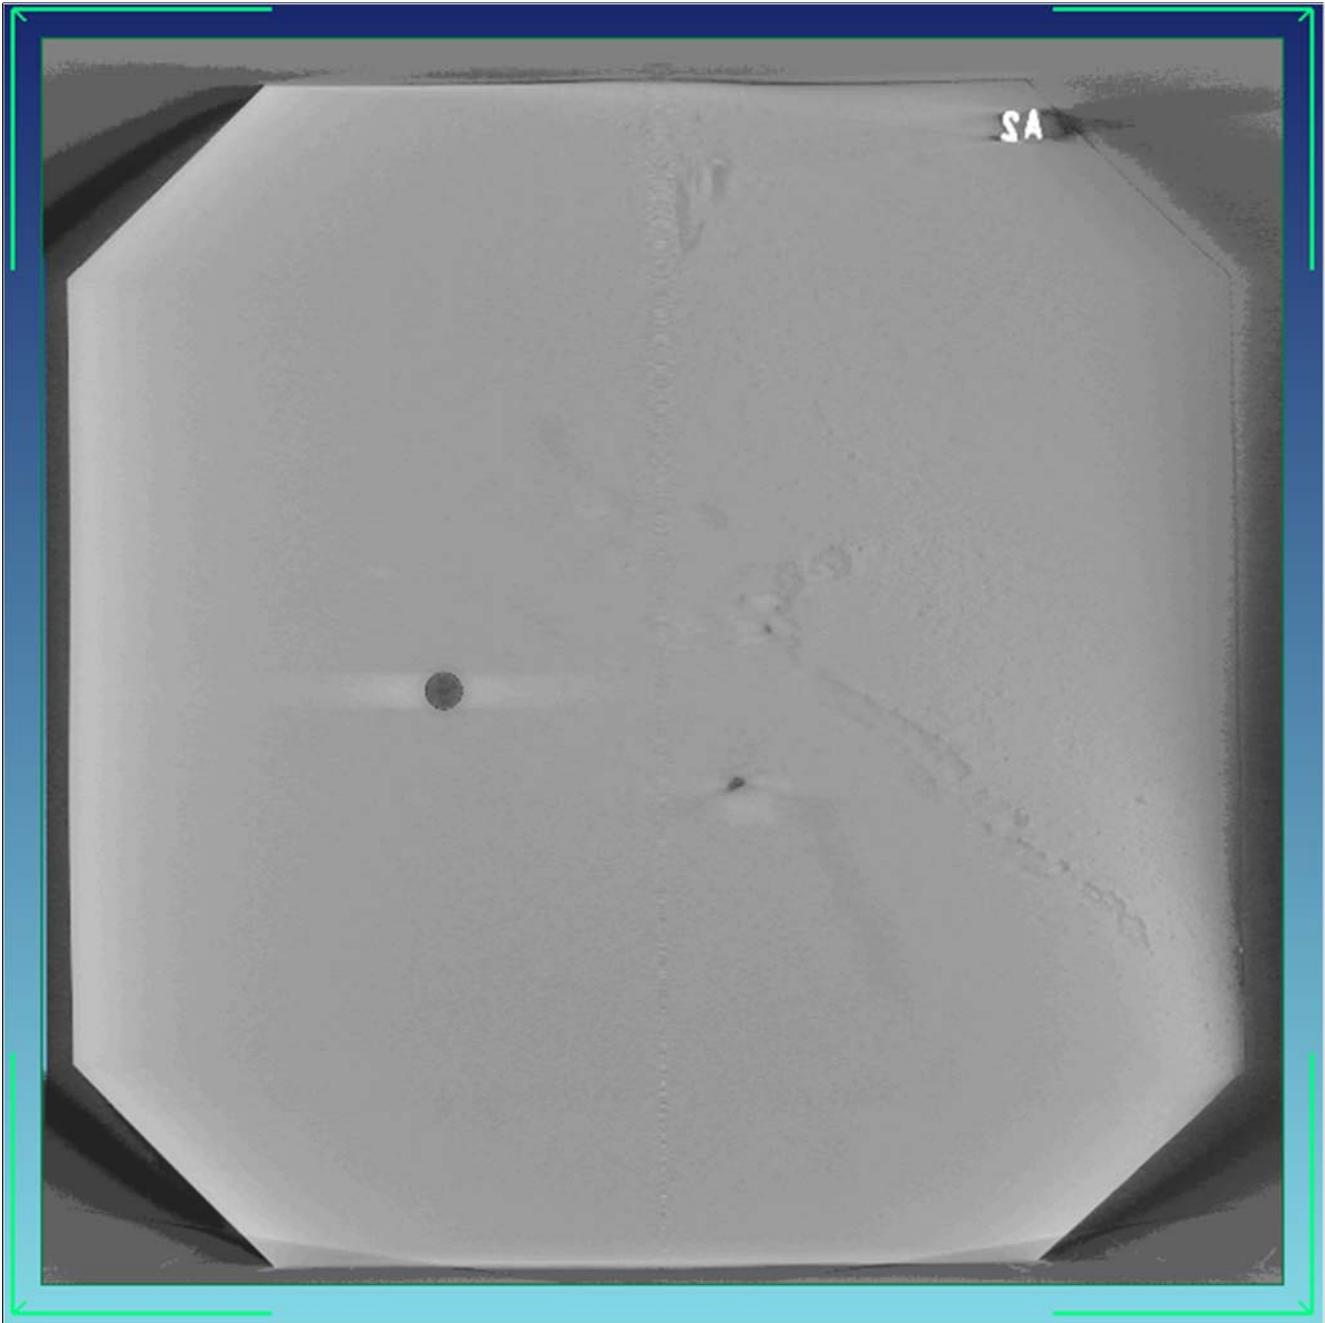
Figure 40. A representative screenshot of the CT scan performed on Coupon A2.

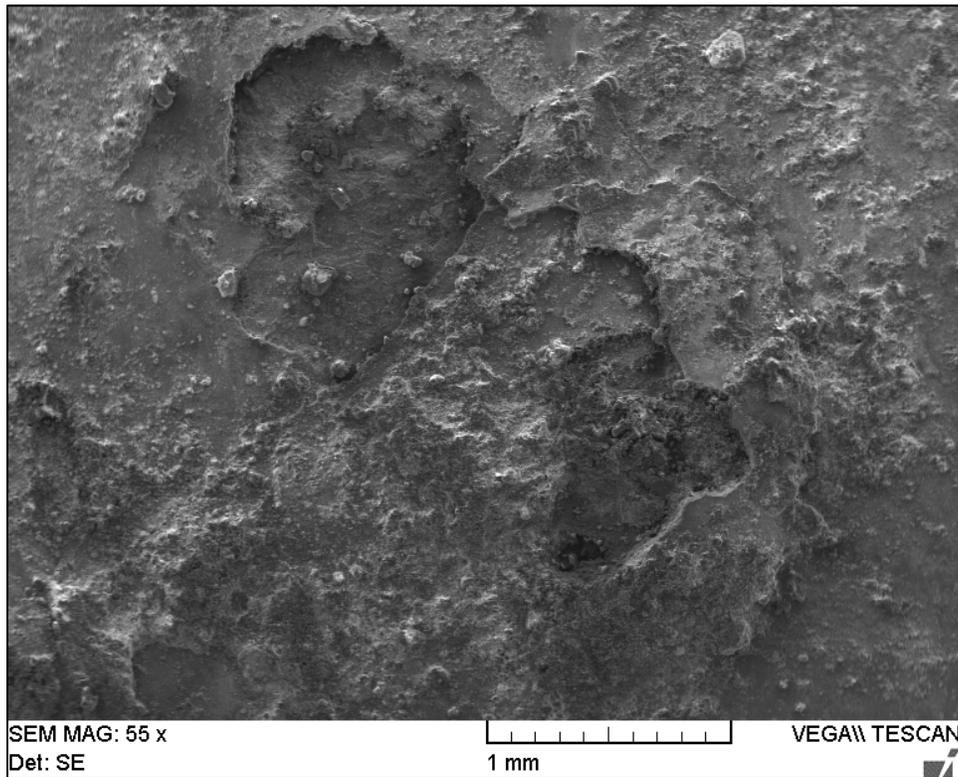
Figure 41. A representative SEM image of a pit on a specimen excised from Coupon 1 labeled as 1-1, prior to cleaning. (SEM, 32X)

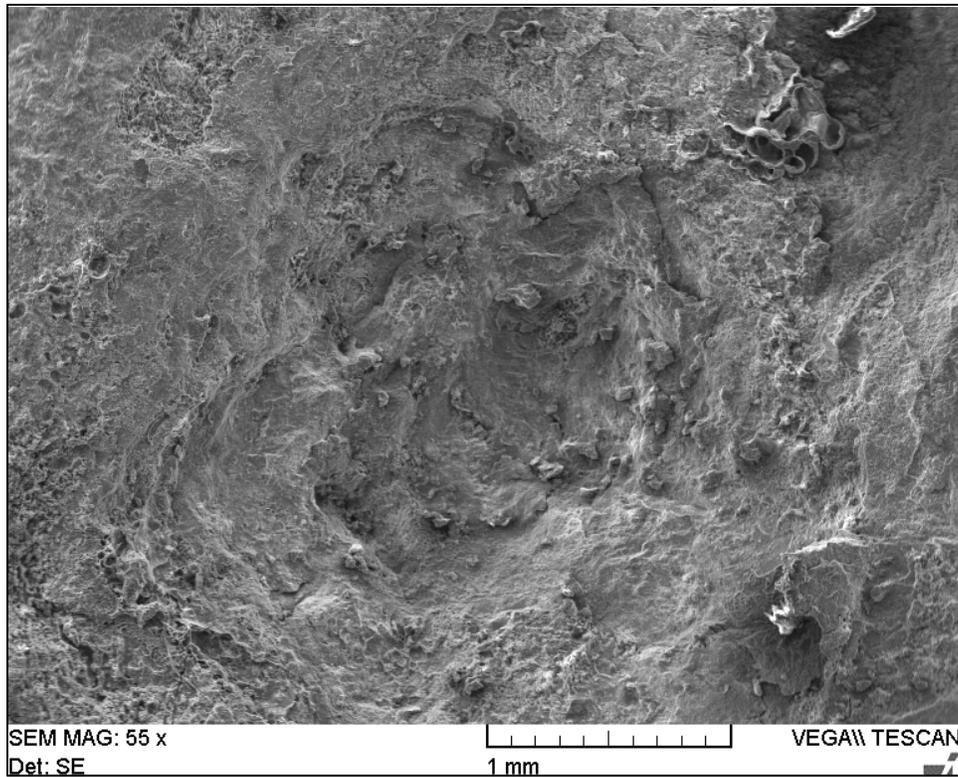
Figure 42. A representative SEM image of a pit on a specimen excised from Coupon 1 labeled as 1-2, prior to cleaning. (SEM, 32X)

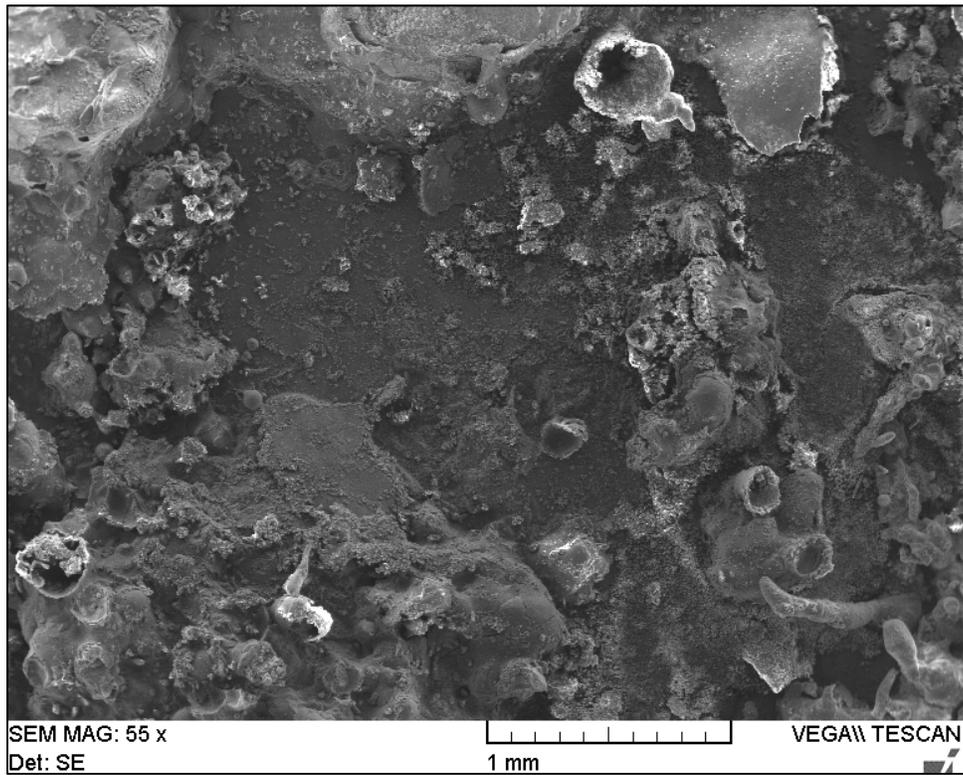
Figure 43. A representative SEM image of a pit on a specimen excised from Coupon 1 labeled as 1-3, prior to cleaning. (SEM, 32X)

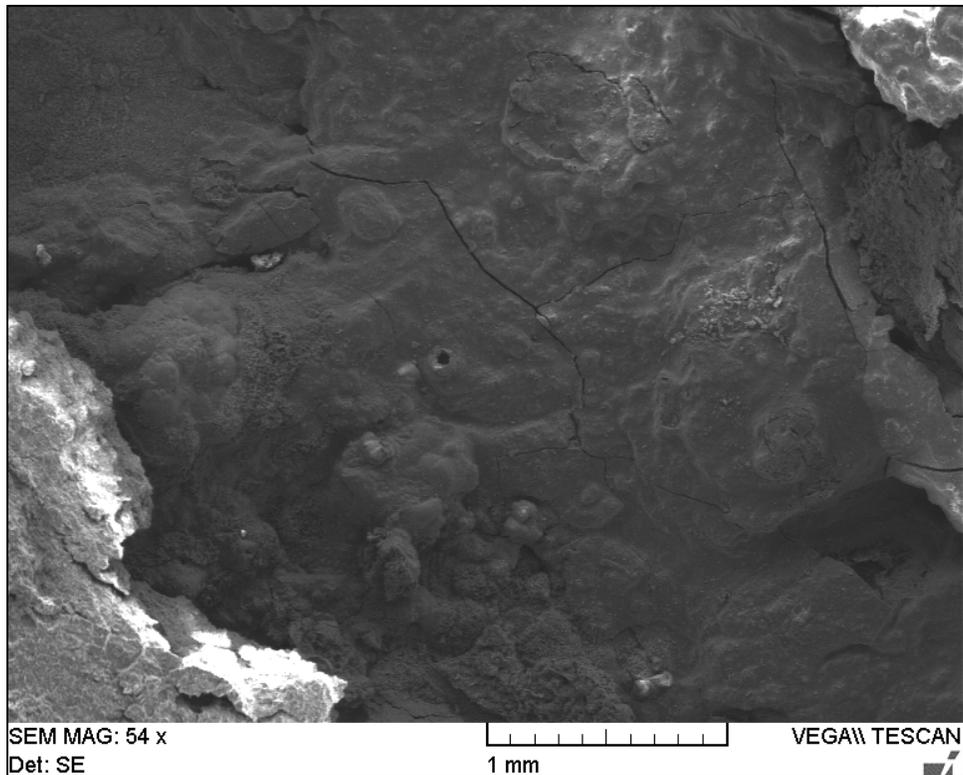
Figure 44. A representative SEM image of a pit on a specimen excised from Coupon 2 labeled as 2-1, prior to cleaning. (SEM, 32X)

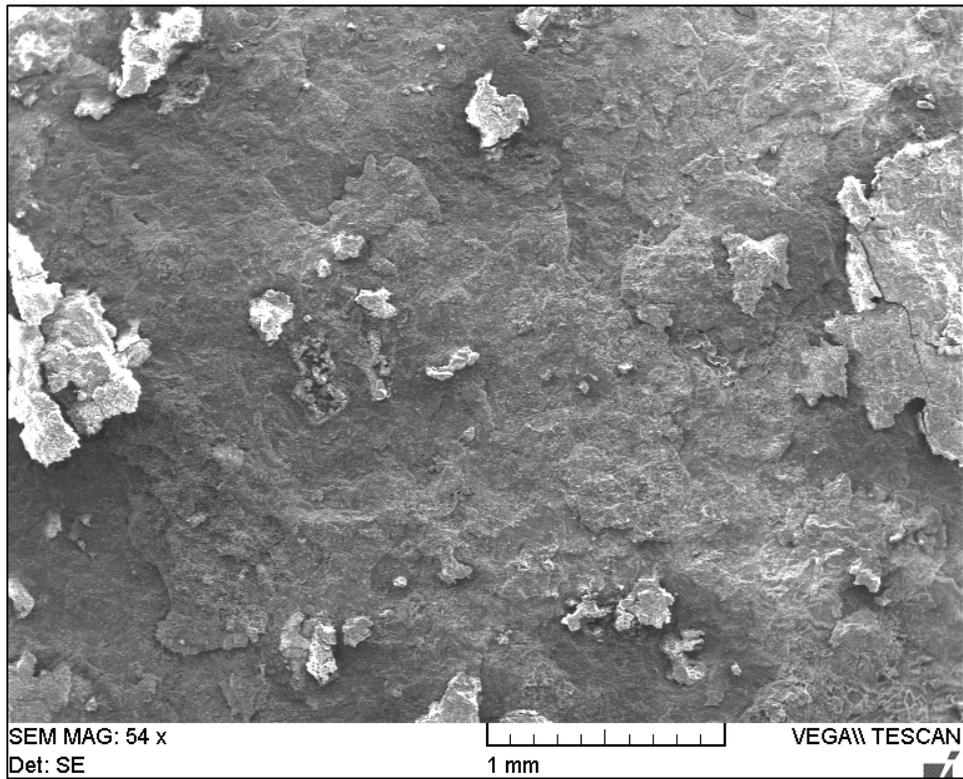
Figure 45. A representative SEM image of a pit on a specimen excised from Coupon 2 labeled as 2-2, prior to cleaning. (SEM, 32X)

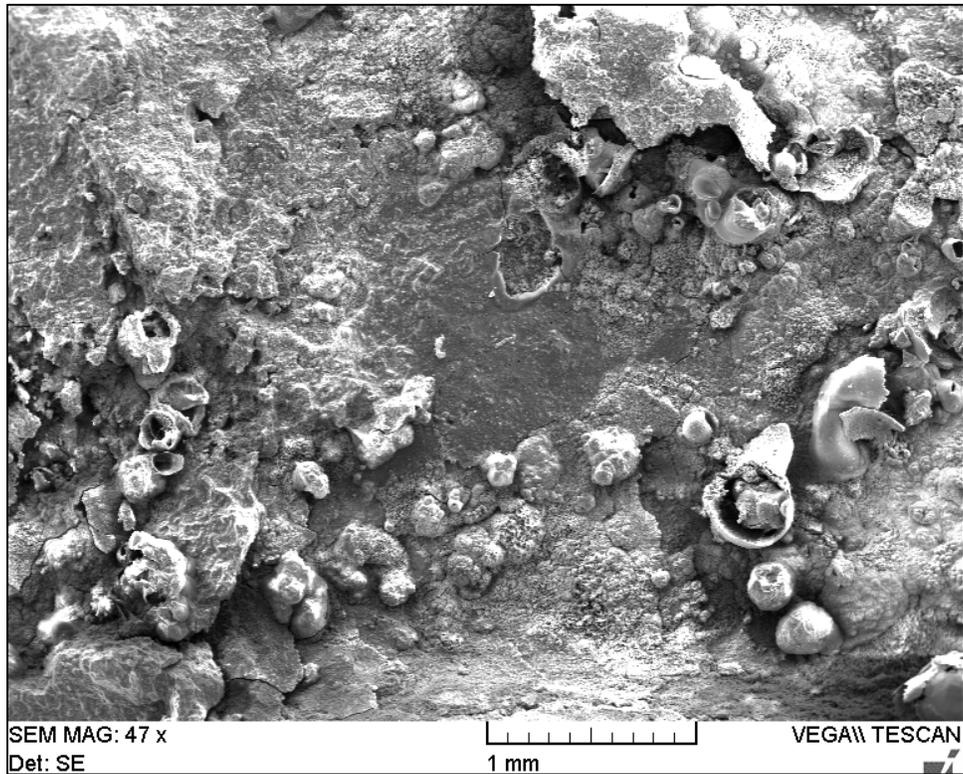
Figure 46. A representative SEM image of a pit on a specimen excised from Coupon 2 labeled as 2-3, prior to cleaning. (SEM, 28X)

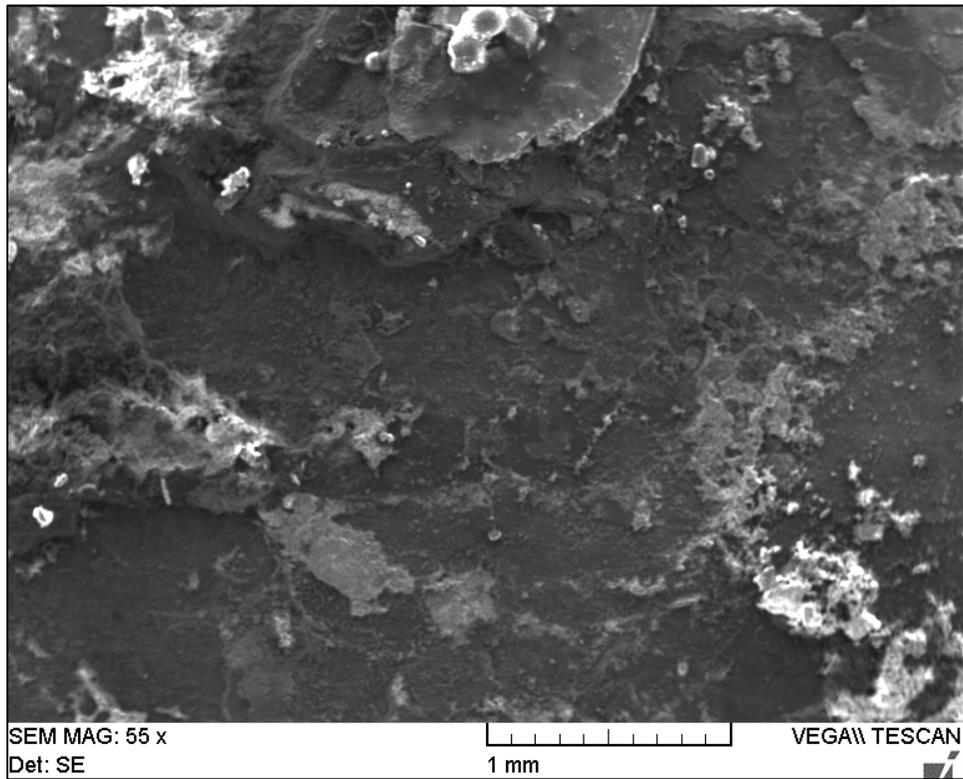
Figure 47. A representative SEM image of a pit on a specimen excised from Coupon 3 labeled as 3-1, prior to cleaning. (SEM, 32X)

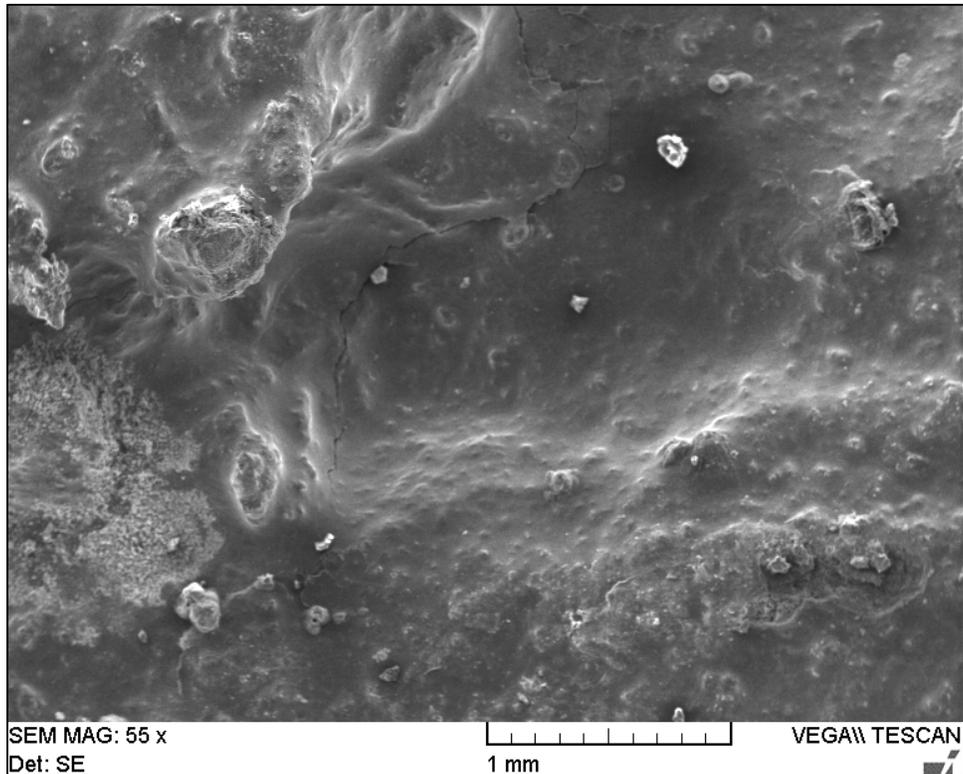
Figure 48. A representative SEM image of a pit on a specimen excised from Coupon 3 labeled as 3-2, prior to cleaning. (SEM, 32X)

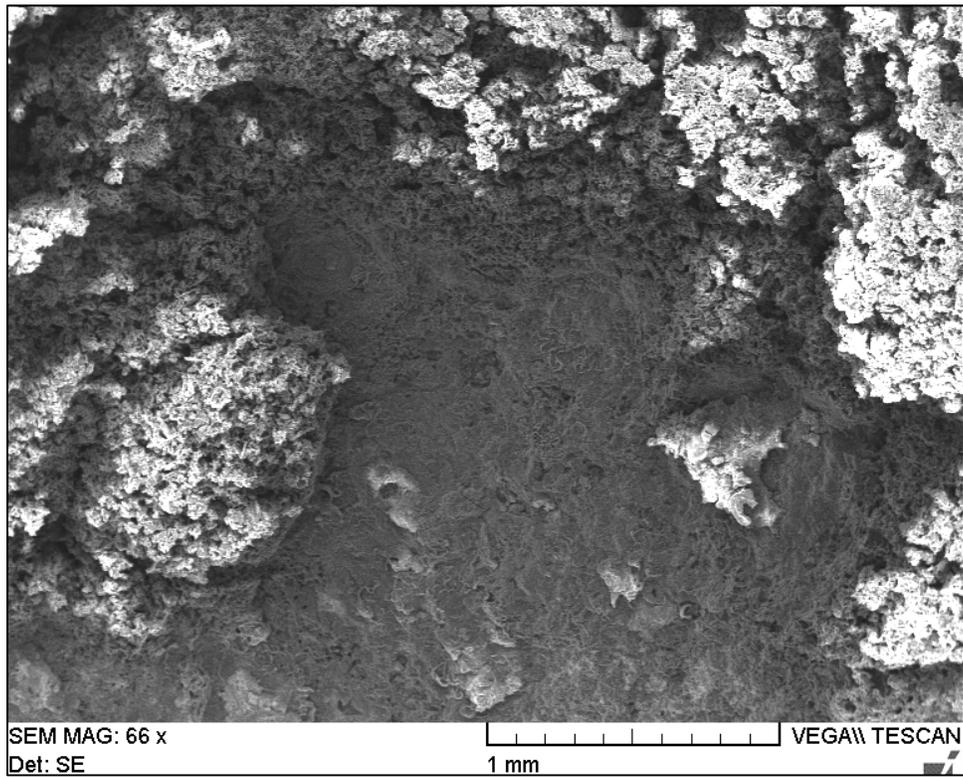
Figure 49. A representative SEM image of a pit on a specimen excised from Coupon 3 labeled as 3-3, prior to cleaning. (SEM, 39X)

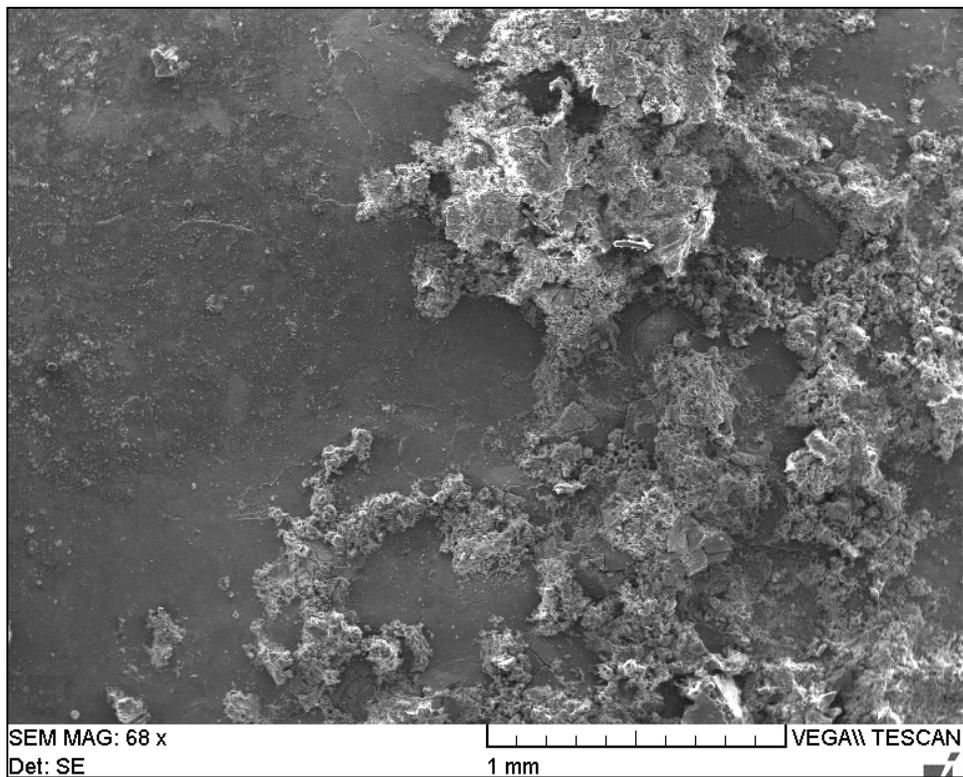
Figure 50. A representative SEM image of the specimen excised from Coupon 5 labeled as 5-1, prior to cleaning. No pits observed. (SEM, 40X)

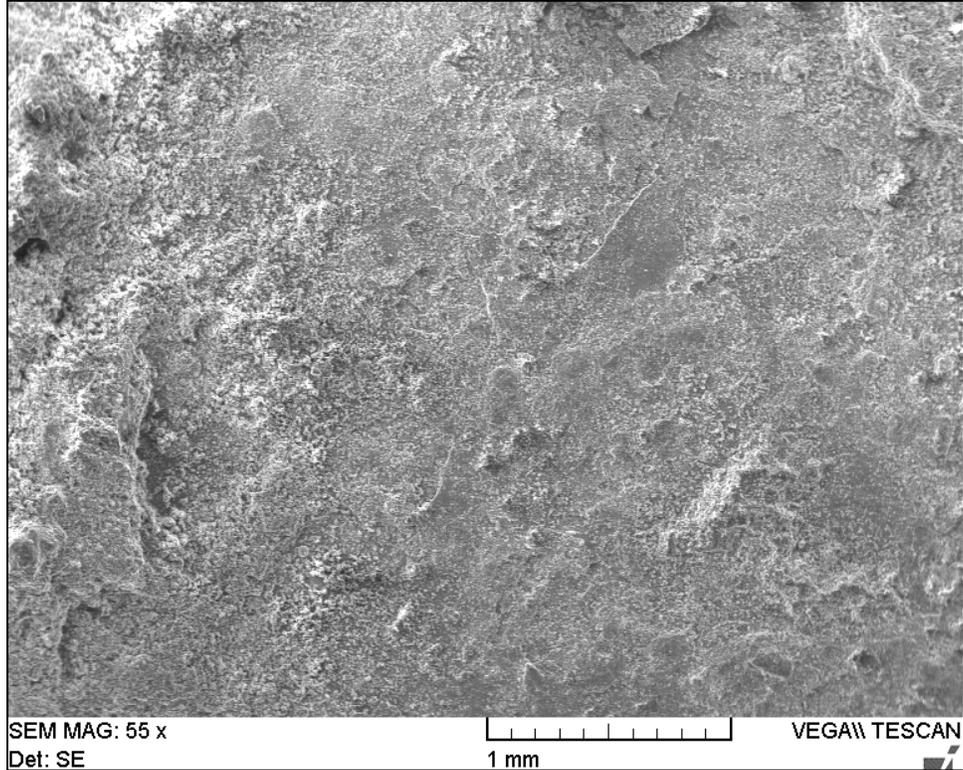
Figure 52. A representative SEM image of a pit on a specimen excised from Coupon 5 labeled as 5-3, prior to cleaning. (SEM, 32X)
