SUBJECT: DESTRUCTIVE ANALYSIS OF 10 STEEL COUPONS REMOVED FROM RED HILL FUEL STORAGE TANK NO. 14, PURSUANT TO SECTION 5.3 OF THE ADMINISTRATIVE ORDER ON CONSENT STATEMENT OF WORK, RED HILL BULK FUEL STORAGE FACILITY, JOINT BASE PEARL HARBOR-HICKAM, OAHU, HAWAII

Destructive Analysis of 10 Steel Coupons Removed from Red Hill Fuel Storage Tank #14

REPORT No. 201801967

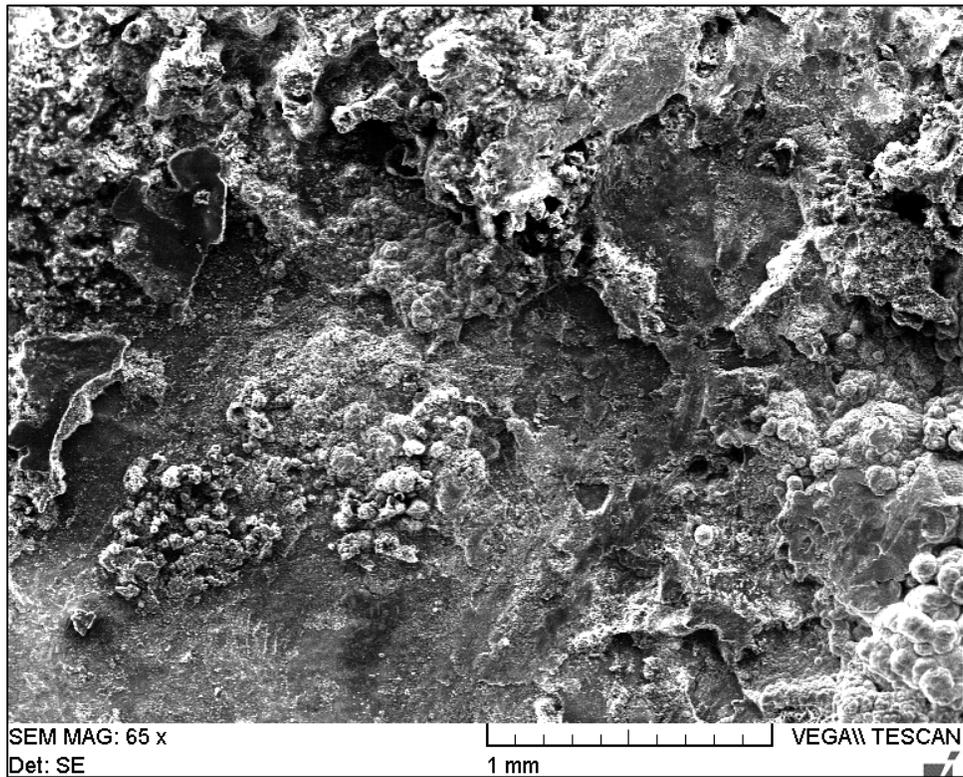
Figure 53. A representative SEM image of a pit on a specimen excised from Coupon 6 labeled as 6-1, prior to cleaning. (SEM, 38X)

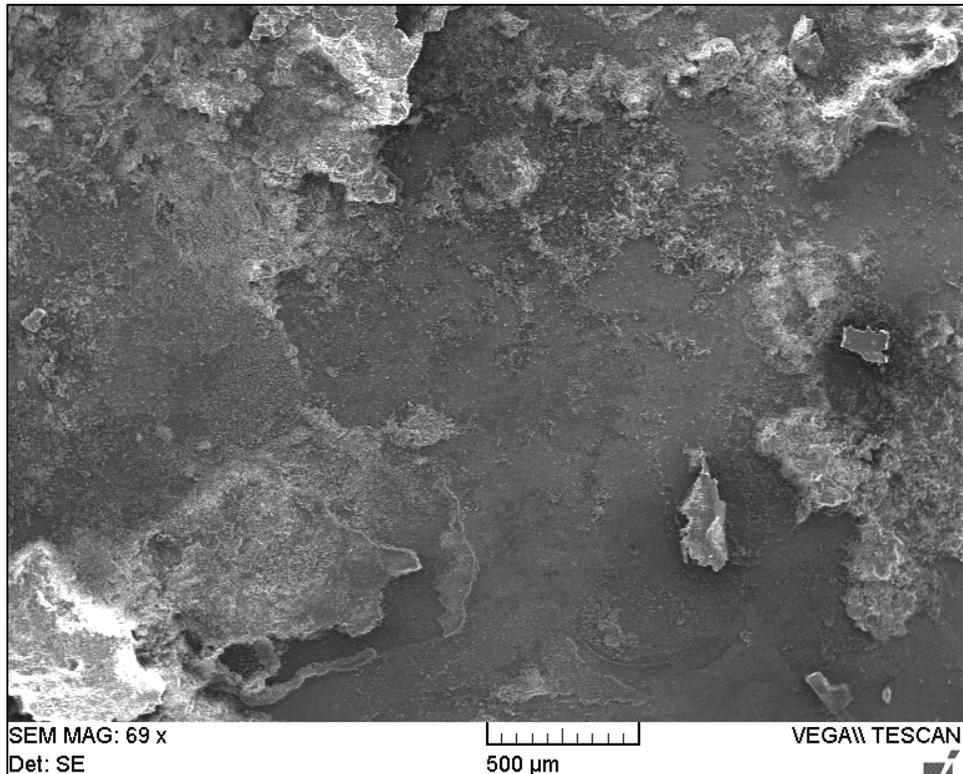
Figure 54. A representative SEM image the surface of a specimen excised from Coupon 6 labeled as 6-2, prior to cleaning. No pit was observed in this location. (SEM, 40X)

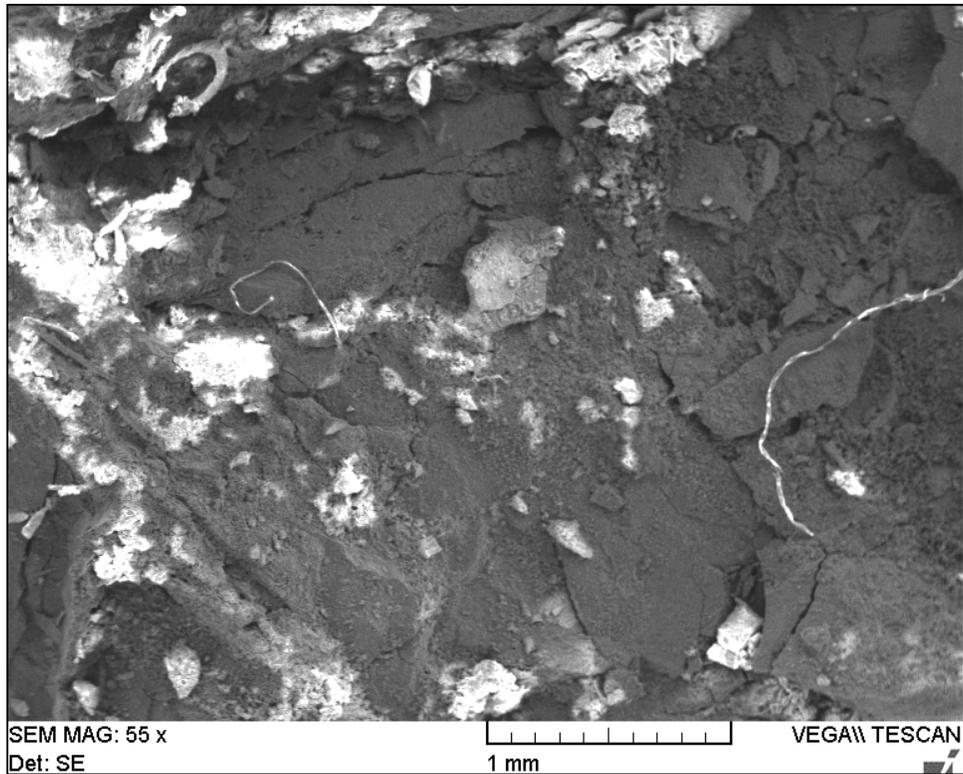
Figure 56. A representative SEM image of a pit on a specimen excised from Coupon 7 labeled as 7-1, prior to cleaning. (SEM, 32X)

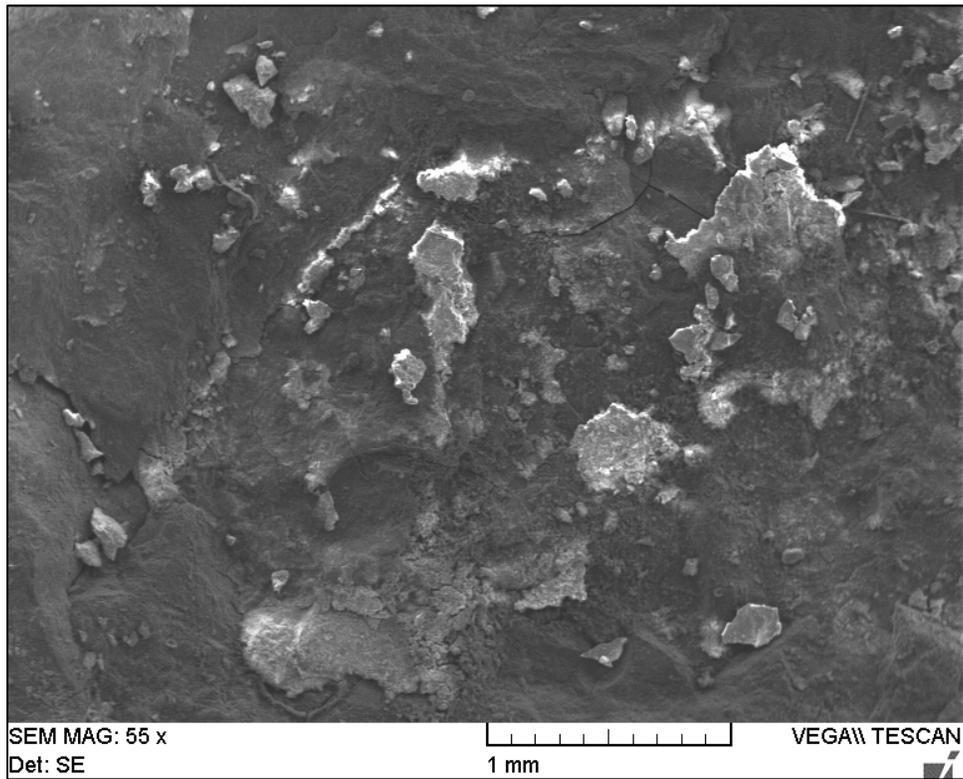
Figure 57. A representative SEM image of a pit on a specimen excised from Coupon 7 labeled as 7-2, prior to cleaning. (SEM, 32X)

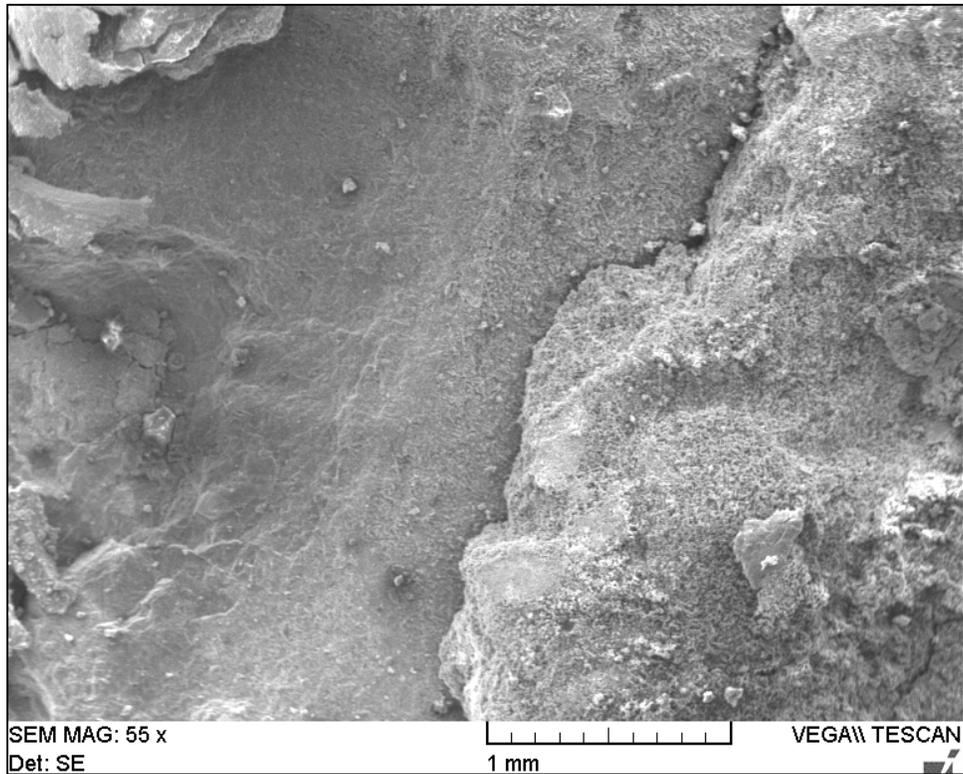
Figure 58. A representative SEM image of a pit on a specimen excised from Coupon 7 labeled as 7-3, prior to cleaning. (SEM, 32X)

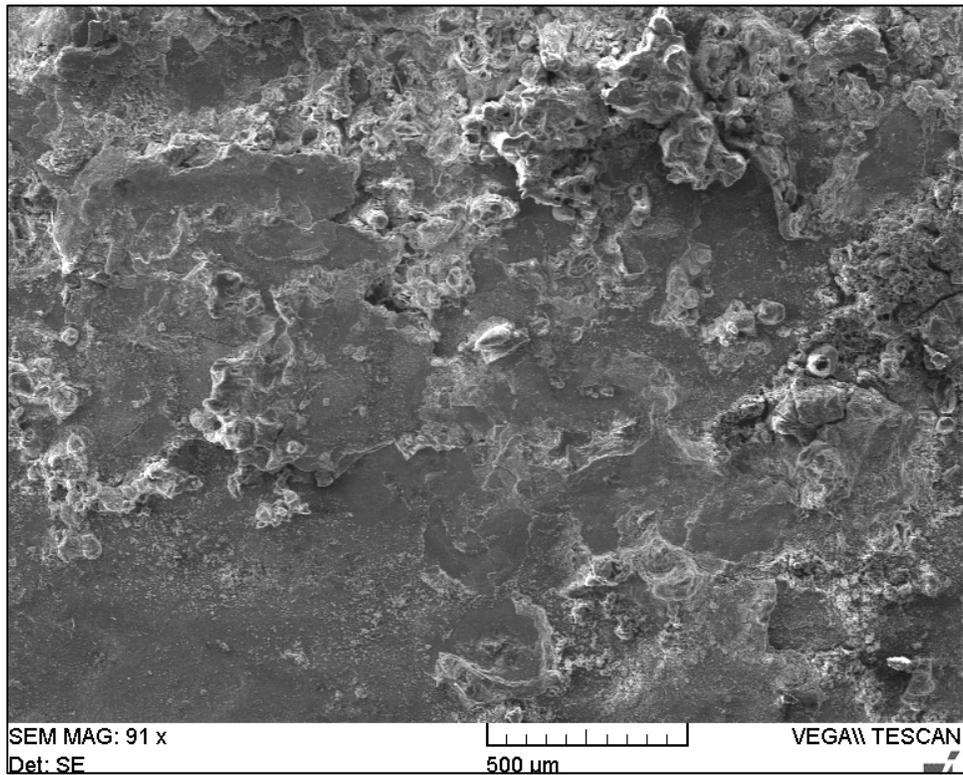
Figure 59. A representative SEM image of a pit on a specimen excised from Coupon 8 labeled as 8-1, prior to cleaning. (SEM, 53X)

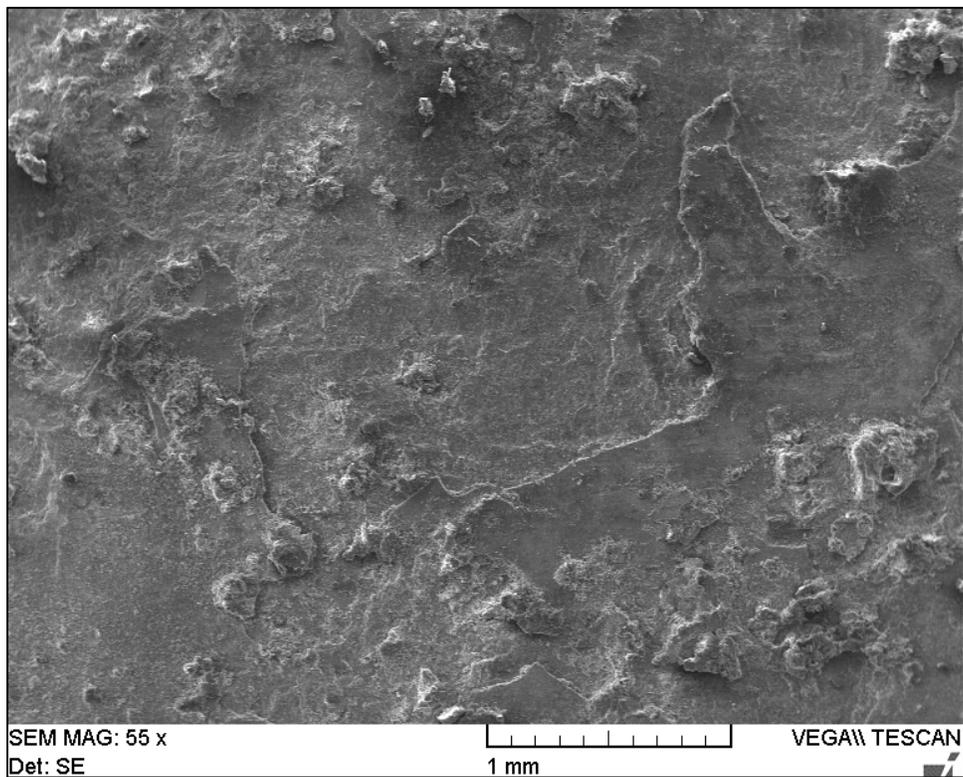
Figure 60. A representative SEM image of a pit on a specimen excised from Coupon 8 labeled as 8-2, prior to cleaning. (SEM, 33X)

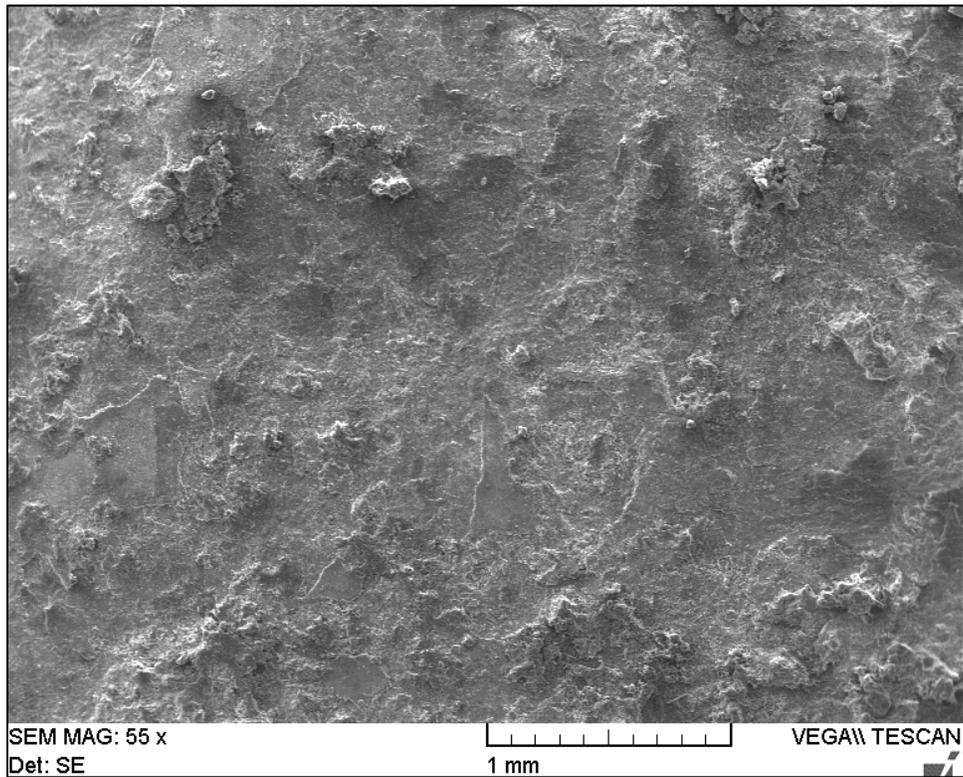
④ This is the weld-repaired plate section. Sample 8-3 exhibited a depression or pit on the painted surface.

Figure 61. A representative SEM image of a pit on a specimen excised from Coupon 8 labeled as 8-3, prior to cleaning. (SEM, 33X)

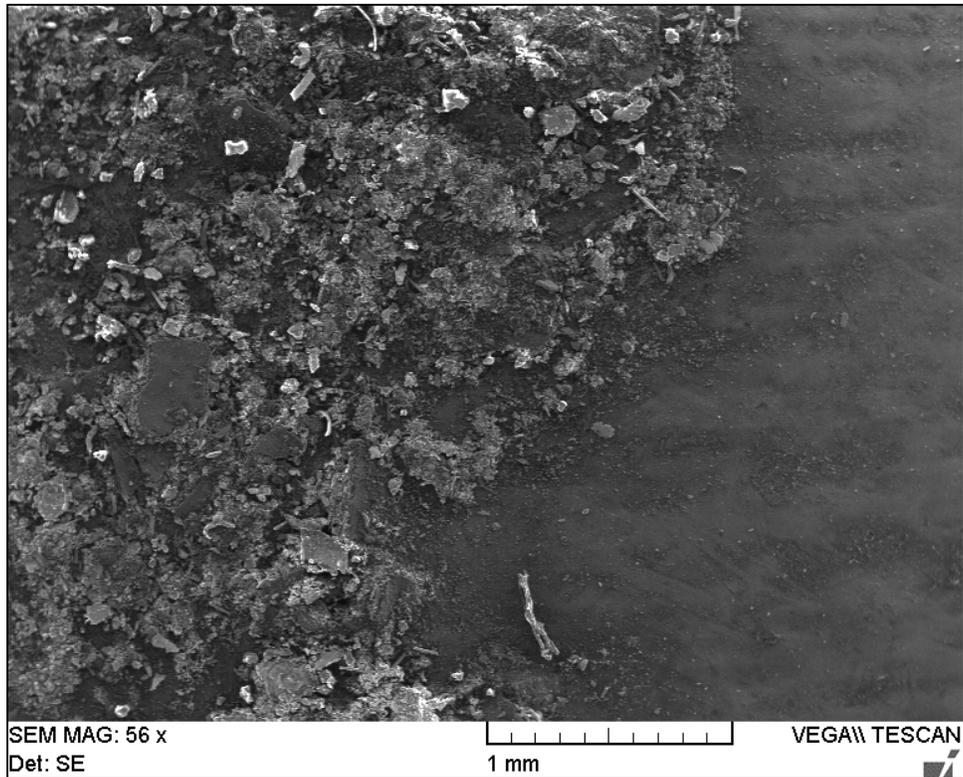
Figure 62. A representative SEM image of the surface of a specimen excised from Coupon 10 labeled as 10-1, prior to cleaning. No pit was observed in this location. (SEM, 33X)

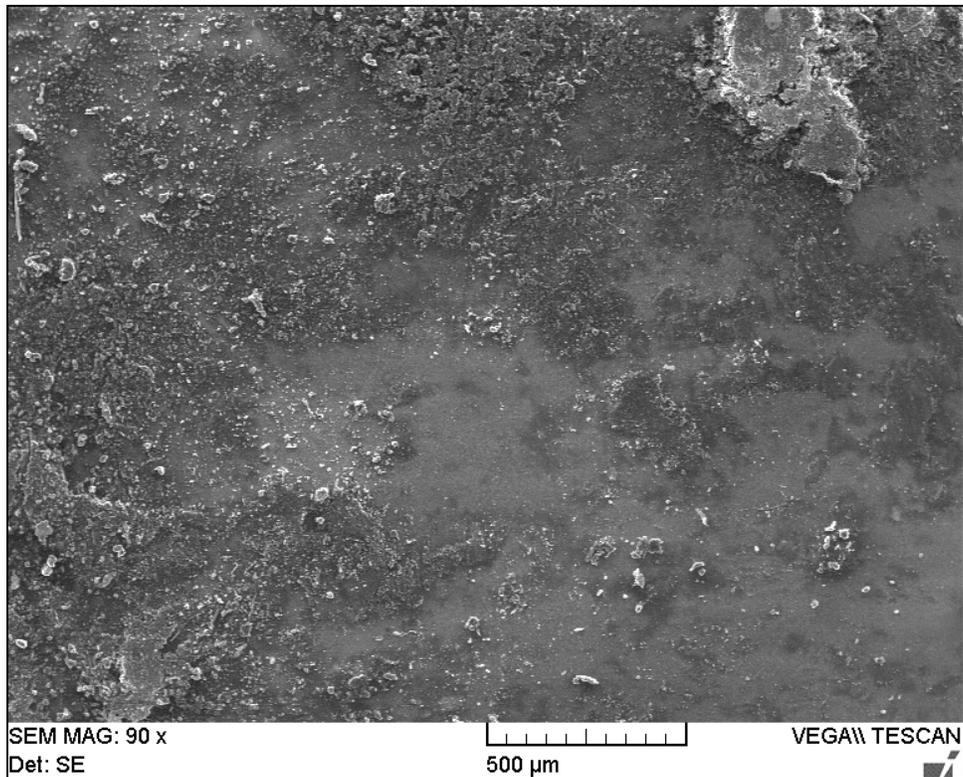
Figure 64. A representative SEM image of the surface on a specimen excised from Coupon 10 labeled as 10-3, prior to cleaning. No pit was observed in this location. (SEM, 53X)

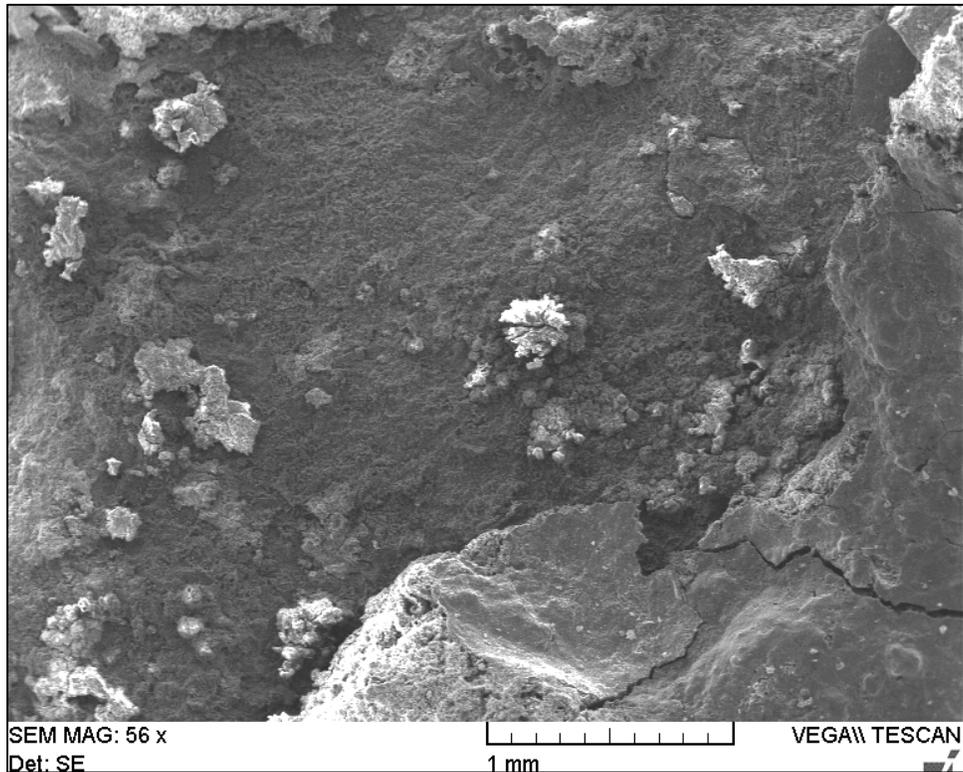
Figure 66. A representative SEM image of a pit on a specimen excised from Coupon A-1 labeled as A1-2, prior to cleaning. (SEM, 33X)

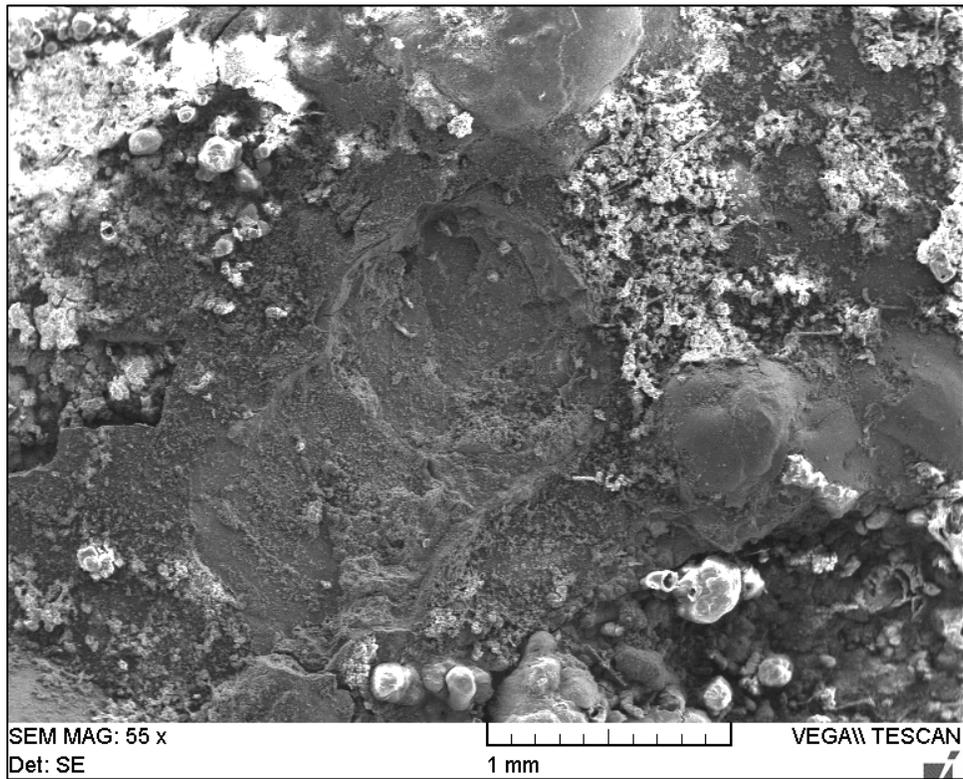
Figure 67. A representative SEM image of a pit on a specimen excised from Coupon A-1 labeled as A1-3, prior to cleaning. (SEM, 32X)

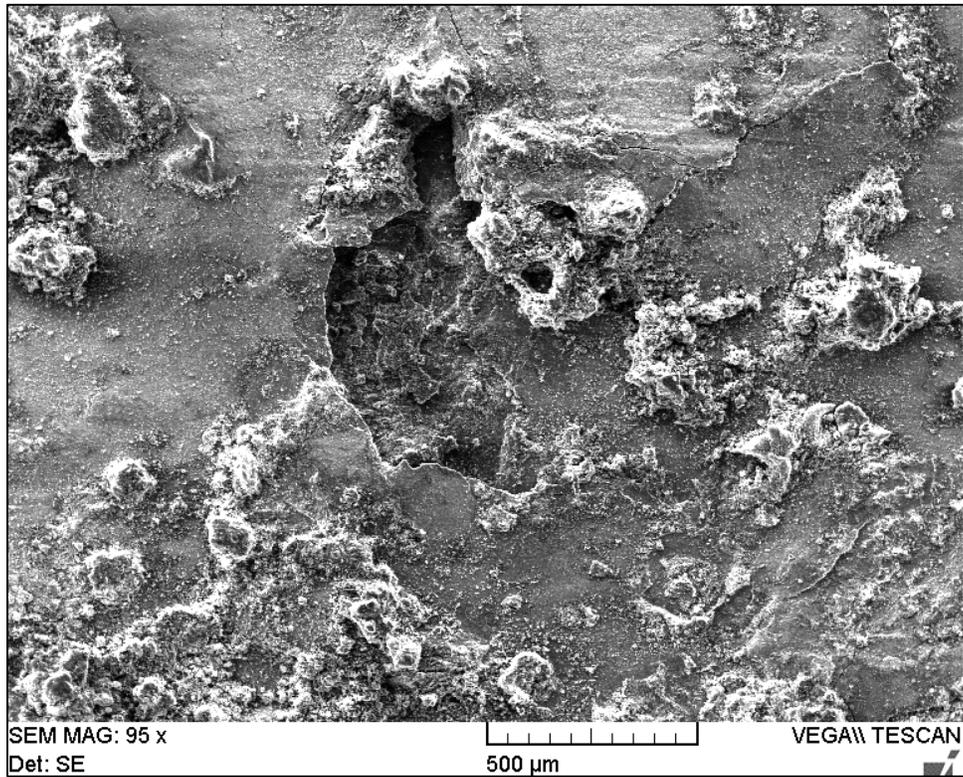
Figure 68. A representative SEM image of a pit on a specimen excised from Coupon A-2 labeled as A2-1, prior to cleaning. (SEM, 56X)

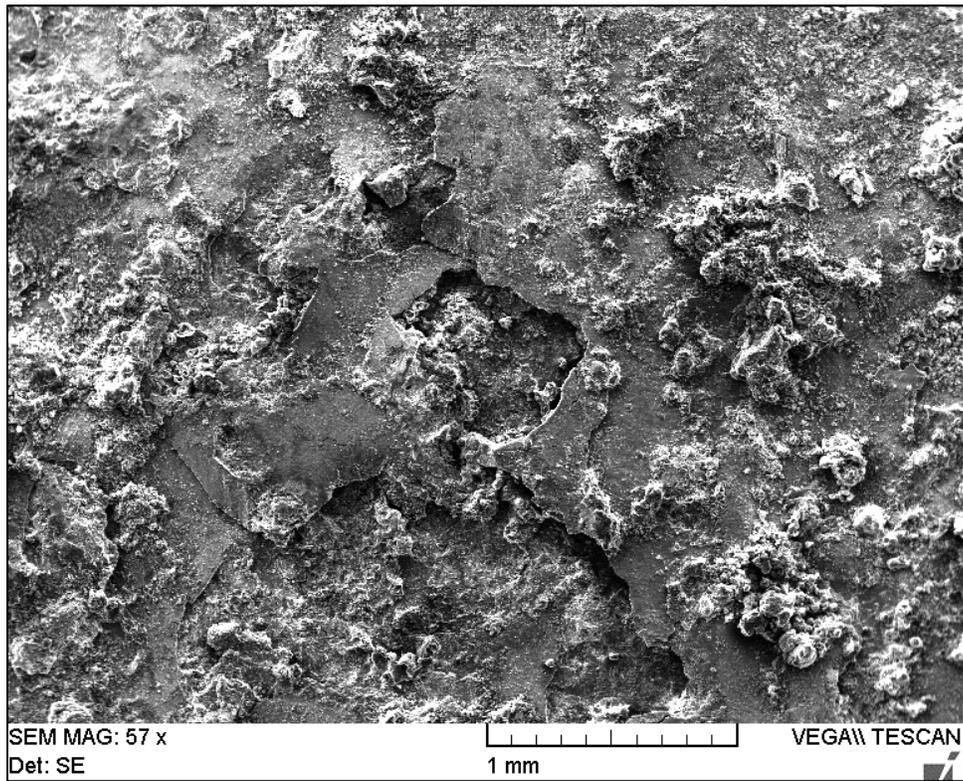
Figure 69. A representative SEM image of a possible pit on a specimen excised from Coupon A-2 labeled as A2-2, prior to cleaning. (SEM, 33X)

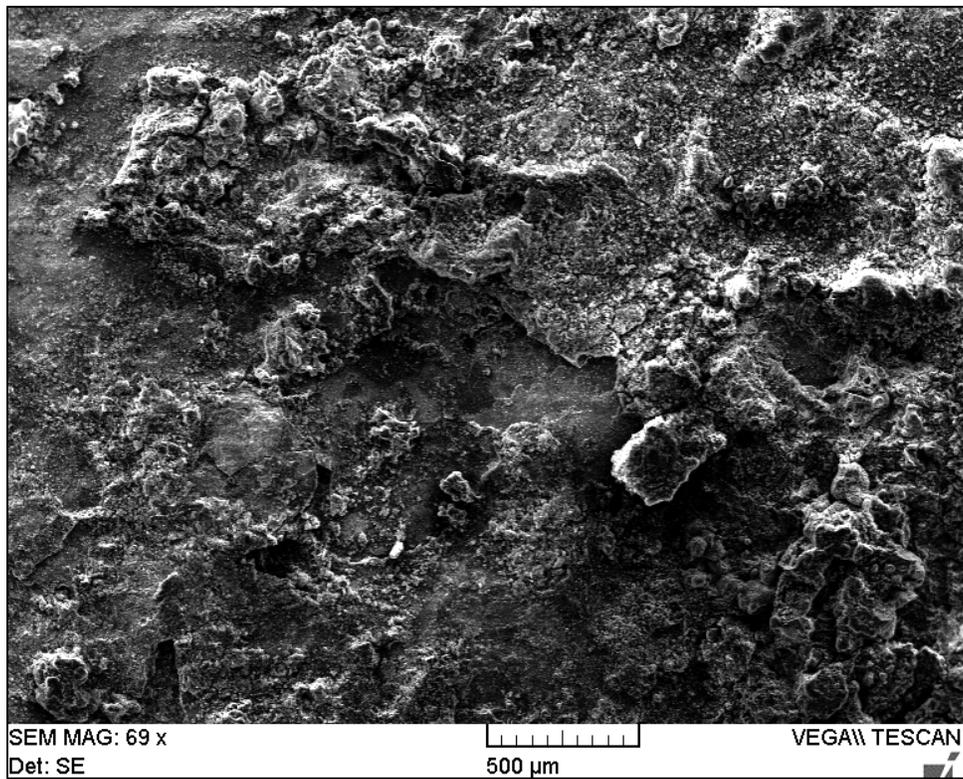
Figure 70. A representative SEM image of a possible pit on a specimen excised from Coupon A-2 labeled as A2-3, prior to cleaning. (SEM, 40X)

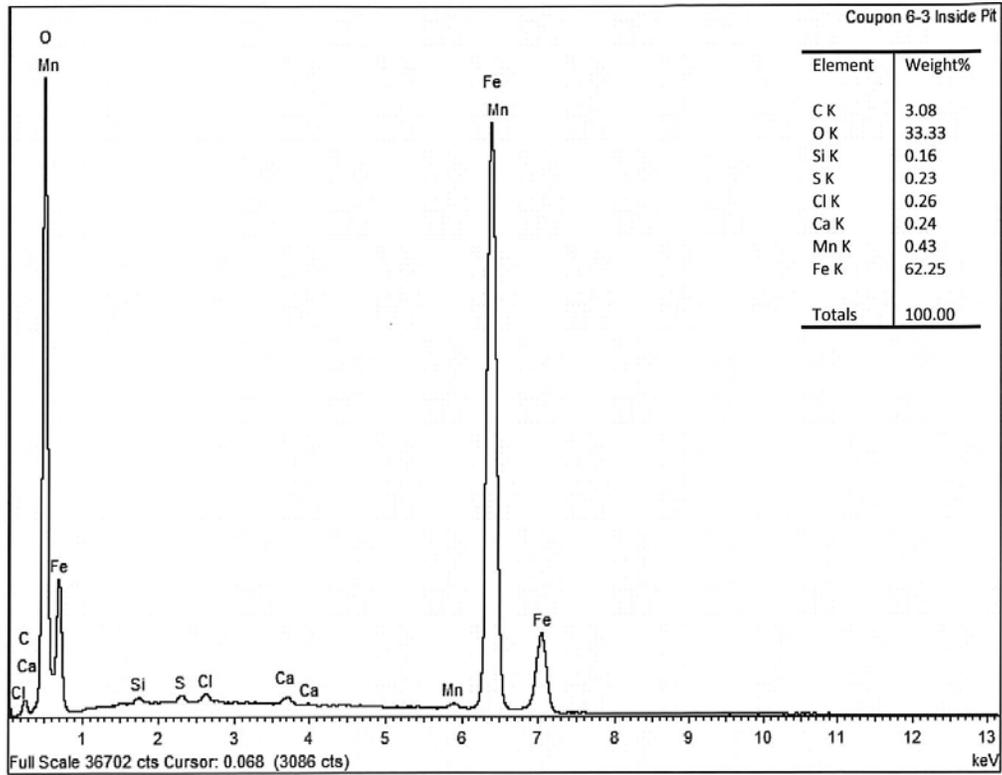
Figure 85. A representative EDS spectrum generated from of a pit on a specimen excised from Coupon 6 labeled as 6-3, prior to cleaning.

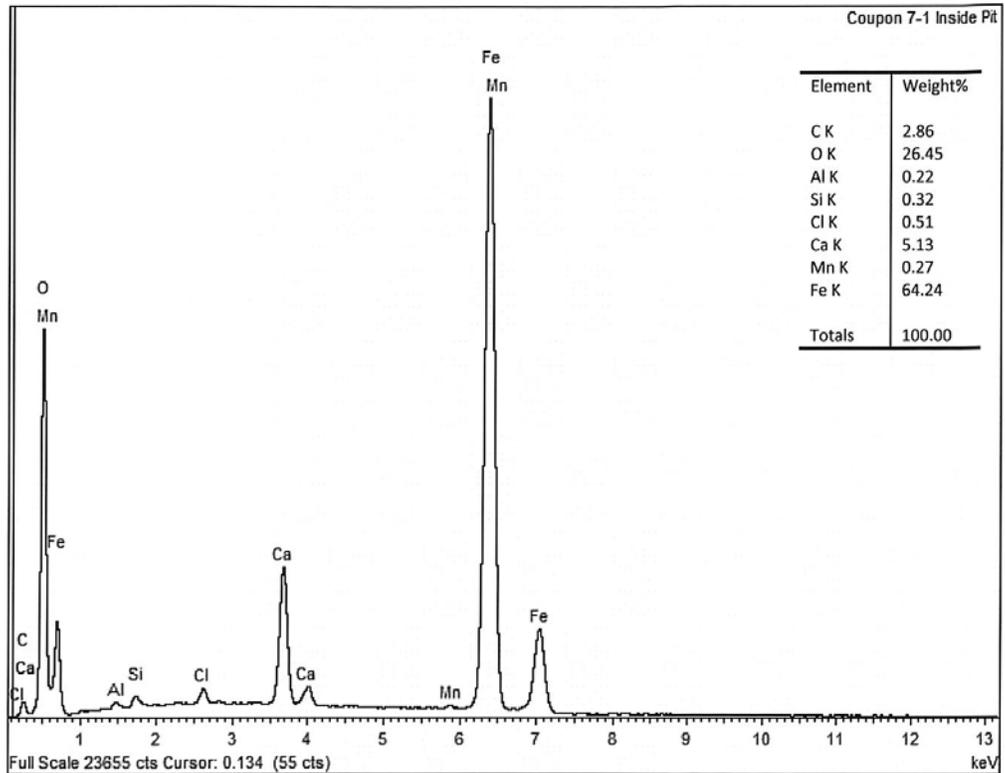
Figure 86. A representative EDS spectrum generated from of a pit on a specimen excised from Coupon 7 labeled as 7-1, prior to cleaning.

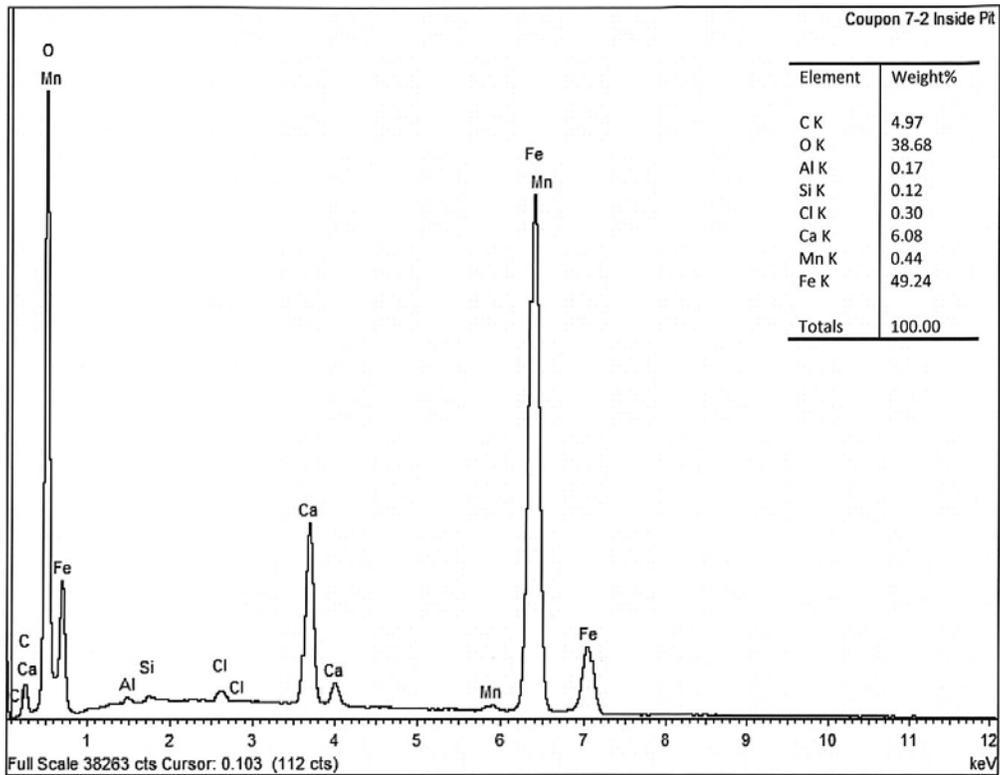
Figure 87. A representative EDS spectrum generated from of a pit on a specimen excised from Coupon 7 labeled as 7-2, prior to cleaning.

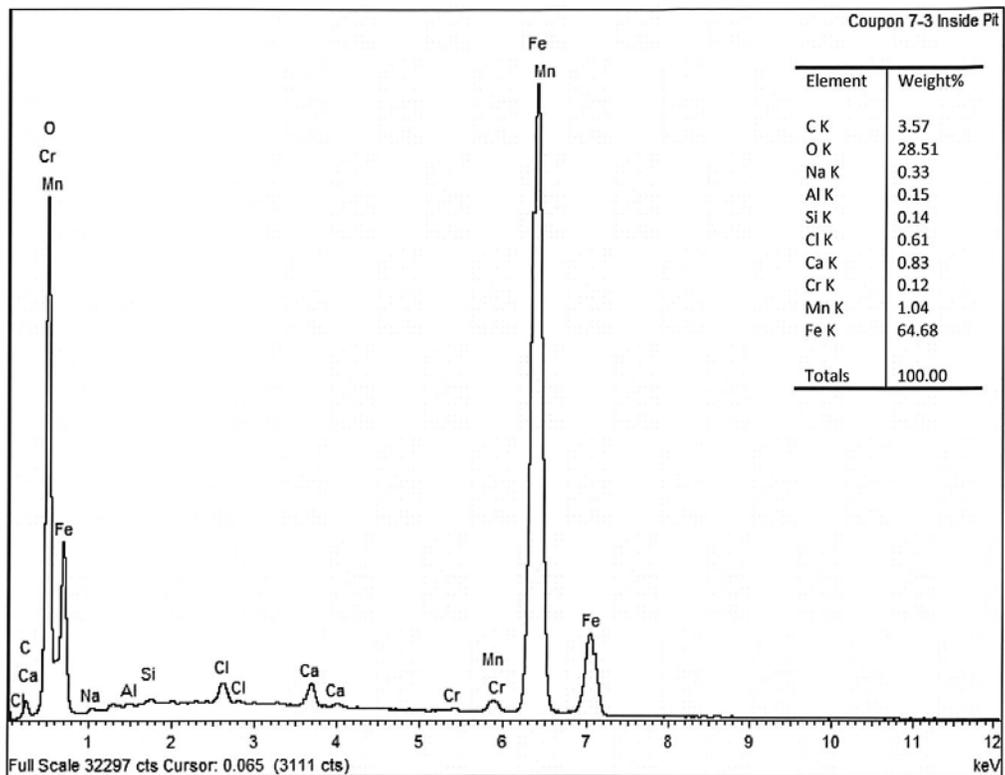
Figure 88. A representative EDS spectrum generated from of a pit on a specimen excised from Coupon 7 labeled as 7-3, prior to cleaning.

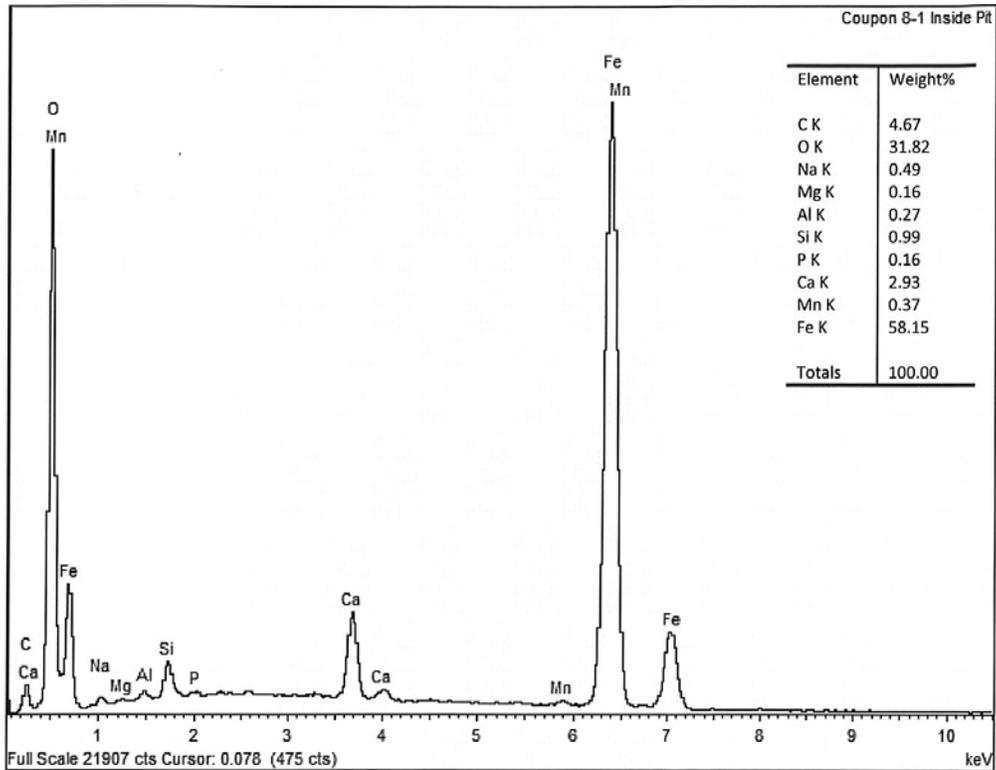
Figure 89. A representative EDS spectrum generated from of a pit on a specimen excised from Coupon 8 labeled as 8-1, prior to cleaning.

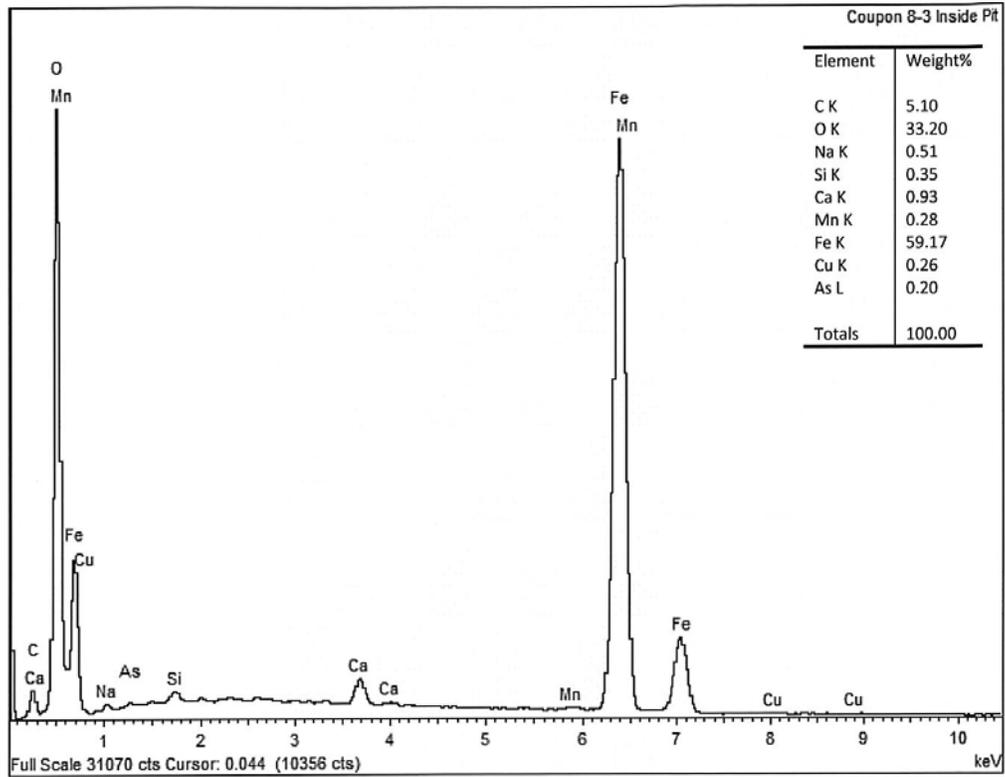
Figure 91. A representative EDS spectrum generated from of a pit on a specimen excised from Coupon 8 labeled as 8-3, prior to cleaning.

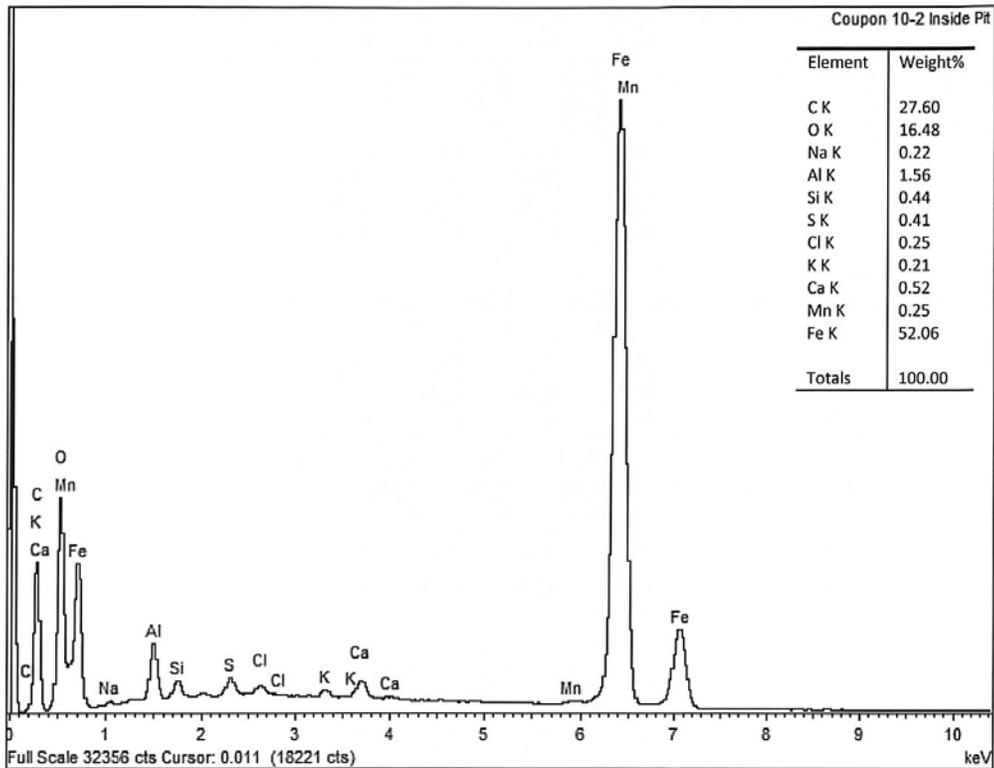
Figure 93. A representative EDS spectrum generated from of a pit on a specimen excised from Coupon 10 labeled as 10-2, prior to cleaning.

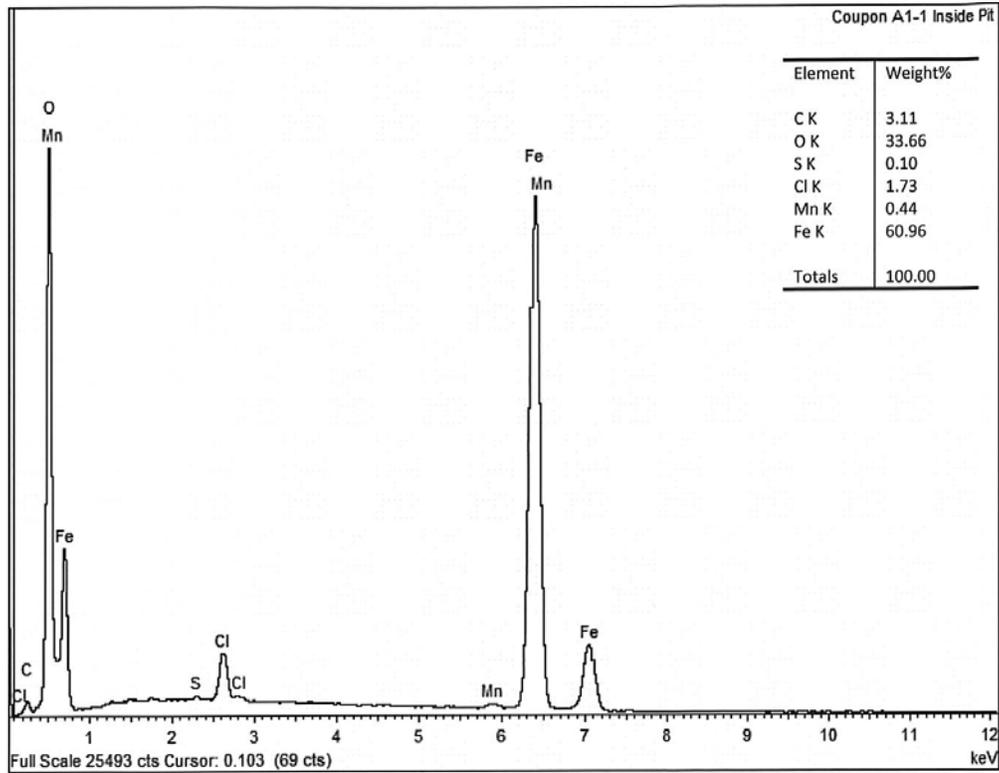
Figure 95. A representative EDS spectrum generated from of a pit on a specimen excised from Coupon A1 labeled as A1-1, prior to cleaning.

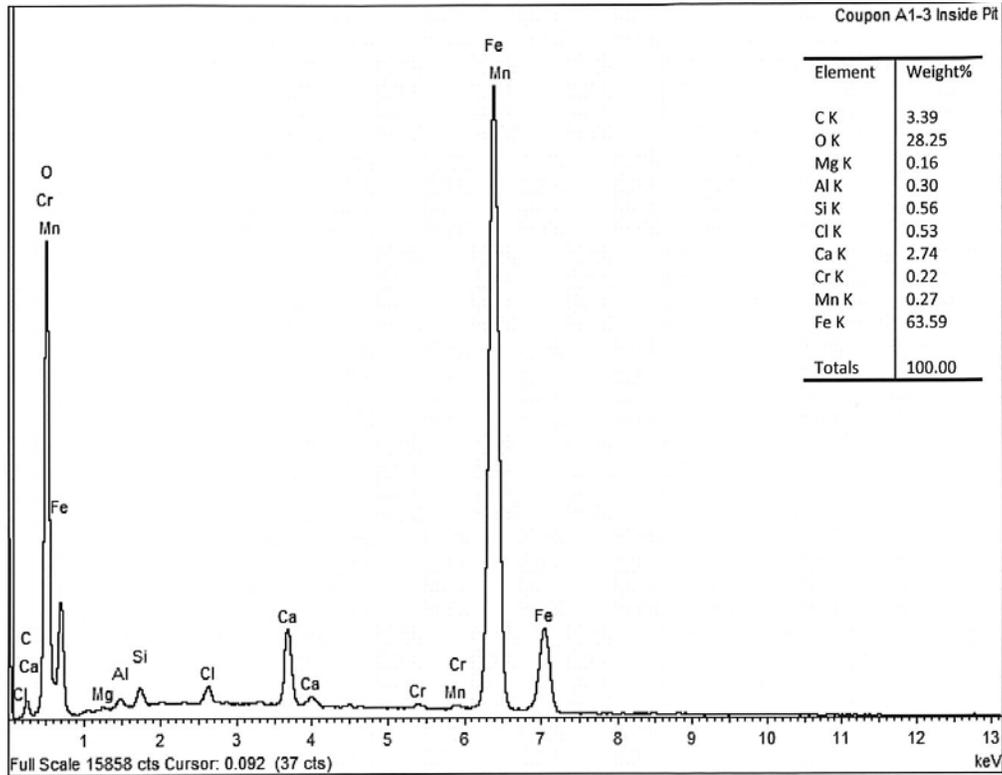
Figure 97. A representative EDS spectrum generated from of a pit on a specimen excised from Coupon A1 labeled as A1-3, prior to cleaning.

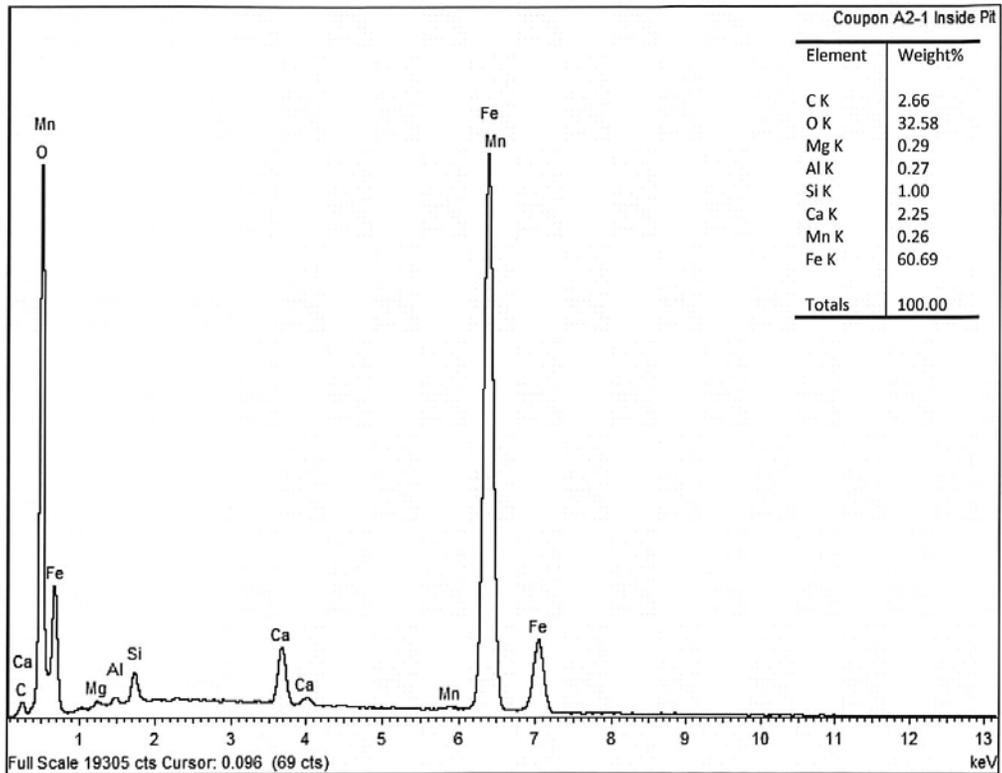
Figure 98. A representative EDS spectrum generated from of a pit on a specimen excised from Coupon A2 labeled as A2-1, prior to cleaning.

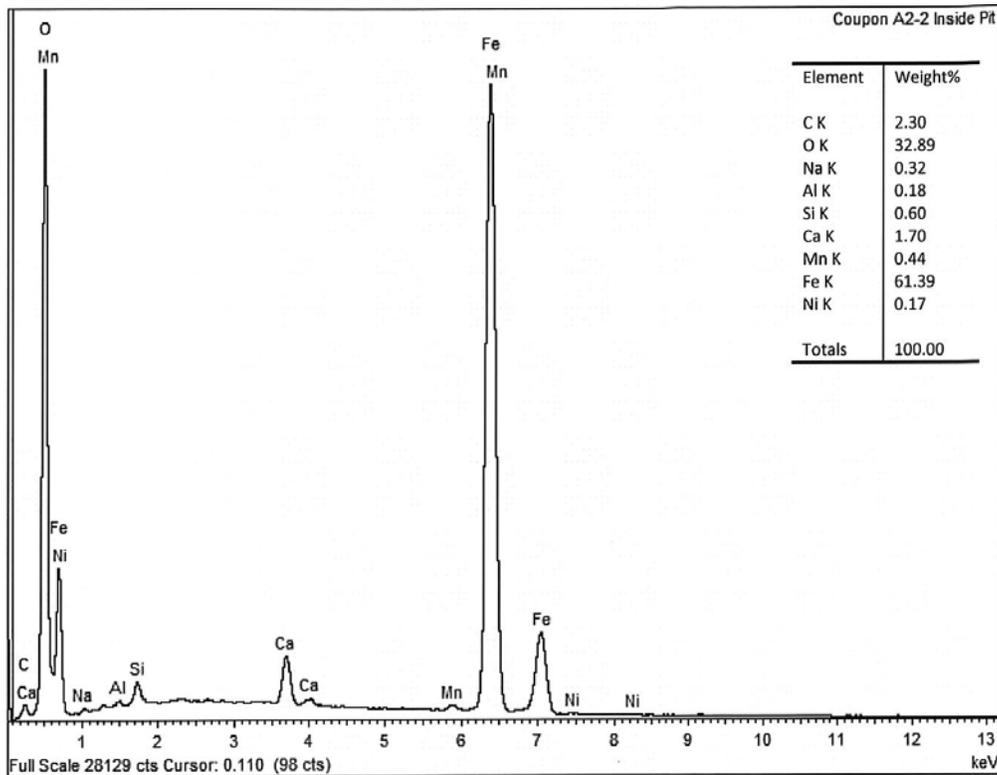
Figure 99. A representative EDS spectrum generated from of a pit on a specimen excised from Coupon A2 labeled as A2-2, prior to cleaning.

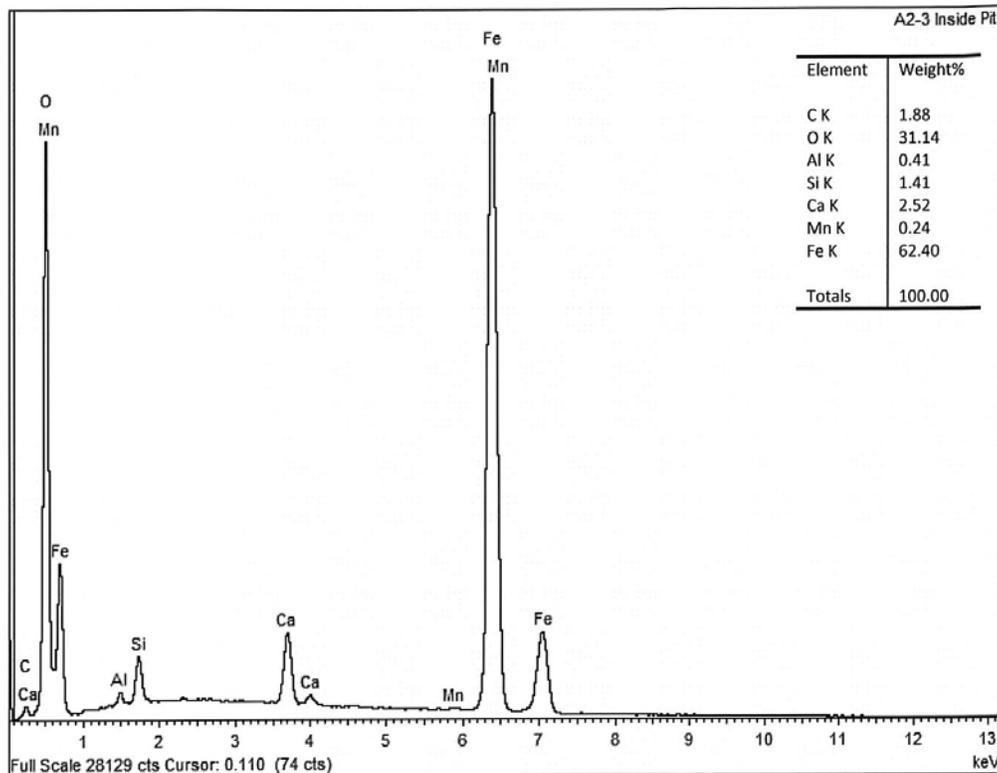
Figure 100. A representative EDS spectrum generated from of a pit on a specimen excised from Coupon A2 labeled as A2-3, prior to cleaning.

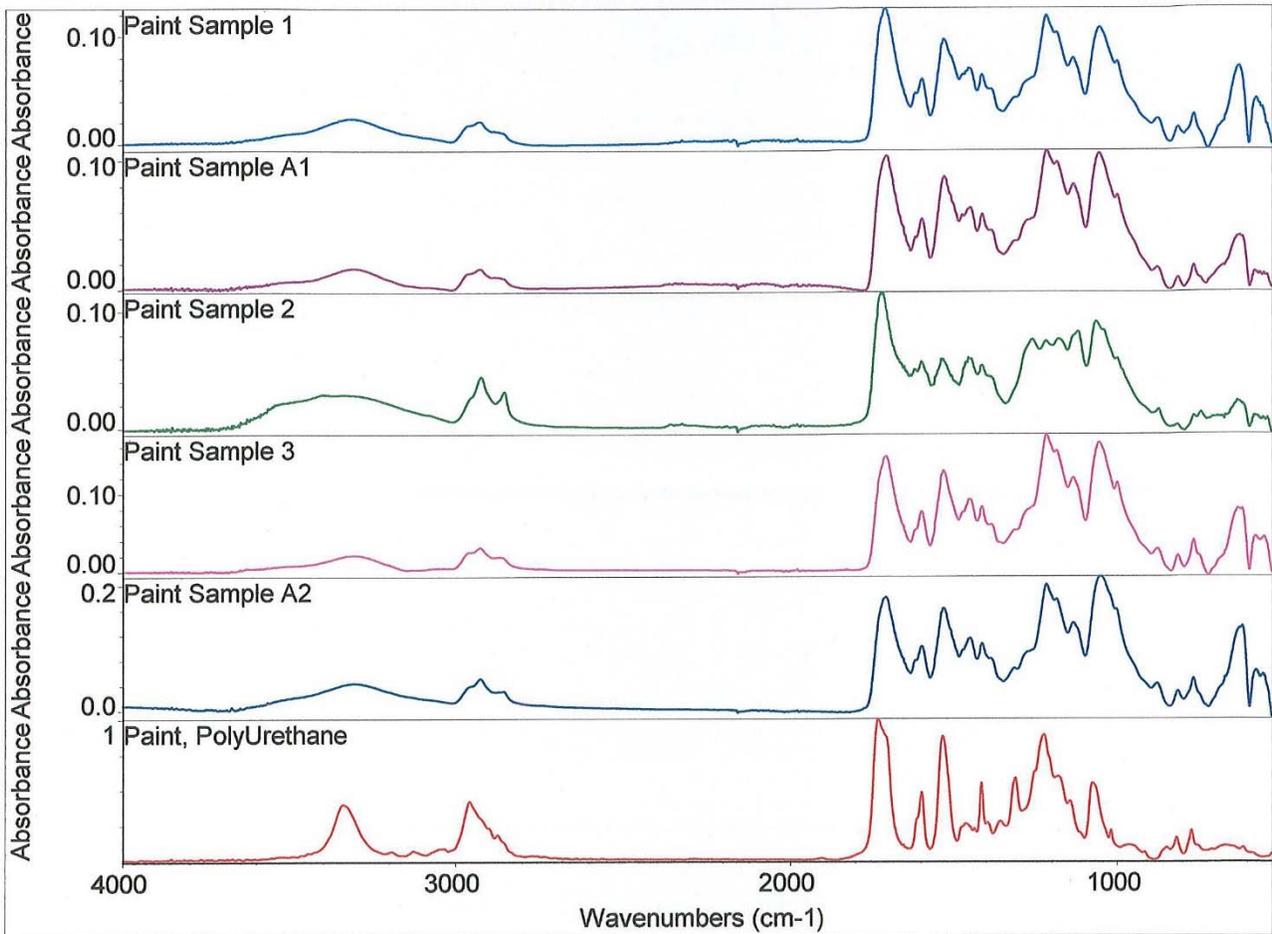
Fourier transform infrared (FTIR) spectroscopy was performed on paint samples removed from each coupon using Attenuated Total Reflectance (ATR) with a diamond crystal. All paint samples were identified as polyurethane enamel. The resulting FTIR spectra of the samples and the best matches from the spectral FTIR library of standards for polyurethane enamel are provided as Figures 111 and 112.

Figure 111. The FTIR spectra generated from a paint samples removed from the exterior surfaces of Coupons 1, A1, 2, A2 and 3 the best matches from the spectral FTIR library of standards for polyurethane enamel.
