SUBJECT: DESTRUCTIVE ANALYSIS OF 10 STEEL COUPONS REMOVED FROM RED HILL FUEL STORAGE TANK NO. 14, PURSUANT TO SECTION 5.3 OF THE ADMINISTRATIVE ORDER ON CONSENT STATEMENT OF WORK, RED HILL BULK FUEL STORAGE FACILITY, JOINT BASE PEARL HARBOR-HICKAM, OAHU, HAWAII

Destructive Analysis of 10 Steel Coupons Removed from Red Hill Fuel Storage Tank #14

REPORT No. 201801967

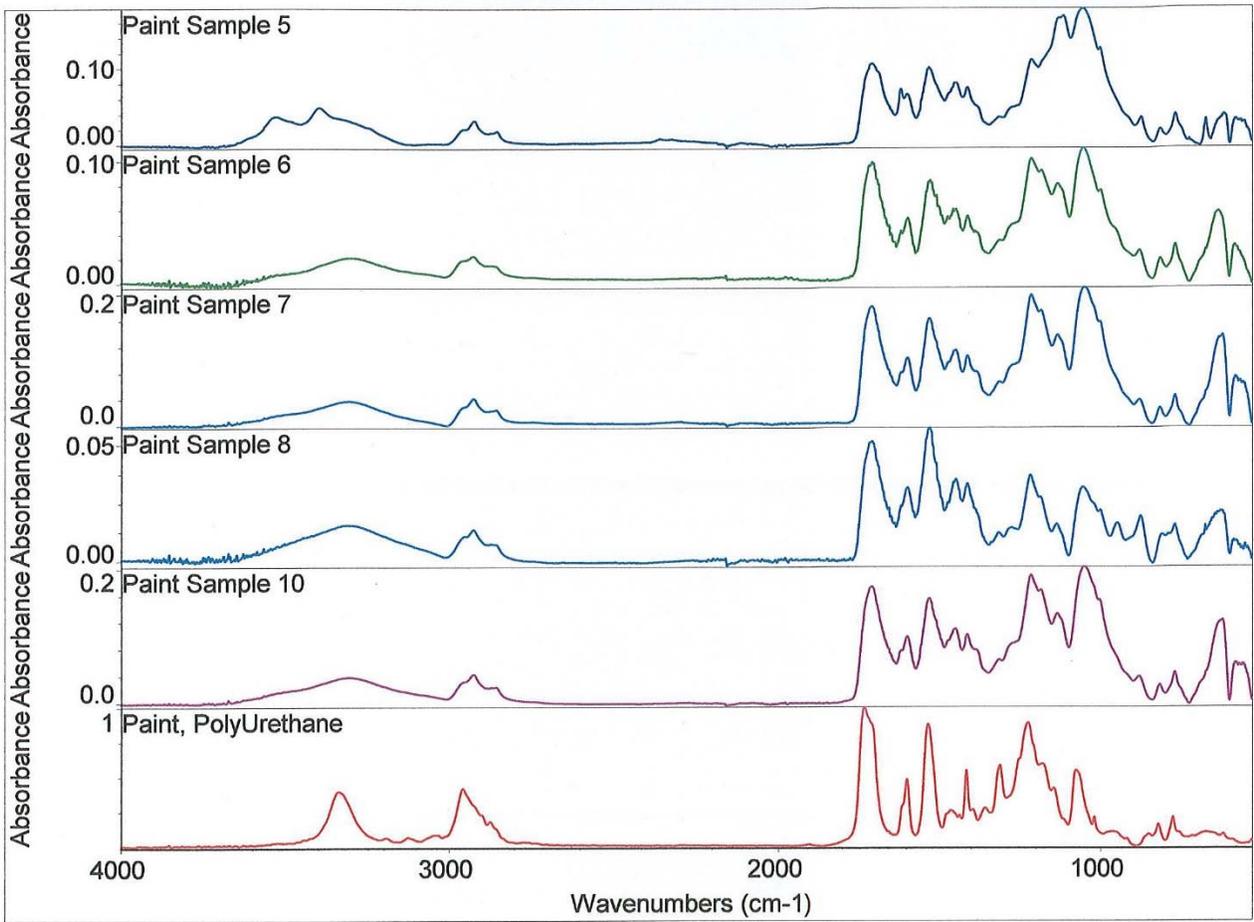
Fourier transform infrared (FTIR) spectroscopy was performed on paint samples removed from each coupon using Attenuated Total Reflectance (ATR) with a diamond crystal. All paint samples were identified as polyurethane enamel. The resulting FTIR spectra of the samples and the best matches from the spectral FTIR library of standards for polyurethane enamel are provided as Figures 111 and 112.

Figure 112. The FTIR spectra generated from a paint samples removed from the exterior surfaces of Coupons 5, 6, 7, 8 and 10 the best matches from the spectral FTIR library of standards for polyurethane enamel.

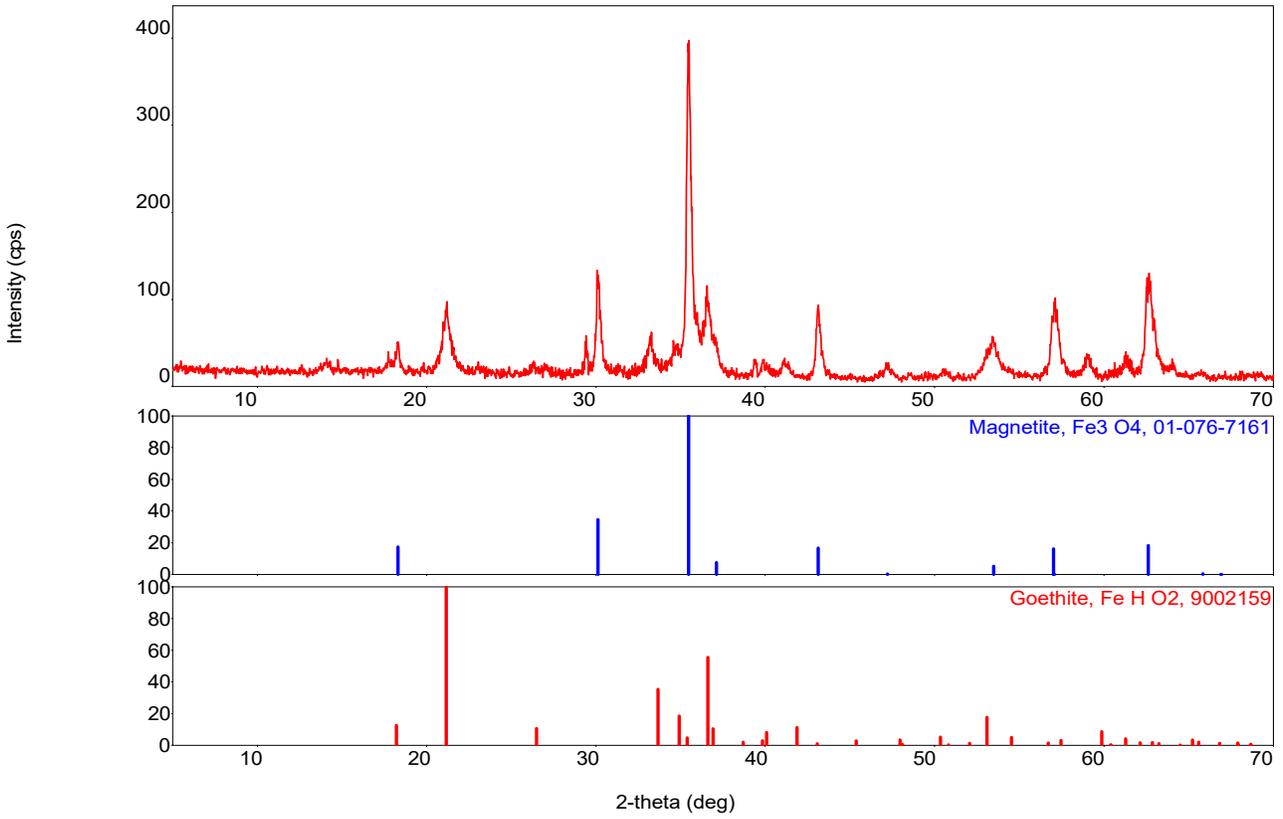
X-Ray Diffraction Spectroscopy (XRD) analysis of the corrosion product from the metal panels revealed the presence of the following crystalline phases: iron oxide (magnetite); iron hydroxide (goethite); calcium carbonate (calcite); silicon dioxide and hydrous calcium aluminum sulfate (ettringite). The results are summarized in Tables 19 and 20. The XRD diffractograms for the corrosion samples are provided as Figures 123 through 128.

Figure 123. The XRD diffractogram generated from corrosion product removed Coupon 1.

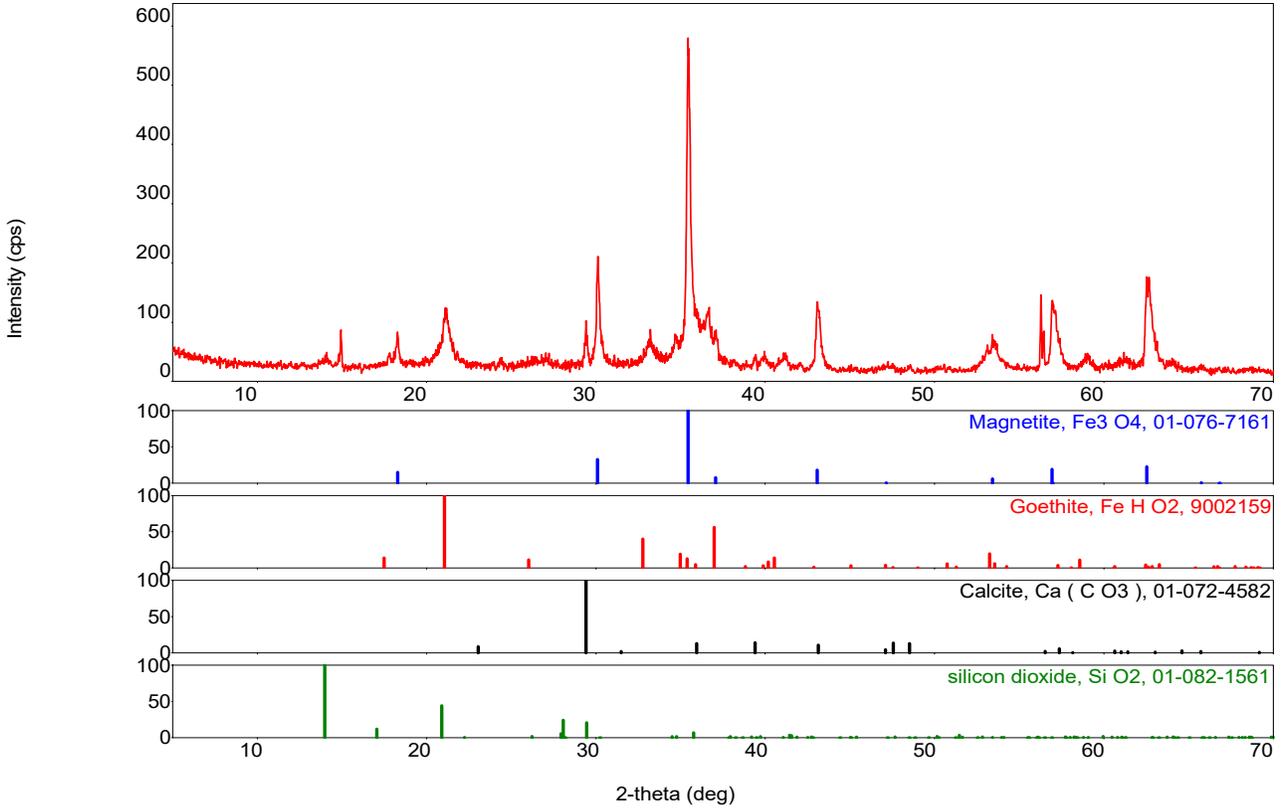
Figure 124. The XRD diffractogram generated from corrosion product removed Coupon 2.

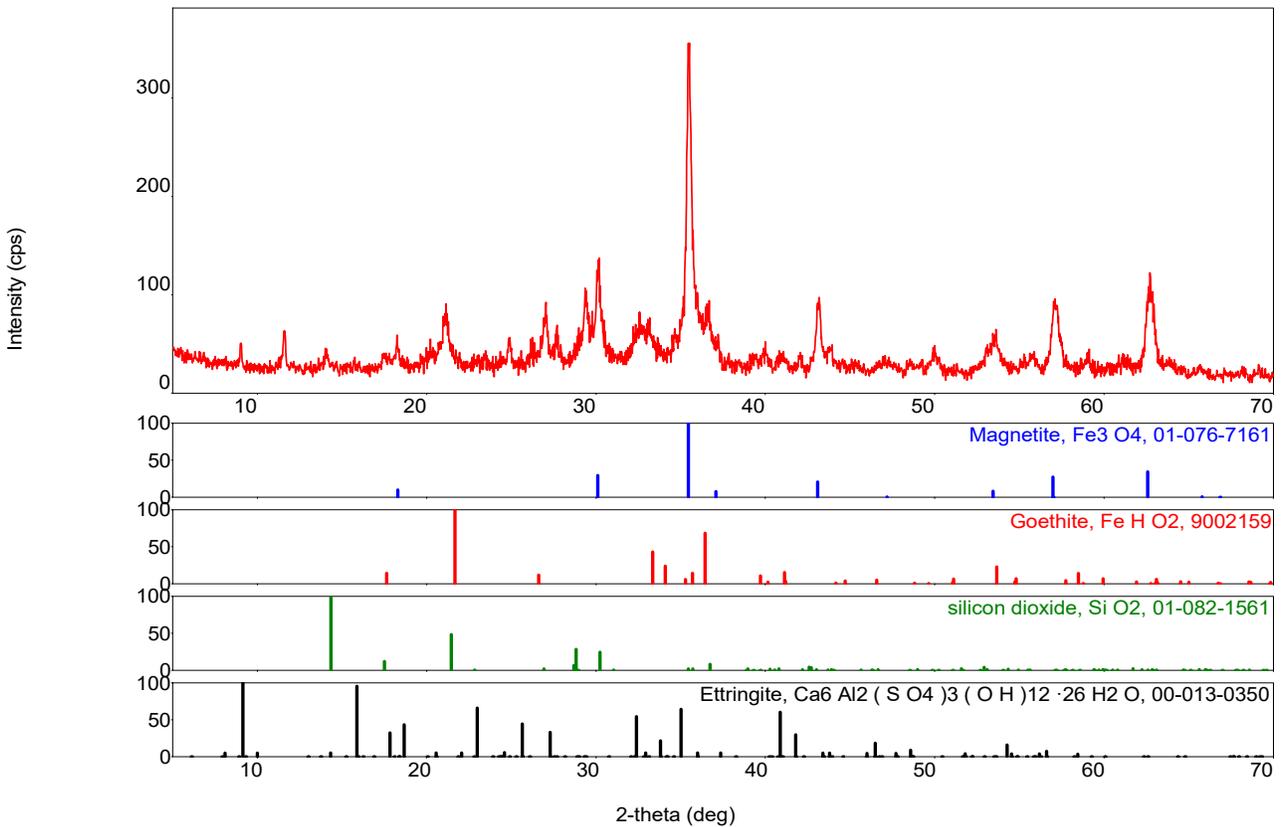
Figure 125. The XRD diffractogram generated from corrosion product removed Coupon 3.

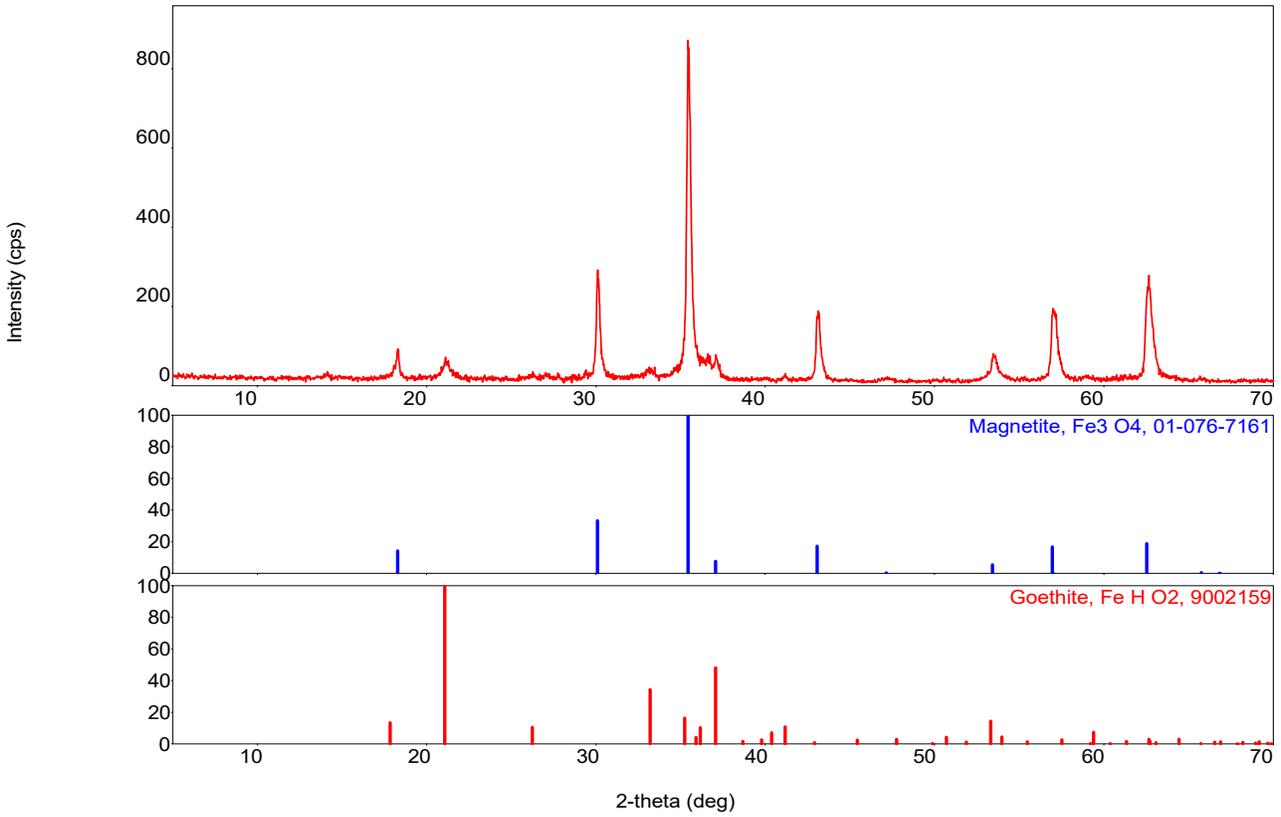
Figure 126. The XRD diffractogram generated from corrosion product removed Coupon 6.

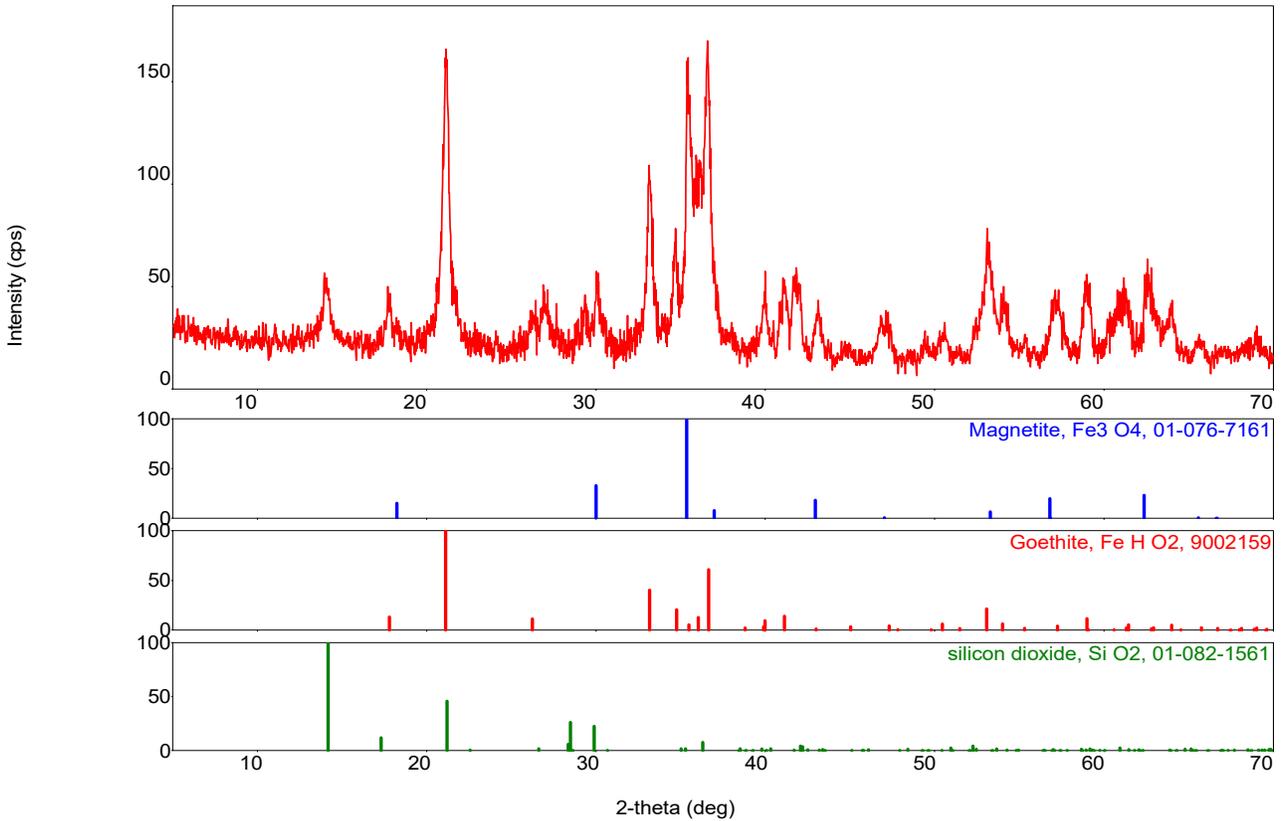
Figure 127. The XRD diffractogram generated from corrosion product removed Coupon 7.

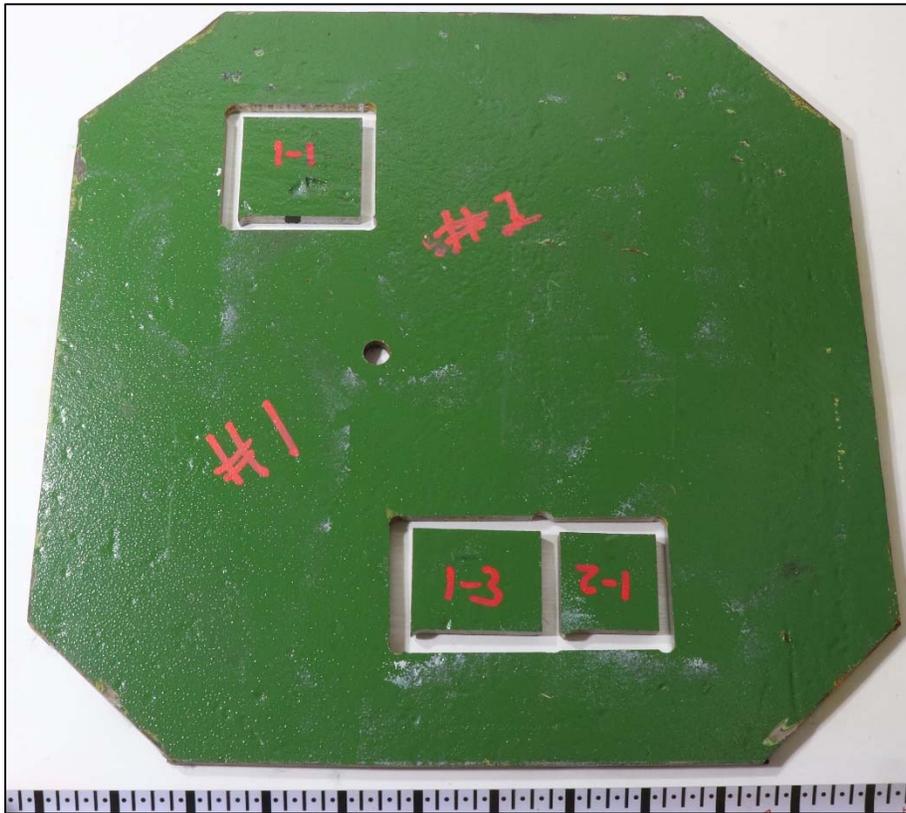
Figure 129. An image of the interior surface of Coupon 1 after CO₂ blast cleaning.

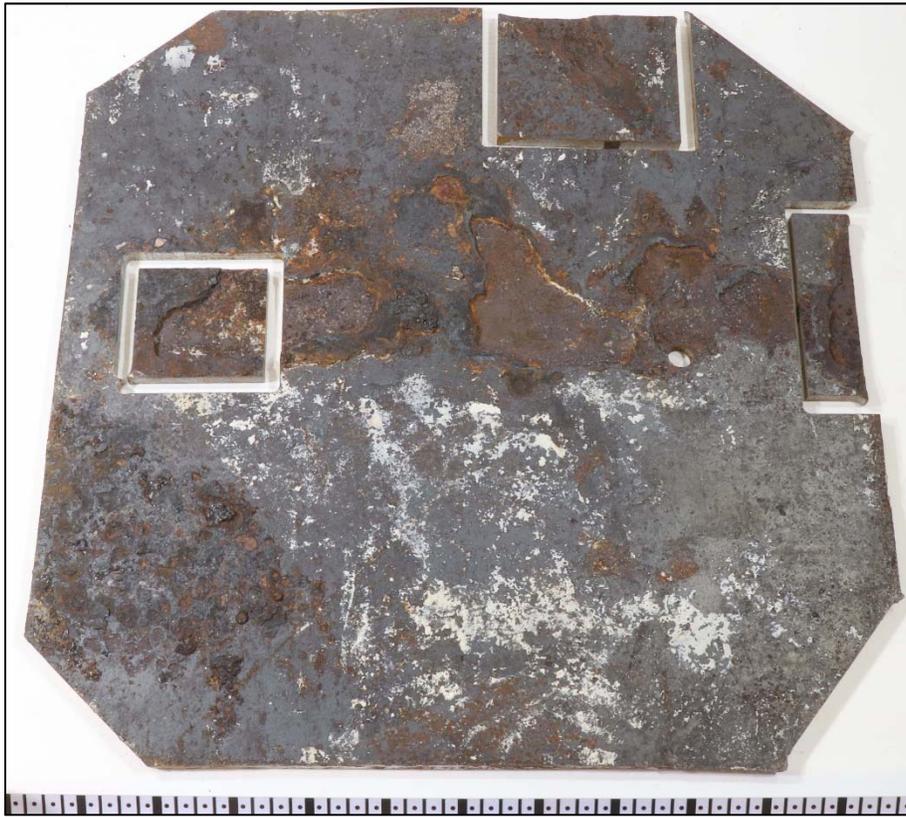
Figure 130. An image of the exterior surface of Coupon 1 after CO₂ blast cleaning.

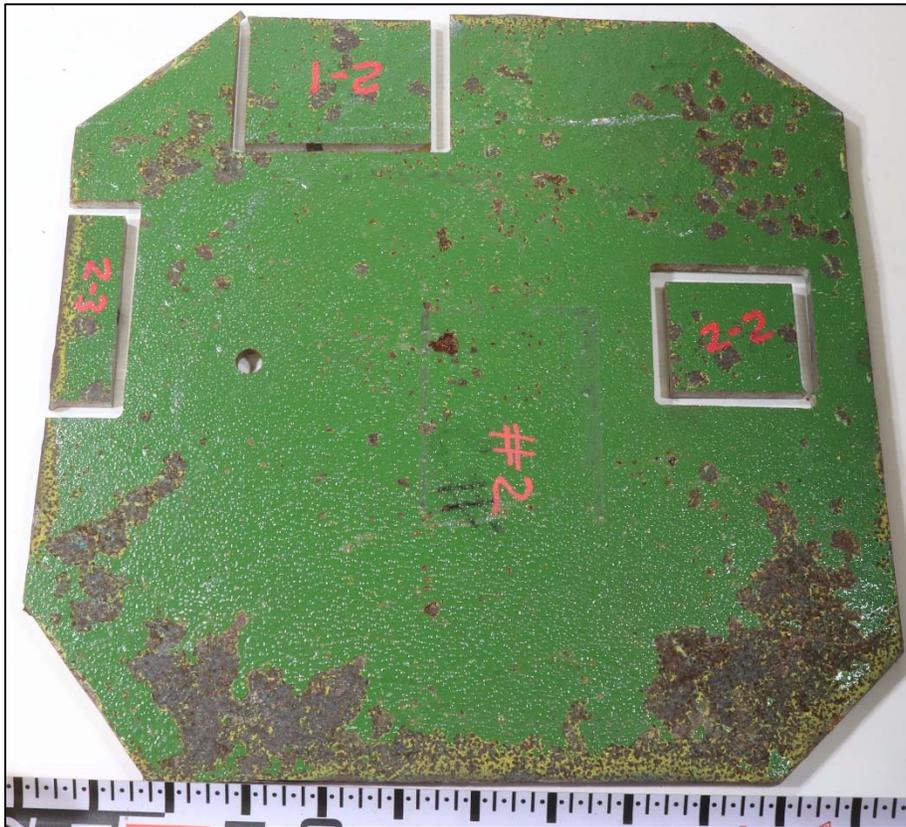
Figure 131. An image of the interior surface of Coupon 2 after CO₂ blast cleaning.

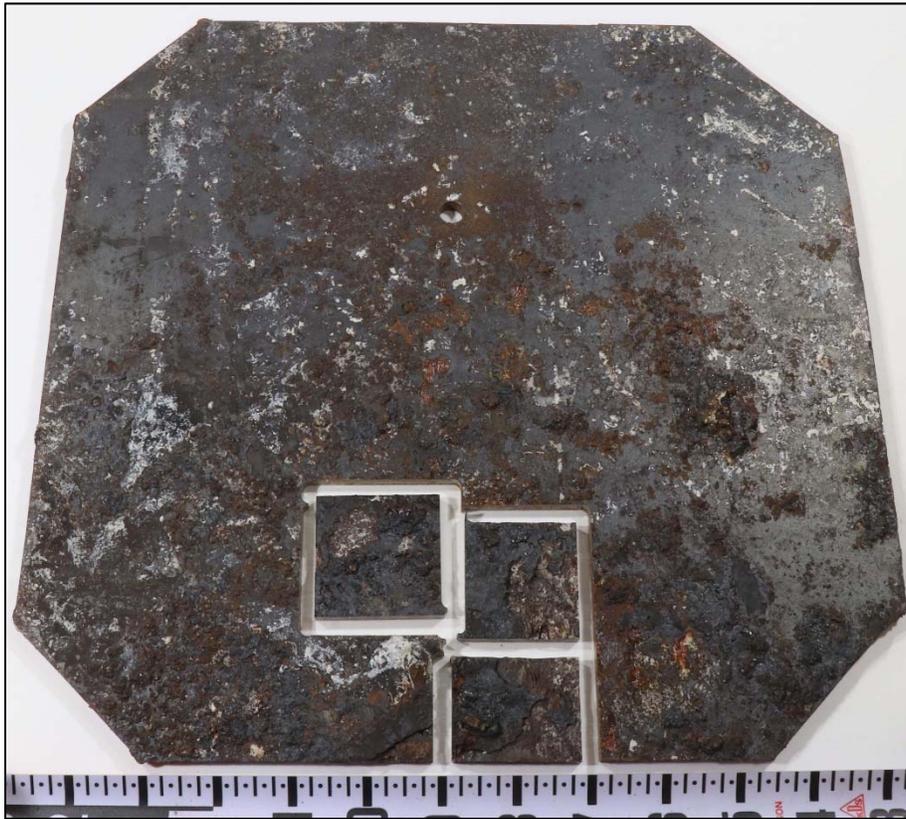
Figure 132. An image of the exterior surface of Coupon 2 after CO₂ blast cleaning.

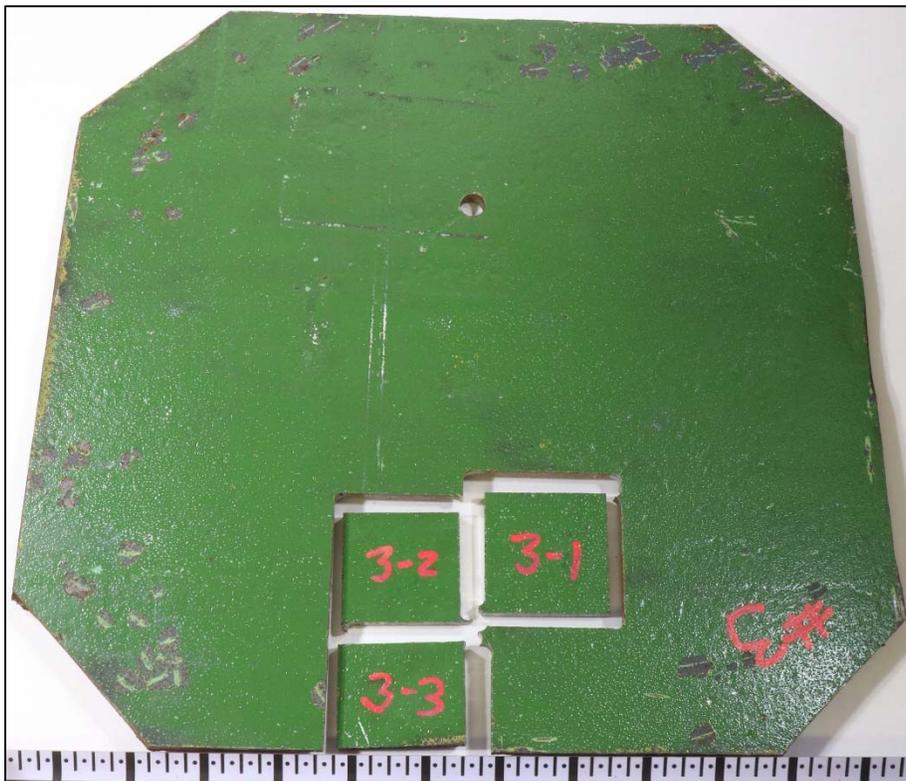
Figure 133. An image of the interior surface of Coupon 3 after CO₂ blast cleaning.

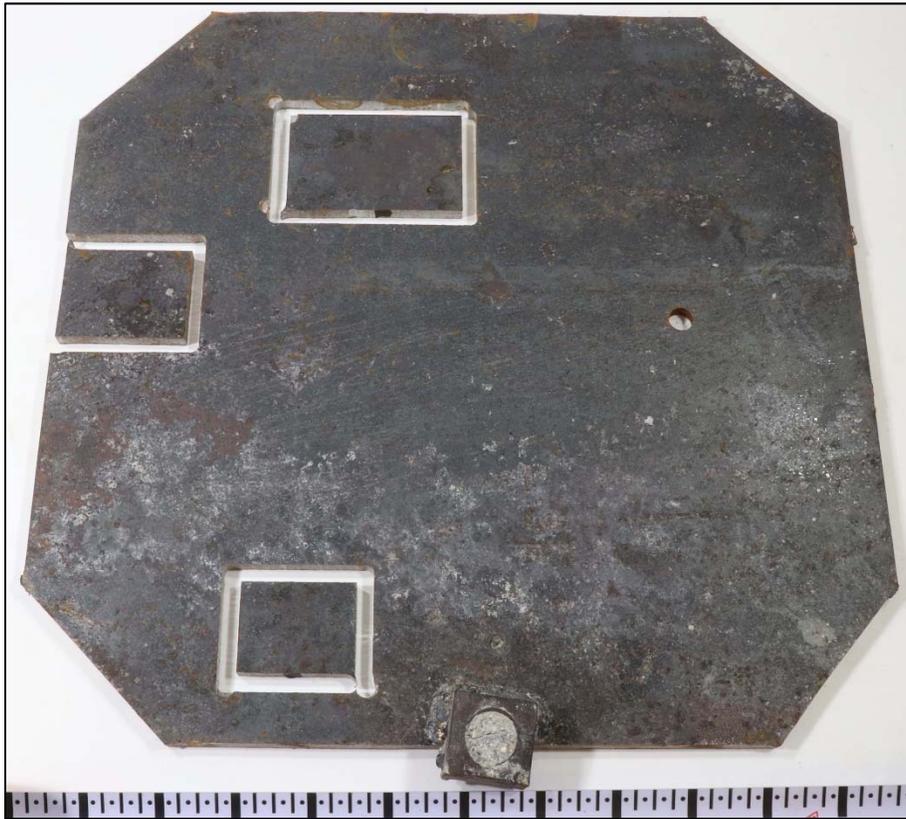
Figure 134. An image of the exterior surface of Coupon 3 after CO₂ blast cleaning.

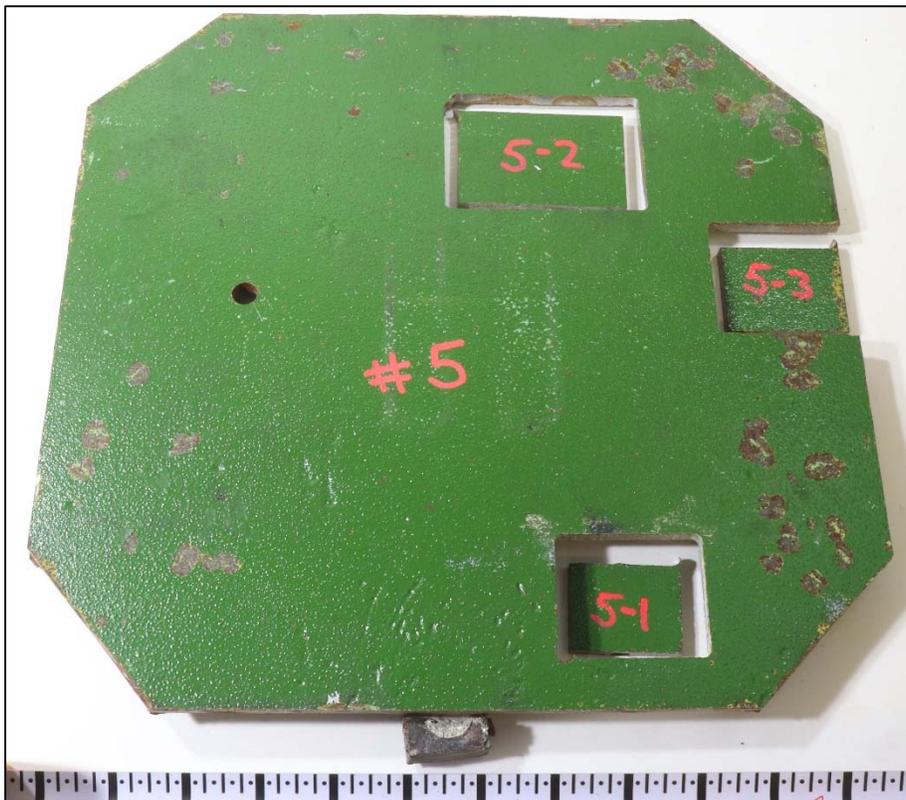
Figure 135. An image of the interior surface of Coupon 5 after CO₂ blast cleaning.

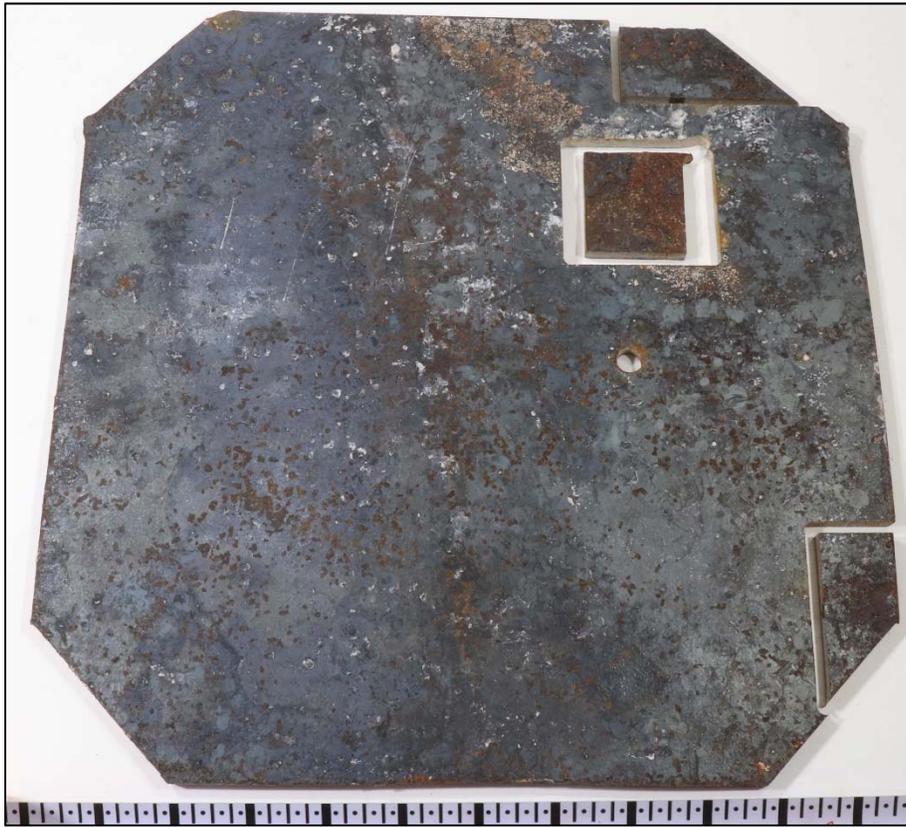
Figure 136. An image of the exterior surface of Coupon 5 after CO₂ blast cleaning.

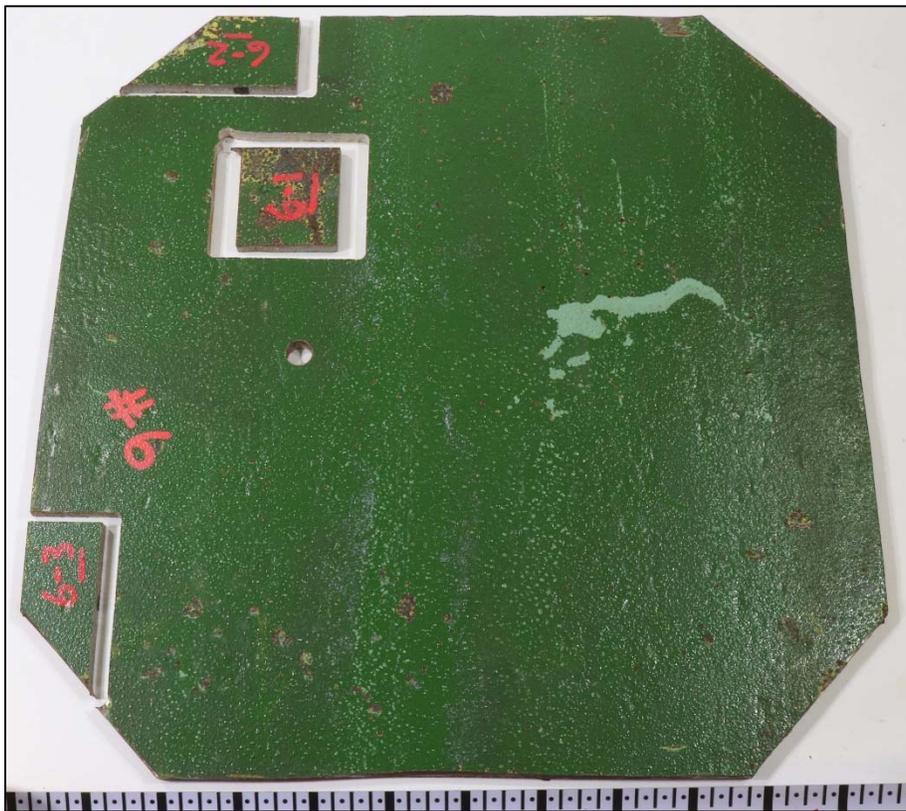
Figure 137. An image of the interior surface of Coupon 6 after CO₂ blast cleaning.

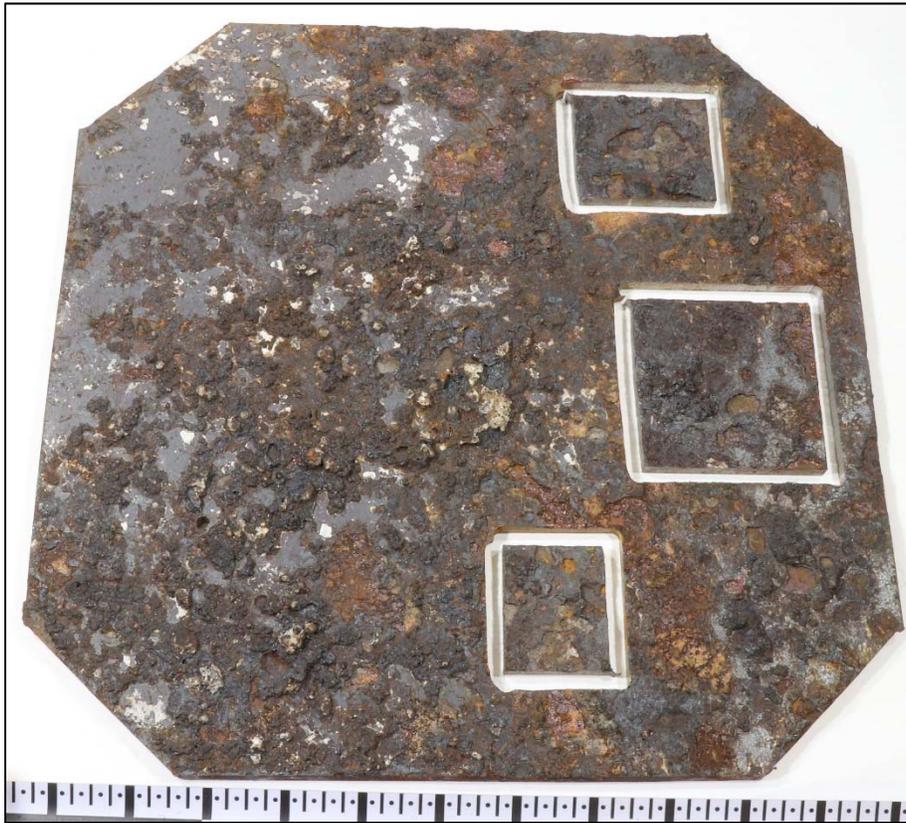
Figure 138. An image of the exterior surface of Coupon 6 after CO₂ blast cleaning.

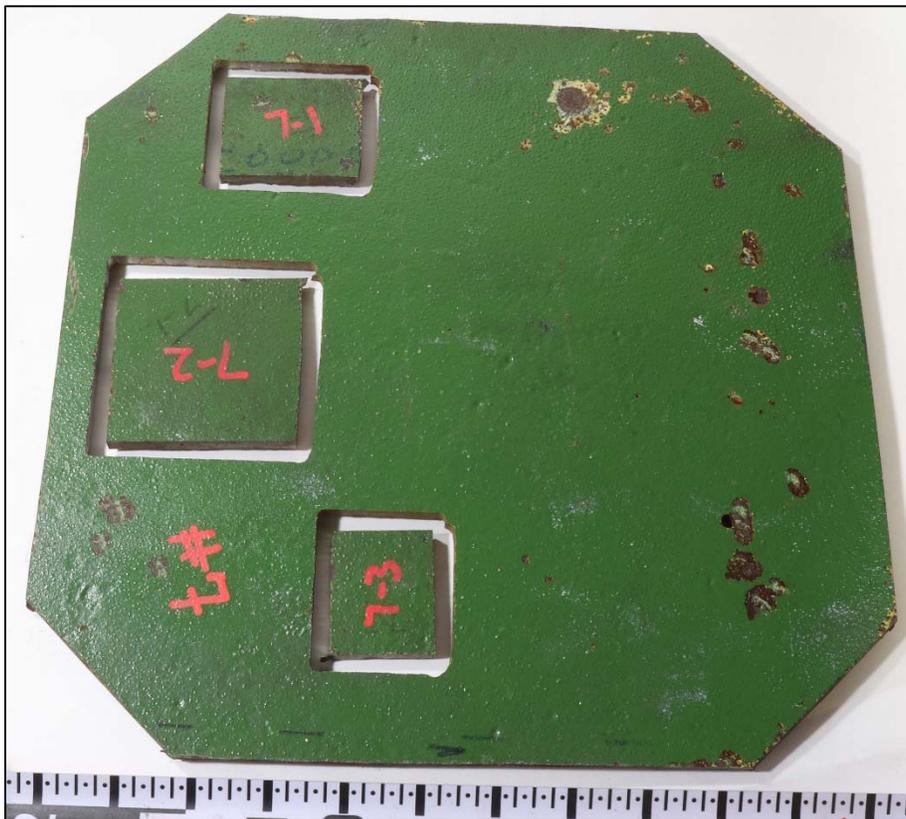
Figure 139. An image of the interior surface of Coupon 7 after CO₂ blast cleaning.

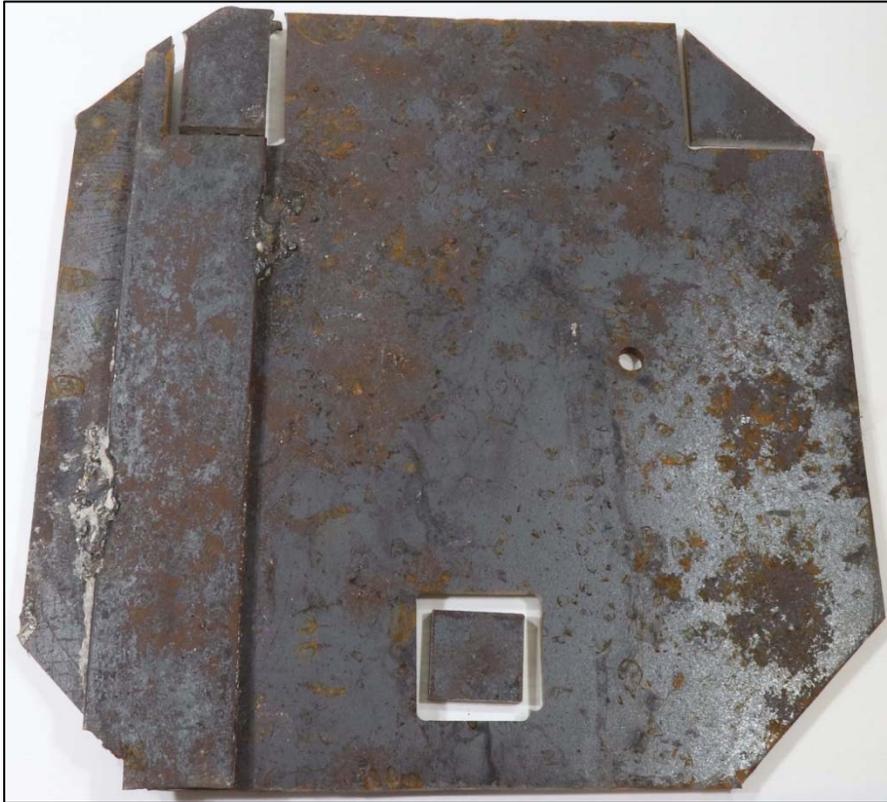
Figure 140. An image of the exterior surface of Coupon 7 after CO₂ blast cleaning.

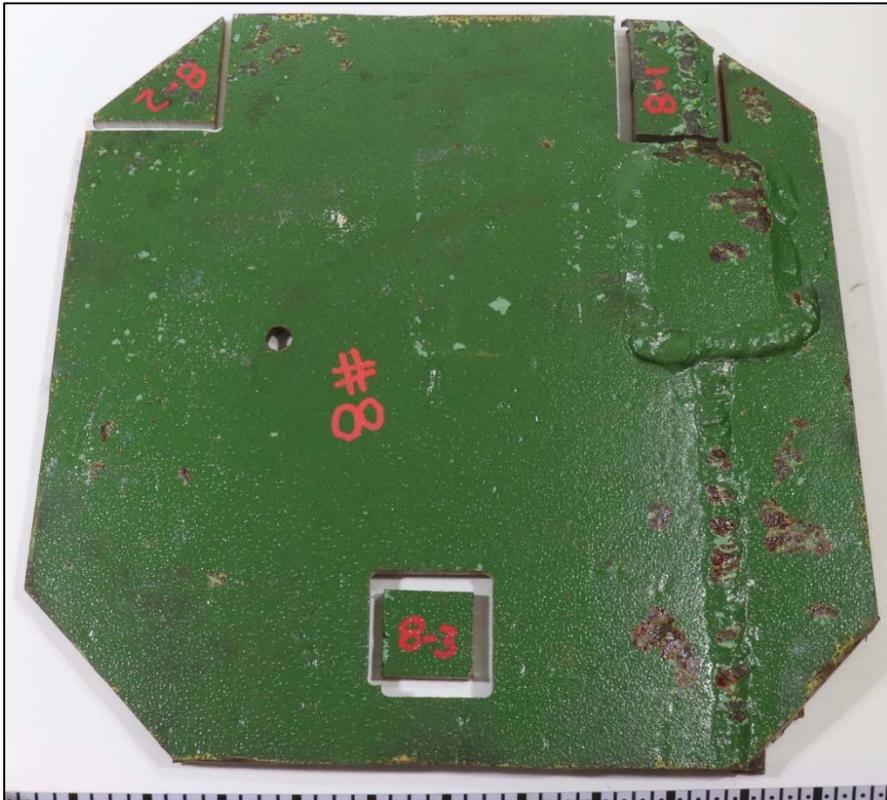
Figure 141. An image of the interior surface of Coupon 8 after CO₂ blast cleaning.

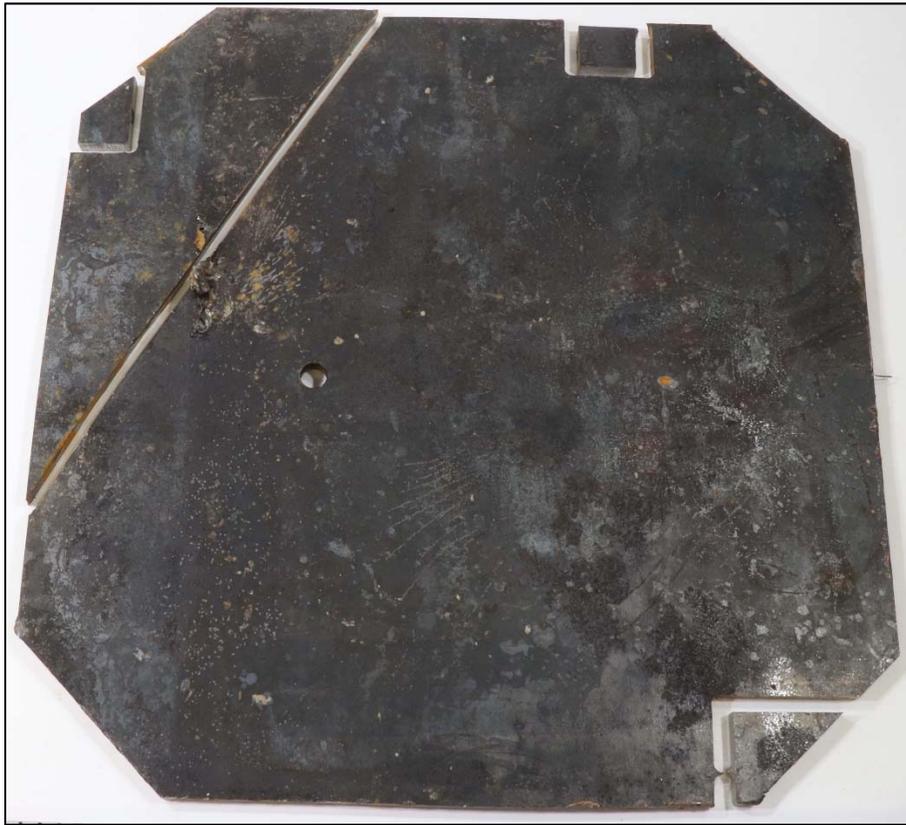
Figure 142. An image of the exterior surface of Coupon 8 after CO₂ blast cleaning.

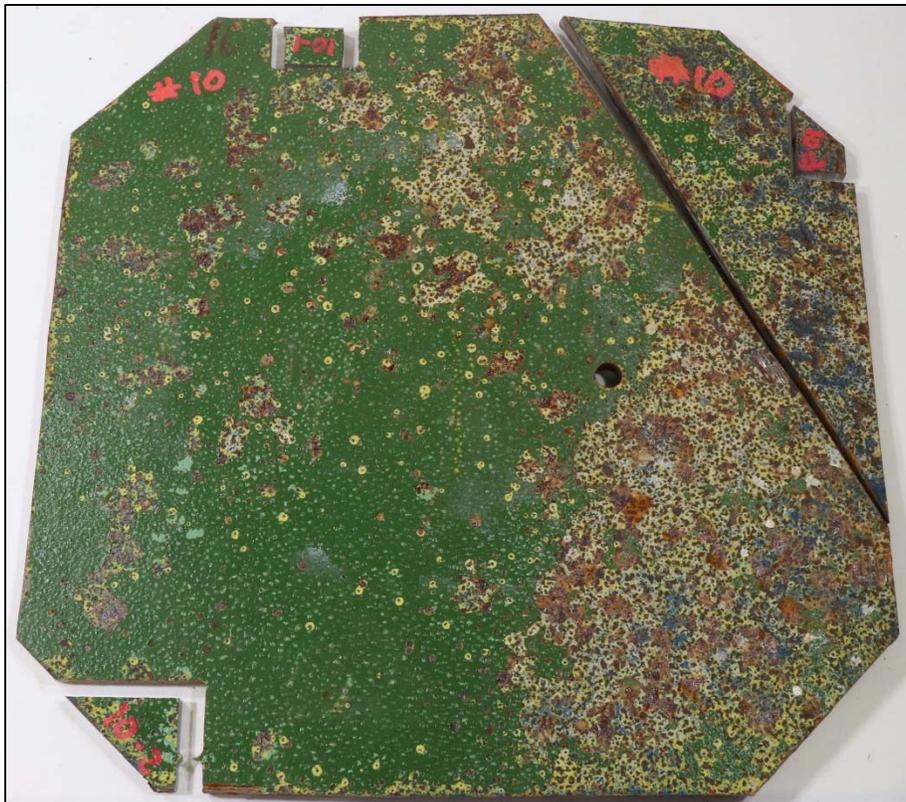
Figure 143. An image of the interior surface of Coupon 10 after CO₂ blast cleaning.

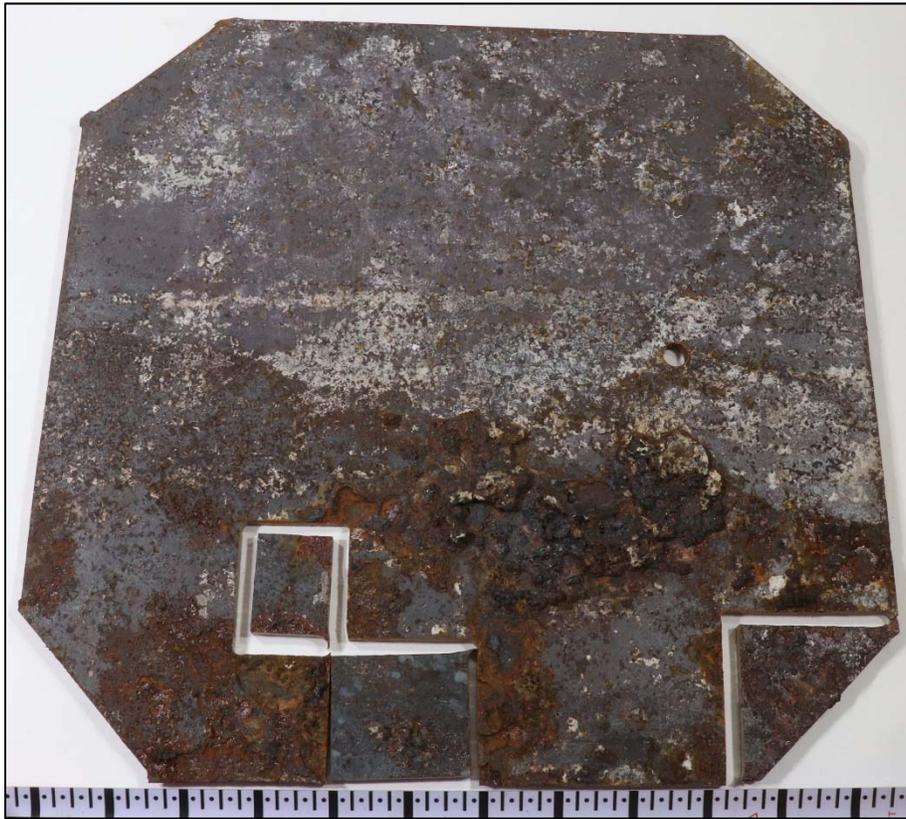
Figure 144. An image of the exterior surface of Coupon 10 after CO₂ blast cleaning.

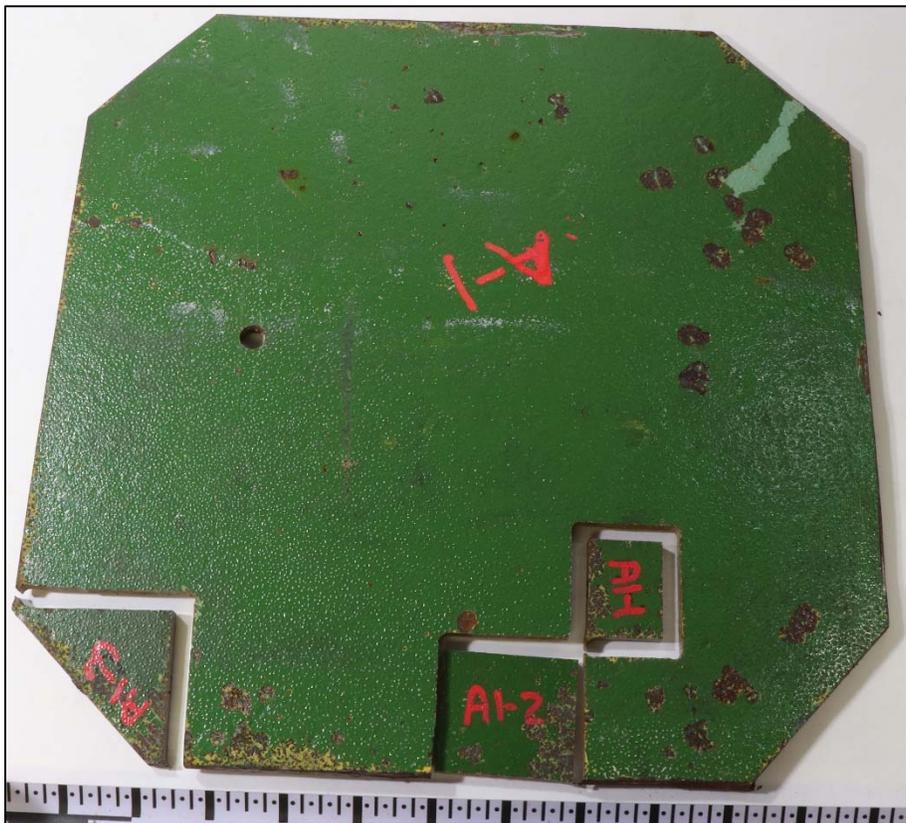
Figure 145. An image of the interior surface of Coupon A1 after CO₂ blast cleaning.

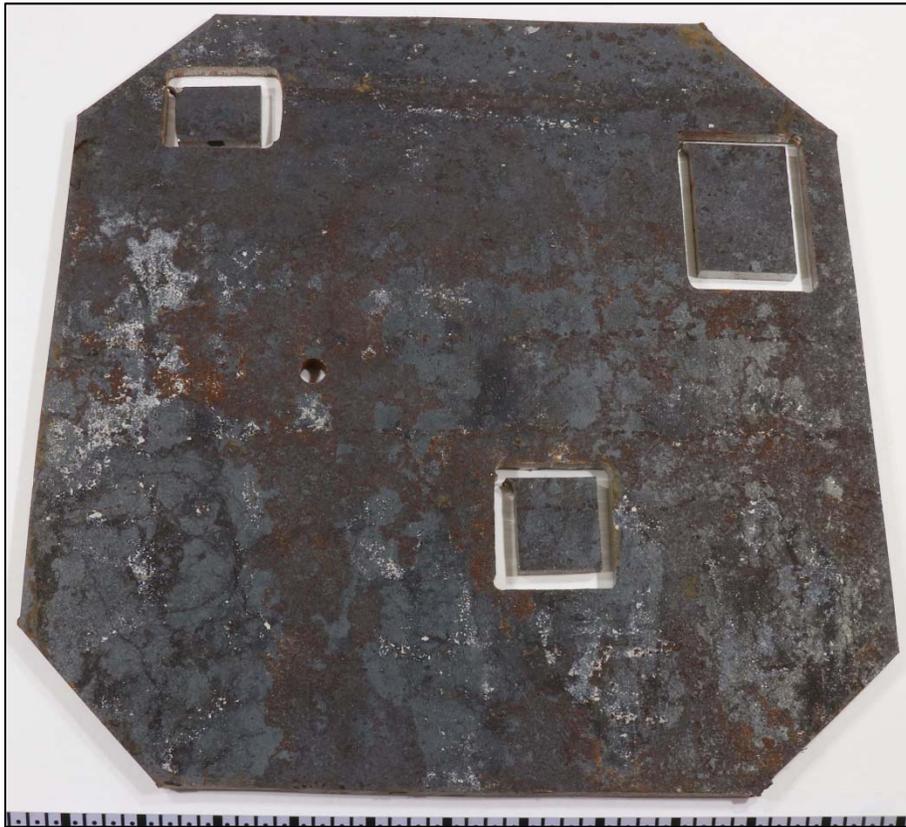
Figure 146. An image of the exterior surface of Coupon A1 after CO₂ blast cleaning.

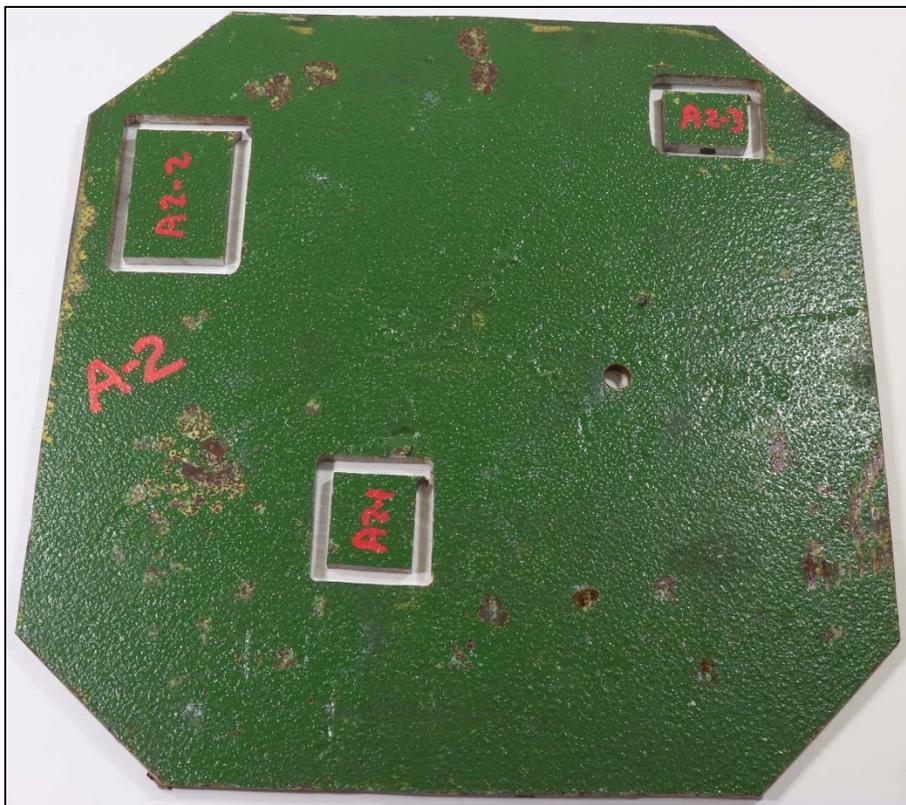
Figure 147. An image of the interior surface of Coupon A2 after CO₂ blast cleaning.

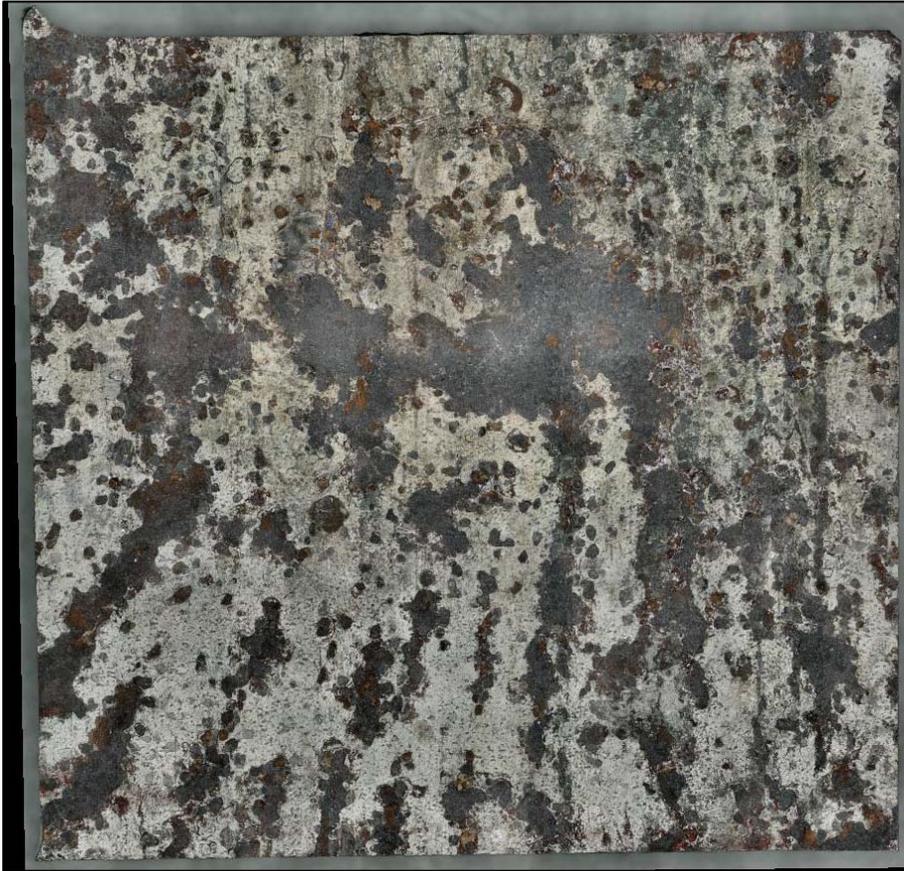
Figure 148. An image of the exterior surface of Coupon A2 after CO₂ blast cleaning.

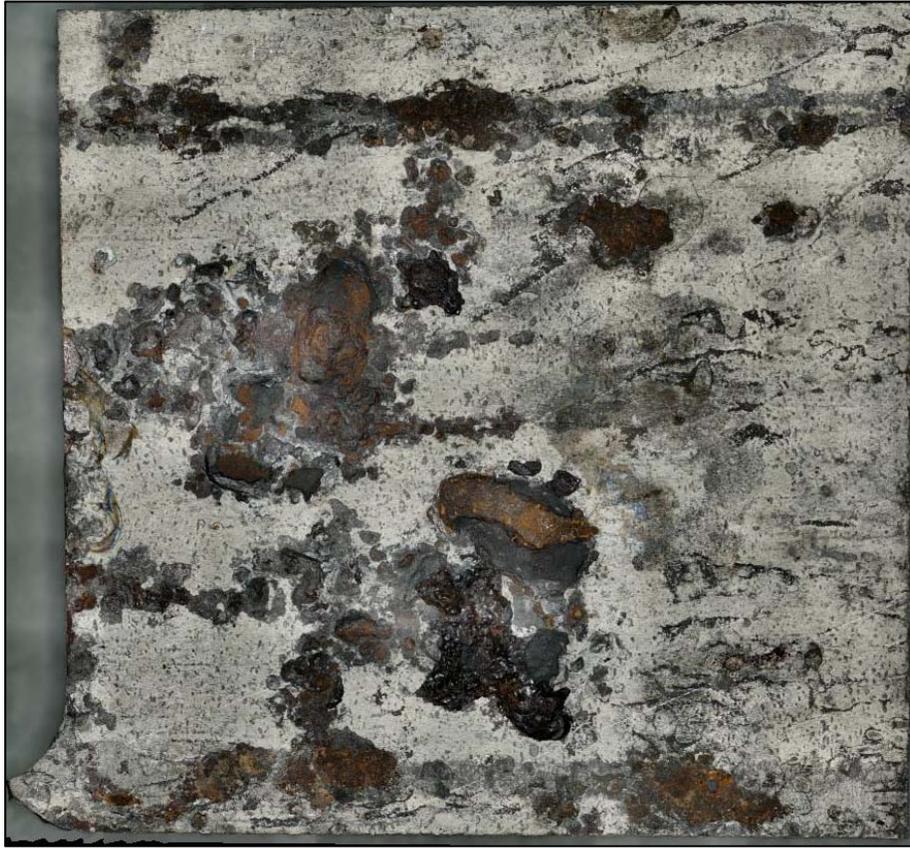
Figure 149. A screenshot of the 3D digital image of a specimen excised from Coupon 1 labeled as 1-1, after CO₂ blast cleaning
