SUBJECT: DESTRUCTIVE ANALYSIS OF 10 STEEL COUPONS REMOVED FROM RED HILL FUEL STORAGE TANK NO. 14, PURSUANT TO SECTION 5.3 OF THE ADMINISTRATIVE ORDER ON CONSENT STATEMENT OF WORK, RED HILL BULK FUEL STORAGE FACILITY, JOINT BASE PEARL HARBOR-HICKAM, OAHU, HAWAII

Destructive Analysis of 10 Steel Coupons Removed from Red Hill Fuel Storage Tank #14

REPORT No. 201801967

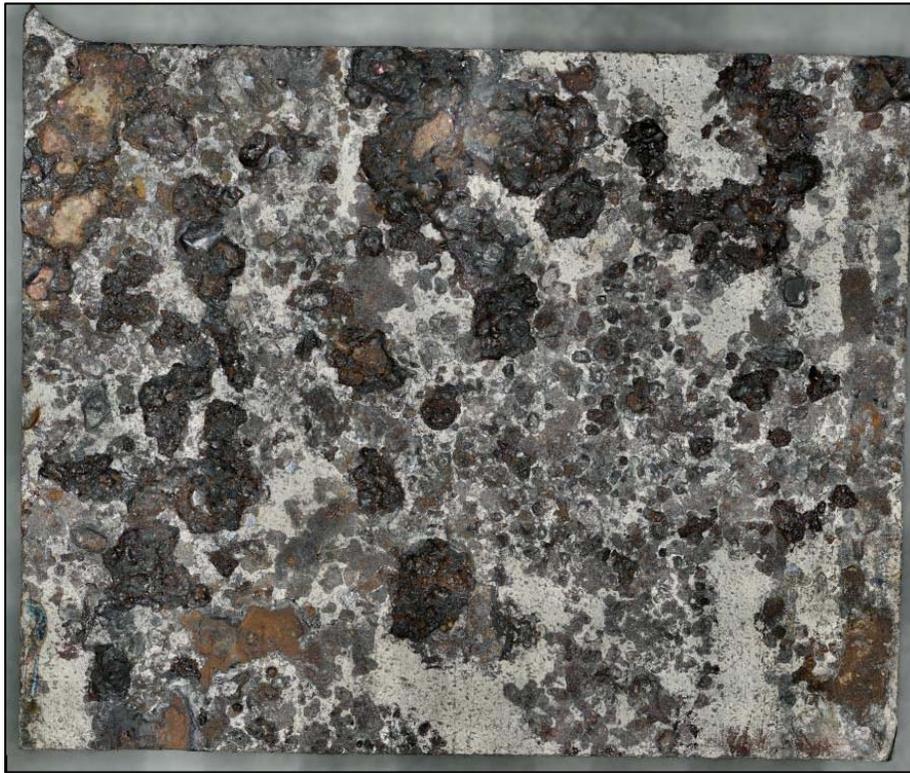
Figure 150. A screenshot of the 3D digital image of a specimen excised from Coupon 1 labeled as 1-2, after CO₂ blast cleaning

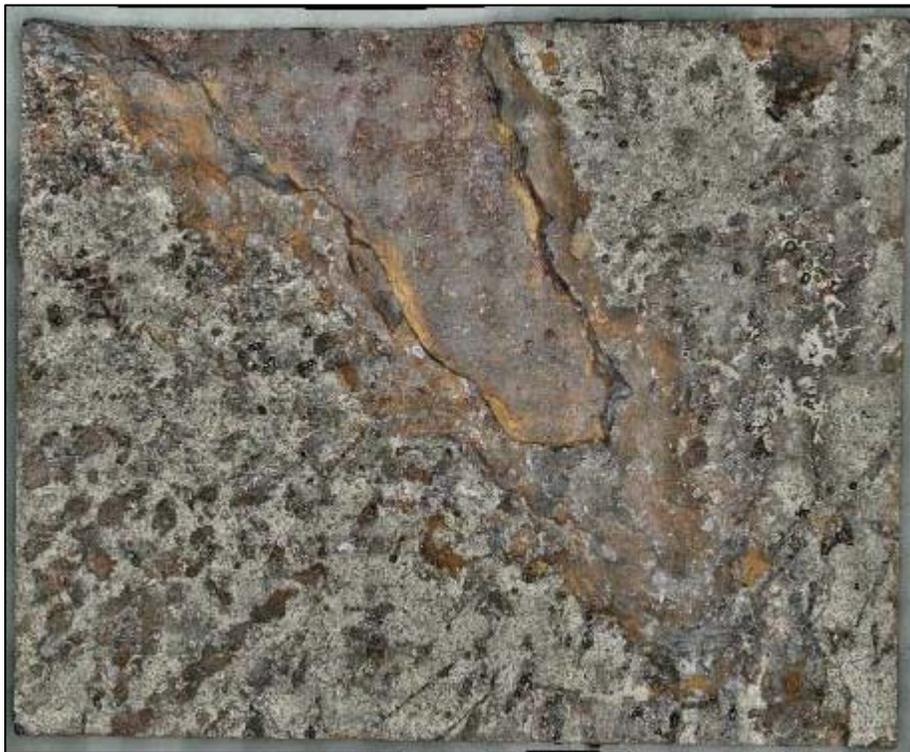
Figure 151. A screenshot of the 3D digital image of a specimen excised from Coupon 1 labeled as 1-3, after CO₂ blast cleaning

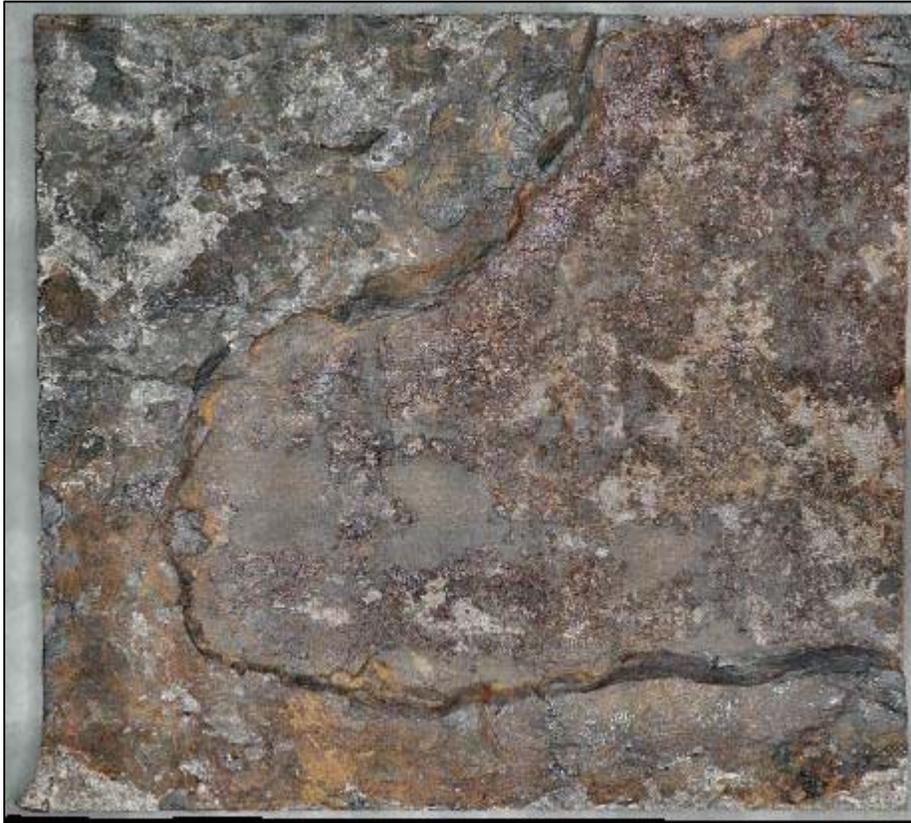
Figure 152. A screenshot of the 3D digital image of a specimen excised from Coupon 2 labeled as 2-1, after CO₂ blast cleaning

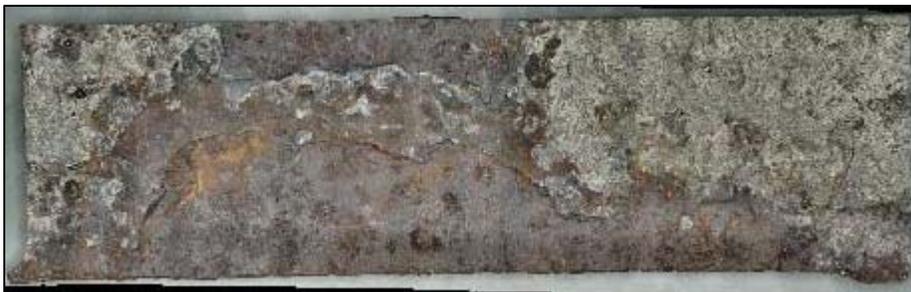
Figure 153. A screenshot of the 3D digital image of a specimen excised from Coupon 2 labeled as 2-2, after CO₂ blast cleaning

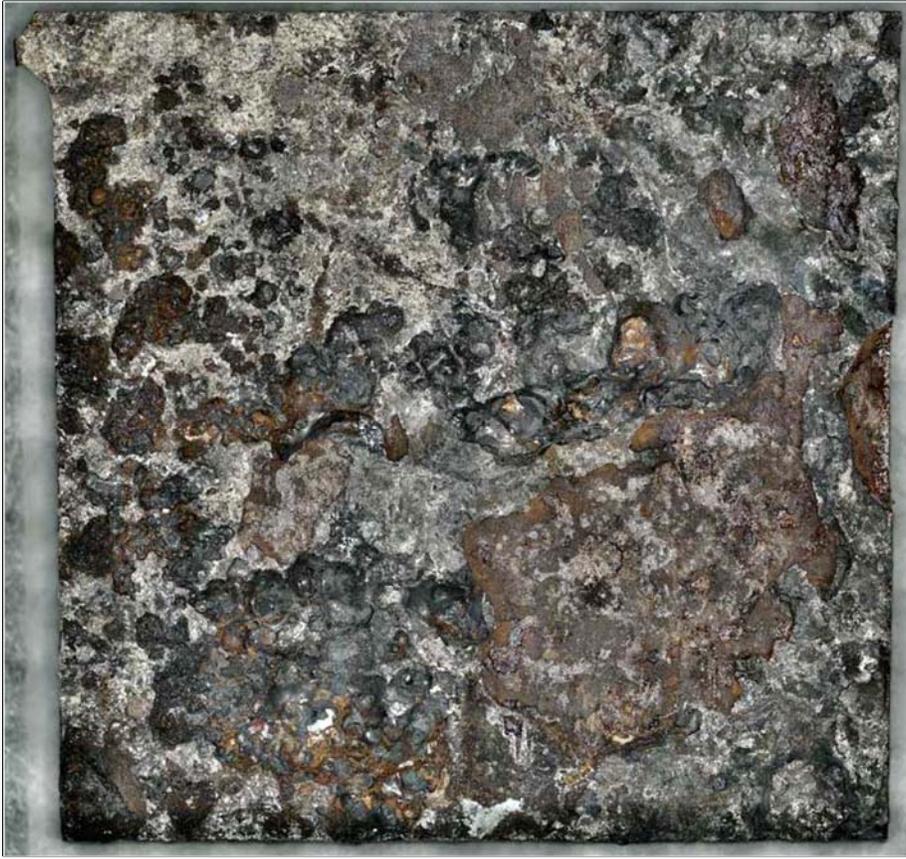
Figure 154. A screenshot of the 3D digital image of a specimen excised from Coupon 2 labeled as 2-3, after CO₂ blast cleaning

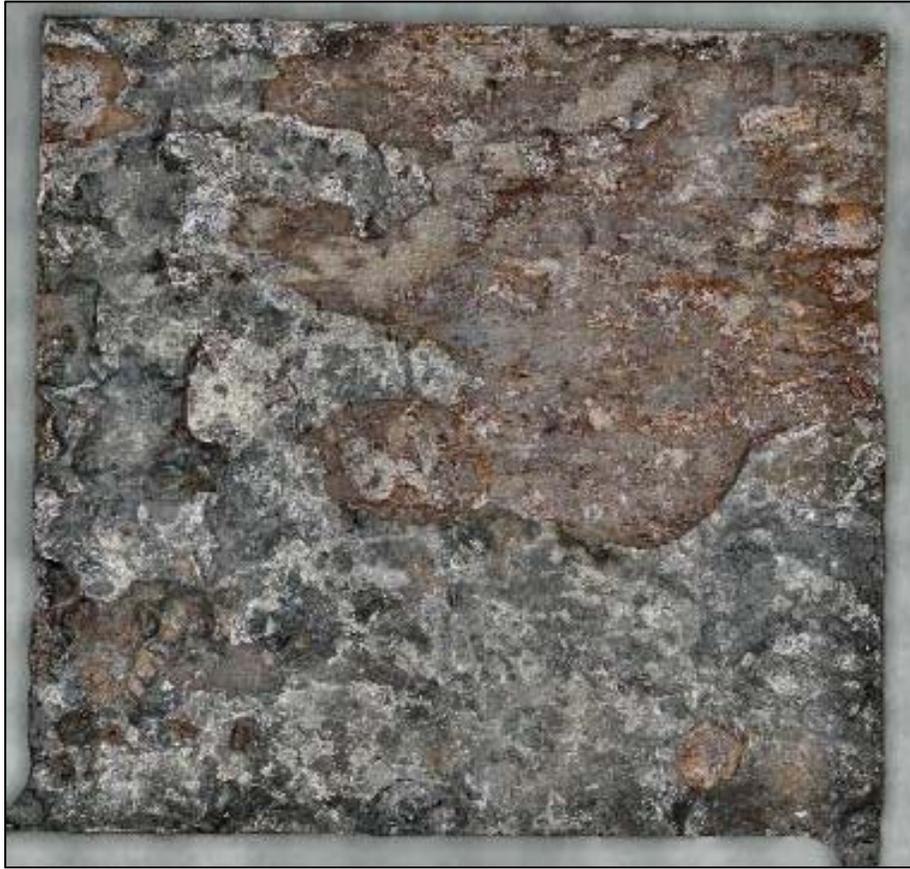
Figure 155. A screenshot of the 3D digital image of a specimen excised from Coupon 3 labeled as 3-1, after CO₂ blast cleaning

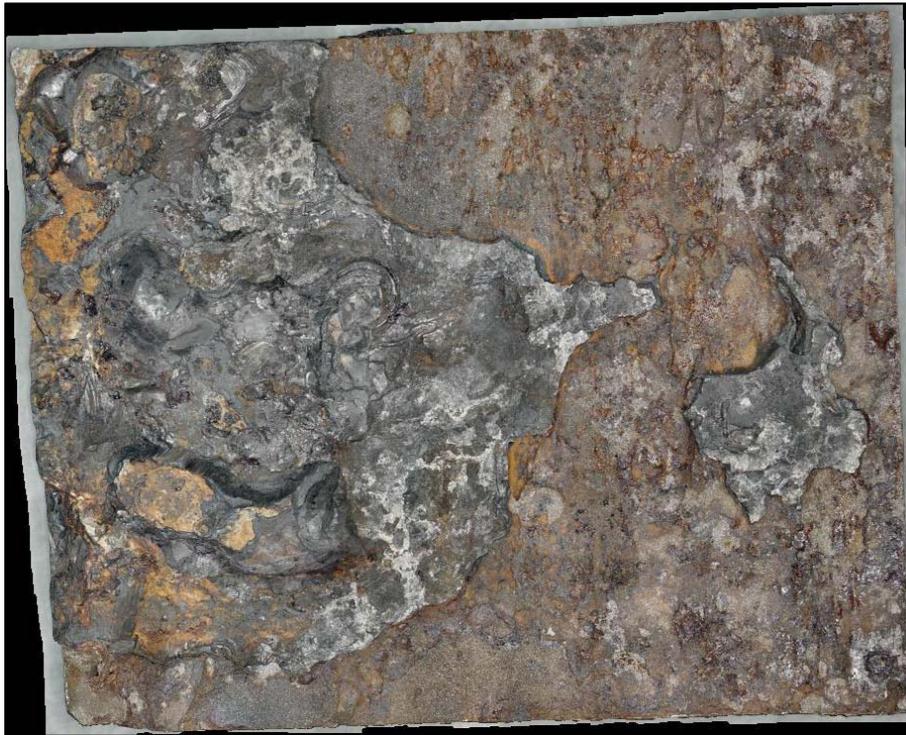
Figure 156. A screenshot of the 3D digital image of a specimen excised from Coupon 3 labeled as 3-2, after CO₂ blast cleaning

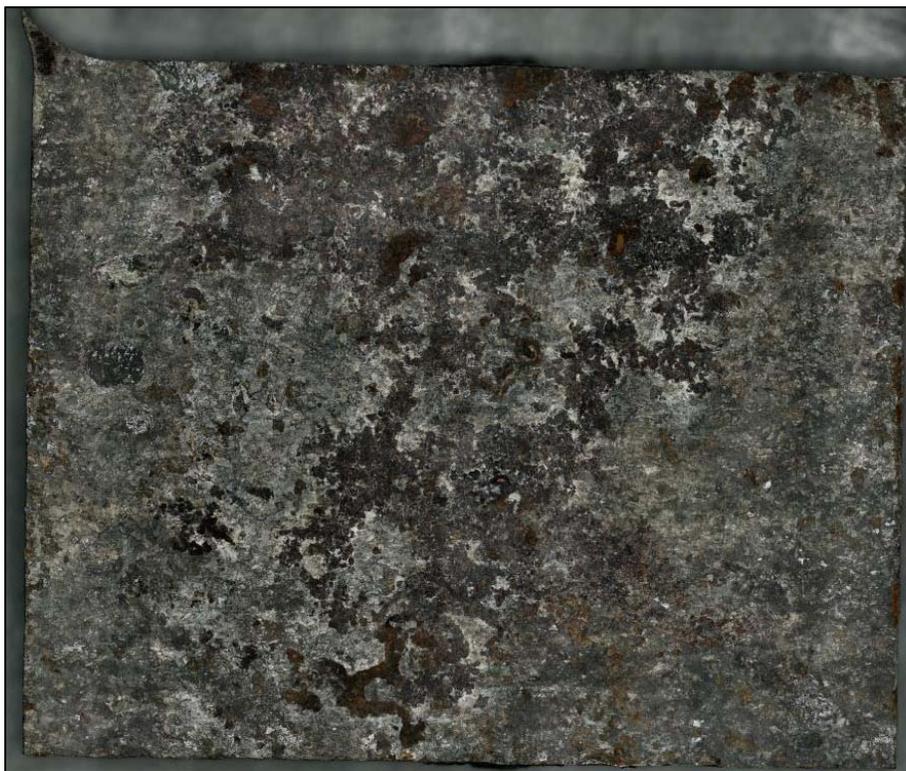
Figure 157. A screenshot of the 3D digital image of a specimen excised from Coupon 3 labeled as 3-3, after CO₂ blast cleaning

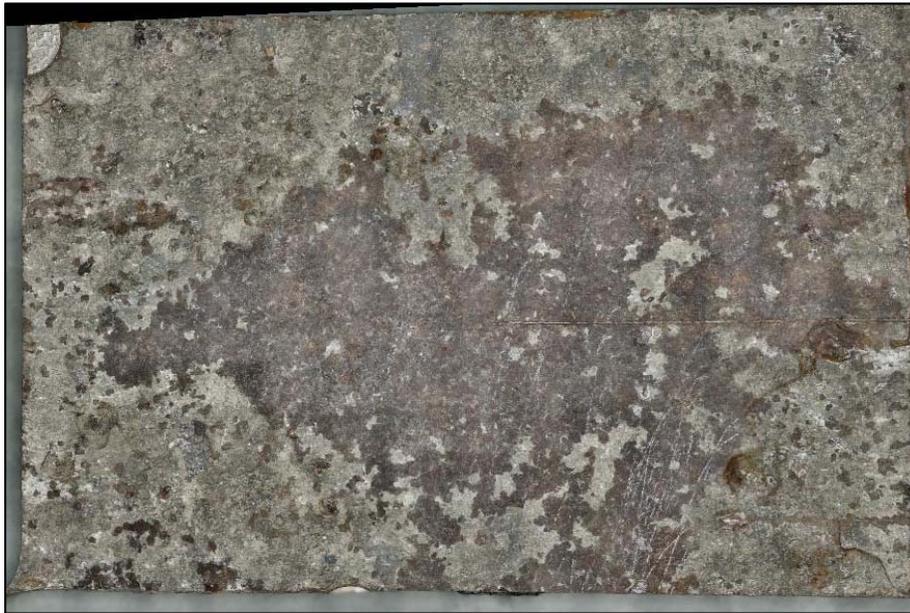
Figure 158. A screenshot of the 3D digital image of a specimen excised from Coupon 5 labeled as 5-1, after CO₂ blast cleaning

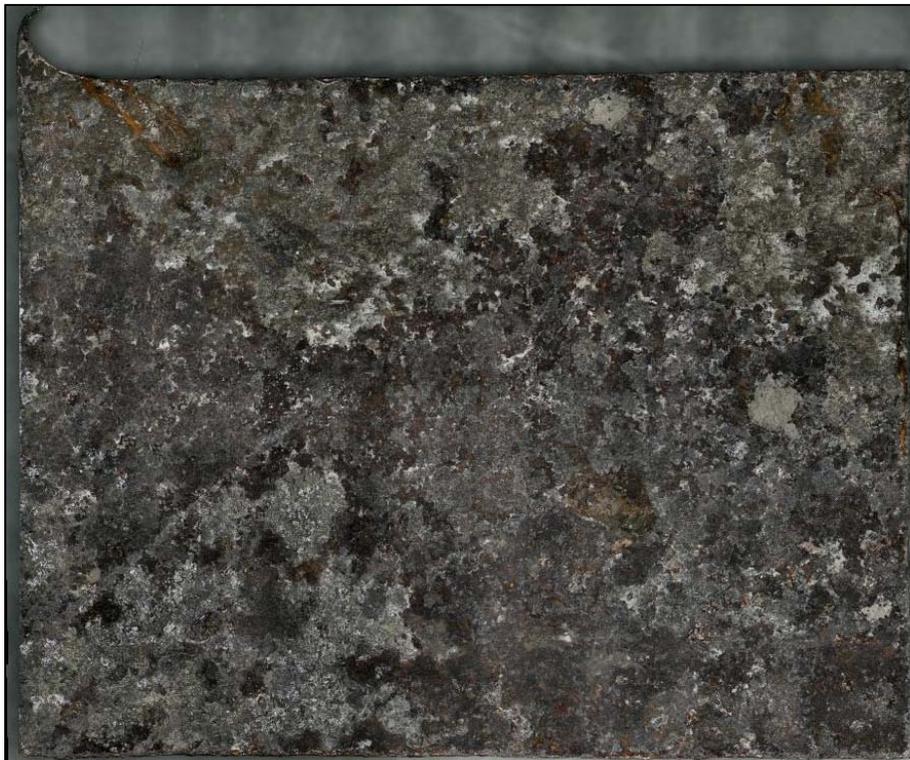
Figure 159. A screenshot of the 3D digital image of a specimen excised from Coupon 5 labeled as 5-2, after CO₂ blast cleaning

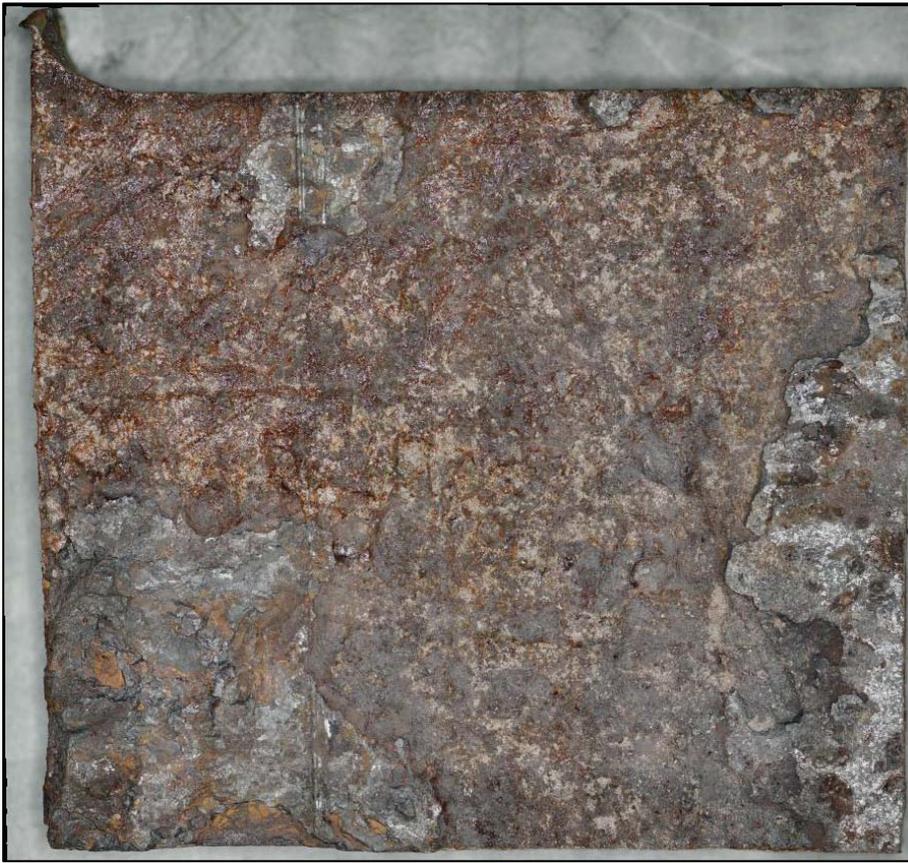
Figure 160. A screenshot of the 3D digital image of a specimen excised from Coupon 5 labeled as 5-3, after CO₂ blast cleaning

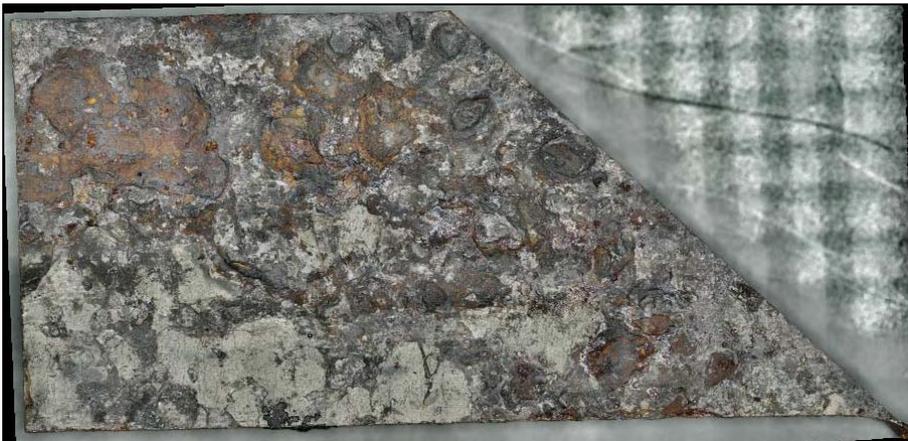
Figure 161. A screenshot of the 3D digital image of a specimen excised from Coupon 6 labeled as 6-1, after CO₂ blast cleaning

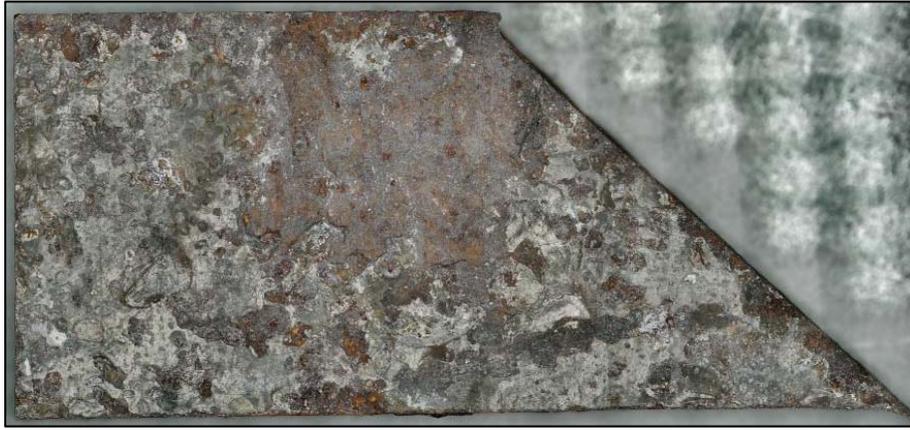
Figure 162. A screenshot of the 3D digital image of a specimen excised from Coupon 6 labeled as 6-2, after CO₂ blast cleaning

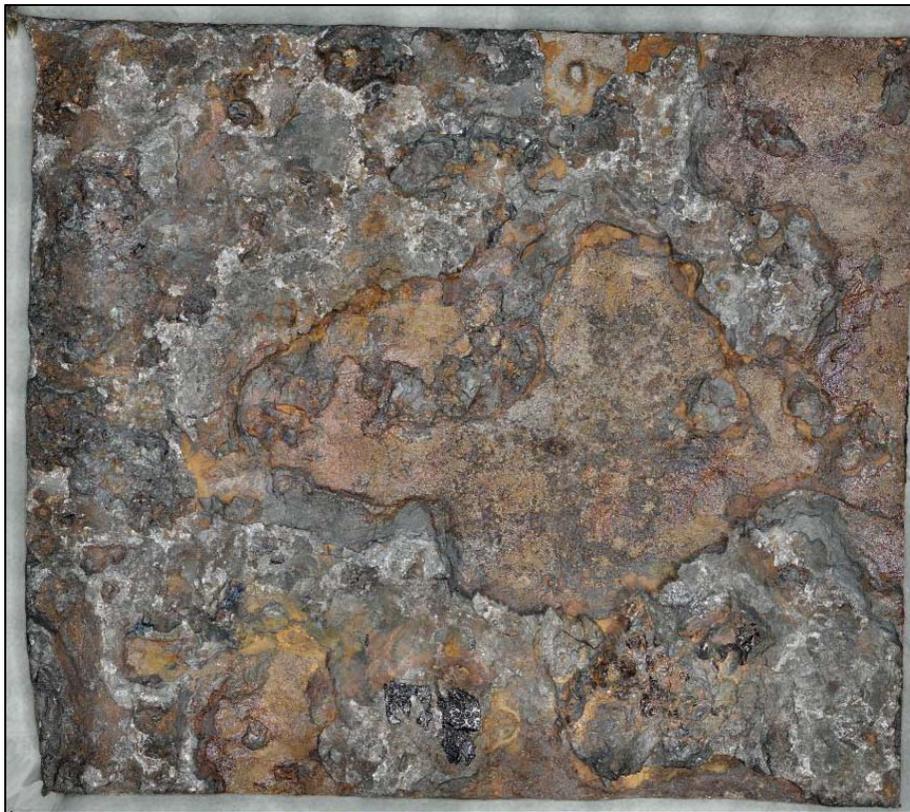
Figure 163. A screenshot of the 3D digital image of a specimen excised from Coupon 6 labeled as 6-3, after CO₂ blast cleaning

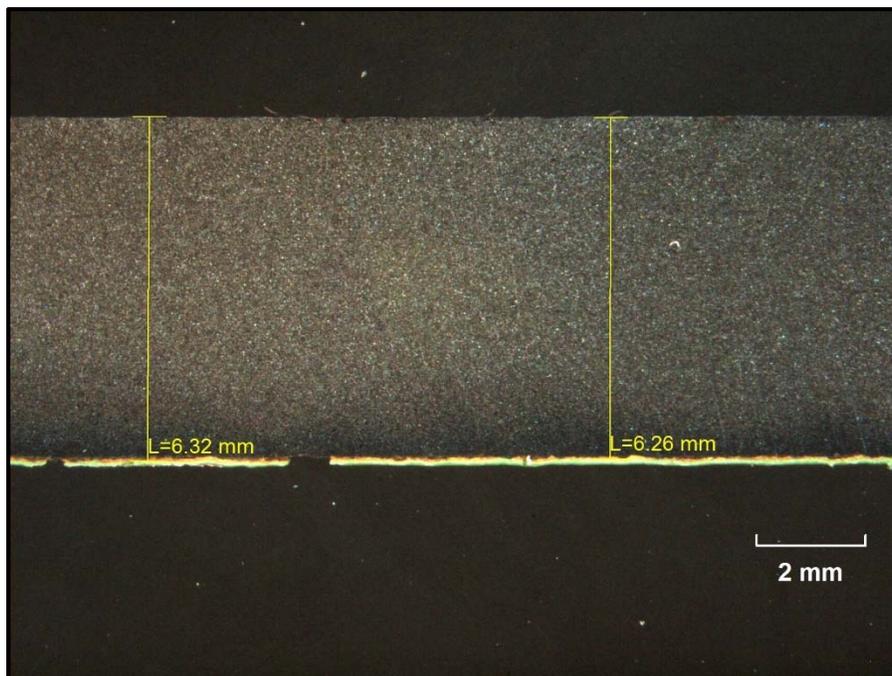
Figure 190. The prepared metallographic cross-section from Sample 5-1 is shown during examination with a stereomicroscope. No significant corrosion was observed. (7X)

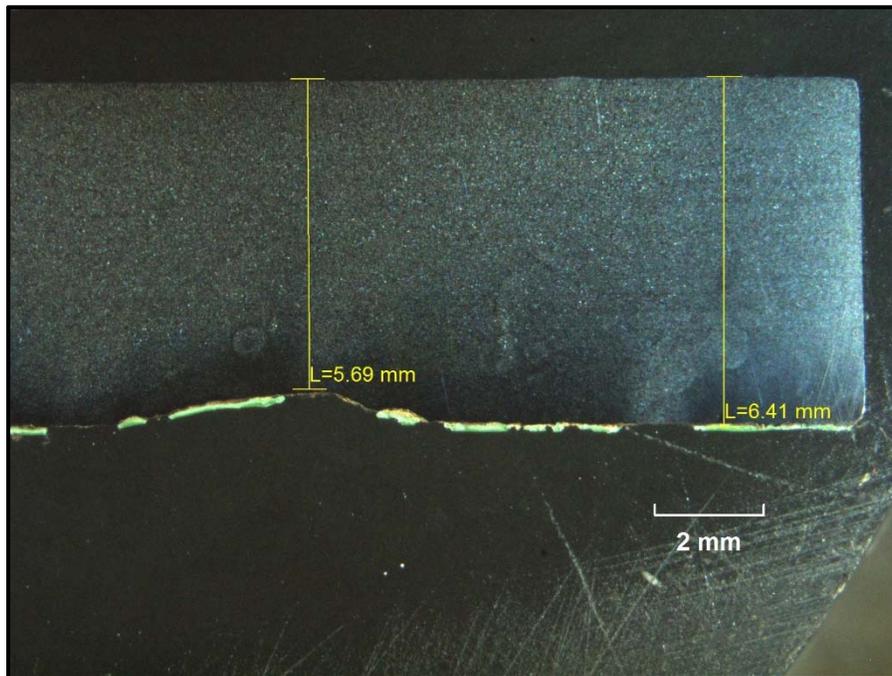
Figure 192. The prepared metallographic cross-section from Sample 5-5 is shown during examination with a stereomicroscope. The thickest remaining wall is shown. Note that the reduction in wall thickness was due to a depression on the painted face of the specimen. (7X)

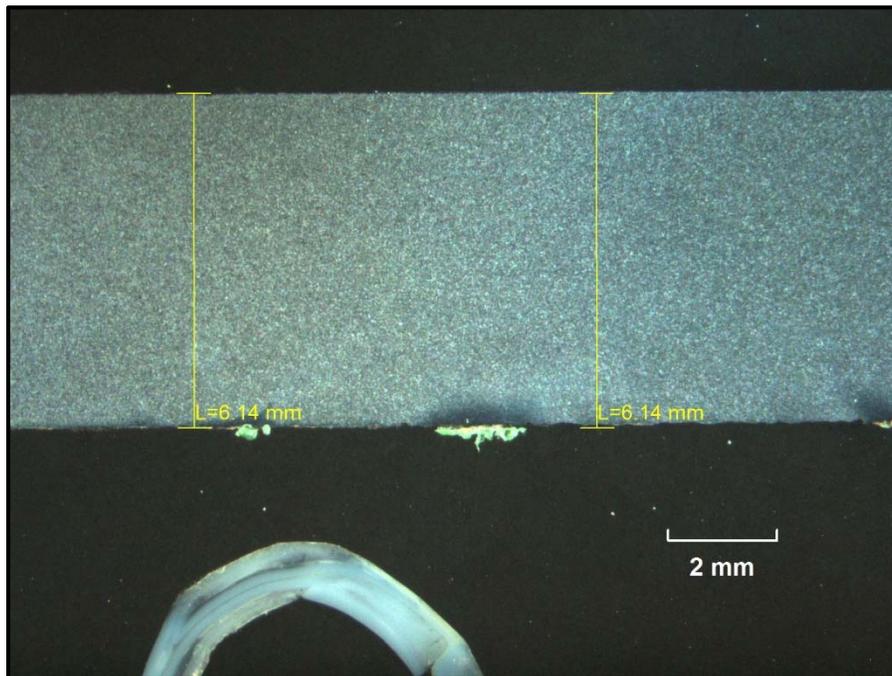
Figure 200. The prepared metallographic cross-section from Sample 10-1 is shown during examination with a stereomicroscope. The thickest location(s) are shown. No pitting was observed. (7X)

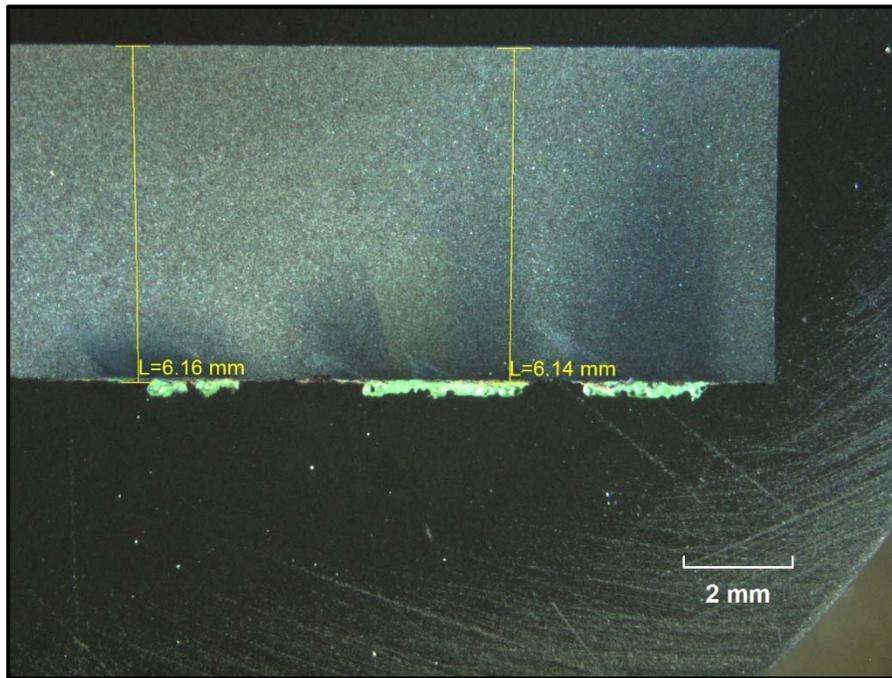
Figure 201. The prepared metallographic cross-section from Sample 10-2 is shown during examination with a stereomicroscope. The thickest location(s) are shown. No pitting was observed. (7X)

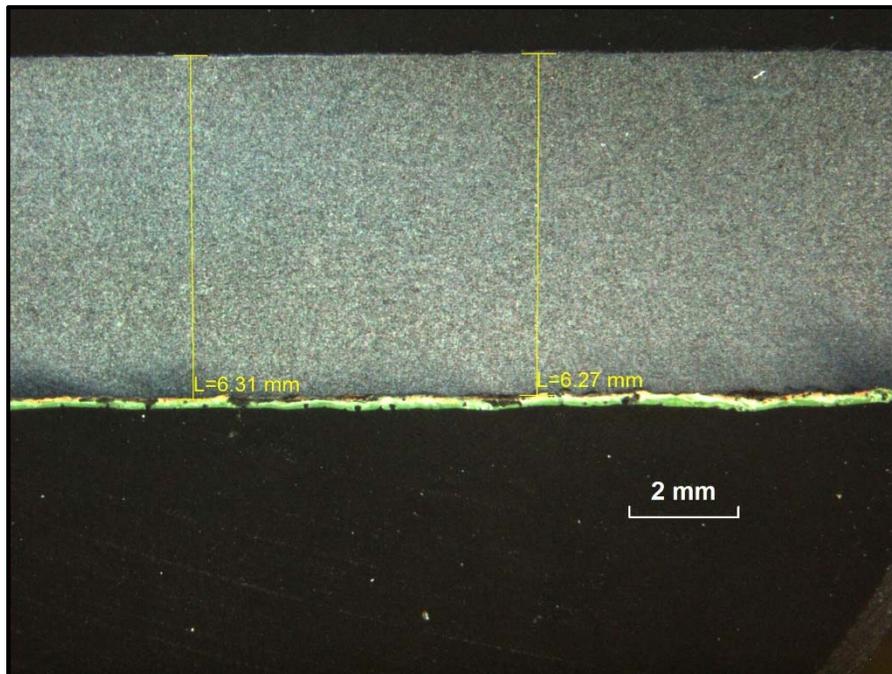
Figure 206. The prepared metallographic cross-section from Sample A2-3 is shown during examination with a stereomicroscope. No pitting was observed. (7X)

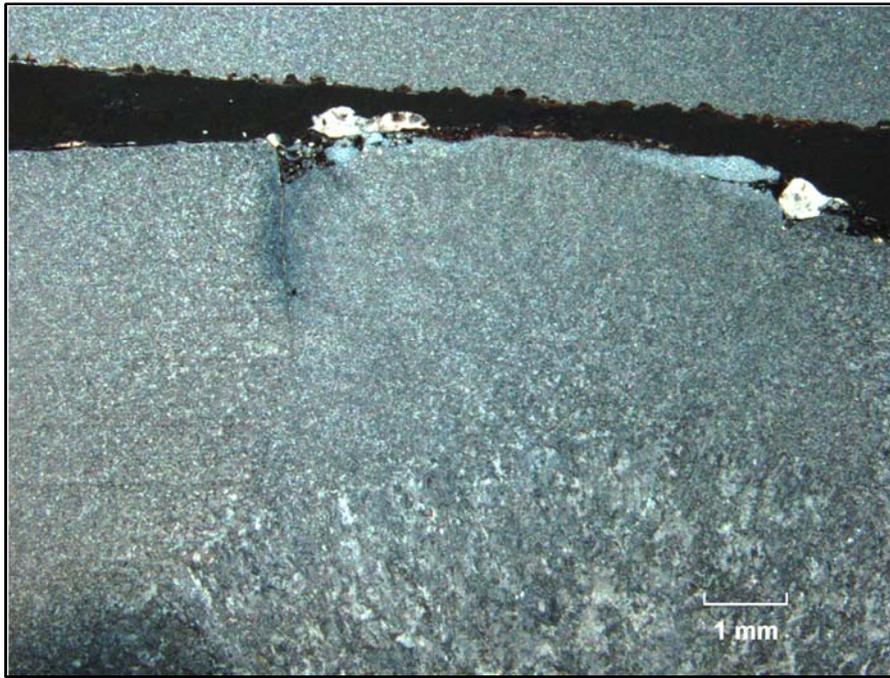
Coupon 8 exhibited what is presumed to be a prior weld repair and/or addition of a backing plate, where a patch was made on the tank wall. Representative images of the welds are presented as Figures 208 through 213. A full weld evaluation is outside the scope of this effort. The results are thus provided for information only.

Figure 209. The location identified in the previous figure is shown at higher magnification. The weld indication (arrow) appeared to be an area of incomplete fusion.

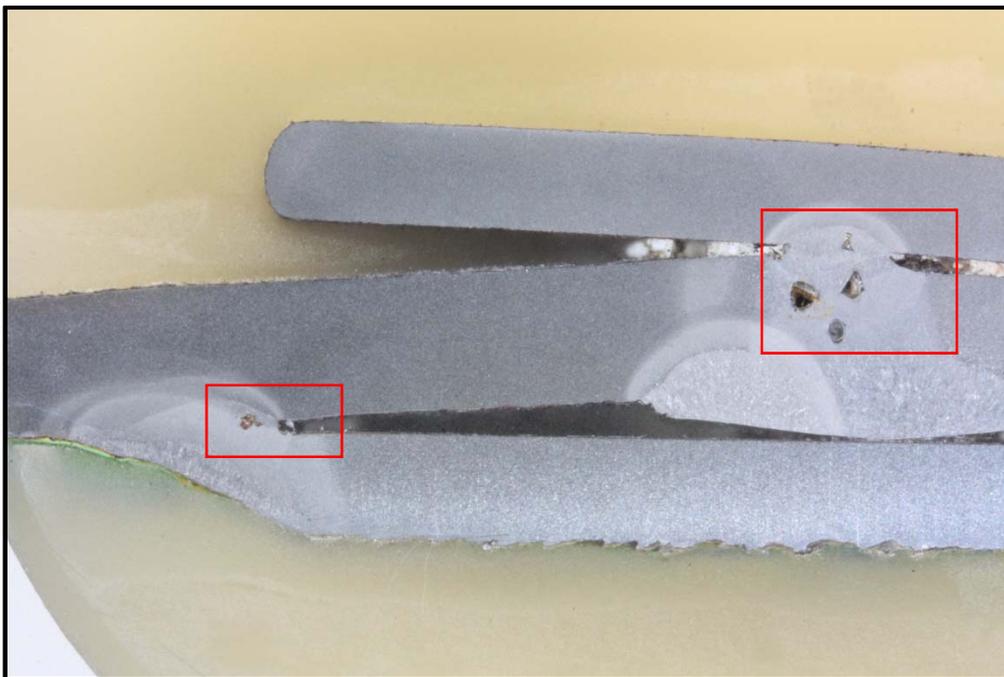
Figure 210. The prepared metallographic cross-section through welded sample 8-4 is shown in an overall view. The painted exterior surface is along the bottom section. The areas identified by the red boxes are shown in the next two figures at higher magnification.

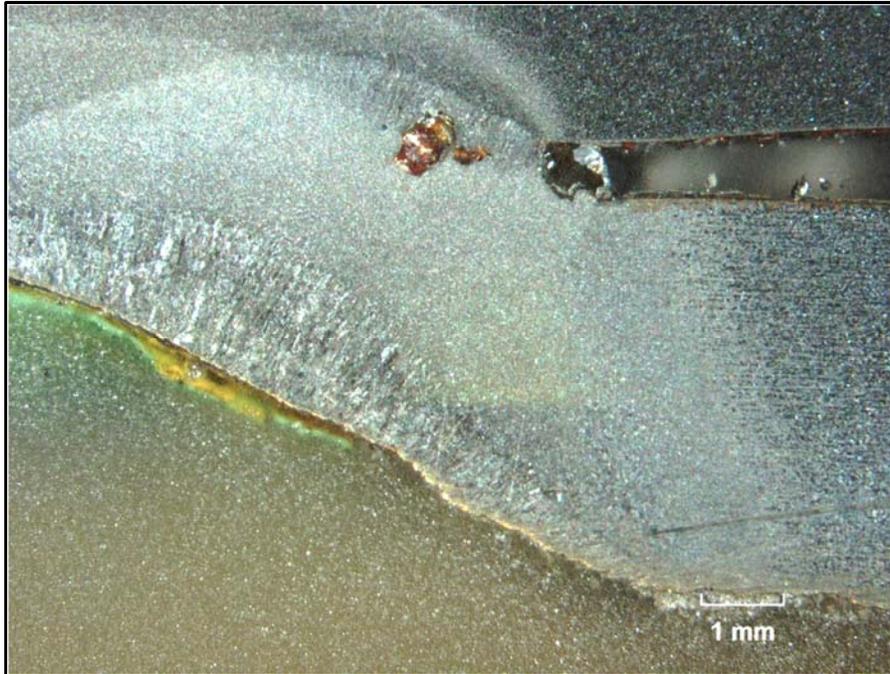
Figure 211. The left-hand feature in Figure 210 is shown at higher magnification. The weld indication (arrow) appeared to be an area of porosity.

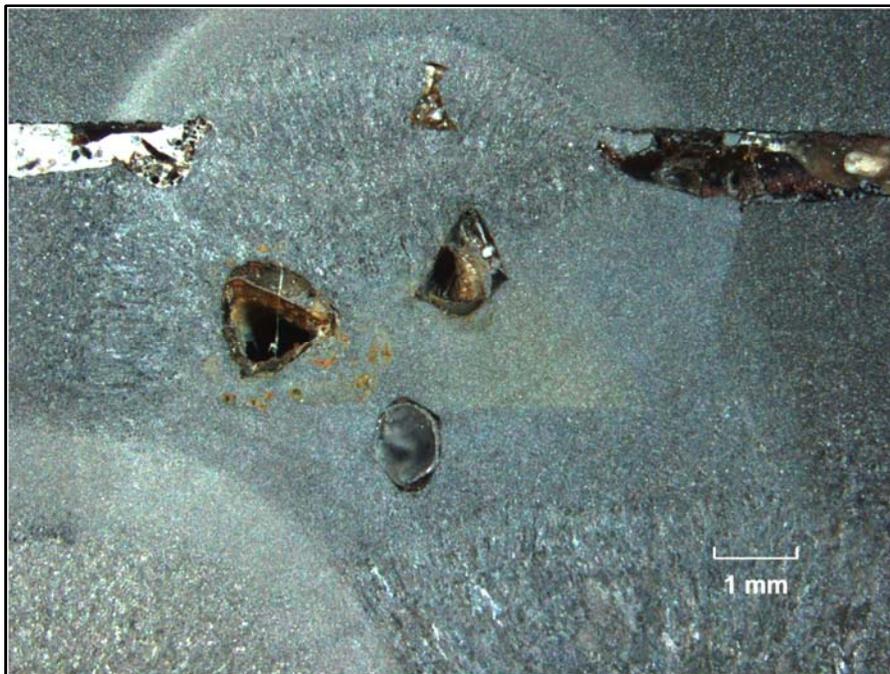
Figure 212. The right-hand feature in Figure 210 is shown at higher magnification. The weld indications appeared to be porosity.

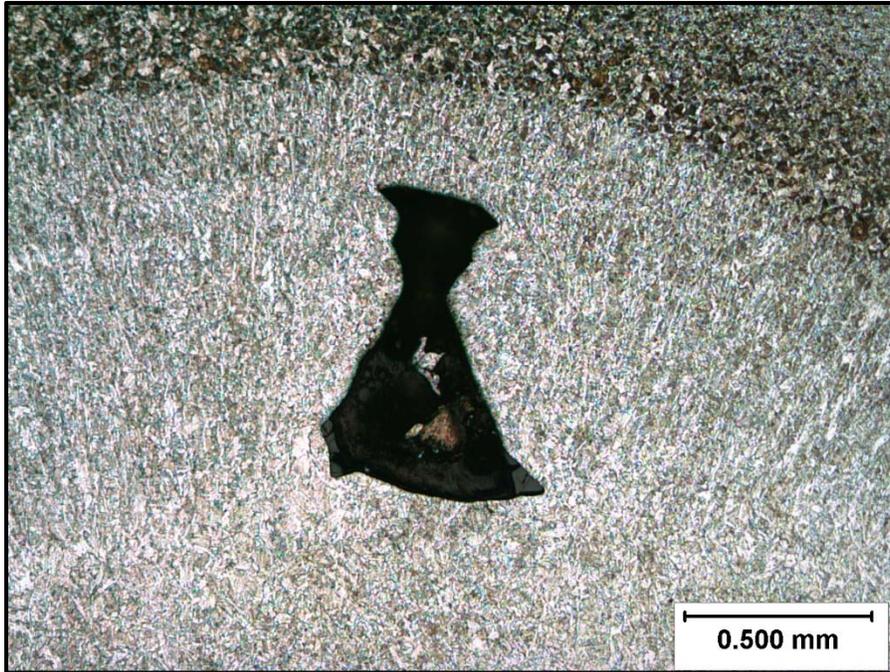
Figure 213. The one of the voids is shown at higher magnification. (2% Nital Etch, 50X)

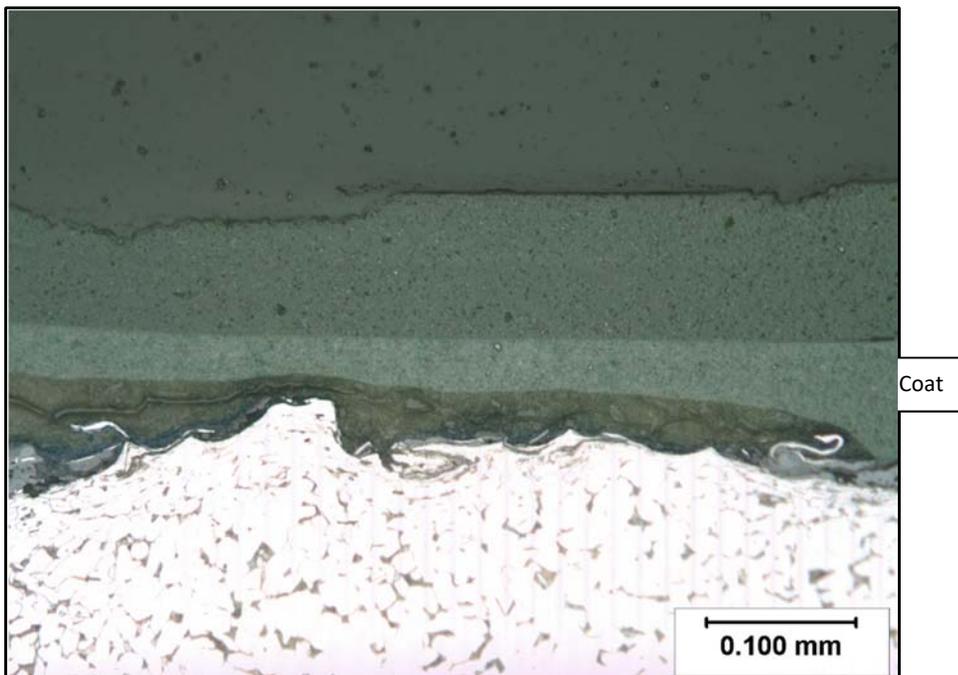
A typical paint layer was examined microscopically and was determined to consist of two layers, as shown in Figure 214. This indicates that the exterior tank wall exhibits a primer layer with a top coat. The scraped paint samples that were excised from each coupon previously for FTIR analysis would likely have captured some of both layers. The FTIR results presented previously were a good match for polyurethane, with no observable secondary component. Although this indicates that both the primer and top coat were polyurethane-based, it cannot be ruled out that the primer exhibited a different composition.

Figure 214. A typical paint layer is shown in cross-section, with key characteristics identified. (2% Nital Etch, 200X)
