**Section 9**

**RECOMMENDED REPAIRS**

MID ATLANTIC ENVIRONMENTAL	
EMERGENCY REPAIRS FOR RED HILL TANKS	
Tank #8 AS BUILT DRAWINGS	
Repair No.: 001	File: 8R001
UPPER DOME	Quadrant: D
Course: EXTENSION	PLATE: 22
Drawn by: Tom Klitcher	Date: 5/4/98

**Dames & Moore**  
Emergency Repairs For Red Hill Tanks at the Fleet Industrial & Supply Center  
Contract No. N62742-96-C-1356

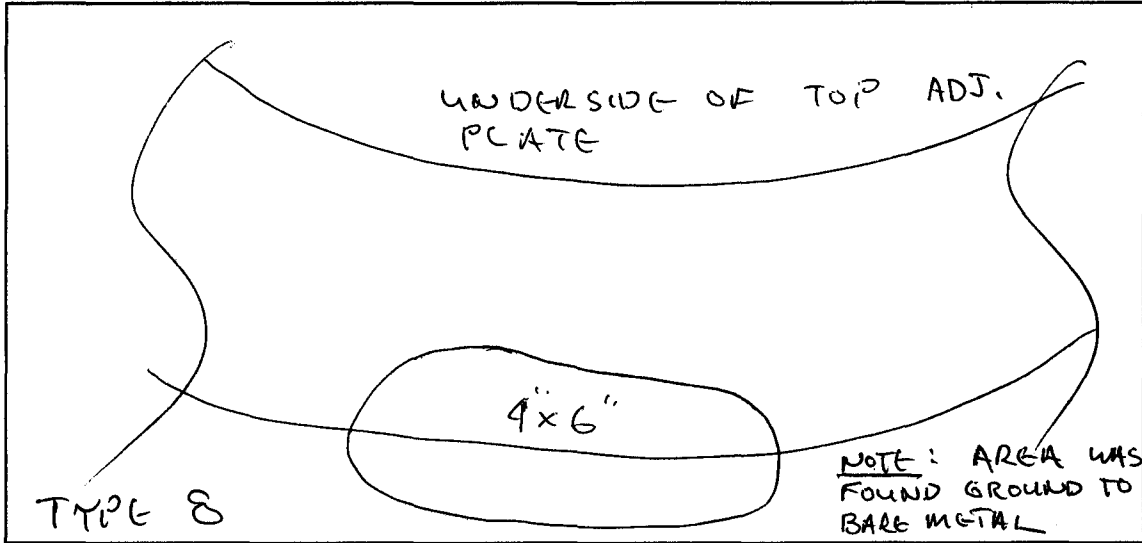
Tank No.: 8 Repair No.: 001 Type: 8 Location: D

NOTE: AREA EAS FOUND TO BE GROUND TO BARE METAL

Coating Type: Epoxy

NDT Performed: Visual:  DFT:  Average DFT: > 8 mils  
< 15 mils

Repair Acceptable: John Walsh Date Accepted: 3-24-98

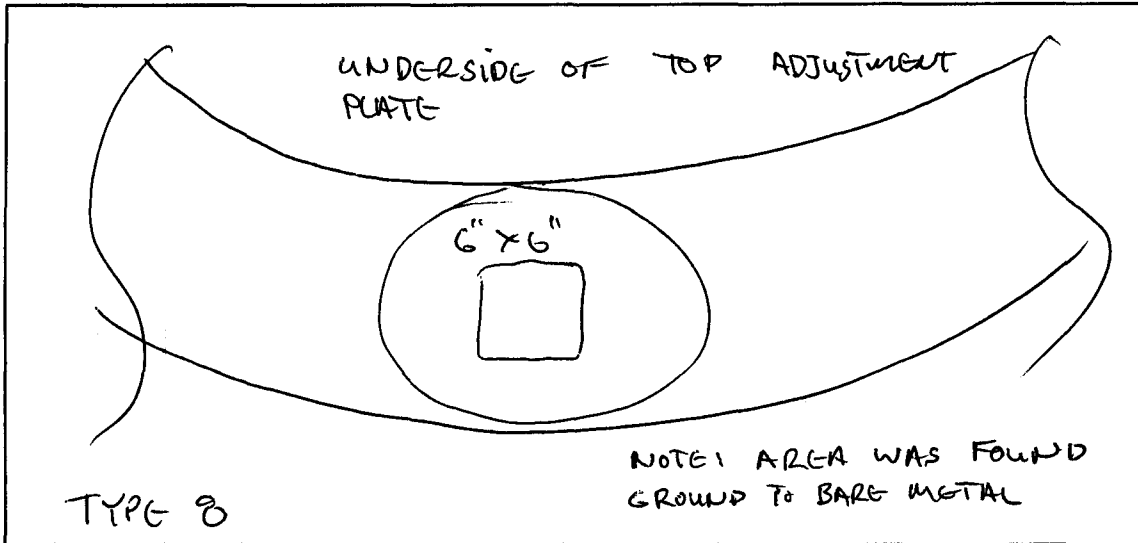
Tank No.: 8 Repair No.: 002 Type: 8 Location: C

MID ATLANTIC ENVIRONMENTAL	
EMERGENCY REPAIRS FOR RED HILL TANKS	
Tank #8 AS BUILT DRAWINGS	
Repair No.: 002	File: 8R001
UPPER DOME	Quadrant: C
Course: EXTENSION	PLATE: 14
Drawn by: Tom Kitchen	Date: 5/4/98

Repair Acceptable: John Zuberell Date Accepted: 3-24-98

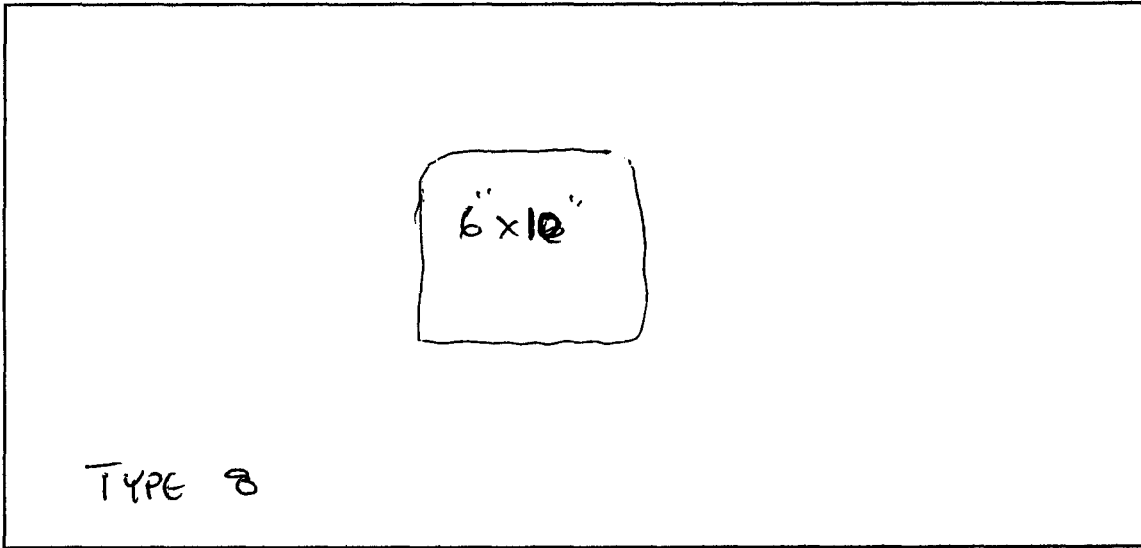
Tank No.: 8 Repair No.: ADD 003 Type: 8 Location: D

<b>MID ATLANTIC ENVIRONMENTAL</b>	
<b>EMERGENCY REPAIRS FOR RED HILL TANKS</b>	
<b>Tank #8 AS BUILT DRAWING</b>	
<b>Repair No.: 003</b>	<b>File #r003</b>
<b>CYLINDER</b>	<b>Quadrant: D</b>
<b>Course: 19</b>	<b>PLATE: 21</b>
<b>Drawn by: Tom Kitchen</b>	<b>Date: 5/4/98</b>

DEFECT INSPECTED BY TK & JF 3/20/98

30 X 50 COATING REPAIR

Repair Acceptable: John Zschell Date Accepted: 3-24-98
