LTR	DESCRIPTION	BY	DATE
REVISIONS			
MID ATLANTIC ENVIRONMENTAL EMERGENCY REPAIRS FOR RED HILL TANKS			
Tank #10			
Repair No.:	340	File:	10r340
Lower dome		Quadrant:	A
Course:	1	Plate:	3
Drawn by:	Tom Kitchen	Date:	5/13/98

Dames & Moore
Emergency Repairs For Red Hill Tanks at the Fleet Industrial & Supply Center
Contract No. N62742-96-C-1356

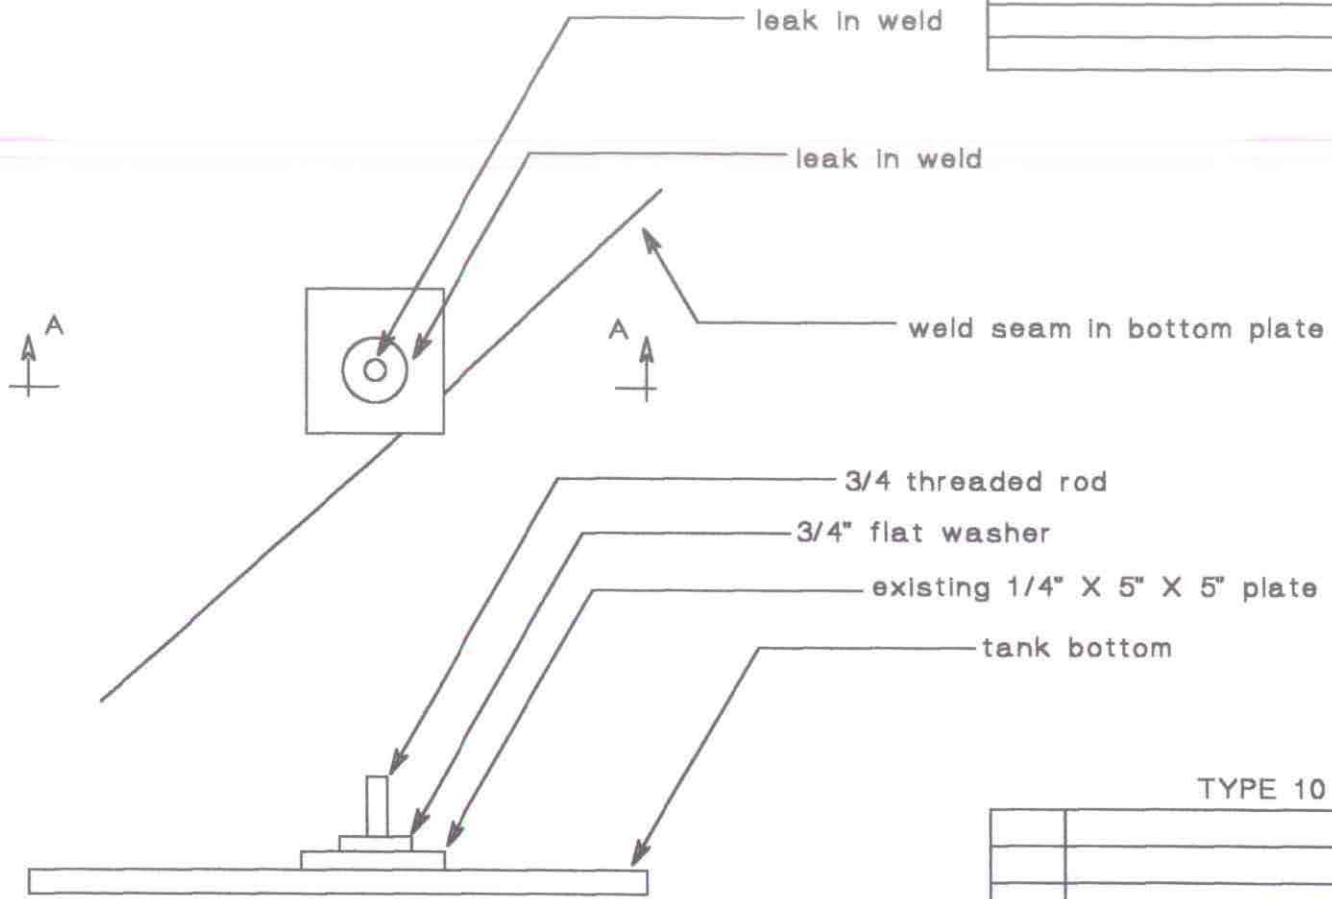
CALENDER OF EVENTS		
EVENT	BY	DATE
Defect Inspected	TK & JF	5/28/98

TYPE 10 REPAIR
