# Emergency Action Plan (EAP)

## NUUANU RESERVOIR NO. 1

State ID # OA-0154

Oahu, Honolulu

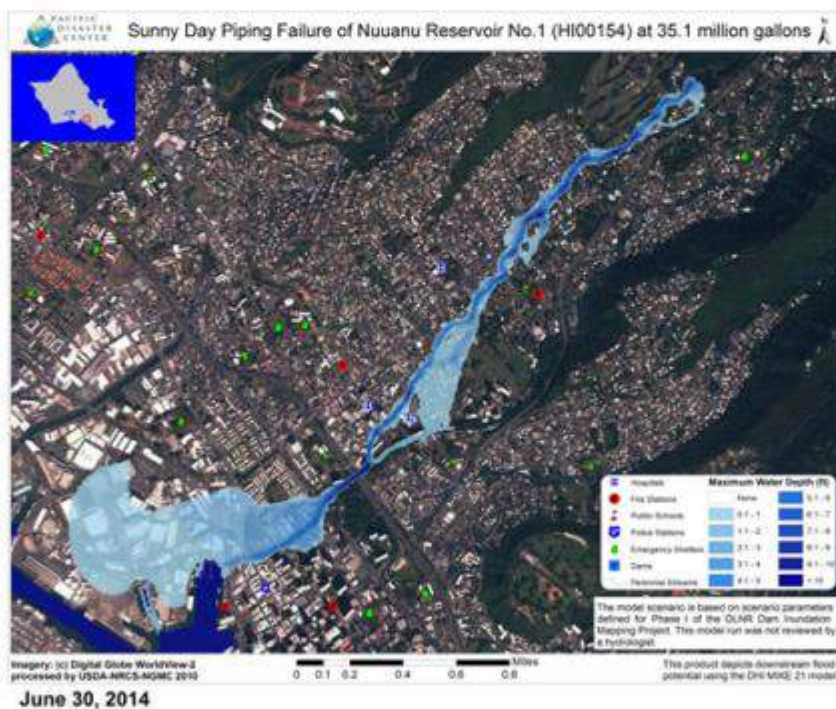
### 4.2 MIKE 21 Model Results – Inundation Map\*

\*While the best available GIS data have been utilized as input to the model and in visualizing model output, due to variations in their currency and accuracy, final product results should be interpreted as "best available estimates" only and not definitive in establishing inundation boundaries.

Parameters	Value	Unit of Measure
Reservoir volume prior to breach:	107.6	acre-feet
Duration of breach:	13.53	minutes
Breach width:	51.53	feet
Distance from dam to ocean:	2.85 (Port)	miles
Type of dam:	Earthen Dam	n/a
Type of breach:	Piping breach originating halfway up the dam face	n/a

It is assumed that the dam fails by piping while at maximum capacity. It is further assumed that 1) the piping failure originates halfway up the dam face, 2) the dam fails under sunny day conditions with dry conditions downstream of the reservoir, and 3) no water is discharged from the spillway. The outflow (discharge hydrograph) from the breached reservoir is modeled using the DHI's MIKE 11 model, and data from historical breaches is used to estimate parameters controlling breach development. The DHI MIKE 21 model is used to route the reservoir discharge down the valley into the ocean. MIKE 21 routes unsteady two dimensional flows using the full Saint-Venant equations. Topography is described by USGS standard 10 meter DEMs. The inundation maps produced by MIKE 21 represent the maximum water depth experienced at any given location. The inundation maps are not snapshots in time because different locations experience maximum flooding at different times. MIKE 21 also provides information on the time of flooding and water velocities.

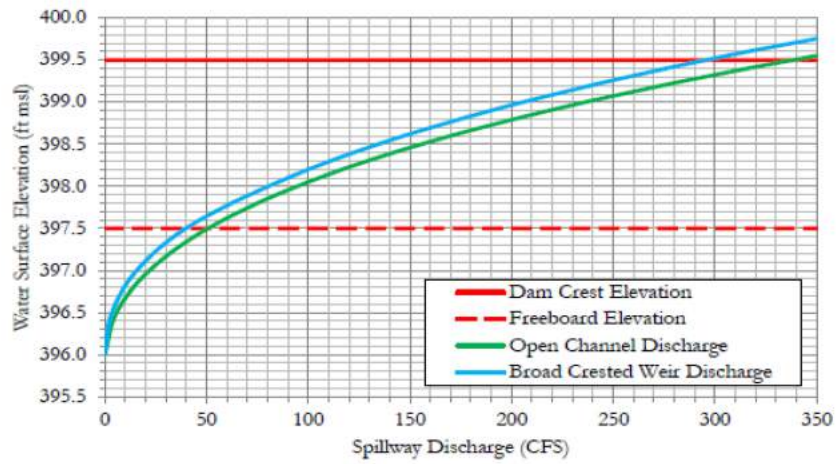
e. Spillway Capacity Curve

Oceanit Laboratories, Inc., 2016. *Hydrologic & Hydraulic Analysis for Nu'uuanu Reservoir No. 1 (OA-0154)*.  
Prepared for Honolulu Board of Water Supply

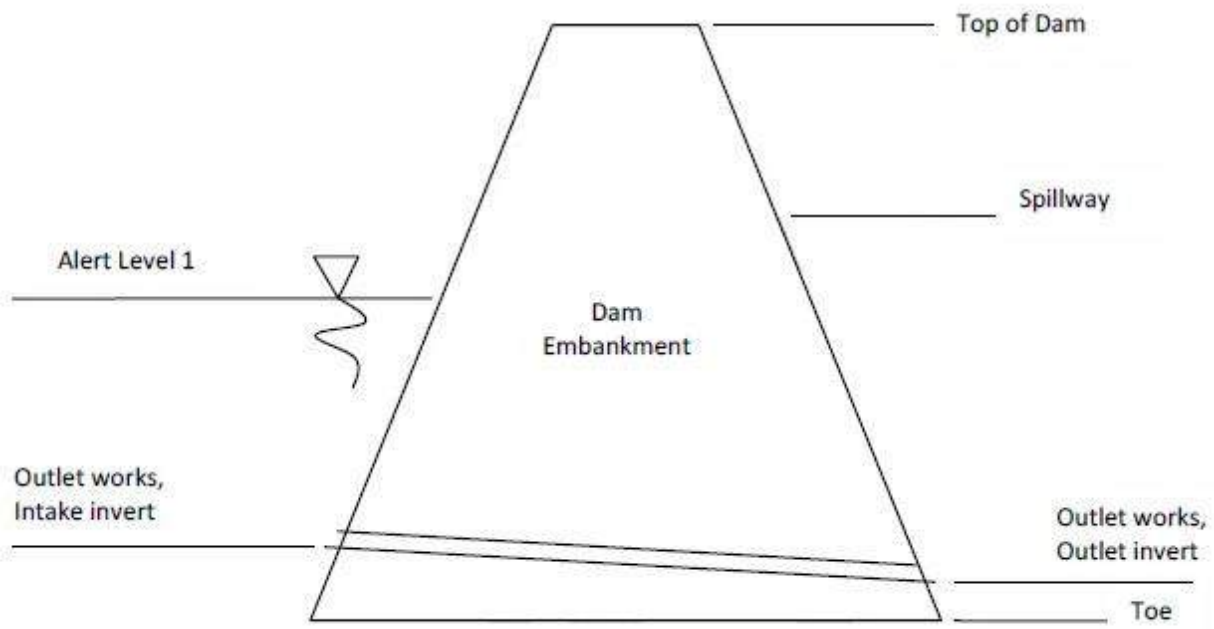
h. Key Elevations

<b>Fill in Elevations for:</b>	<b>Elevation</b>	<b>Staff Gage</b>
1	Top of Dam	399.5	
2	Spillway	396	
3	Normal Operating Level	381.5	
4	Toe	365.5	
5	*PMF level (see Other Dam Info on next page)	400.1	
6	EAP Alert Level 3 (See Section VIII)	399.5	
7	EAP Alert Level 2 (See Section VIII)	396-399.5	
8	EAP Alert Level 1 (See Section VIII)	395

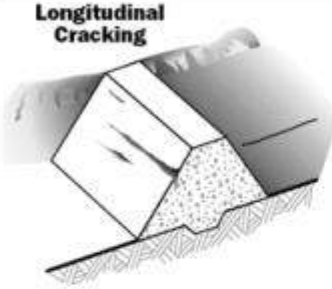
<p><b>Longitudinal Cracking</b></p> </div> <div style="text-align: center;">

<p><b>Erosion</b></p> </div> </div>		
<b>Longitudinal Cracking</b>	<ol style="list-style-type: none"> <li>1. Drying and shrinkage of surface material.</li> <li>2. Downstream movement or settlement of embankment.</li> </ol> <ol style="list-style-type: none"> <li>1. Can be an early warning of a potential slide.</li> <li>2. Shrinkage cracks allow water to enter the embankment and freezing will further crack the embankment.</li> <li>3. Settlement or slide, showing loss of strength in embankment that can lead to failure.</li> </ol>	<ol style="list-style-type: none"> <li>1. If cracks are from drying, dress area with well-compacted material to keep surface water out and natural moisture in.</li> <li>2. If cracks are extensive, a qualified engineer should inspect the condition and recommend further actions.</li> </ol> <p>DLNR NOTIFICATION REQUIRED</p>

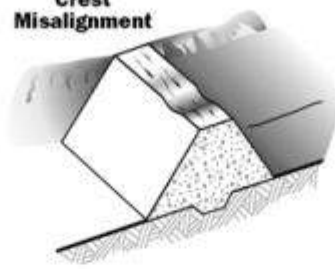
<p><b>Crest Misalignment</b></p>	<p><b>Low Area in Crest of Dam</b></p>

<ol style="list-style-type: none"> <li>1. Movement between adjacent parts of the structure.</li> <li>2. Uneven deflection of dam under loading by reservoir.</li> <li>3. Structural deformation or failure near area of misalignment.</li> </ol>	<ol style="list-style-type: none"> <li>1. Establish monuments across crest to determine exact amount, location, and extent of misalignment.</li> <li>2. Engineer should determine cause of misalignment and supervise all steps necessary to reduce threat to dam and correct condition.</li> <li>3. Following remedial action, monitor crest monuments according to a schedule to detect any movement.</li> </ol> <p>DLNR NOTIFICATION REQUIRED</p>
Crest Misalignment	<ol style="list-style-type: none"> <li>1. Area of misalignment is usually accompanied by low area in crest which reduces freeboard.</li> <li>2. Can produce local areas of low embankment strength which may lead to failure.</li> </ol>

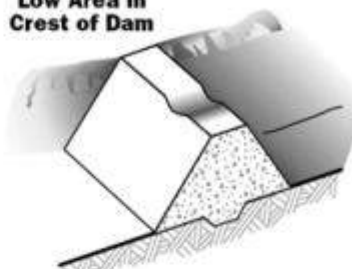
Problem	Probable Cause and Possible Consequences	Recommended Actions
Low Area in Crest	<ol style="list-style-type: none"> <li>1. Excessive settlement in the embankment or foundation directly beneath the low area in the crest.</li> <li>2. Internal erosion of embankment material.</li> <li>3. Foundation spreading to upstream and/or downstream direction.</li> <li>4. Prolonged wind erosion of crest area.</li> <li>5. Improper final grading following construction. Reduces freeboard available to pass flood flows safely through spillway.</li> </ol>	<ol style="list-style-type: none"> <li>1. Establish monuments along length of crest to determine exact amount, location, and extent of settlement in crest.</li> <li>2. Engineer should determine cause of low area and supervise all steps necessary to reduce possible threat to the dam and correct condition.</li> <li>3. Reestablish uniform crest elevation over crest length by filling in low area using proper construction techniques. This should be supervised by engineer.</li> <li>4. Reestablish monuments across crest of dam and routinely monitor monuments to detect any settlement.</li> </ol>

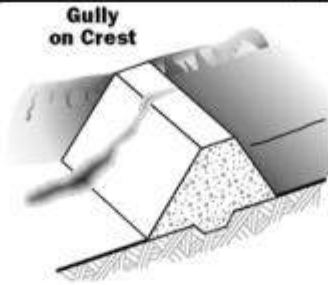
<p><b>Gully on Crest</b></p>

<p><b>Ruts Along Crest</b></p>	
Gully on Crest	<ol style="list-style-type: none"> <li>1. Poor grading and improper drainage of crest. Improper drainage causes surface runoff to collect and drain off crest at low point in upstream or downstream shoulder.</li> <li>2. Inadequate spillway capacity which has caused dam to overtop.</li> <li>1. Can reduce available freeboard.</li> <li>2. Reduces cross-sectional area of dam.</li> <li>3. Inhibits access to all parts of the crest and dam.</li> <li>4. Can result in a hazardous condition if due to overtopping. Heavy vehicle traffic without adequate or proper maintenance or proper crest surfacing</li> </ol>	<ol style="list-style-type: none"> <li>1. Restore freeboard to dam by adding fill material to low area, using proper construction techniques.</li> <li>2. Regrading crest to provide proper drainage of surface runoff.</li> <li>3. If gully was caused by overtopping, create adequate spillway that meets current design standards. This should be done by engineer.</li> <li>4. Reestablish protective cover.</li> </ol>

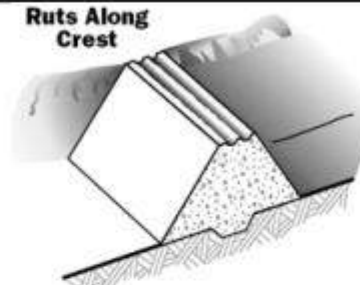
Problem	Probable Cause and Possible Consequences	Recommended Actions
Ruts Along Crest	<ol style="list-style-type: none"> <li>1. Inhibits easy access to all parts of crest.</li> <li>2. Allows continued development of rutting.</li> <li>3. Allows standing water to collect and saturate crest of dam.</li> <li>4. Operating and maintenance vehicles can get stuck.</li> </ol>	<ol style="list-style-type: none"> <li>1. Drain standing water from ruts.</li> <li>2. Regrade and recompact crest to restore integrity and provide proper drainage to upstream slope.</li> <li>3. Provide gravel or road base material to accommodate traffic.</li> <li>4. Periodically maintain and regrade to prevent ruts reforming.</li> </ol>

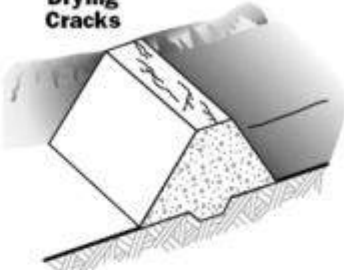
</div> <div style="text-align: center;"> <p><b>Drying Cracks</b></p>

Drying Cracks	<p>Material on the crest of dam expands and contracts with alternate wetting and drying of weather cycles. Drying cracks are usually short, shallow, narrow, and numerous. Point of entry for surface runoff and surface moisture, causing saturation of adjacent embankment areas. This saturation, and later drying of the dam, could cause further cracking.</p>	<ol style="list-style-type: none"> <li>Seal surface cracks with a tight, impervious material.</li> <li>Routinely grade crest to proper drainage and fill cracks.</li> <li>Cover crest with non-plastic material (not clay) to prevent large variations in moisture content.</li> </ol>

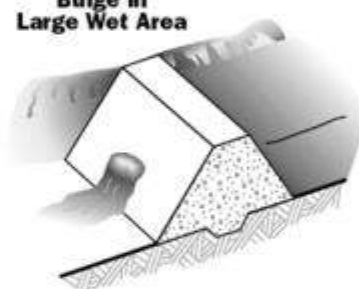
**Large Area Wet or Producing Flow**

A seepage path has developed through the abutment or embankment materials and failure of the dam can occur.

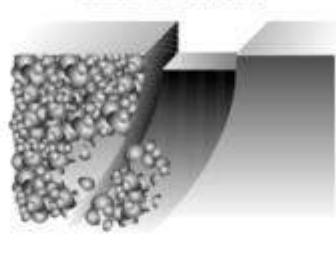
<p><b>Breakdown and Loss of Riprap</b></p>	<p>Slope too steep; material poorly graded; failure of subgrade; flow velocity too high; improper placement of material; bedding material or foundation washed away.</p> <p>Erosion of channel bottom and banks; failure of spillway.</p>	<p>Design a stable slope for channel bottom and banks. Riprap material should be well-graded (the material should contain small, medium and large particles). Subgrade should be properly prepared before placement of riprap. Install filter fabric if necessary. Control flow velocity in the spillway by proper design. Riprap should be placed according to specification.</p> <p>DLNR NOTIFICATION REQUIRED</p>

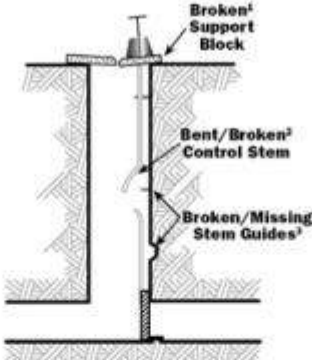
Problem	Probable Cause and Possible Consequences	Recommended Actions
<p style="text-align: center;"><b>Control Works</b></p>

<p>The diagram illustrates a cross-section of a control stem assembly. At the top, a 'Broken<sup>1</sup> Support Block' is shown. Below it, the 'Bent/Broken<sup>2</sup> Control Stem' is depicted. Further down, 'Broken/Missing Stem Guides<sup>3</sup>' are indicated. The stem is shown passing through a concrete structure, with the guides providing support and alignment.</p>		
<p><b>Damage to Control Works</b></p>	<ol style="list-style-type: none"> <li>1. <b>BROKEN SUPPORT BLOCK</b> Concrete deterioration. Excessive force exerted on control stem by trying to open gate when it was jammed.  Causes control support block to tile; control stem may bind. Control head works may settle. Gate may not open all the way. Support block may fail completely, leaving outlet inoperable.</li> <li>2. <b>BENT/BROKEN CONTROL STEM</b> Rust. Excess force used to open or close gate. Inadequate or broken stem guides.  Outlet is inoperable.</li> <li>3. <b>BROKEN/MISSING STEM GUIDES</b> Rust. Inadequate lubrication. Excess force used to open or close gate when jammed.  Loss of support for control stem. Stem may buckle and break under normal use (as in this example).</li> </ol>	<p>Any of these conditions can mean the control is either inoperable or, at best, partly operable. Use of the system should be minimized or discontinued. If the outlet system has a second control valve, consider using it to regulate releases until repairs can be made. Engineering help is recommended.</p>

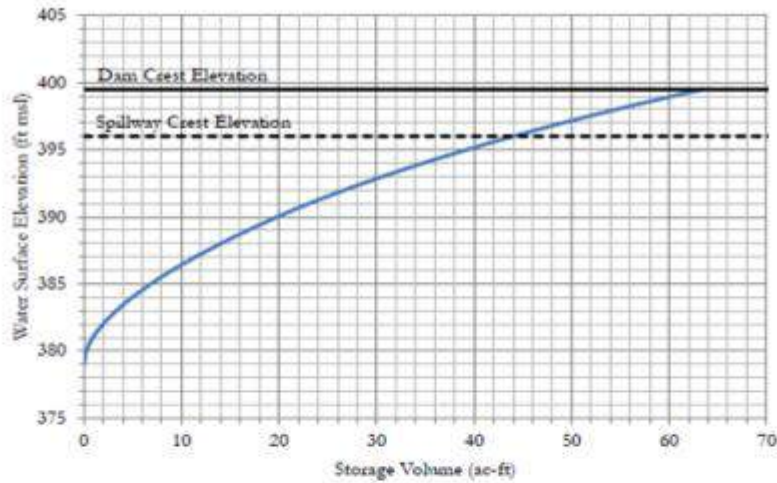
Figure 3-10: Nu'uanu Reservoir No. 1 Storage Capacity Curve

**1. Nu'uanu Reservoir No. 1 Storage Capacity Curve**
