# Emergency Action Plan (EAP)

## NUUANU DAM NO. 4

State ID # OA-0001

HONOLULU, Oahu, Honolulu

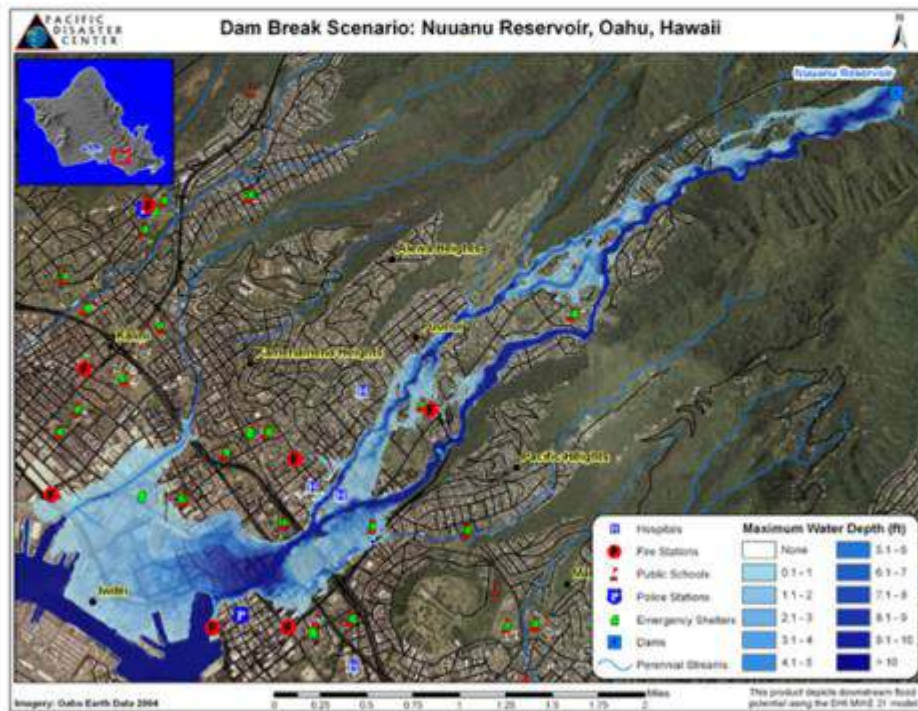
### 4.2 MIKE 21 Model Results – Inundation Map\*

\*While the best available GIS data have been utilized as input to the model and in visualizing model output, due to variations in their currency and accuracy, final product results should be interpreted as "best available estimates" only and not definitive in establishing inundation boundaries.

It is assumed that each dam fails by piping while at maximum capacity. It is further assumed that 1) the piping failure originates halfway up the dam face, 2) the dam fails under sunny day conditions with dry conditions downstream of the reservoir, and 3) no water is discharged from the spillway. The outflow (discharge hydrograph) from the breached reservoir is modeled using the NWS' DAMBRK model (within the Danish Hydrological Institute's MIKE 11 model), and data from historical breaches is used to estimate parameters controlling breach development. The DHI MIKE 21 model is used to route the reservoir discharge down the valley into the ocean. MIKE 21 routes unsteady two dimensional flows using the full Saint-Venant equations. Topography is described by USGS standard 10 meter DEMs. The inundation maps produced by MIKE 21 represent the maximum water depth experienced at any given location. The inundation maps are not snapshots in time because different locations experience maximum flooding at different times. MIKE 21 also provides information on the time of flooding and water velocities.

Parameters	Value	Unit of Measure
Reservoir volume prior to breach:	3,600	acre-feet
Duration of breach:	37	minutes
Breach width:	148	feet
Distance from dam to ocean:	4.60	miles
Type of dam:	Earthen Dam	n/a
Type of breach:	Piping breach originating halfway up the dam face	n/a

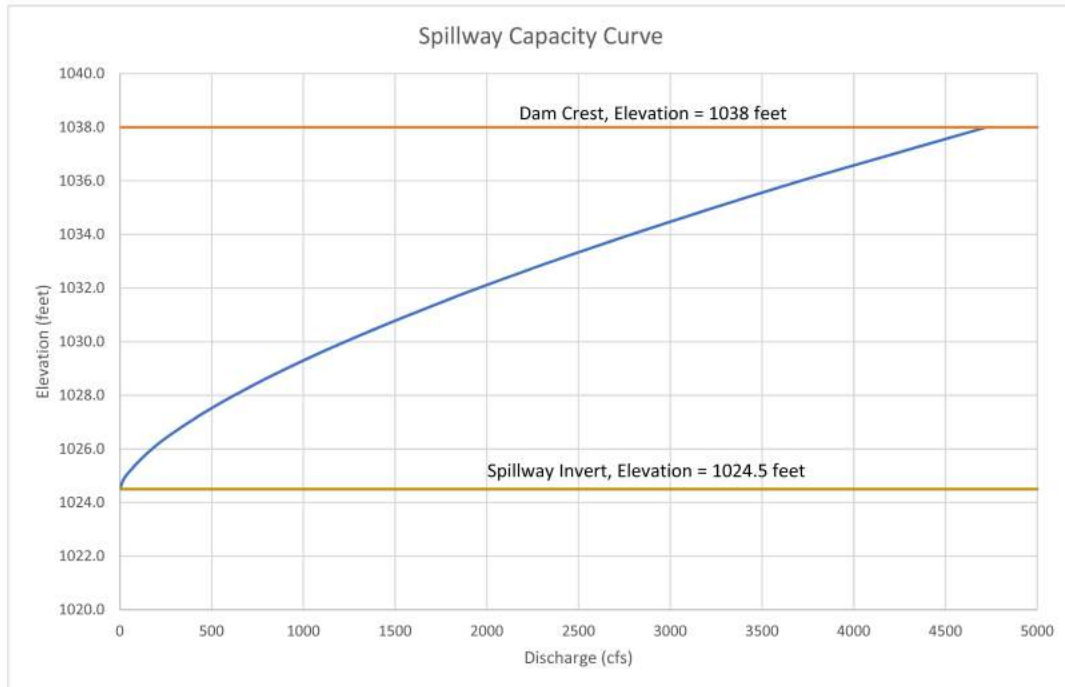
e. Spillway Capacity Curve

Elevation (feet)	Discharge (cfs)	
1024.5	0.00	
1025.0	33.65	
1026.0	174.84	
1027.0	376.19	
1028.0	623.16	
1029.0	908.49	
1030.0	1227.56	
1031.0	1577.14	
1032.0	1954.75	
1033.0	2358.46	
1034.0	2786.67	
1035.0	3238.05	
1036.0	3711.48	Values calculated from Ernest K Hirata & Associates, Inc. 1999. <i>Phase II Dam Safety Investigation Nuuanu Reservoir No. 4</i> . Prepared for Honolulu Board of Water Supply
1038	4720.64

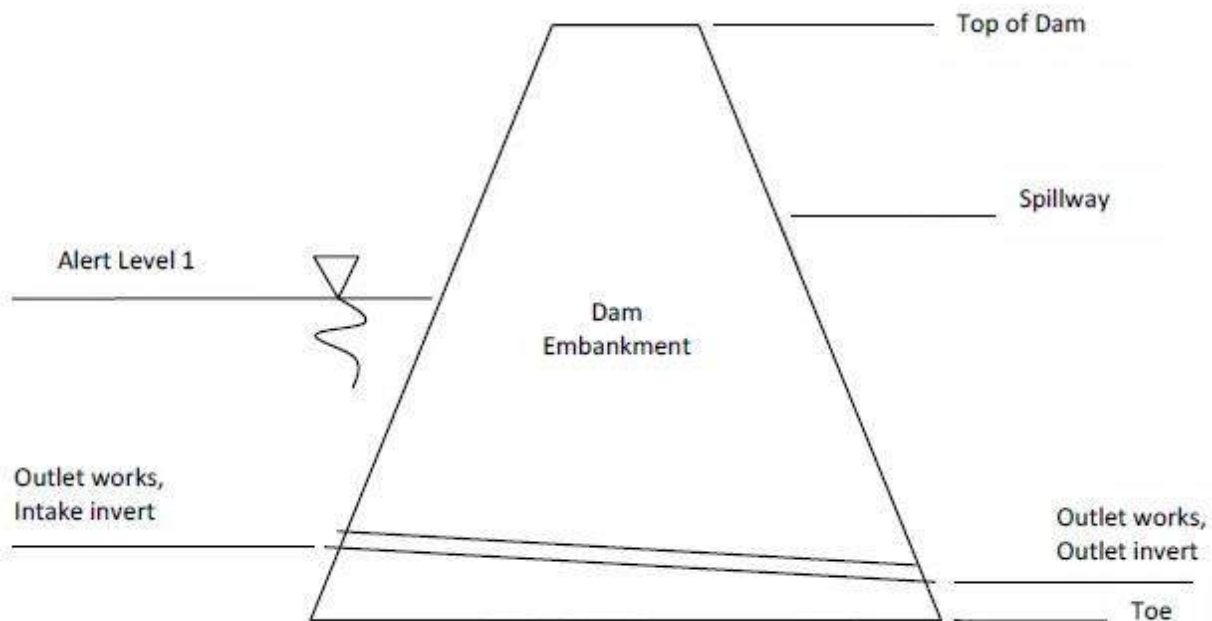
h. Key Elevations

<b>Fill in Elevations for:</b>	<b>Elevation</b>	<b>Staff Gage</b>
1	Top of Dam	1038	70
2	Spillway	1024.5	56.5
3	Normal Operating Level	993.5	25.5
4	Outlet Works, Upper Intake invert	1012.5	44.5
5	Outlet Works, Middle Intake invert	994.5	26.5
6	Outlet Works, Lower Intake invert	975.75	7.75
7	Outlet works, Outlet invert	964.3	-
8	Toe	972	4
9	PMF level	1035.1	67.1
10	EAP Alert Level 3 (See Section VIII)	1038	70
11	EAP Alert Level 2 (See Section VIII)	1024.5-1038	56.5-70
12	EAP Alert Level 1	1022.5	54.5

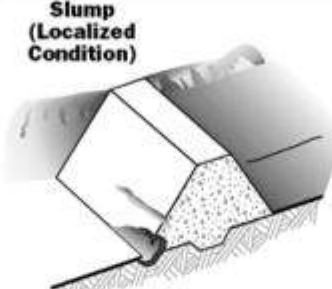
<p><b>Slump (Localized Condition)</b></p> </div> <div style="text-align: center;">

<b>Slump (localized condition)</b>	<p>Preceded by erosion undercutting a portion of the slope. Can also be found on steep slopes. Can expose impervious zone to erosion and lead to additional slumps.</p>	<ol style="list-style-type: none"> <li>1. Inspect area for seepage.</li> <li>2. Monitor for progressive failure.</li> <li>3. Have a qualified engineer inspect the condition and recommend further action.</li> </ol> <p>DLNR NOTIFICATION REQUIRED</p>

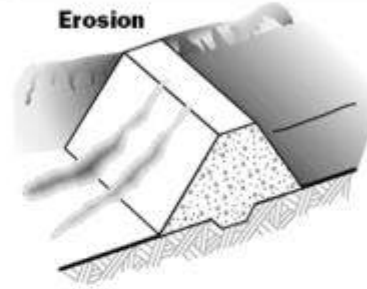
Problem	Probable Cause and Possible Consequences	Recommended Actions
<b>Erosion</b>	Water from intense rainstorms or snowmelt carries surface material down the slope, resulting in continuous troughs. Can be hazardous if allowed to continue. Erosion can lead to eventual deterioration of the downstream slope and failure of the structure.	<ol style="list-style-type: none"> <li>1. The preferred method to protect eroded areas is rock or riprap.</li> <li>2. Reestablishing protective grasses can be adequate if the problem is detected early.</li> </ol>
<div style="display: flex; justify-content: space-around; align-items: center;"> <div style="text-align: center;"> <p><b>Trees/ Obscuring Brush</b></p>

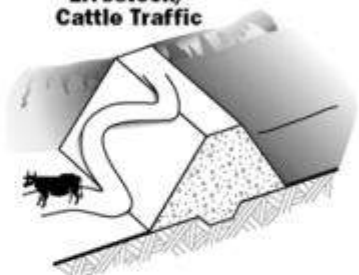
</div> <div style="text-align: center;"> <p><b>Livestock/ Cattle Traffic</b></p>

<b>Livestock (such as cattle) Traffic</b>	Excessive travel by livestock especially harmful to slope when wet.  Creates areas bare of erosion protection and causes erosion channels. Allows water to stand. Area susceptible to drying cracks.	<ol style="list-style-type: none"> <li>1. Fence livestock outside embankment area.</li> <li>2. Repair erosion protection, i.e. riprap, grass.</li> </ol>

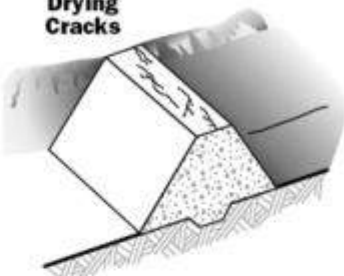
</div> <div style="text-align: center;"> <p><b>Drying Cracks</b></p>

Drying Cracks	<p>Material on the crest of dam expands and contracts with alternate wetting and drying of weather cycles. Drying cracks are usually short, shallow, narrow, and numerous. Point of entry for surface runoff and surface moisture, causing saturation of adjacent embankment areas. This saturation, and later drying of the dam, could cause further cracking.</p>	<ol style="list-style-type: none"> <li>1. Seal surface cracks with a tight, impervious material.</li> <li>2. Routinely grade crest to proper drainage and fill cracks.</li> <li>3. Cover crest with non-plastic material (not clay) to prevent large variations in moisture content.</li> </ol>

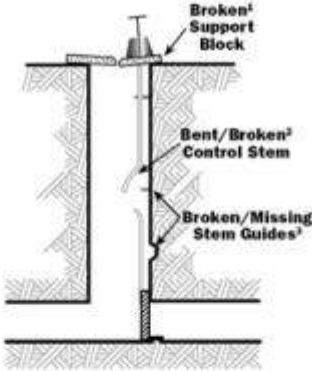
Problem	Probable Cause and Possible Consequences	Recommended Actions
<p style="text-align: center;"><b>Control Works</b></p>

Damage to Control Works	<ol style="list-style-type: none"> <li><b>BROKEN SUPPORT BLOCK</b> Concrete deterioration. Excessive force exerted on control stem by trying to open gate when it was jammed.  Causes control support block to tilt; control stem may bind. Control head works may settle. Gate may not open all the way. Support block may fail completely, leaving outlet inoperable.</li> <li><b>BENT/BROKEN CONTROL STEM</b> Rust. Excess force used to open or close gate. Inadequate or broken stem guides.  Outlet is inoperable.</li> <li><b>BROKEN/MISSING STEM GUIDES</b> Rust. Inadequate lubrication. Excess force used to open or close gate when jammed.  Loss of support for control stem. Stem may buckle and break under normal use (as in this example).</li> </ol>	<p>Any of these conditions can mean the control is either inoperable or, at best, partly operable. Use of the system should be minimized or discontinued. If the outlet system has a second control valve, consider using it to regulate releases until repairs can be made. Engineering help is recommended.</p>

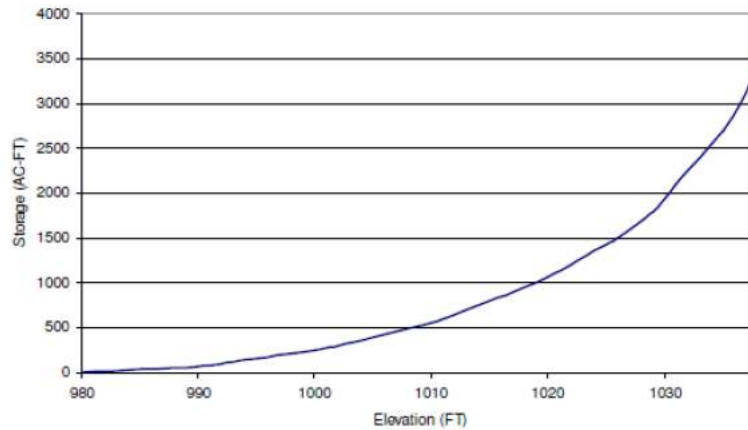
**1. Nu'uanu Reservoir No. 4 Storage Capacity Curve**

**Figure 4-4. Elevation-storage curve for Nu'uanu Reservoir No. 4**

Oceanit, 2008. *Dam Break Analysis For Nu'uanu Reservoir (H1001)*. Prepared for Army Corps of Engineers.
