Canopy Interception of Native Versus Invaded Mesic Forest in Mākaha Valley, O`ahu: A Comparative Study Nancy Matsumoto, Amy Tsuneyoshi, Kaimana Wong and Michele Harman - Honolulu Board of Water Supply (as of July 2018)

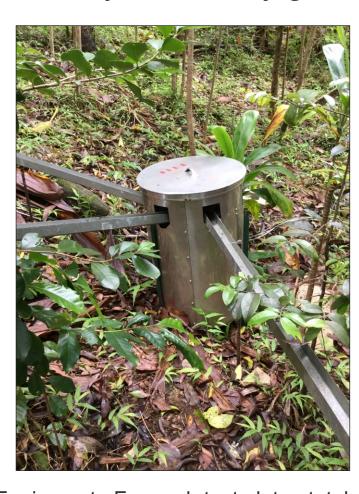
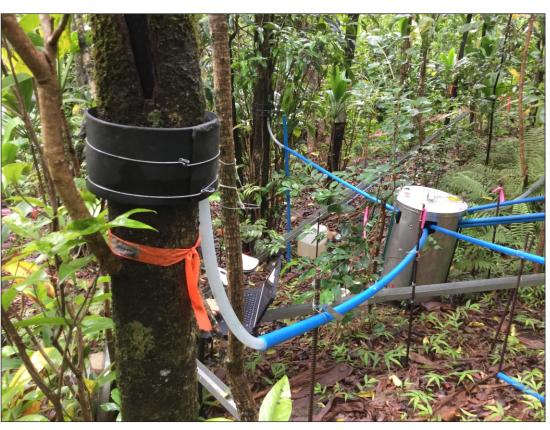
Throughfall Equipment: For each test plot, a total of three troughs lead to a fabricated tipping bucket (150 mL / tip) rain gauge. The gauge is nested in a stainless steel can, levelled and anchored to the ground for stability. Troughs were installed under trees typical of the test plots (species, diameter, height) in configurations that represented the average canopy and gap proportions and minimized overlap of throughfall collection between troughs.
