FINAL- 2009 - BIENNIAL TANK INTEGRITY TESTING REPORT (CDRL A001) BFCUST #11 – (RPI# - PRL-338) *at* FISC RED HILL / PEARL HARBOR, HI

FINAL 2009 BIENNIAL INTEGRITY TESTING REPORT

BFCUST # 11

FISC RED HILL – PEARL HARBOR, HI

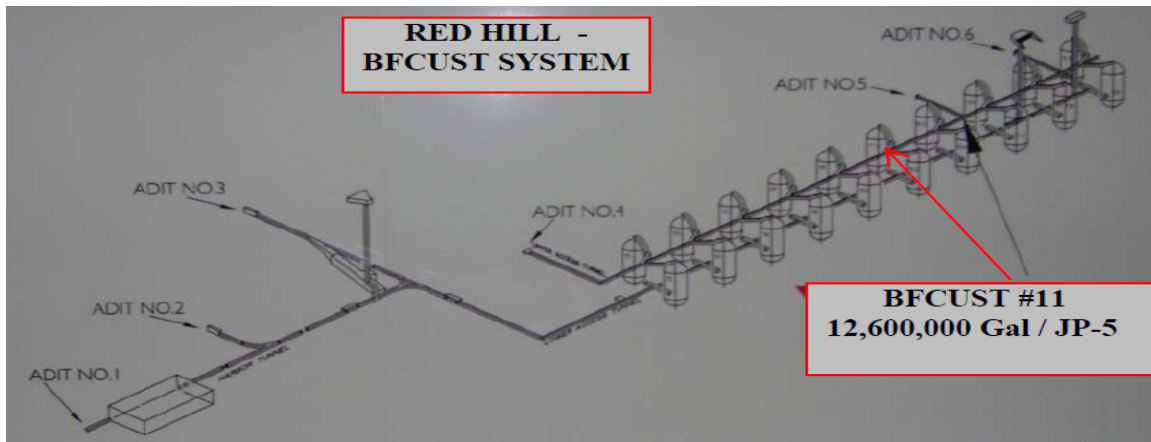
Figure 1: RED HILL – BFCUST SYSTEM – BFCUST # 11

Figures 1-3 show details of the Red Hill system and typical tank access points.

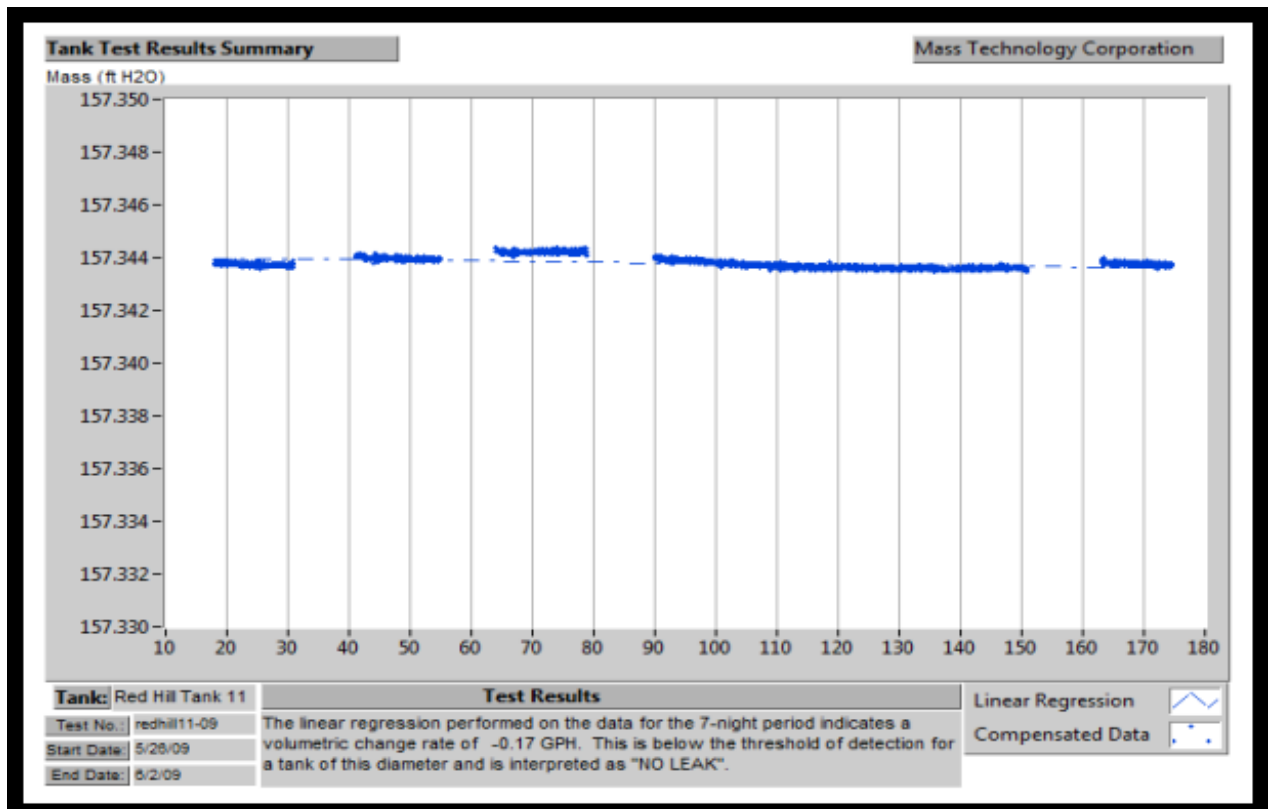
The fluid mass data was recorded over a 168-hour period. A linear regression of the recorded fluid mass data resulted in a leak rate detected below the minimum detection level of 0.7 gallons per hour. All tank valves were adequately secured such that any fluid loss was isolated to leakage. Therefore, the containment integrity of the tank was not compromised and the test is considered conclusive.
