# **FINAL- 2008 - BIENNIAL TANK INTEGRITY TESTING REPORT (CDRL A001) – BFCUST #3 *at* FISC RED HILL / PEARL HARBOR, HI**

**FINAL 2009 BIENNIAL INTEGRITY TESTING REPORT**  
**(CDRL A001)**  
**OF**  
**BFCUST # 3**

**FISC RED HILL – PEARL HARBOR, HI**

The scope of this project is to perform biennial integrity testing of Bulk Field Constructed Underground Storage Tank (BFCUST) #3 at the FISC Red Hill / Bulk Fuel Storage Facility, Pearl Harbor, HI. BFCUST #3 has a capacity of 12,600,000 gallons and contains JP-8. Testing is being conducted as best management practice.

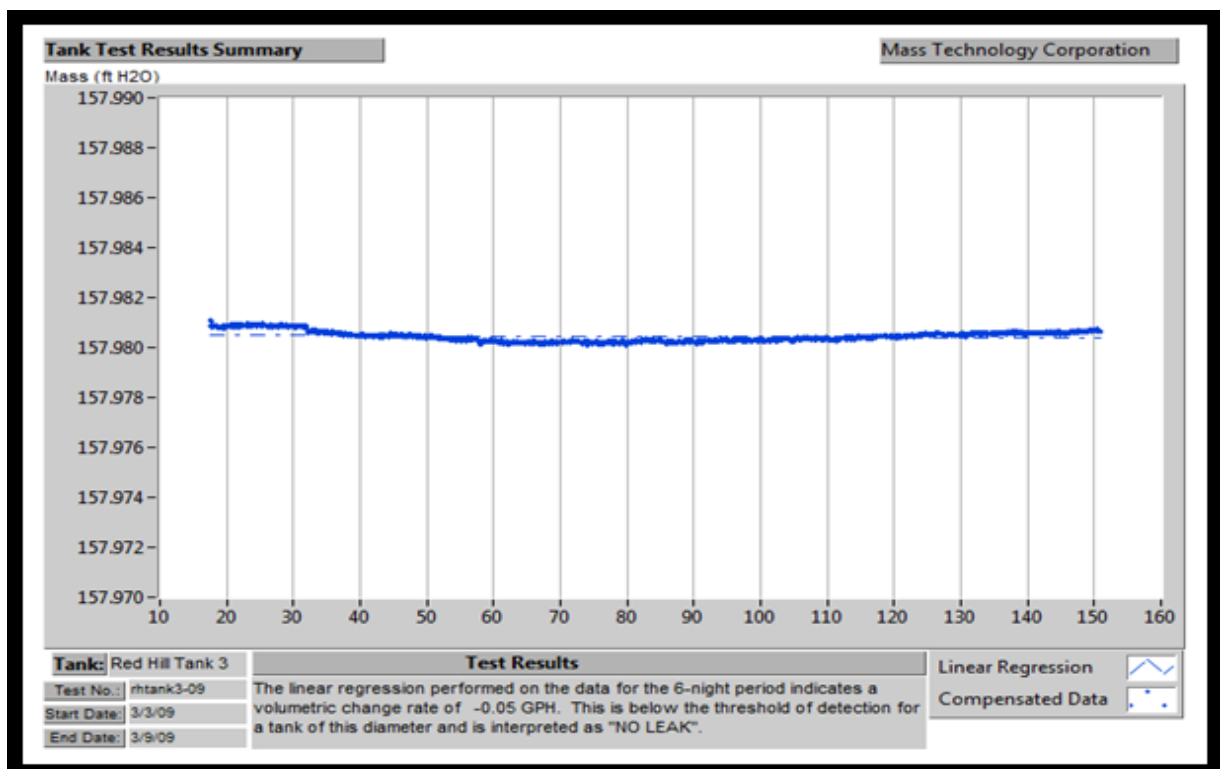
The fluid mass data was recorded over a 144-hour test period. A linear regression of the recorded fluid mass data resulted in no leak detected above the minimum detection level of 0.7 gallons per hour. All tank valves were adequately secured such that any fluid loss was isolated to leakage. Therefore, the containment integrity of the tank has not been compromised and the tank is considered not to be leaking.
