# FINAL- 2009 - BIENNIAL TANK INTEGRITY TESTING REPORT (CDRL A001) BFCUST #5 – (RPI# - PRL-332) *at* FISC RED HILL PEARL HARBOR, HI

**FINAL 2009 BIENNIAL INTEGRITY TESTING REPORT**

**BFCUST # 5**

**FISC RED HILL – PEARL HARBOR, HI**

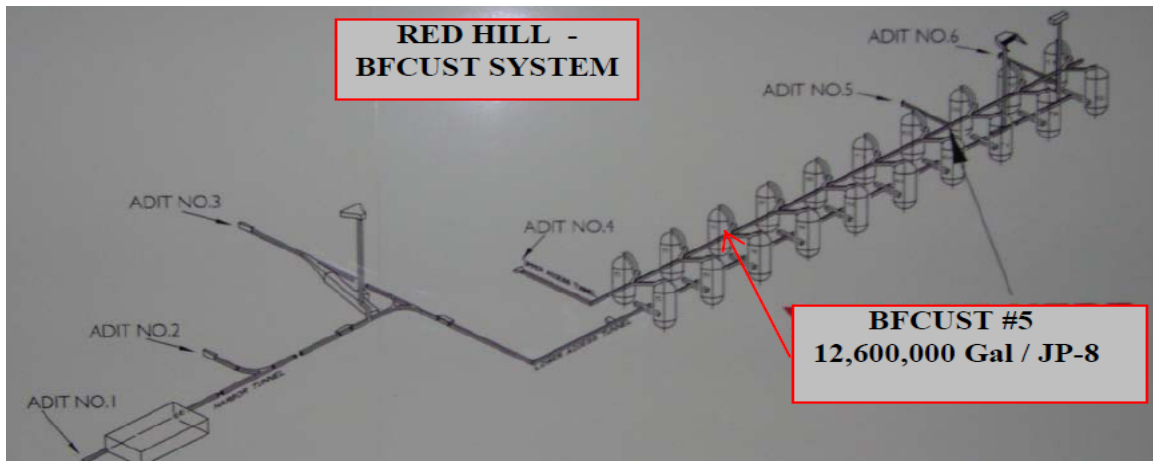
**Figure 1: RED HILL – BFCUST SYSTEM – BFCUST # 5**

Figures 1-3 show details of the Red Hill system and typical tank access points.

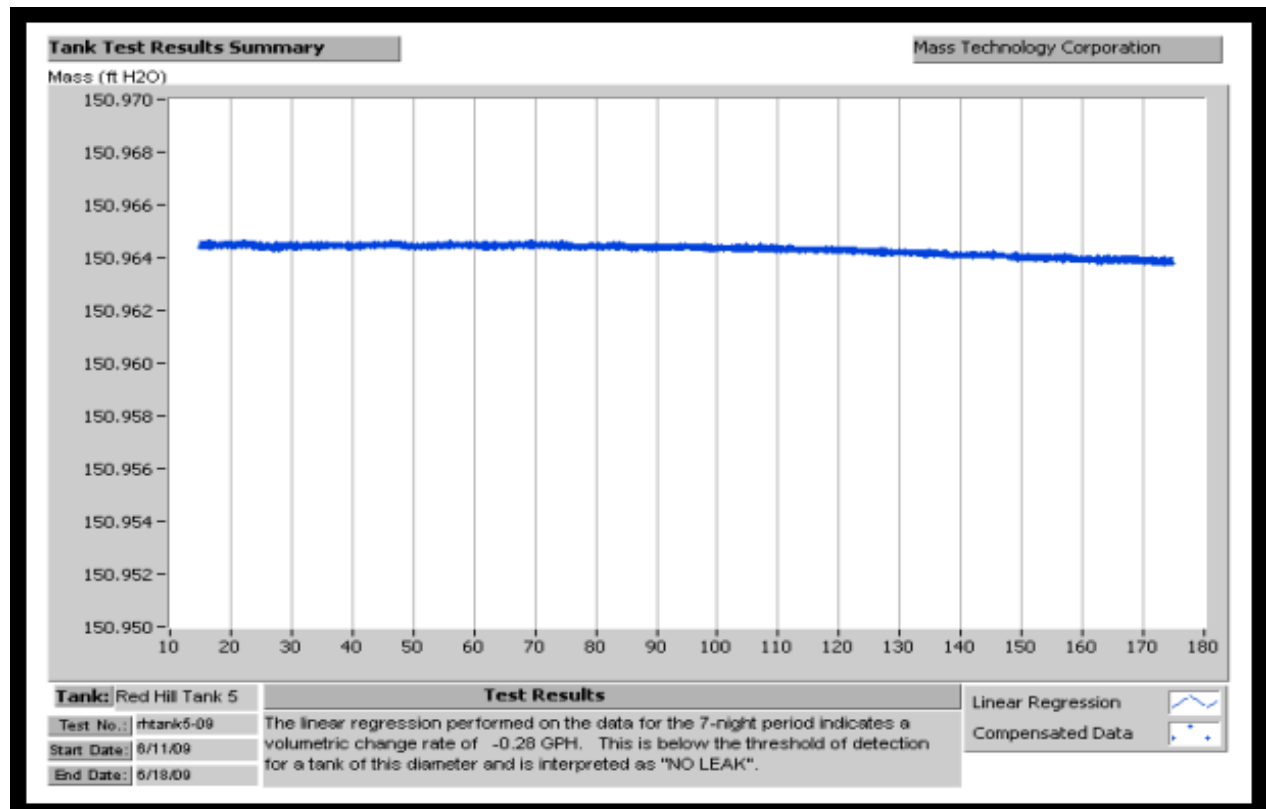
The fluid mass data was recorded over a 168-hour period. A linear regression of the recorded fluid mass data resulted in a leak rate detected below the minimum detection level of 0.7 gallons per hour. All tank valves were adequately secured such that any fluid loss was isolated to leakage. Therefore, the containment integrity of the tank was not compromised and the test is considered conclusive.

Tank # 5 is certified to be tight.
