# FINAL 2011 BIENNIAL INTEGRITY TESTING REPORT OF BULK FIELD CONSTRUCTED UNDERGROUND STORAGE TANK 11

## NAVAL STATION PEARL HARBOR / RED HILL, HAWAII

*Project: 119864  
Task: 4.1.41*

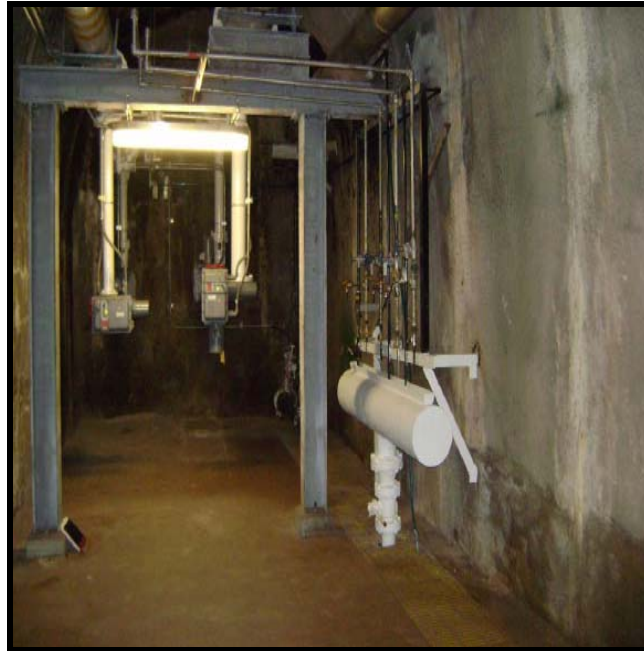
**Figure 1-2: Typical Tank Bottom Access**

BFCUST 11 is 100 feet in diameter, 250 feet in height and has a capacity of 12,600,000 gallons of JP-5. The BFCUSTs at Red Hill are constructed within Red Hill and are accessible through a tunnel system. The top tunnel runs approximately 60 feet below the top section of the tanks and the bottom tunnel runs equal to the bottom level of the tanks. The issue/ receipt and water drain pipelines are accessible immediately adjacent to each tank within the lower tunnel.

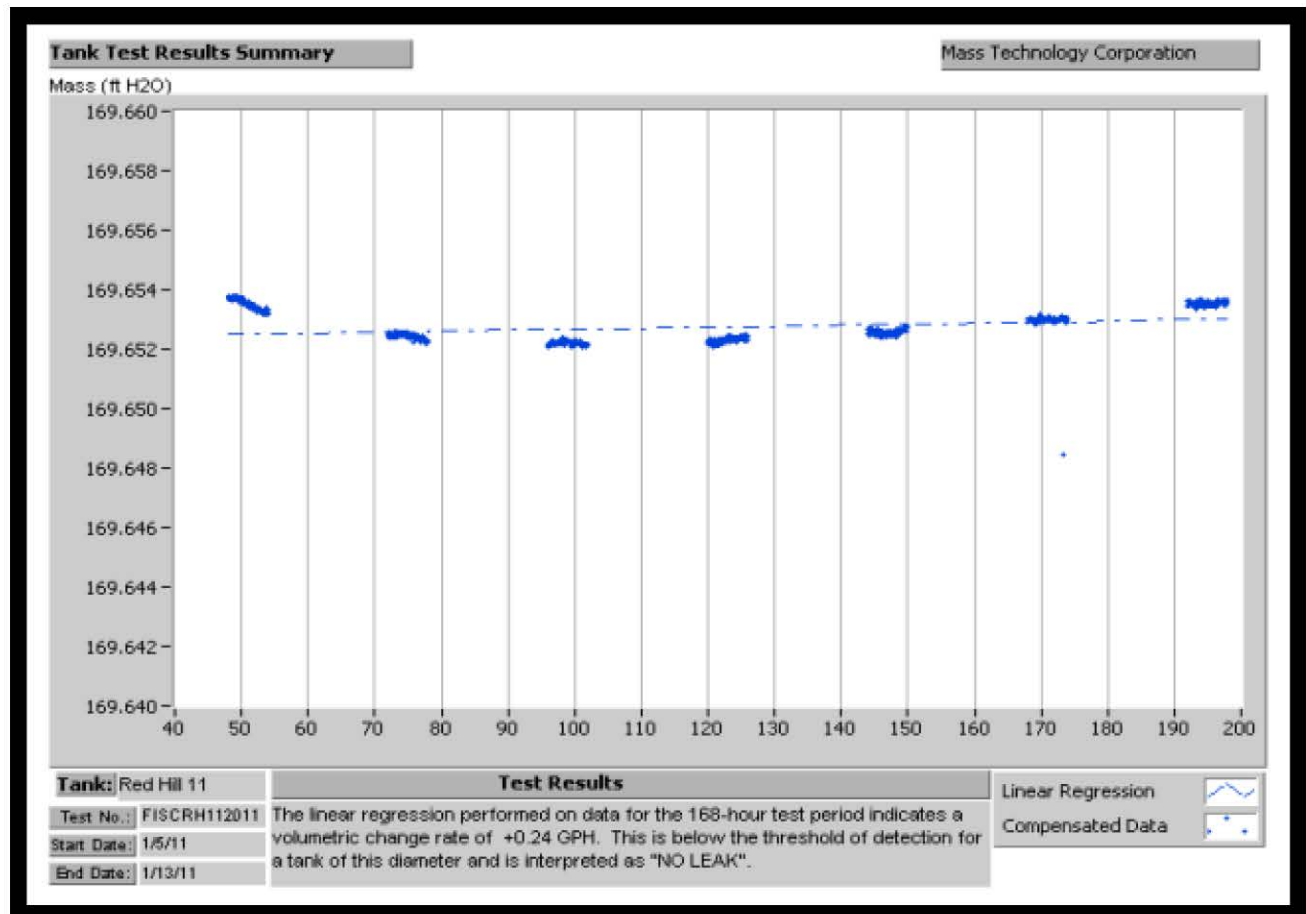
The fluid mass data was recorded over a 168-hour period. A linear regression of the recorded fluid mass data resulted in a leak rate detected below the minimum detection level of 0.7 gallons per hour. All tank valves were adequately secured such that any fluid loss was isolated to leakage. Therefore, the containment integrity of the tank was not compromised and the test is considered conclusive.

Tank # 11 is certified to be tight.
