# FINAL 2011 BIENNIAL INTEGRITY TESTING REPORT OF BULK FIELD CONSTRUCTED UNDERGROUND STORAGE TANK 3

## NAVAL STATION PEARL HARBOR / RED HILL, HAWAII

*Date:*  
**11 MARCH 2011**

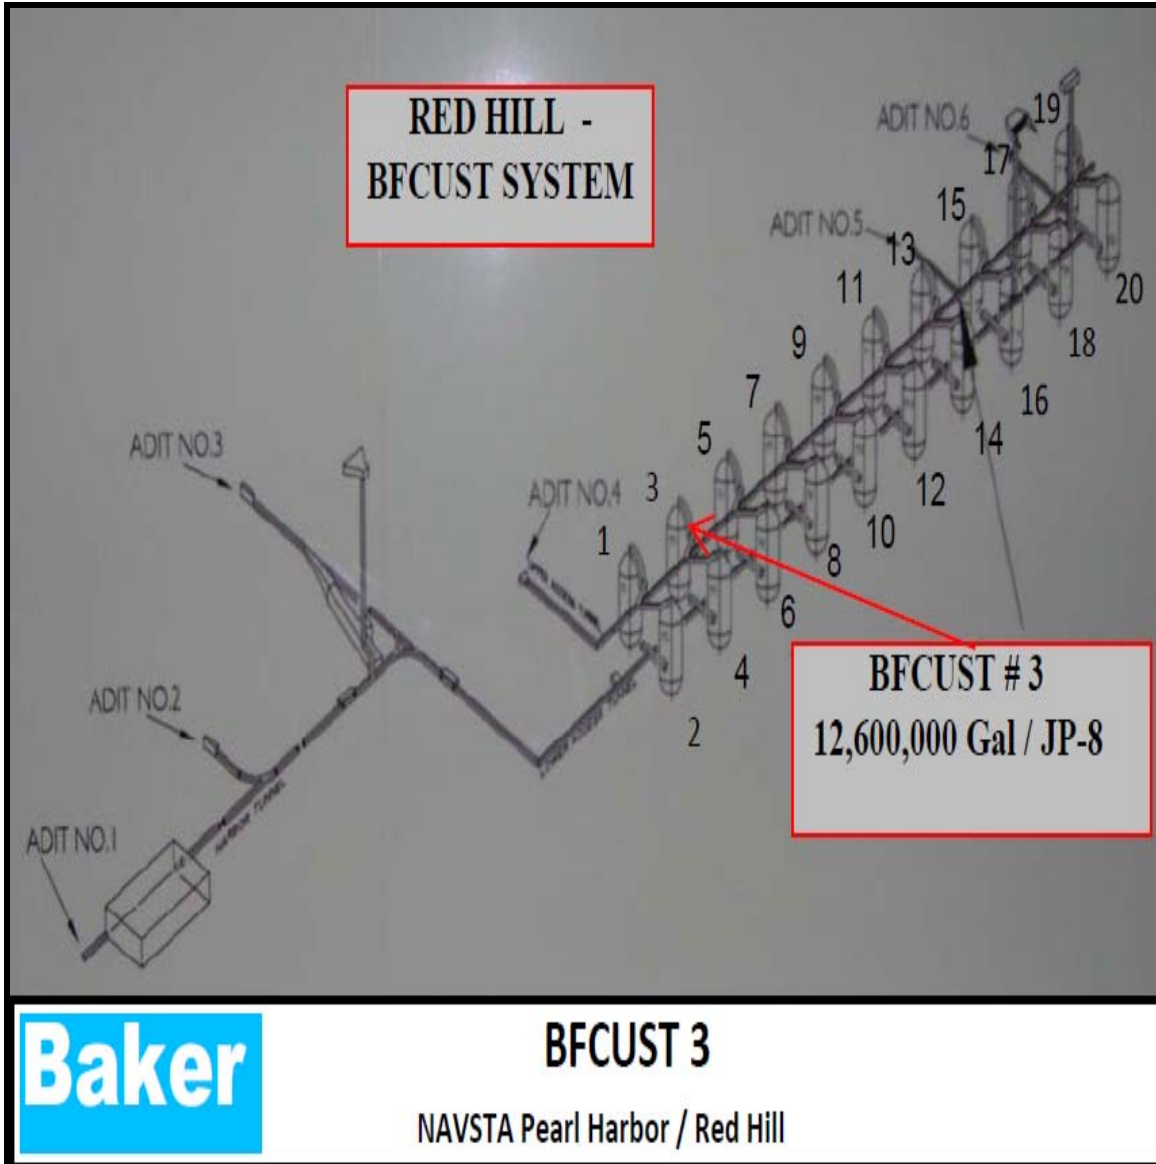
**Figure 1-1: RED HILL – System Layout**

A Mass Technology Corporation (MTC) integrity test on BFCUST 3 was performed from 13 February to 21 February 2011. Table 1-1 provides a description of the system tested. Figure 1-1 provides a detail of the Red Hill system layout and location of BFCUST 3. Figures 1-2 and 1-3 provide photographs of typical top and bottom of tank access.

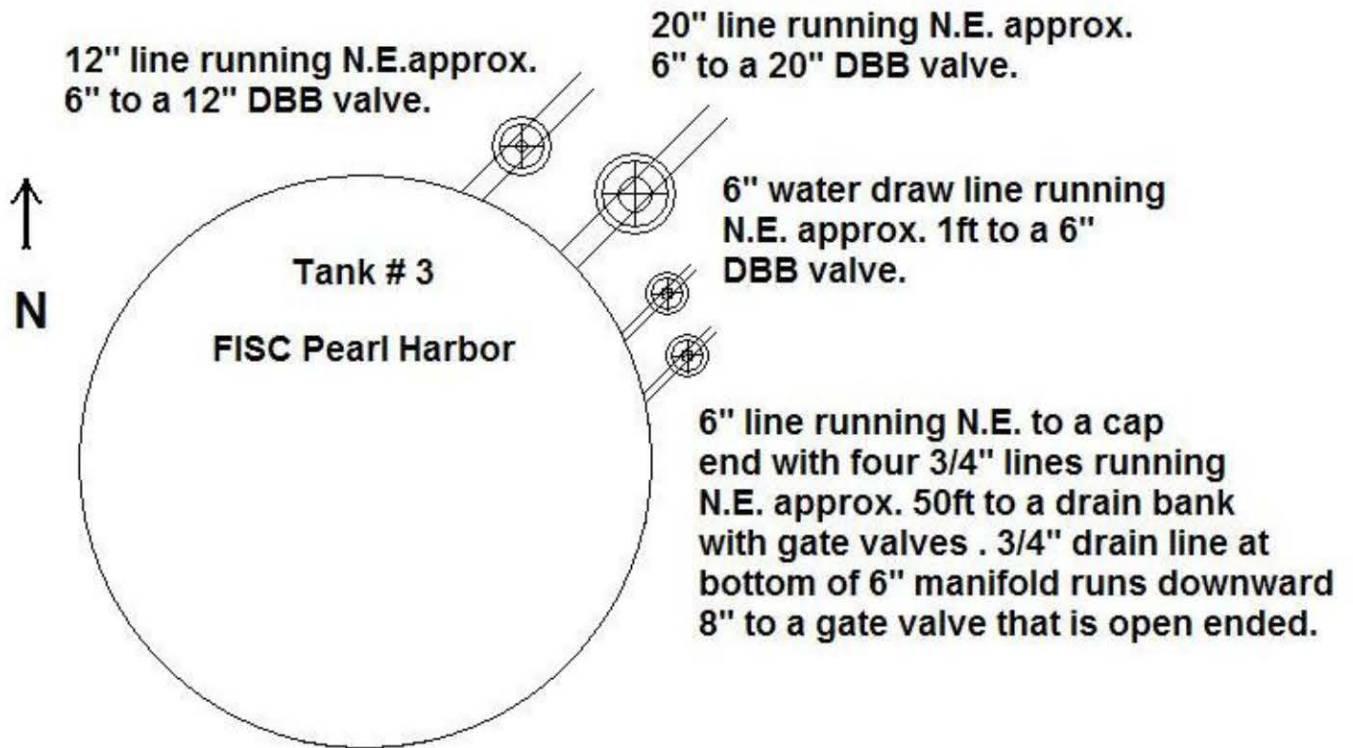
**Tank Data Tank # 03**

Diameter: 100 ft.  
Tank Type: Vertical UST  
Properties: 0.80 Specific Gravity

Height: 250 ft.  
Contents: JP-8  
Product Level: 201.5 ft.

All dimensions, line locations, sizes and valve descriptions have been furnished by the facility operator.

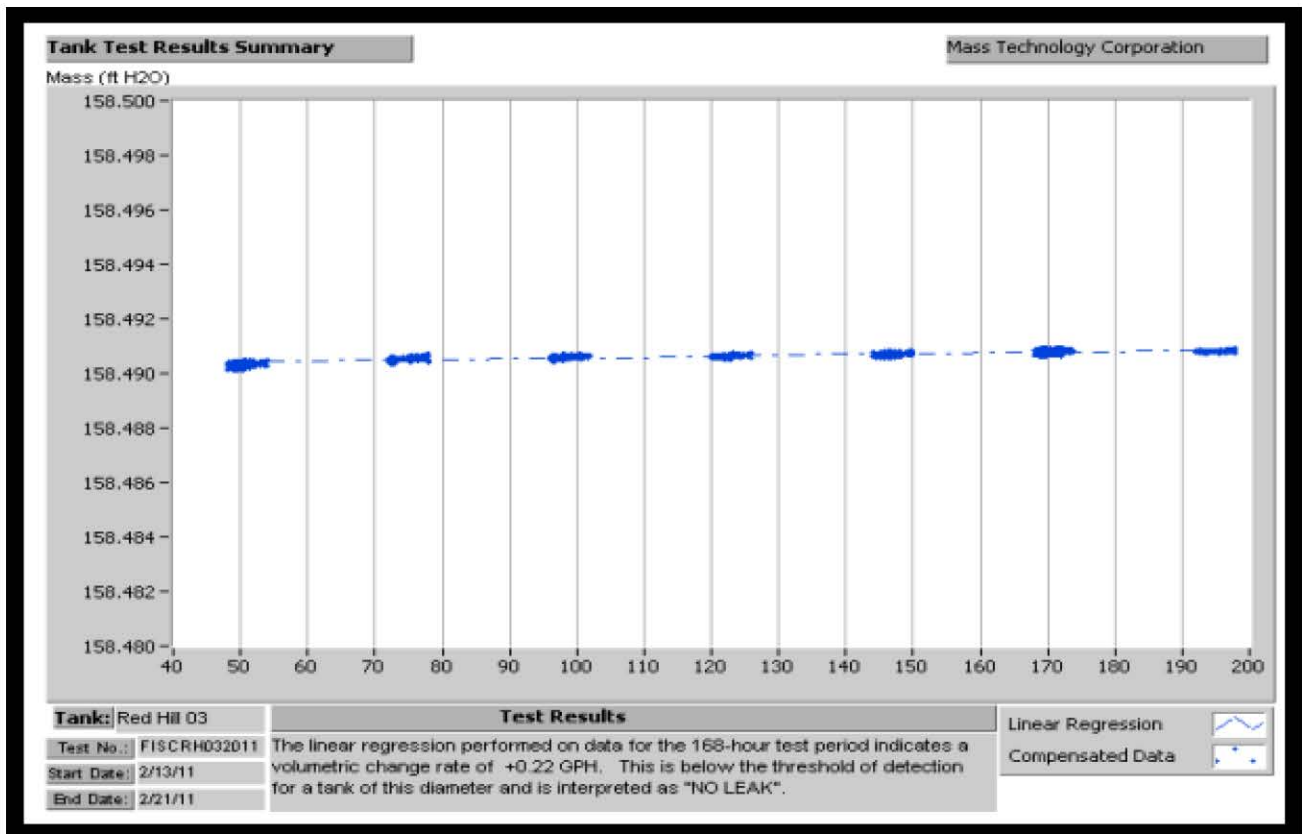
The fluid mass data was recorded over a 168-hour period. A linear regression of the recorded fluid mass data resulted in a leak rate detected below the minimum detection level of 0.7 gallons per hour. All tank valves were adequately secured such that any fluid loss was isolated to leakage. Therefore, the containment integrity of the tank was not compromised and the test is considered conclusive.

Tank # 03 is certified to be tight.
