FINAL 2011 BIENNIAL INTEGRITY TESTING REPORT OF BULK FIELD CONSTRUCTED UNDERGROUND STORAGE TANK 6

NAVAL STATION PEARL HARBOR / RED HILL, HAWAII

Date:
10 MARCH 2011

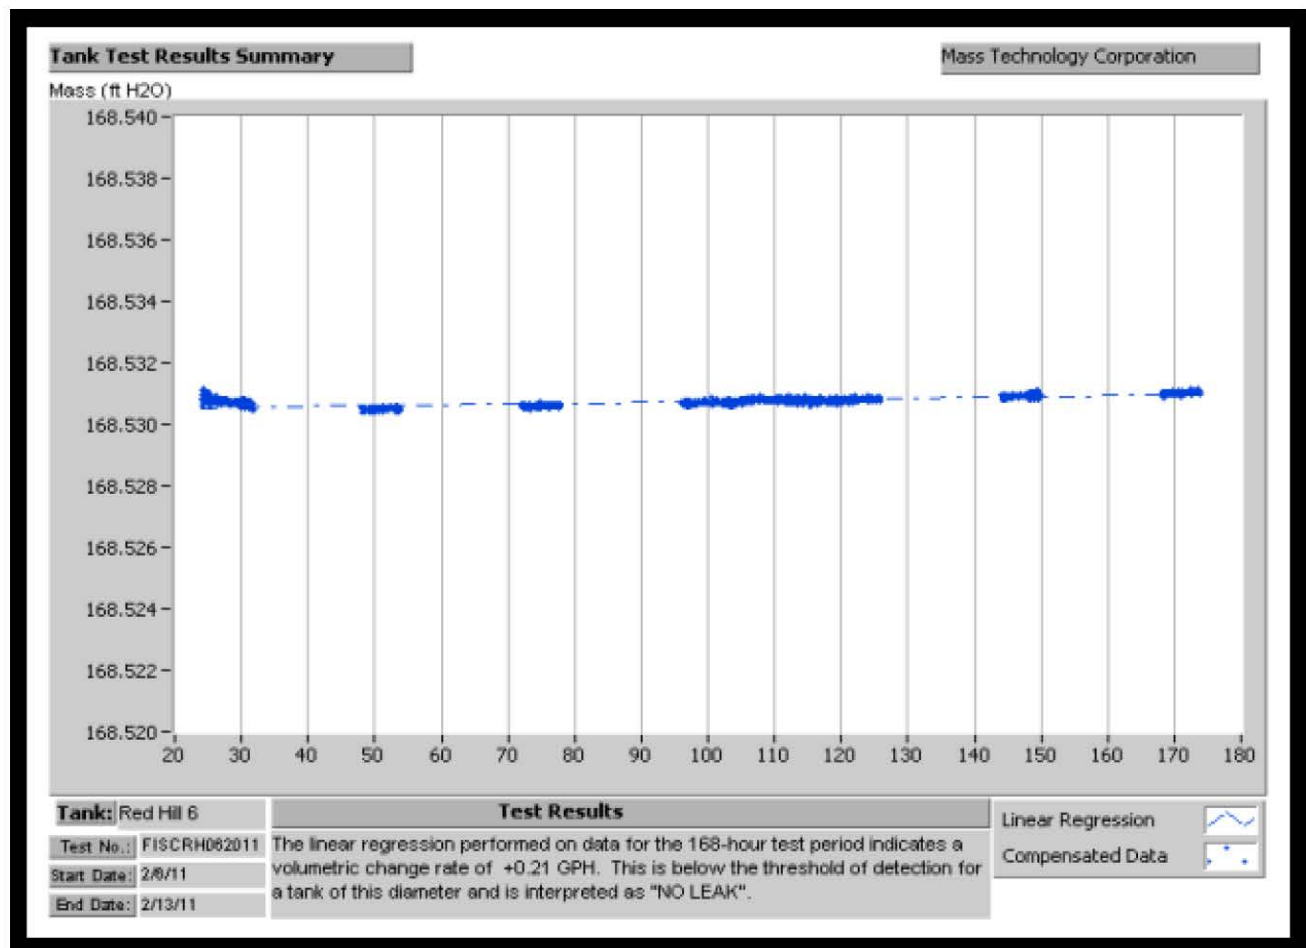
The fluid mass data was recorded over a 168-hour period. A linear regression of the recorded fluid mass data resulted in a leak rate detected below the minimum detection level of 0.7 gallons per hour. All tank valves were adequately secured such that any fluid loss was isolated to leakage. Therefore, the containment integrity of the tank was not compromised and the test is considered conclusive.

Tank # 06 is certified to be tight.
