Michael Baker Jr., Inc. Virginia Beach, VA

11 MARCH 2011

# FINAL 2011 BIENNIAL INTEGRITY TESTING REPORT OF BULK FIELD CONSTRUCTED UNDERGROUND STORAGE TANK 12

## NAVAL STATION PEARL HARBOR / RED HILL, HAWAII

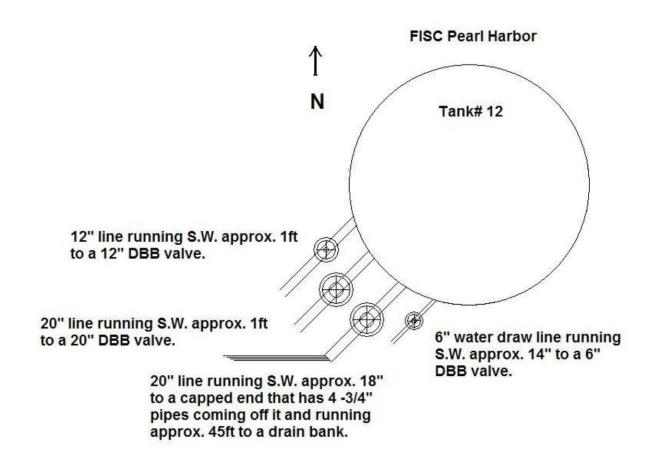
Diameter: 100 ft. Height: 250 ft.

Tank Type: Vertical UST Contents: JP-5

Properties: 0.82 Specific Gravity Product Level: 211.7 ft.

All dimensions, line locations, sizes and valve descriptions have been furnished by the facility operator.

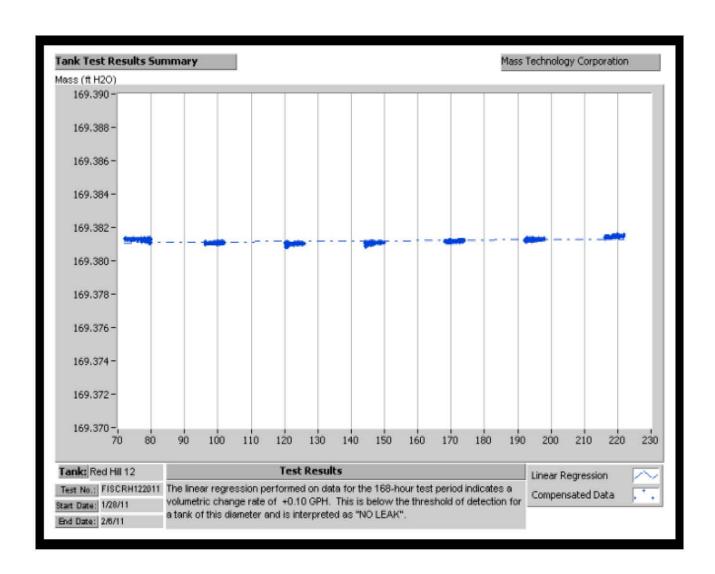
The fluid mass data was recorded over a 168-hour period. A linear regression of the recorded fluid mass data resulted in a leak rate detected below the minimum detection level of 0.7 gallons per hour. All tank valves were adequately secured such that any fluid loss was isolated to leakage. Therefore, the containment integrity of the tank was not compromised and the test is considered conclusive.

Tank # 12 is certified to be tight.
