# FINAL 2011 BIENNIAL INTEGRITY TESTING REPORT OF BULK FIELD CONSTRUCTED UNDERGROUND STORAGE TANK 13

NAVAL STATION
PEARL HARBOR / RED HILL,
HAWAII

**Final 2011 Biennial Integrity Testing Report** Of Bulk Field Constructed Underground Storage Tank 13

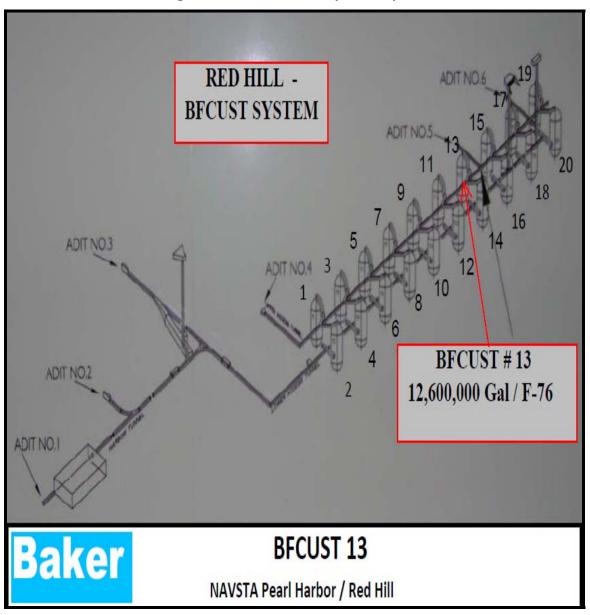
Figure 1-1: RED HILL – System Layout

A Mass Technology Corporation (MTC) integrity test on BFCUST 13 was performed from 18 February to 25 February 2011. Table 1-1 provides a description of the system tested. Figure 1-1 provides a detail of the Red Hill system layout and location of BFCUST 13. Figures 1-2 and 1-3 provide photographs of typical top and bottom of tank access.

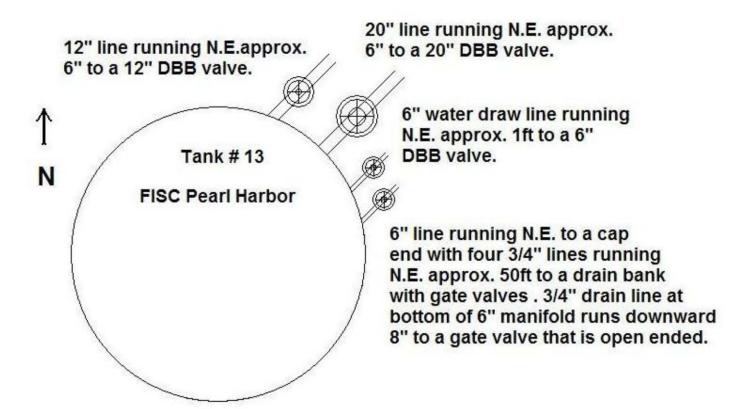
Diameter:100 ft.Height:250 ft.Tank Type:Vertical USTContents:F-76Properties:0.82 Specific GravityProduct Level:211.6 ft.

All dimensions, line locations, sizes and valve descriptions have been furnished by the facility operator.

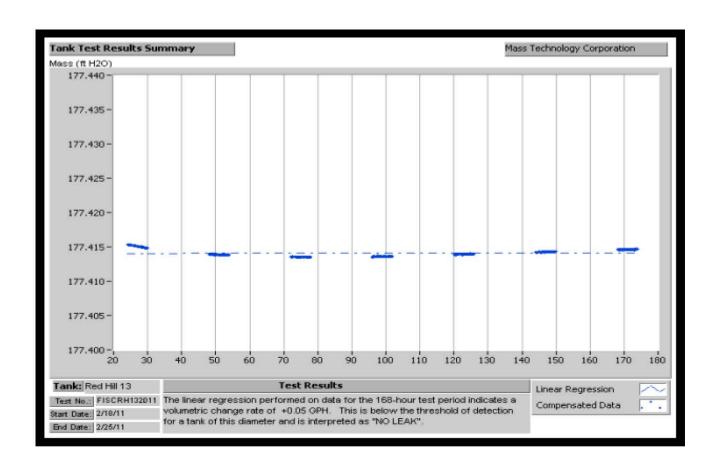
The fluid mass data was recorded over a 168-hour period. A linear regression of the recorded fluid mass data resulted in a leak rate detected below the minimum detection level of 0.7 gallons per hour. All tank valves were adequately secured such that any fluid loss was isolated to leakage. Therefore, the containment integrity of the tank was not compromised and the test is considered conclusive.

Tank # 13 is certified to be tight.
